**THREATENED RESOURCES DOCUMENTED
IN MARYLAND, 1995-96**

Center for Historic Architecture and Engineering
College of Urban Affairs and Public Policy
University of Delaware
Newark, Delaware

1996

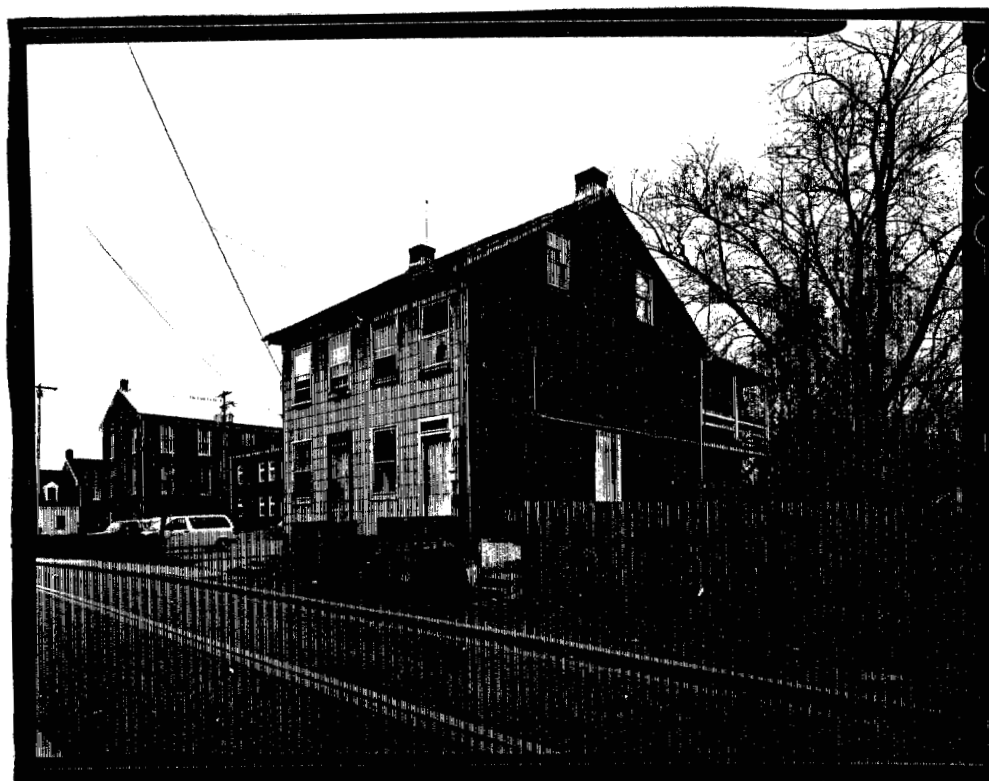
Figure 3: 111-113 Ice Street, perspective of the north and east elevations looking south.

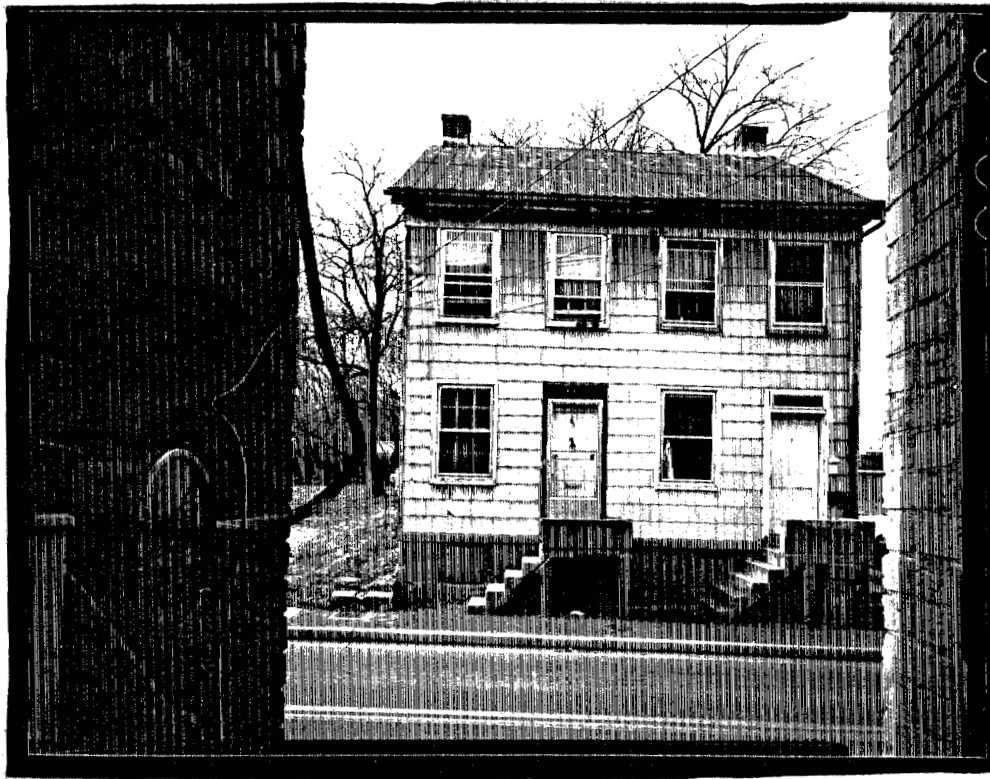
Figure 4: 111-113 Ice Street, view of the east elevation looking west.

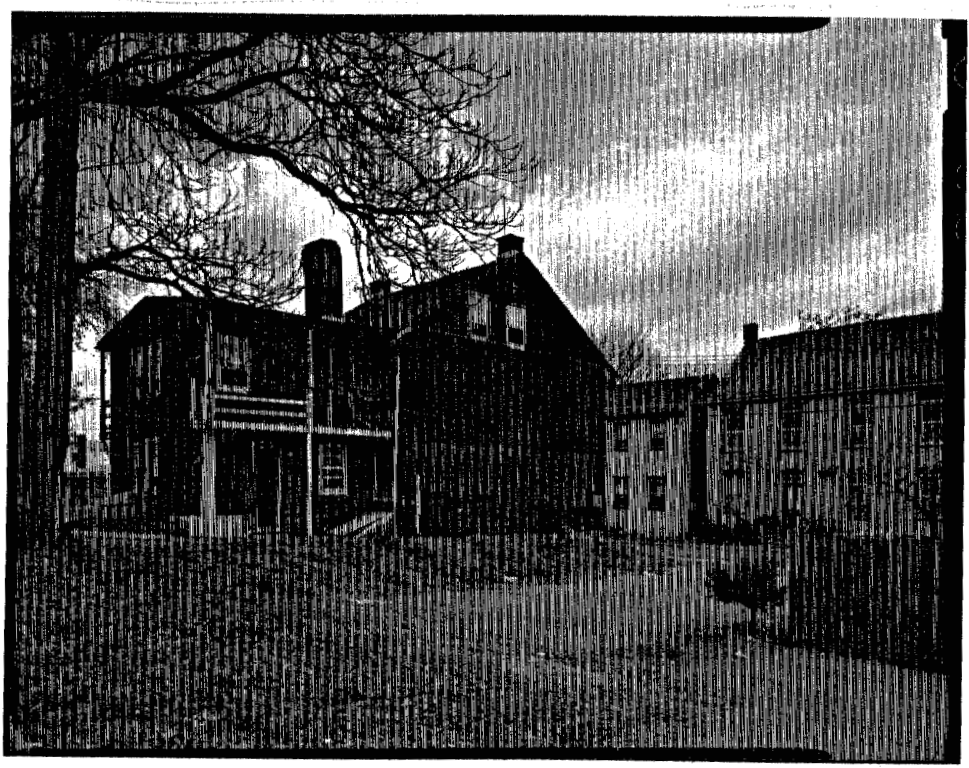
Figure 5: 111-133 Ice Street, perspective of the south and west elevations looking northeast.

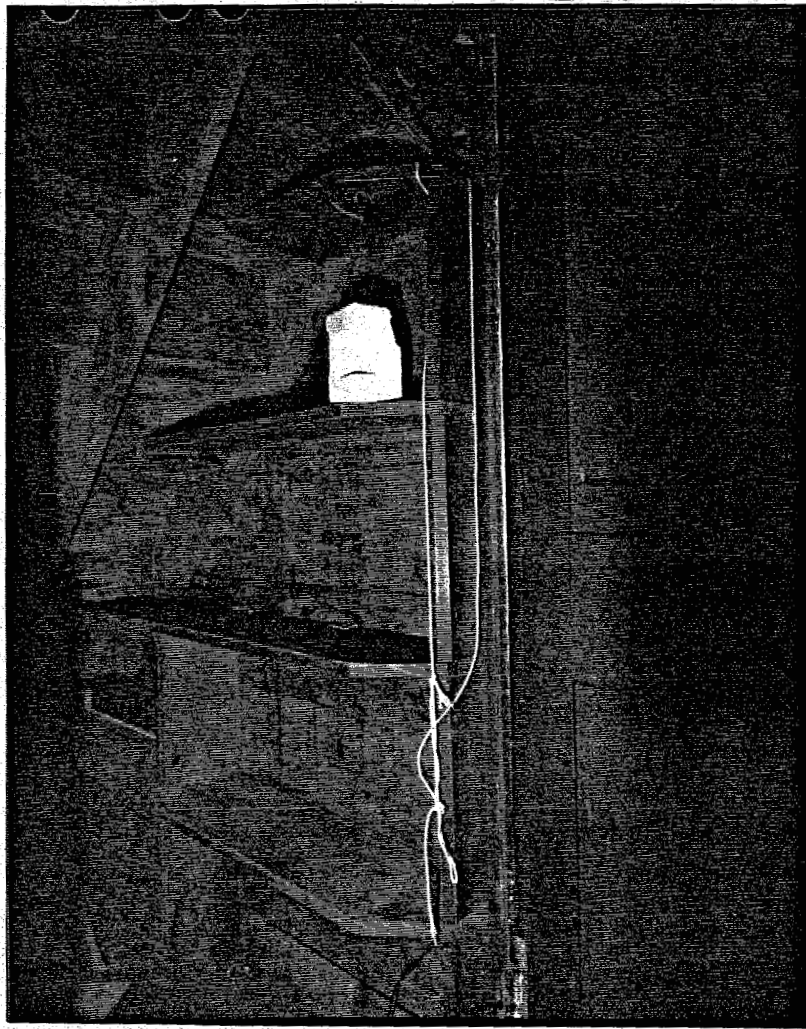
Figure 9: 111-113 Ice Street, first floor: detail of shelves in the closet under the north stairs, looking north.

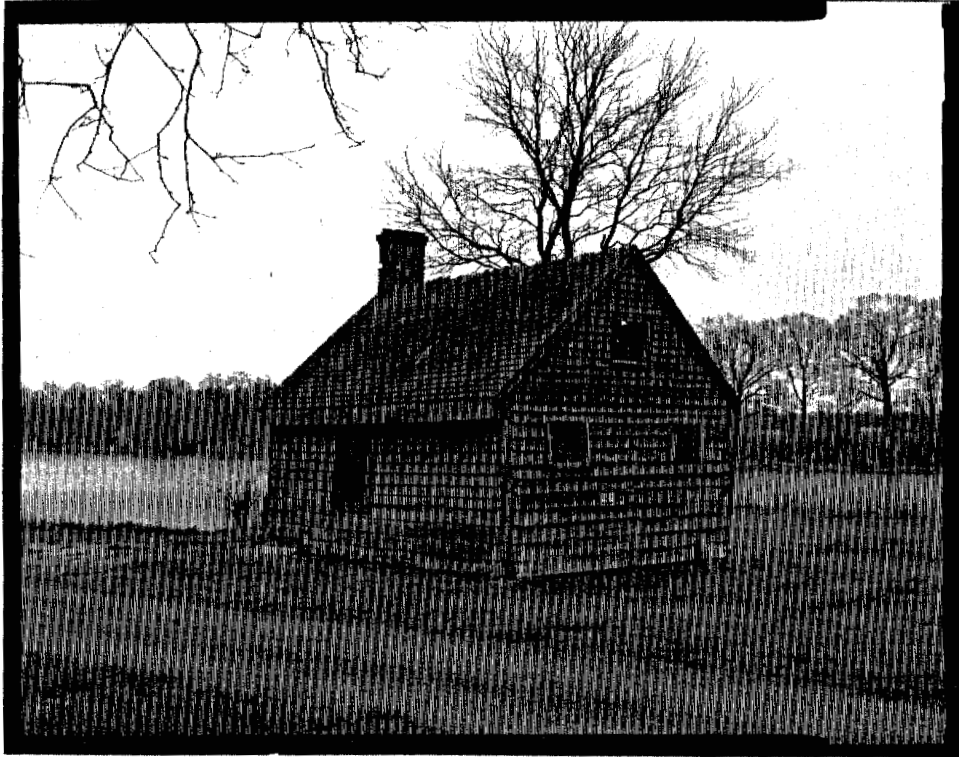
Figure 31: Hermitage Quarter, perspective of north and east elevations looking southwest.

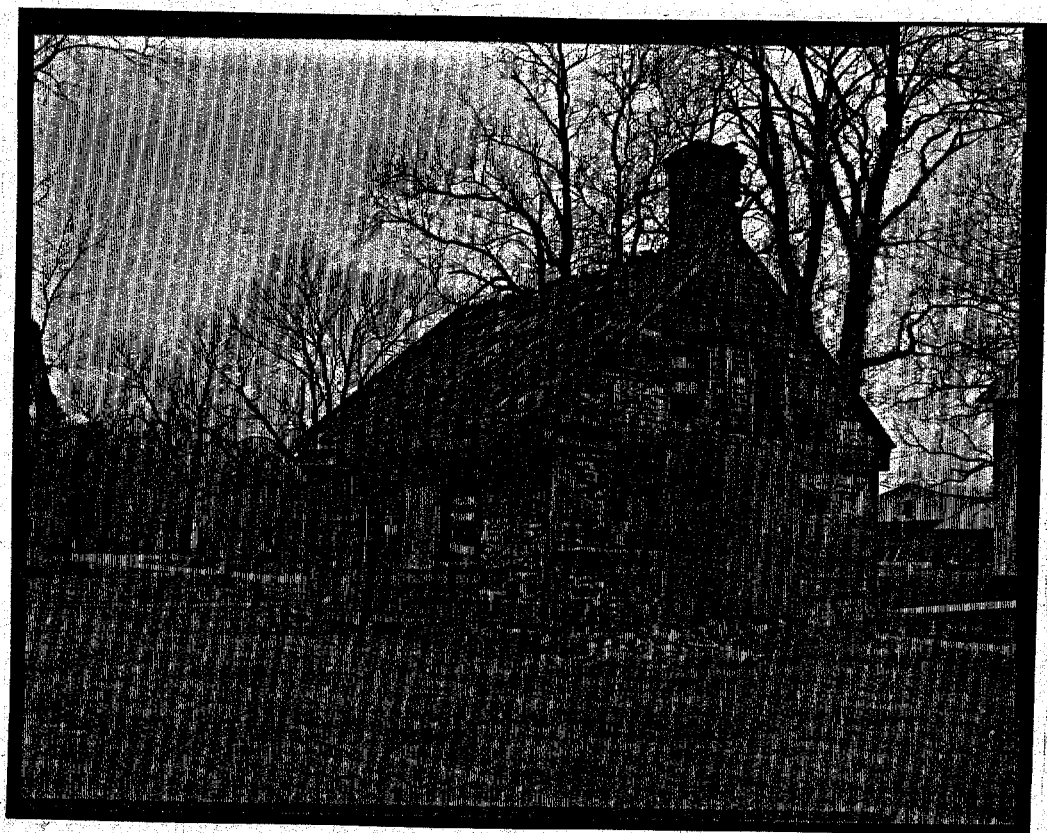
chimney was heavily damaged by a tornado and the south elevation is very deteriorated. A boxed cornice lines the eaves.

Figure 32: Hermitage Quarter, perspective of south and west elevations looking northeast.

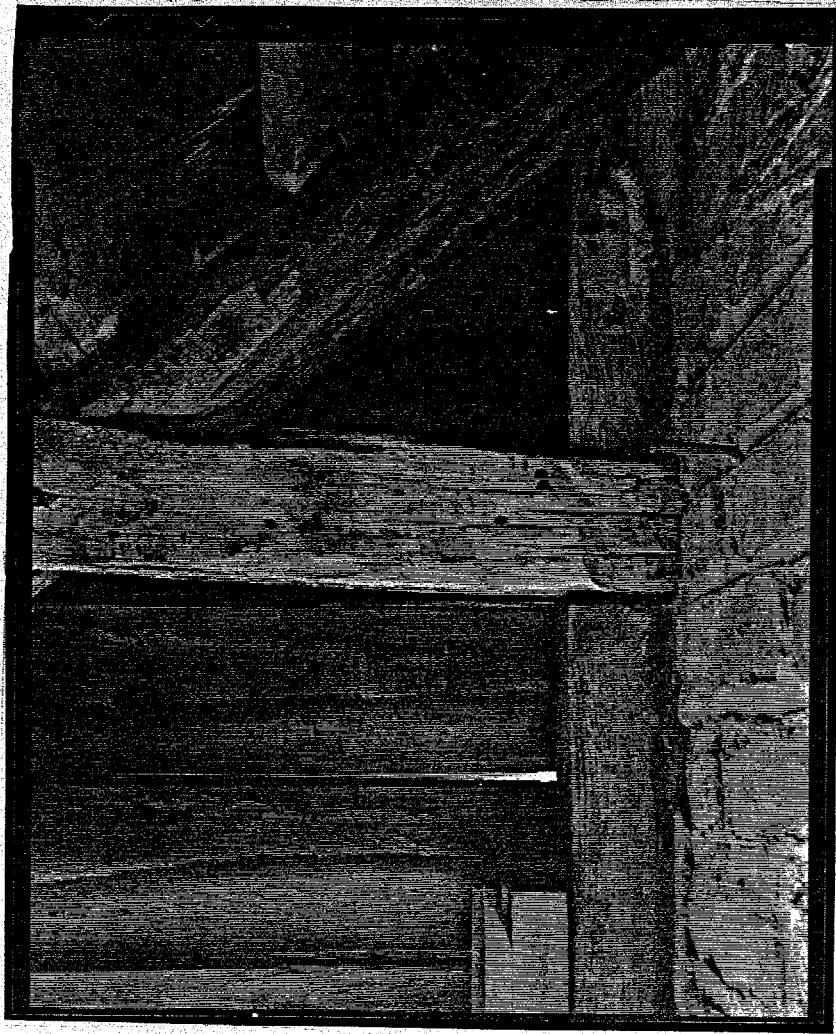
Figure 39: Hermitage Quarter, detail of collar beam and chimney stack in south gable end of attic, looking south.
