KENT COUNTY

Site Name: Reynolds House
CRS Number: K-4406
HABS Number: DE-000

Site Name: Saint Paul's AME Church
CRS Number: K-2107.117
HABS Number: DE-000

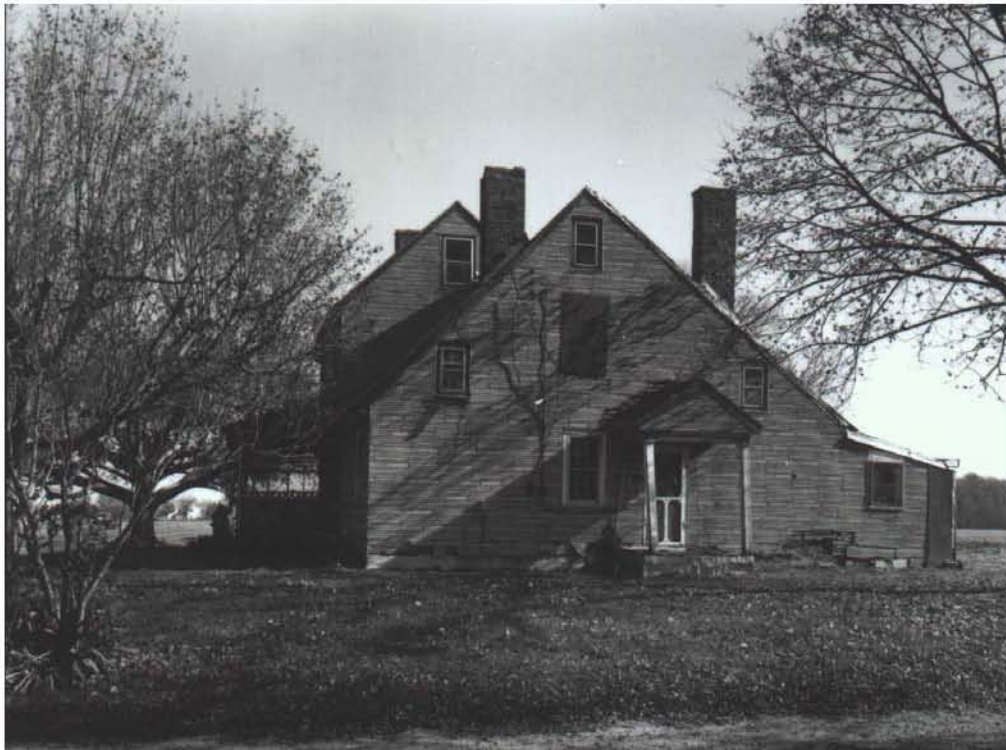
The west gable elevation of the wing has an irregular window pattern. Two six-over-six-light sash windows are located on the first floor. On the second floor there is a two-over-two-

Figure 47: Reynolds House, view of the west elevation, looking east.

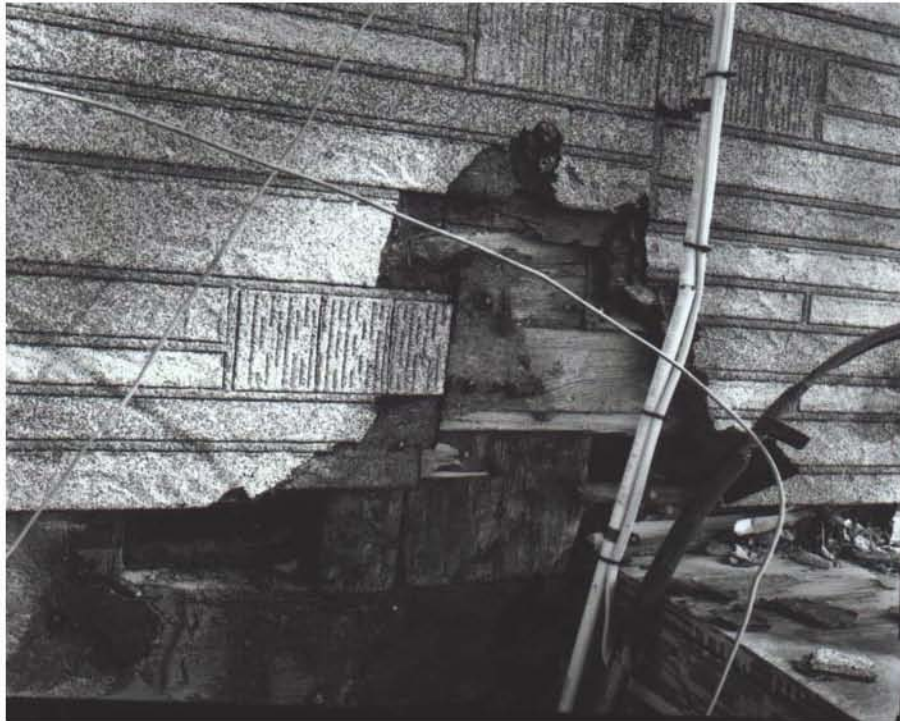
Figure 48: Reynolds House, detail of the siding on the west elevation.

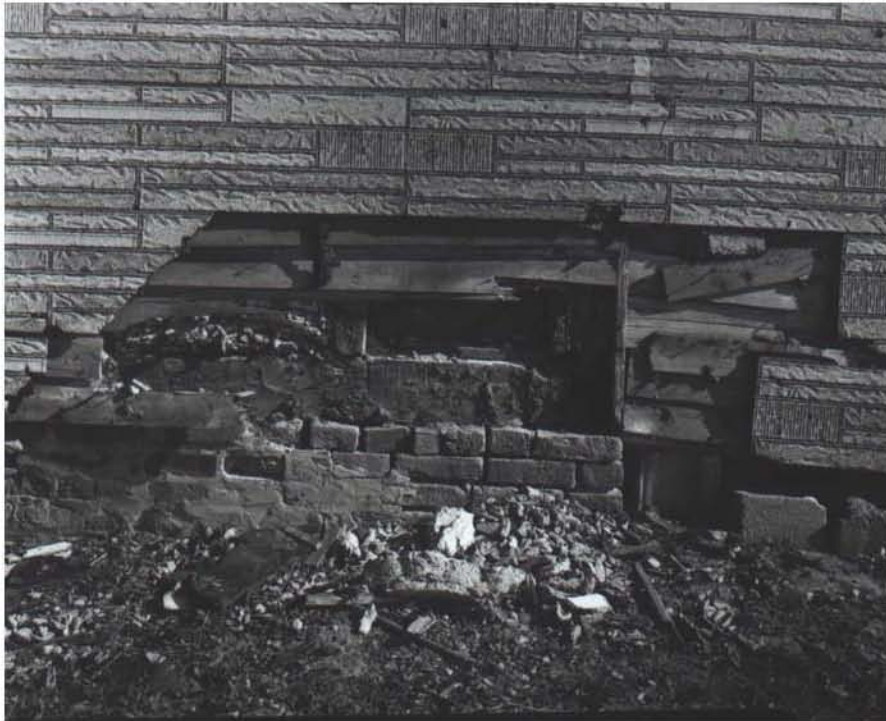
Figure 49: Reynolds House, detail of siding and exposed post and sill on the west elevation.

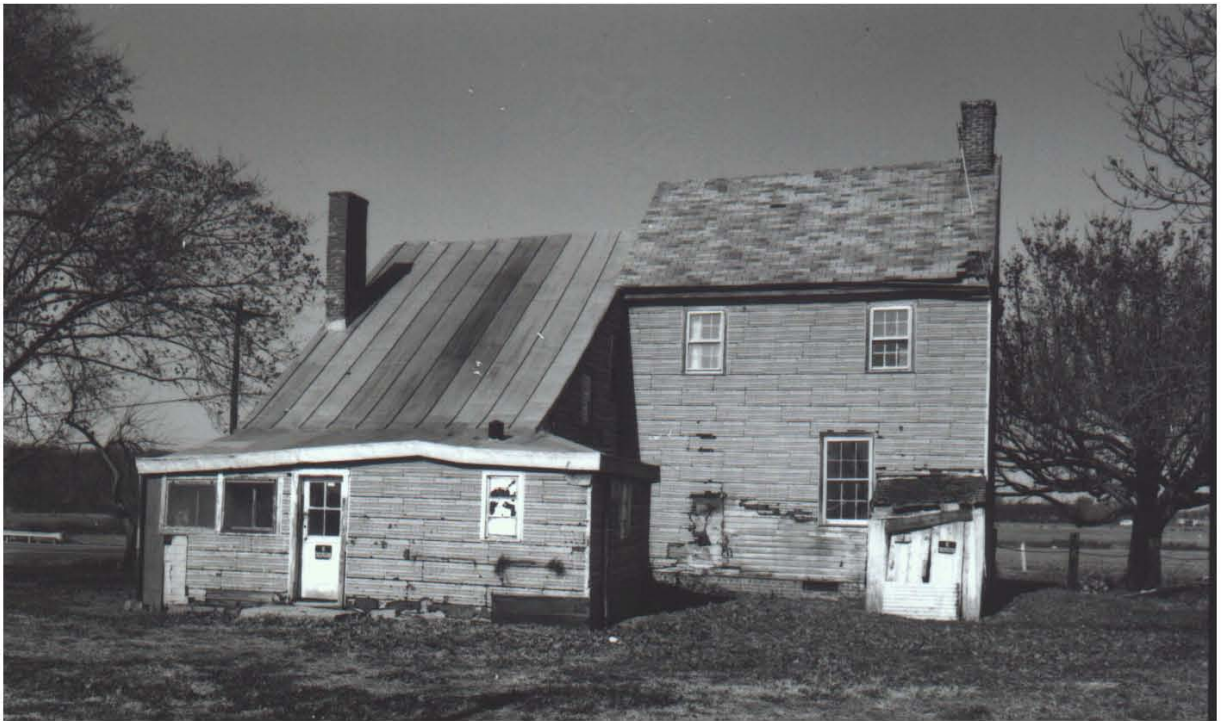
The south elevation of the main block has one six-over-six-light sash window on the first floor adjoining a bulkhead entry on the southeast corner of the elevation. The bulkhead entry is enclosed in a small shed addition. To the west of the bulkhead, there is evidence of a door opening was filled in. The second floor has two six-over-six-light sash windows spaced evenly across this elevation which again terminates with a box cornice. The south elevation of the shed addition has three casement windows and a door.

Figure 51: Reynolds House, view of south elevation looking north.

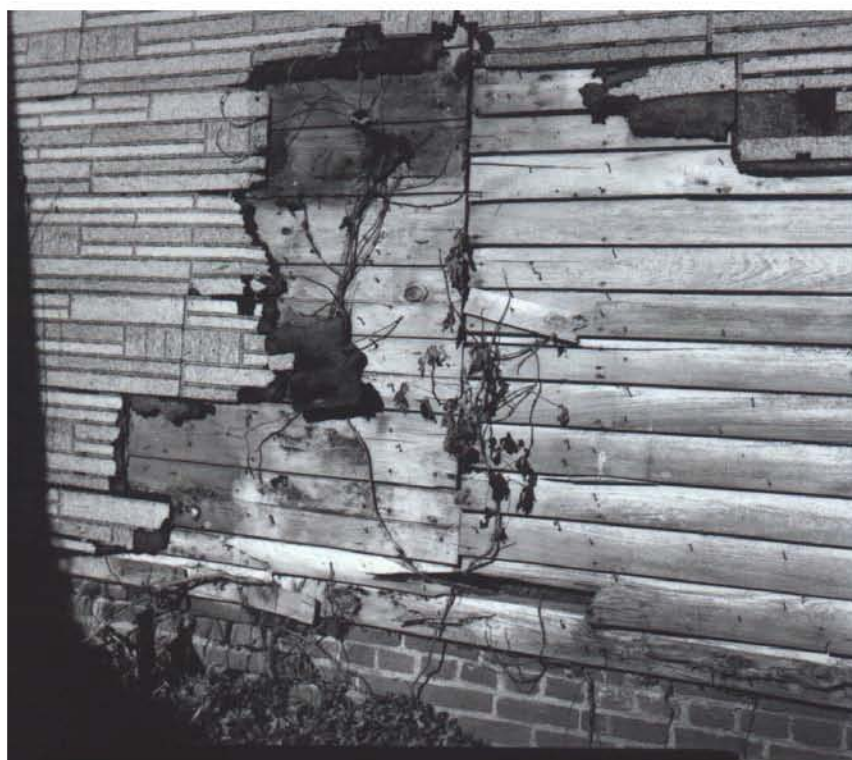
Figure 52: Reynolds House, detail of south elevation of Period III block, showing filled opening for earlier door.

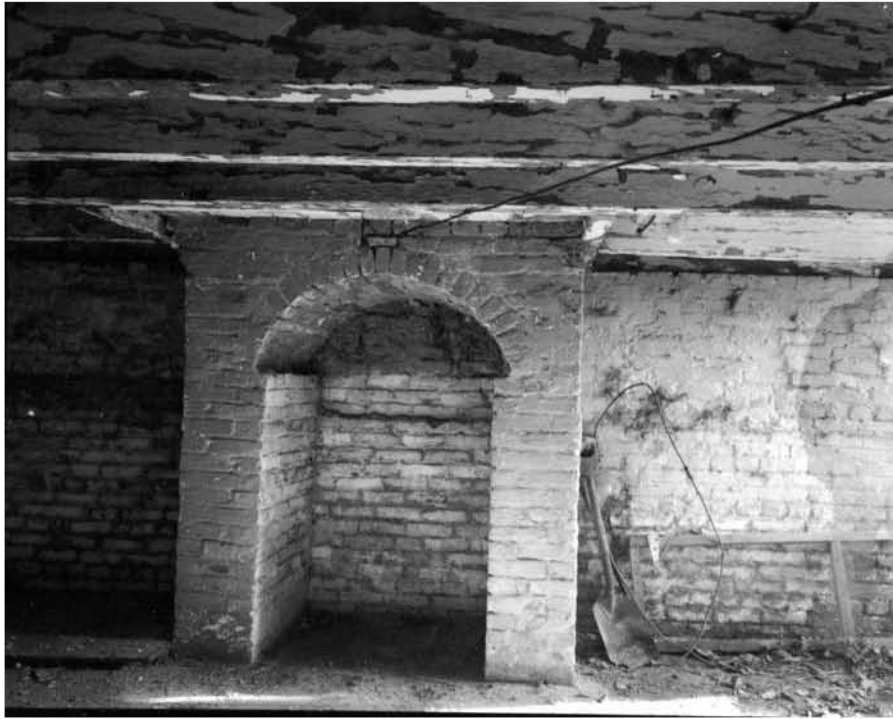
A cellar below the main block is reached by the bulkhead at the southeast corner of the south elevation. The walls of the cellar are brick and the plan is divided into two spaces, each measuring approximately 18 by 10 feet. The eastern section has a relieving arch centered against the east wall. The ceiling joists and the walls are white washed in this section indicating that this area was used for food storage. The joists are notched onto a hewn sill, which is mortised and

Figure 53: Reynolds House, cellar, relieving arch on east wall looking east.

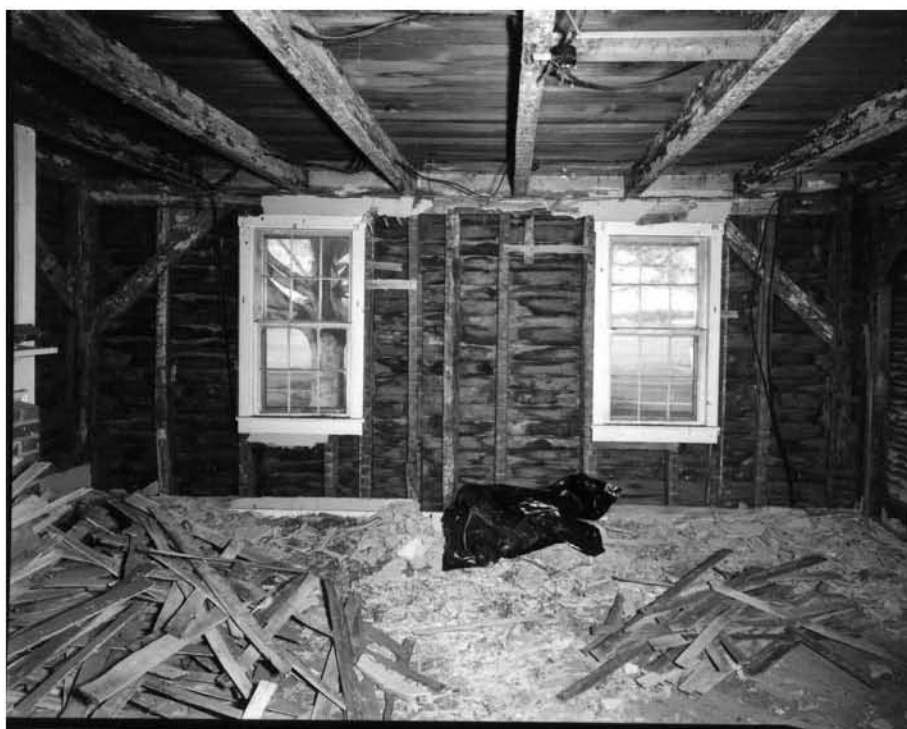
Figure 54: Reynolds House, first floor, Period I section: view of north wall looking north.

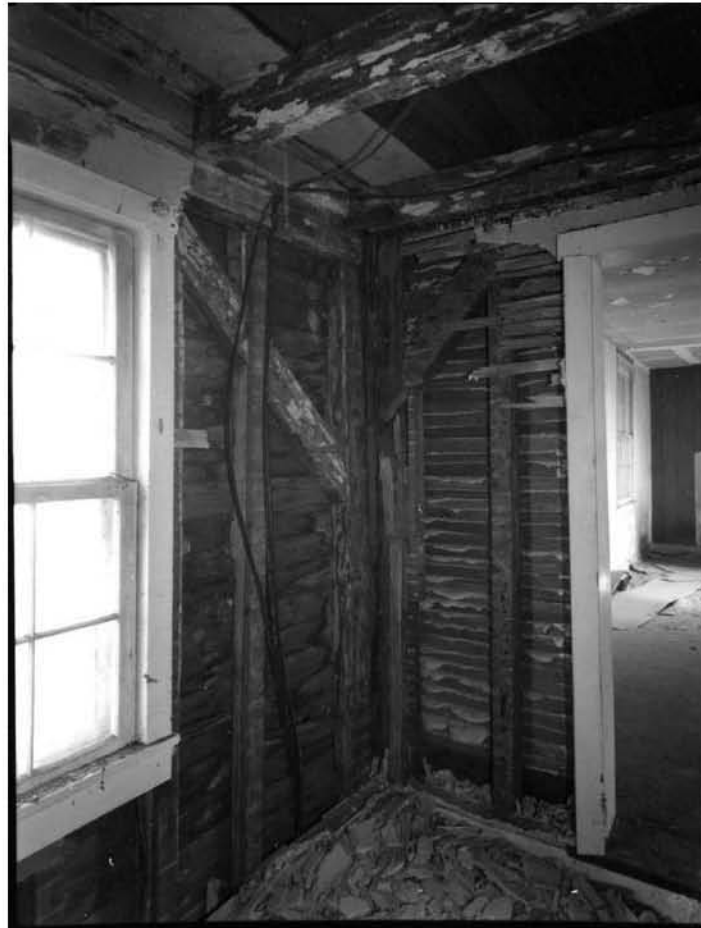
Figure 55: Reynolds House, first floor, Period I section: detail of framing in northeast corner looking northeast.

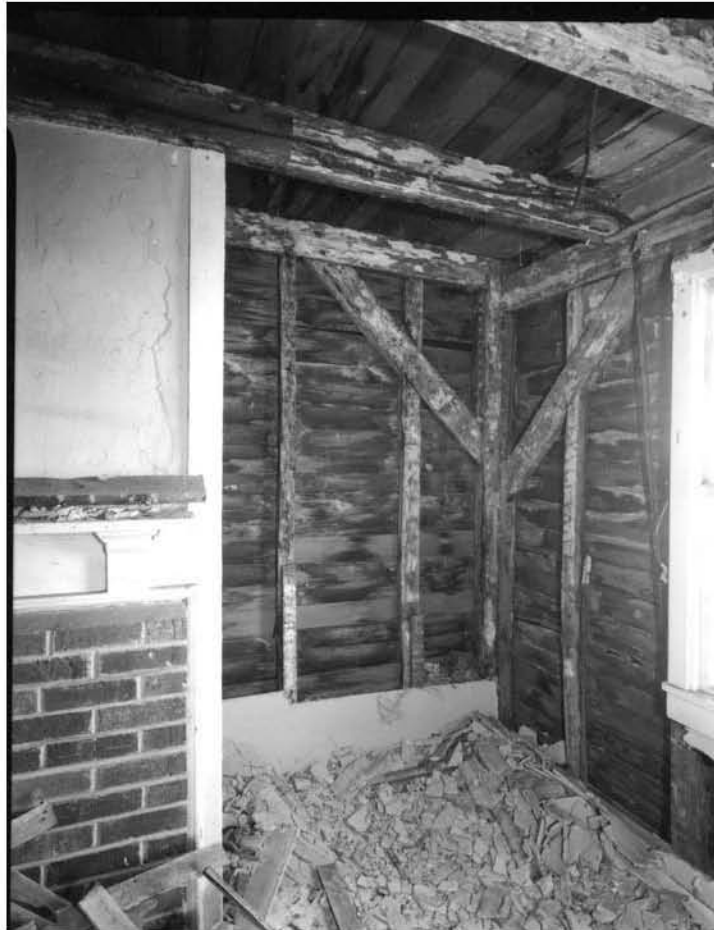
Figure 56: Reynolds House, first floor, Period I section: detail of framing in northwest corner looking northwest.

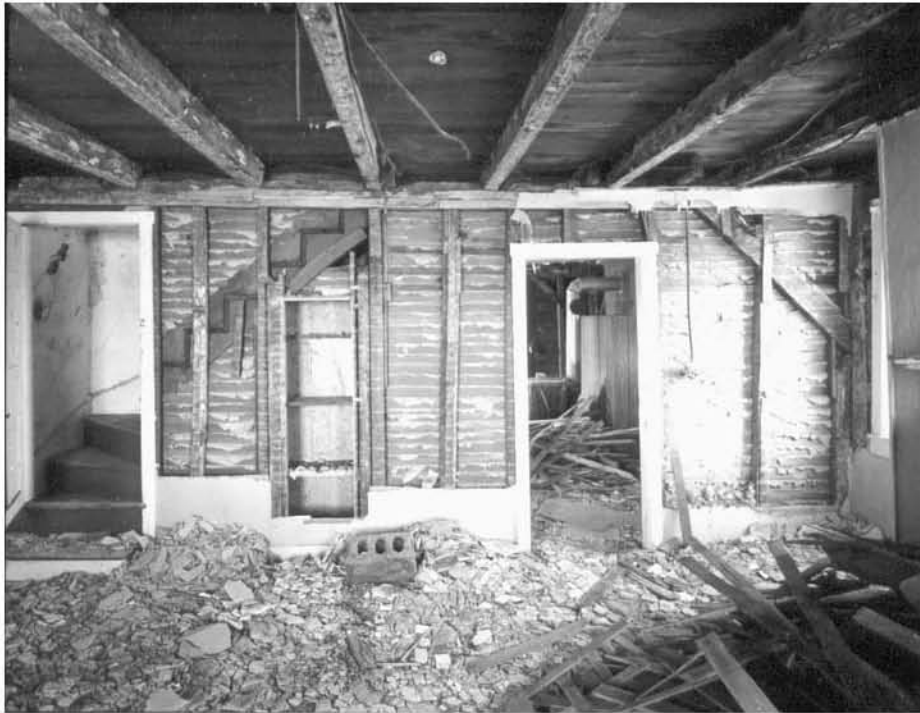
Figure 57: Reynolds House, first floor, Period I section: view of south wall looking south.

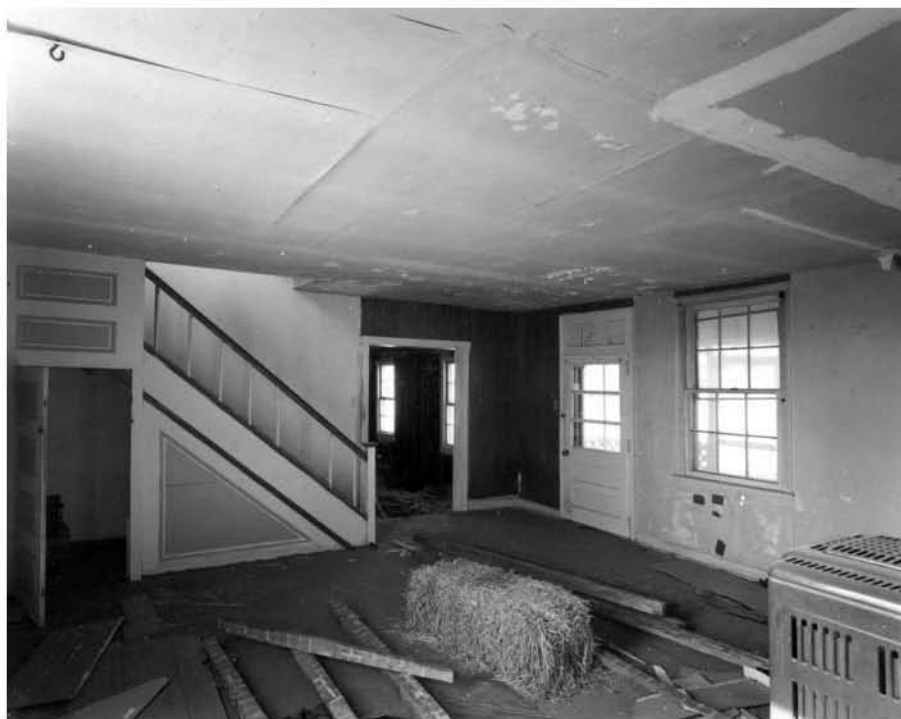
The first floor of the main block is currently one room, measuring 21 by 17 feet, but evidence on the walls and the ceiling indicates that it was originally a side-hall plan with a corridor along the stair. The door in the north elevation opened into the stair passage, measuring 7 by 17 feet, with the stair being located against the west wall in the southwest corner of the space. The stair has a straight run that ends in a winder turn to the landing, and a closet with shelves underneath. A shadow of an original door opening is located opposite the entry door on the south wall to the left of the stair. A shadow of a partition wall also remains visible on the ceiling in this area indicating a narrow corridor. The remaining part of the first floor space, which was once a separate room measuring 14 by 17 feet, has two windows in the north wall and one in the south wall. A fourth window, once located on the east wall north of the fireplace, has been filled in. The chimney is located against the east wall. The fireplace has been closed off but the carved fireplace surround is intact. The walls in this space are covered with lath and plaster, likely the wall covering over the timber frame from the beginning.

Figure 58: Reynolds House, first floor, Period III: view of north and west walls looking northwest.

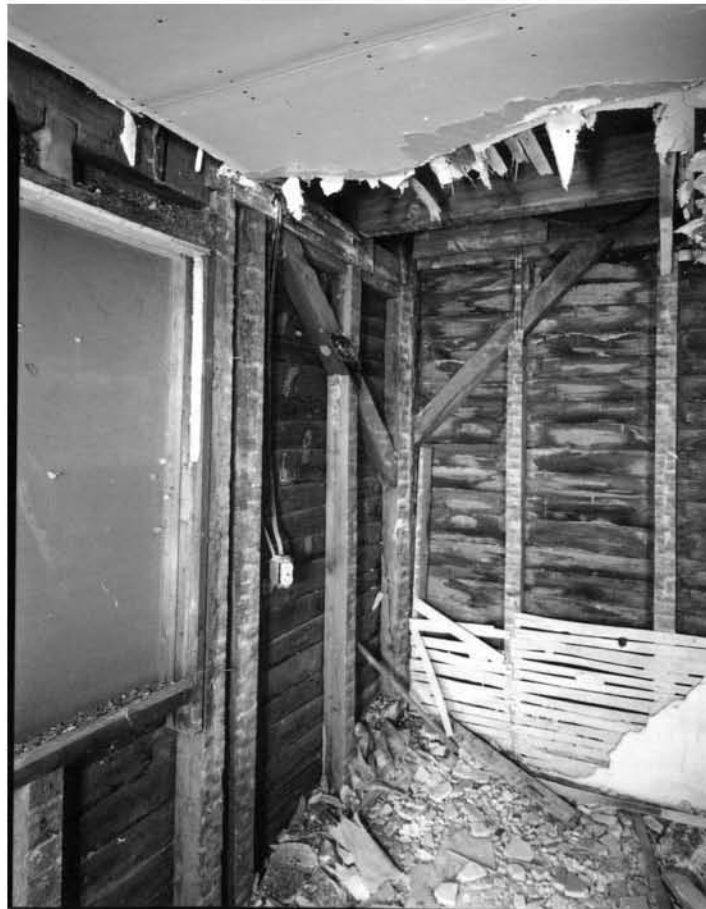
Figure 59: Reynolds House, first floor, Period II section: detail of framing in southwest corner looking southwest.

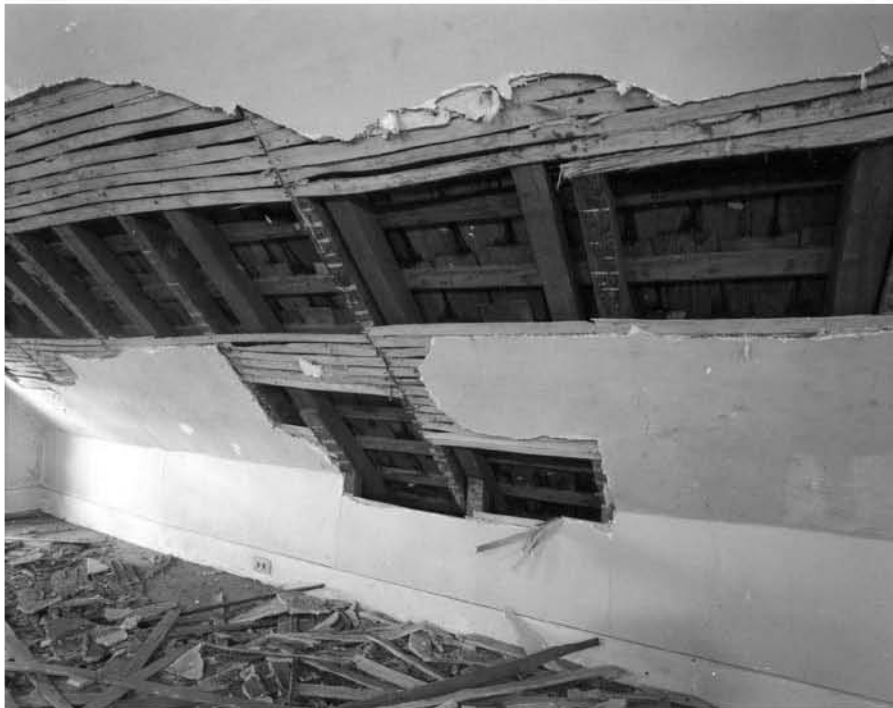
Figure 60: Reynolds House, second floor, Period I/II section: detail of roof framing in north wall.

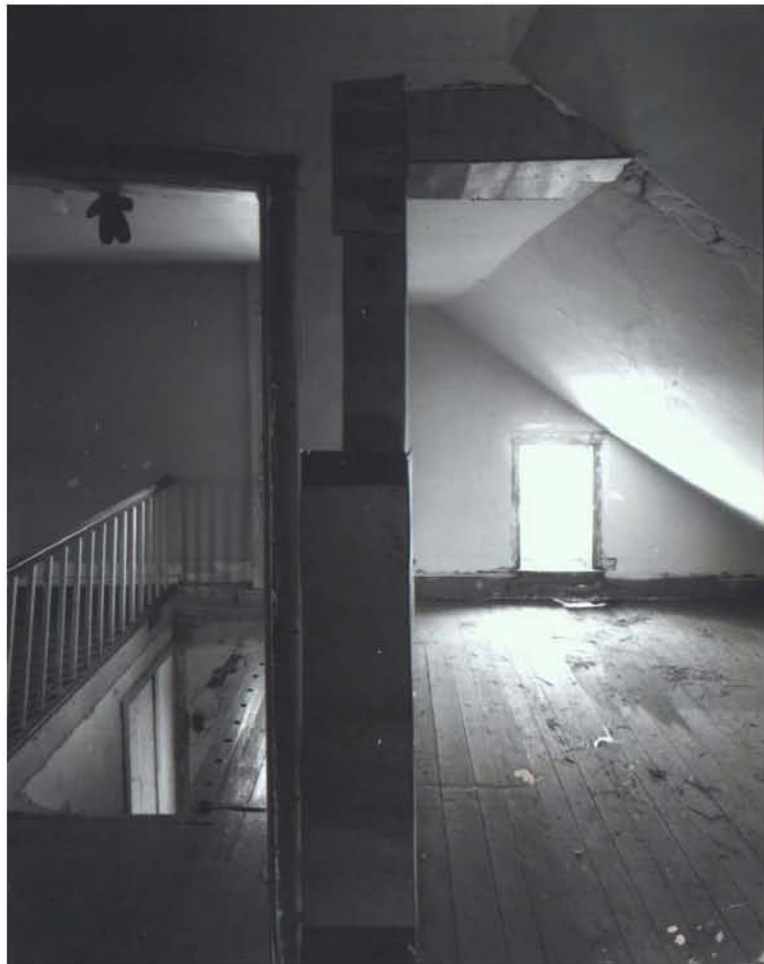
Figure 61: Reynolds House, second floor, Period I/II section: view of northeast and southwest rooms looking east.

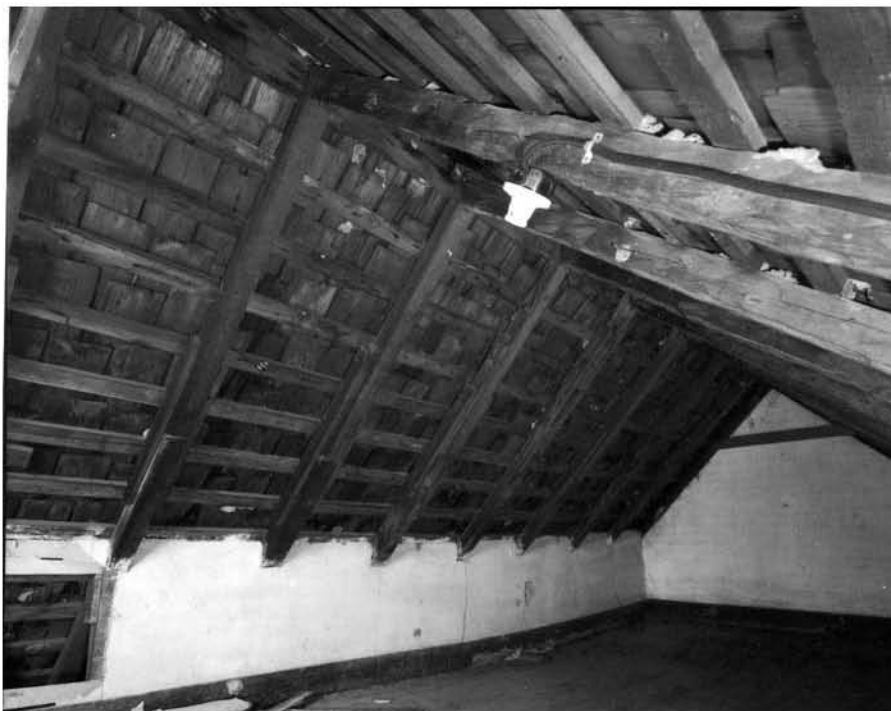
The attic of the wing has undergone extensive alterations. The rafters on the north side of the building are sawn whereas those on the south side are hewn. All are simply butt joined at the ridge. The sawn rafters for the north face of the roof extend below the knee wall where they are scabbed on to older hewn rafters below indicating that the roof was raised over this section after its original construction. The hewn rafters for the south face are continuous from the ridge to the eaves and may have been salvaged from another building when this roof was raised.

Figure 62: Reynolds House, attic, Period I/II section: view of rafters and north wall looking northeast.
