OPEN FILE REPORT No. 14

SINKHOLES, HOCKESSIN AREA, DELAWARE

BY
JOHN H. TALLEY

MARCH 1981

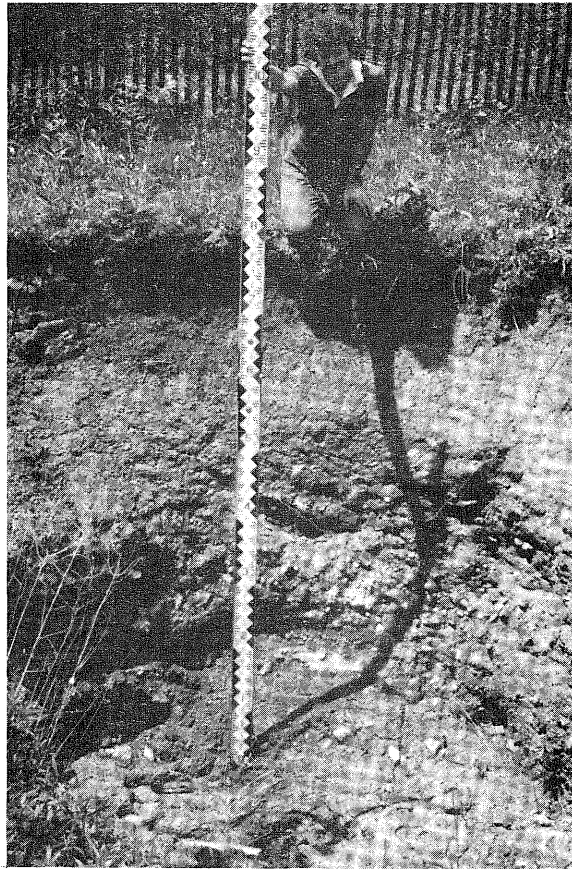
In May 1978, Sinkhole No. 1 was circular, about 18 feet in diameter, and 8.5 feet deep (Talley, 1980a). The walls were steep-sided, indicating rapid development (Figure 5). A small hole near the center of the bottom of the sink acted as a conduit for rapid infiltration of water and fine-grained soil into the subsurface. Marble was not exposed in this sinkhole.

Figure 5. Sinkhole No. 1, Francis
J. Swift Park
(from Talley, 1980a).

Drilling around the sinkhole revealed the presence of a 2- to 9-foot thick section of soil, silt, sand, and gravel (Figure 5). A thick section of weathered Cockeysville marble extends from about 9 feet to 50-70 feet below land surface. Relatively hard, fresh marble underlies the weathered rock zone. In April 1979 the water level was about 35 feet below land surface.

Sinkhole No. 1 was repaired in late May 1980 by backfilling with medium to large crushed stone. Bentonite clay was placed over the stone to prevent the infiltration of surface water. Topsoil was in turn placed over the bentonite clay so that natural vegetation would grow over the sink. As of January 1981 no additional subsidence has occurred at this site.

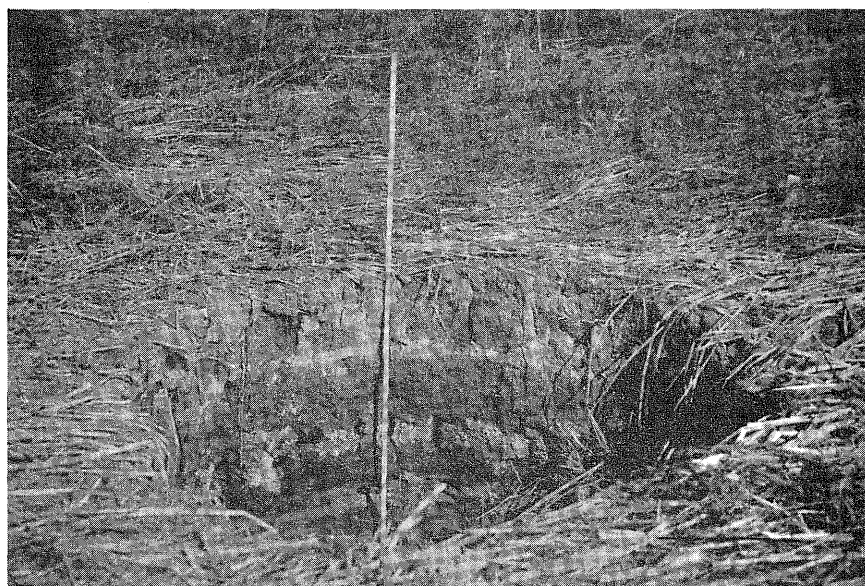
Sinkhole No. 2 was discovered during aerial reconnaissance of the valley on October 17, 1979. The sinkhole is located on the flood plain of a small tributary of Mill Creek and developed very rapidly immediately following a period of 14.19 inches of rainfall during September and October (Figure 6). Evidence supporting rapid development is: (1) vertical walls; (2) undisturbed vegetation draping into the hole and fresh roots entering the sink from sides; and, (3) fresh, moist soil on the bottom and sides of the hole.

Figure 6. Sinkhole No. 2, Francis J. Swift Park.
Photograph taken approximately one week
after formation.

Sinkhole No. 2 was repaired utilizing the same method as that used to repair Sinkhole No. 1.

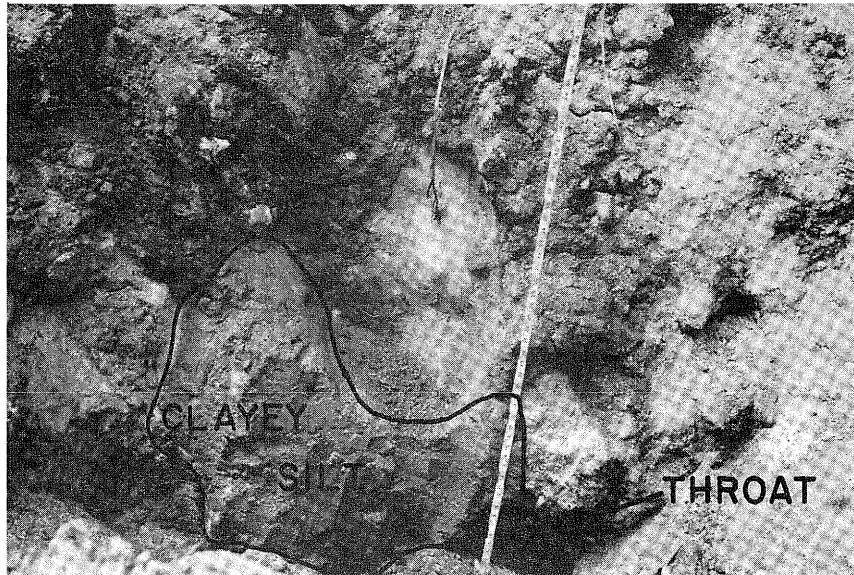
The feature was about 6 feet in diameter and 3 feet deep in June 1980. Excavation prior to repair revealed the existence of an irregular bedrock surface and a 3-foot wide zone of soft carbonate rock and clayey silt. The orientation of this zone is N 34°E, nearly parallel with a major joint set. A small hole that probably functioned as a throat into which the surficial material collapsed and was carried away is shown in Figure 7. A 3-foot by 3-foot pod of clayey silt is apparent above and to the left of the throat. The presence of this

Figure 7. Sinkhole No. 2, Francis J. Swift Park. Note pod of clayey-silt and the throat.

clayey silt, which is incompatible with the adjacent bedrock, suggests that the material was implaced through collapse into a void at some time in the past.

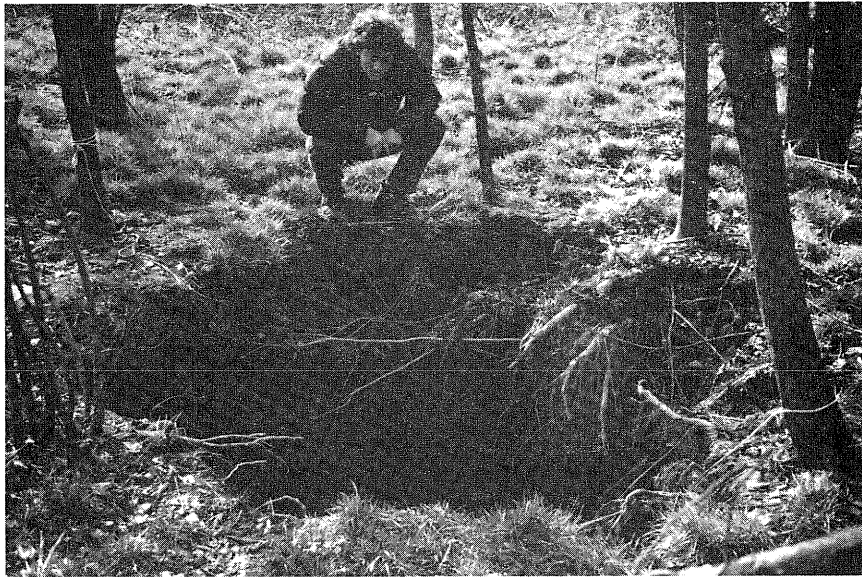
Sinkhole No. 3 is located on the flood plain of a small tributary of Mill Creek. Soil and debris on the ground surface near the sinkhole indicate that this portion of the flood plain is subjected to periodic flooding. Sinkhole No. 3 formed in the fall of 1979 during a period of above average precipitation and was, at that time, about 8.5 feet in diameter and 10 to 12 feet deep. Fresh soil exposed in the vertical walls and fresh roots suspended in the sinkhole (Figure 8) suggests rapid formation. A cave in the bottom of the sink reaches a length of 10 feet. The cave formed in marble and calcareous

Figure 8. Sinkhole No. 3. Note fresh roots extending into the sink.

schist that strikes N 48° E and dips to the southeast at an angle of 28° (Scheinfeld, 1980). The floor of the cave consists of broken carbonate rocks; the throat, through which approximately 12 cubic yards of soil was carried away, was not evident in the sinkhole.
