Site Name: John T. Simmons Farmstead

CRS Number: N-4039

Location: 515 Christiana Road
Bear vicinity
White Clay Creek Hundred
New Castle County, Delaware

Type of Documentation: Level II: Partial Intensive
Annotated field notes (5 sheets)
Measured drawings--CAD (4 sheets)
Black and white 4" x 5" photographs (13)
Architectural data narrative

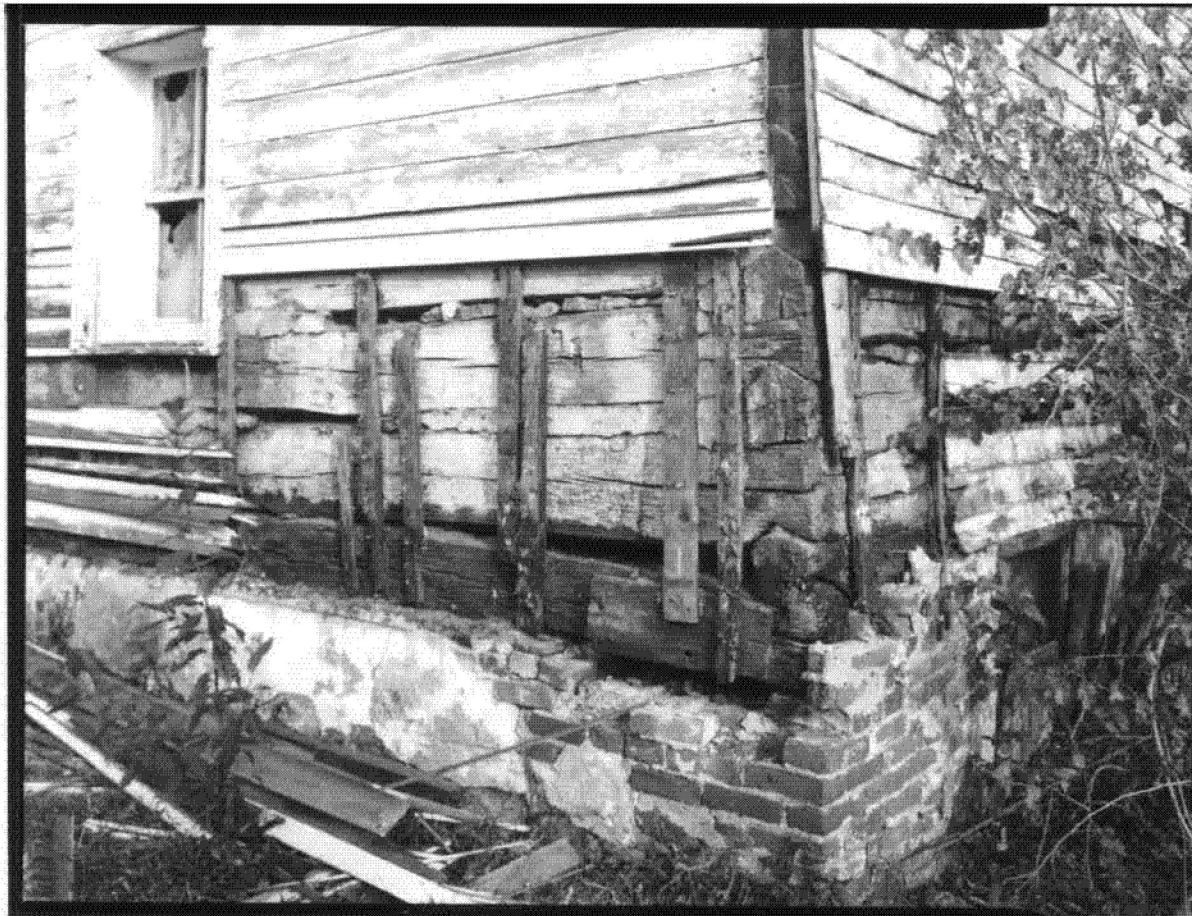
The gable-roofed, single-pile kitchen ell, or Period I section, is sheathed in clapboard with a composition-shingled roof and a low, rubble fieldstone foundation. The southwest corner of the foundation has been repaired with brick. The northwest elevation is divided into two symmetrical bays on each of the two floors. The first floor features an entrance (boarded up) to the north and a two-over-two-light double-hung sash window to the south. The second floor contains two windows equally spaced in the elevation. On the first floor a third bay to the north contains a window lighting the connecting passage.

The removal of a portion of siding from the southern corner of the Period I section revealed details about its log construction. The rough-hewn logs measure approximately nine by nine inches and are joined by V-notching. The spaces between the logs are filled with stone chinking that has been parged with a cement-like material. Vertical wood nailers are equally spaced along the log walls.

Figure 84: Simmons Farm House, detail of log construction on the south corner of the Period I section showing foundation with brick repair, looking north.

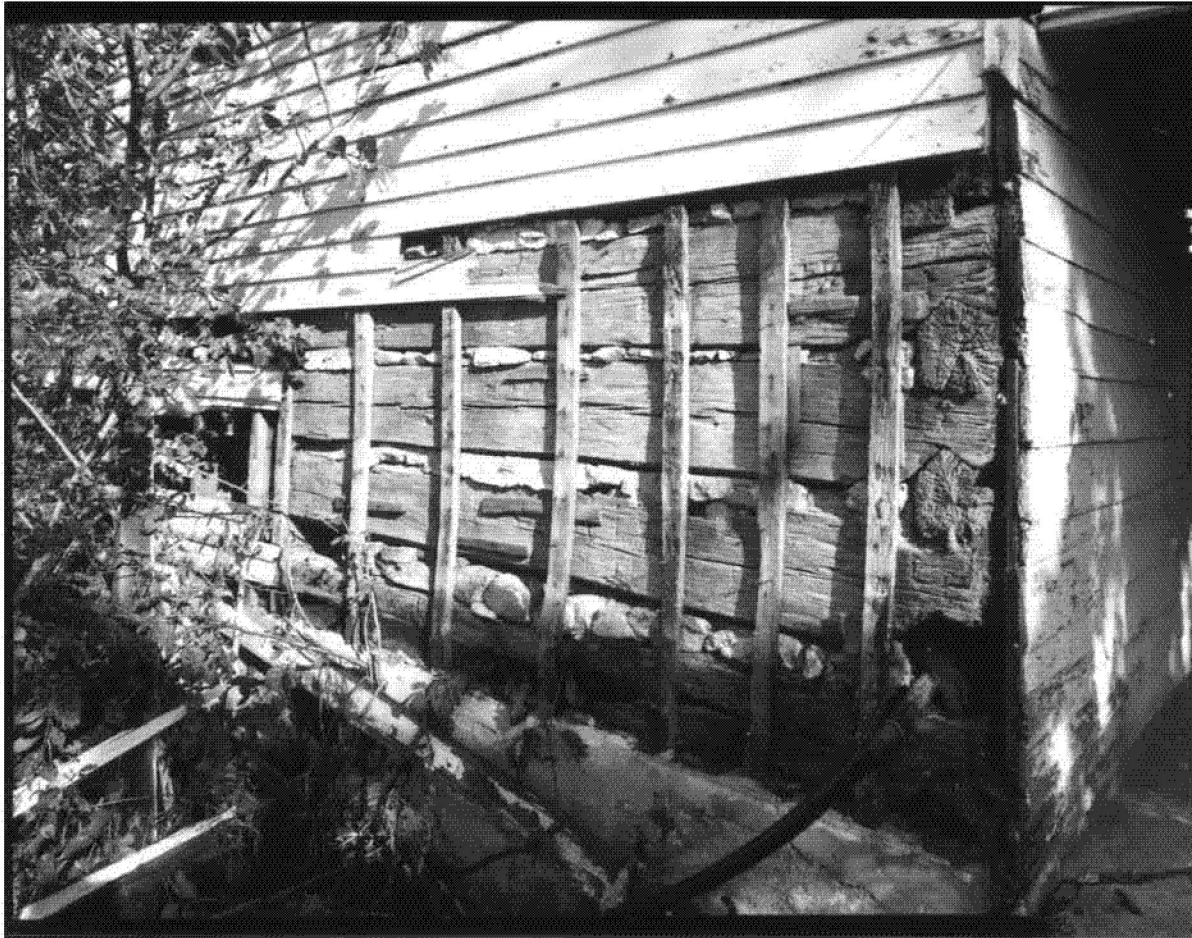
Figure 85: Simmons Farm, detail of log construction on the southwest elevation of the Period I section, looking northwest.

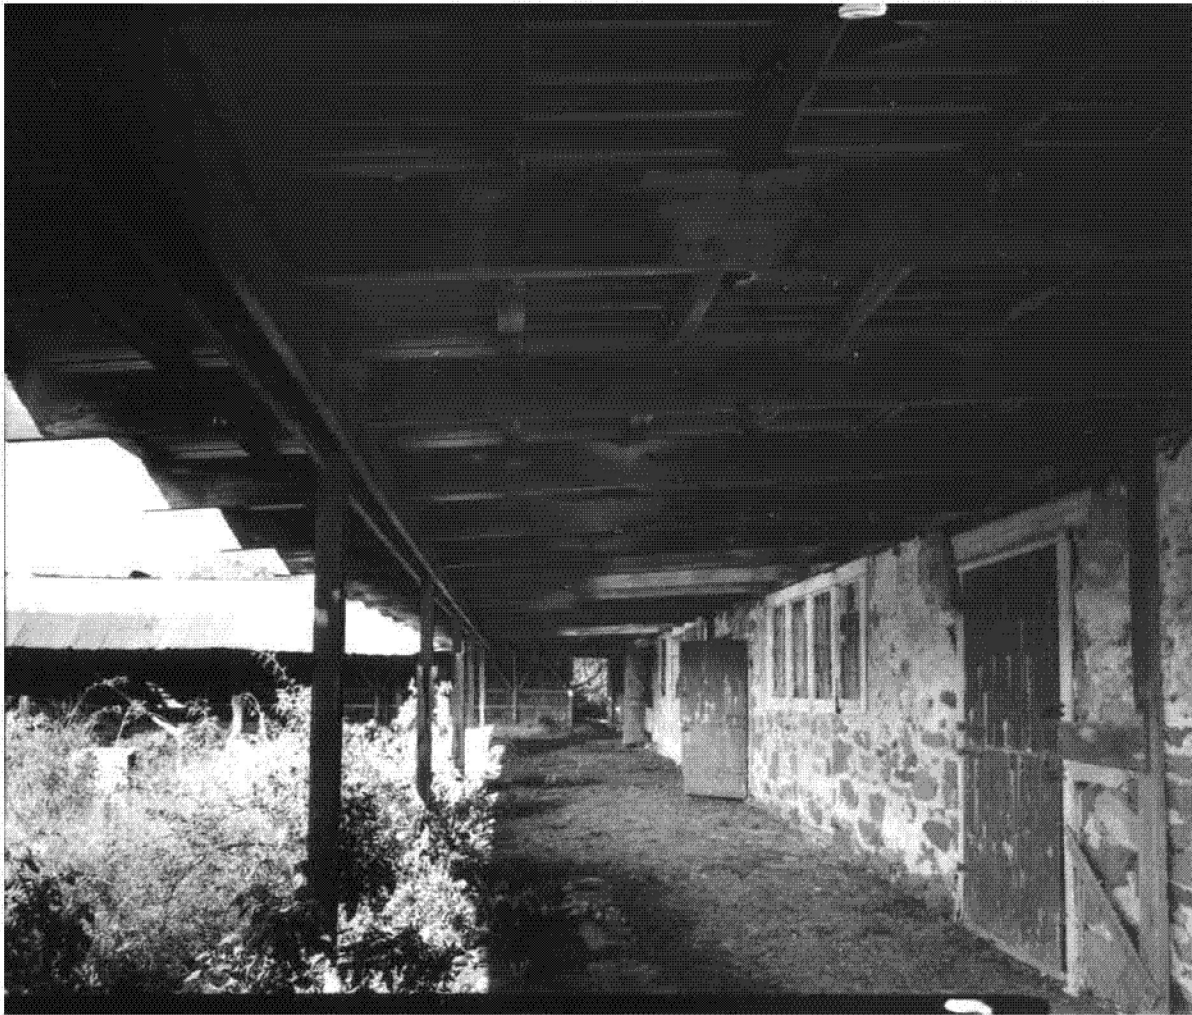
Figure 89: Simmons Farm, view of the forebay of the dairy barn, showing the fieldstone walls and stable doors, looking west.
