Site Name: Charles I. du Pont Tenant Farm

CRS Number: K-3737

Type of Documentation: Level II: Partial Intensive
Annotated field notes (8 sheets)
Measured drawings--CAD (4 sheets)
Black and white 4" x 5" photographs (19)
Architectural data narrative

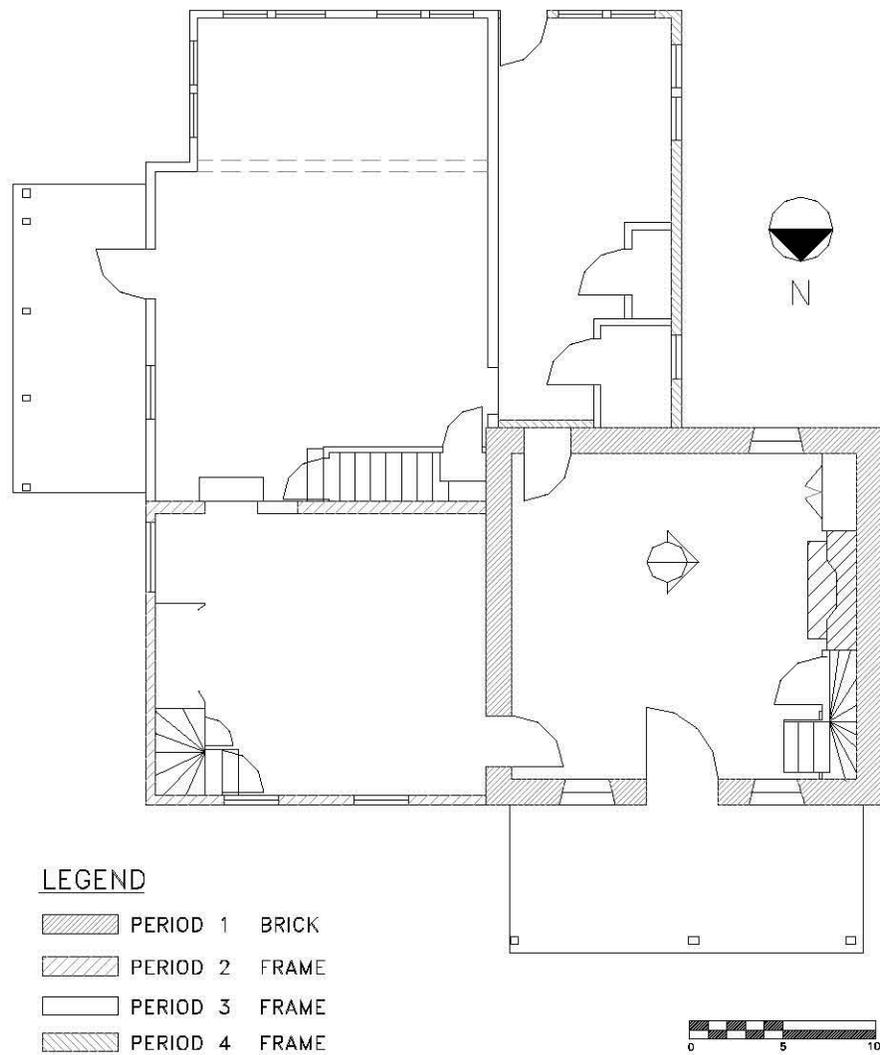
Figure 9: Charles I. du Pont Tenant Farm House, first floor plan.

Farm House. The main dwelling contains four separate construction periods, ranging from the last quarter of the eighteenth century through the mid-twentieth century. The initial period of construction, likely *circa* 1780, resulted in a brick hall-chamber-plan dwelling measuring 22 by 22 feet. Two-and-a-half stories high and three bays wide, the house had an interior end chimney in the west gable. The front (north) elevation is built in Flemish bond with a central door flanked by nine-over-nine-light sash windows. Only two windows, six-over-nine lights, pierce the second floor of this elevation. A shed-roofed porch covers the lower story. The porch has a concrete block foundation, tongue-in-groove ceiling, concrete steps at the east end, and square-cut wooden railings at the west end.

The Period I block features a chambered hall plan. The front door opens into the hall, which measures 20 x 20 feet. Symmetrically placed windows flank the front door. The entire west wall of the hall is paneled, with a centrally placed fireplace. There is a built-in cupboard at the south end of the wall, featuring a curved back wall, arched door with fanlight, butterfly shelves, and carved trim. At the north end of the wall, a board and batten door opens into a boxed winder stair that leads to the second floor chamber. Three steps to the winder protrude into the room. The south wall of the hall originally featured two symmetrically placed windows. Due to the shed addition on the west side of the rear ell of the house, the window on the east end of the wall has been removed or blocked by drywall, and a door has been added to provide access to the porch addition. The east wall of this room features a door that leads to the second period addition. This door appears to be composed of two doors stuck together. The side that

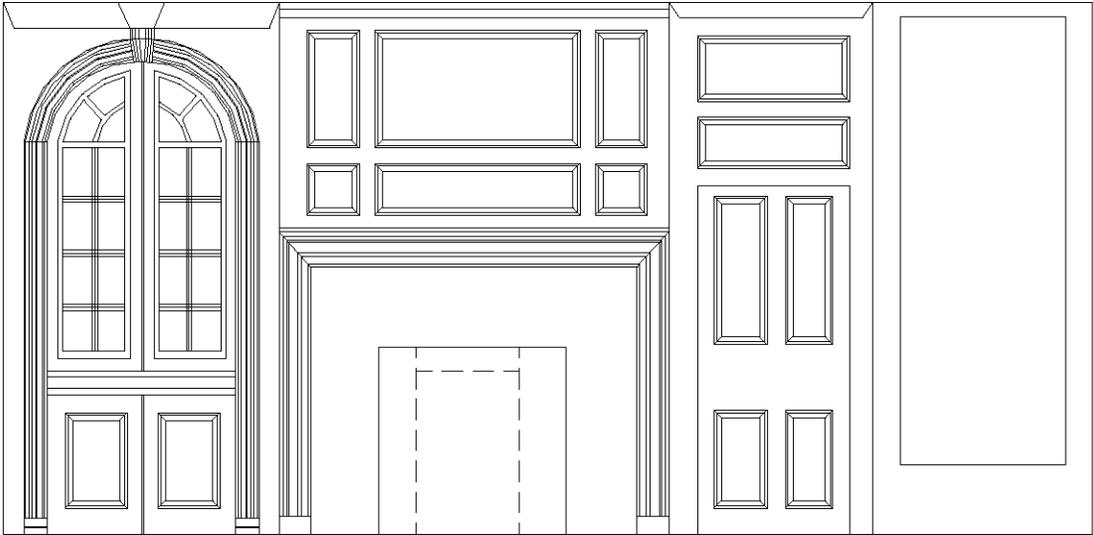
Figure 10: Charles I. du Pont Tenant Farm House, Period I, paneling on west wall of first floor room.

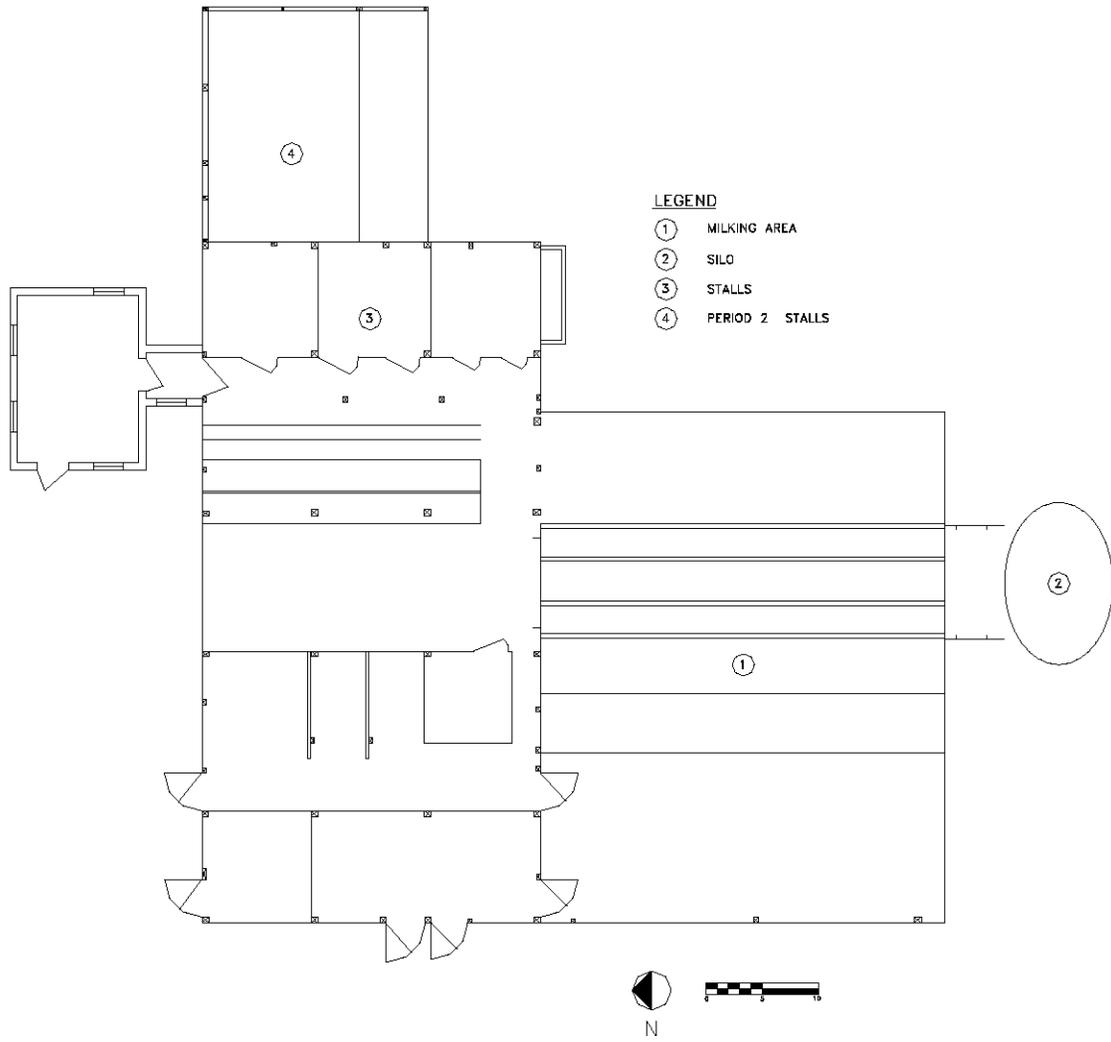
Figure 11: C. I. du Pont Farm, dairy barn, framing plan.

A large T-shaped gable-roofed dairy barn contained the bulk of the agricultural activity on the farm. Surrounded by a cement block wall that formed a work yard at the rear of the barn, the barn displays several generations of milking equipment along with stalls, grain storage, and a hayloft. A large machine shed stands to one side of the barnyard, and a cement block milk house extends from the front elevation of the barn.

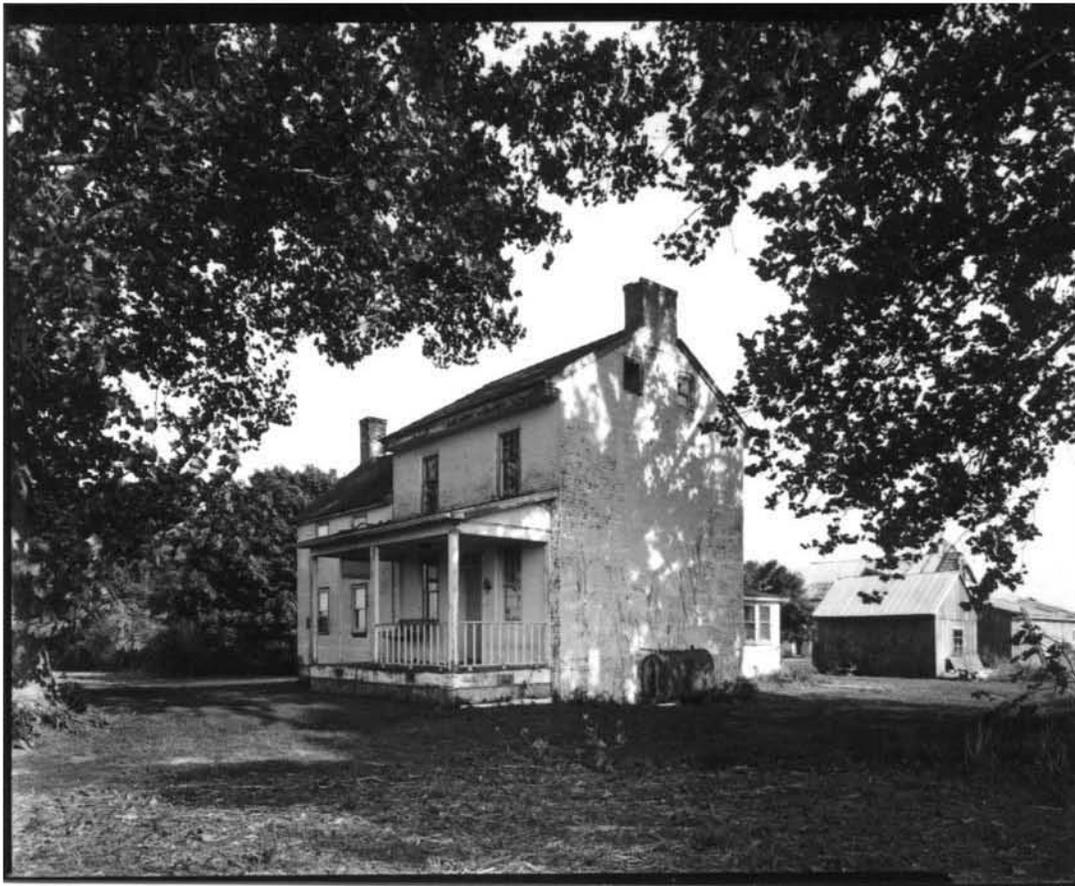
Figure 12: Charles I. du Pont Tenant Farm House, perspective of the north and west elevations looking southeast.

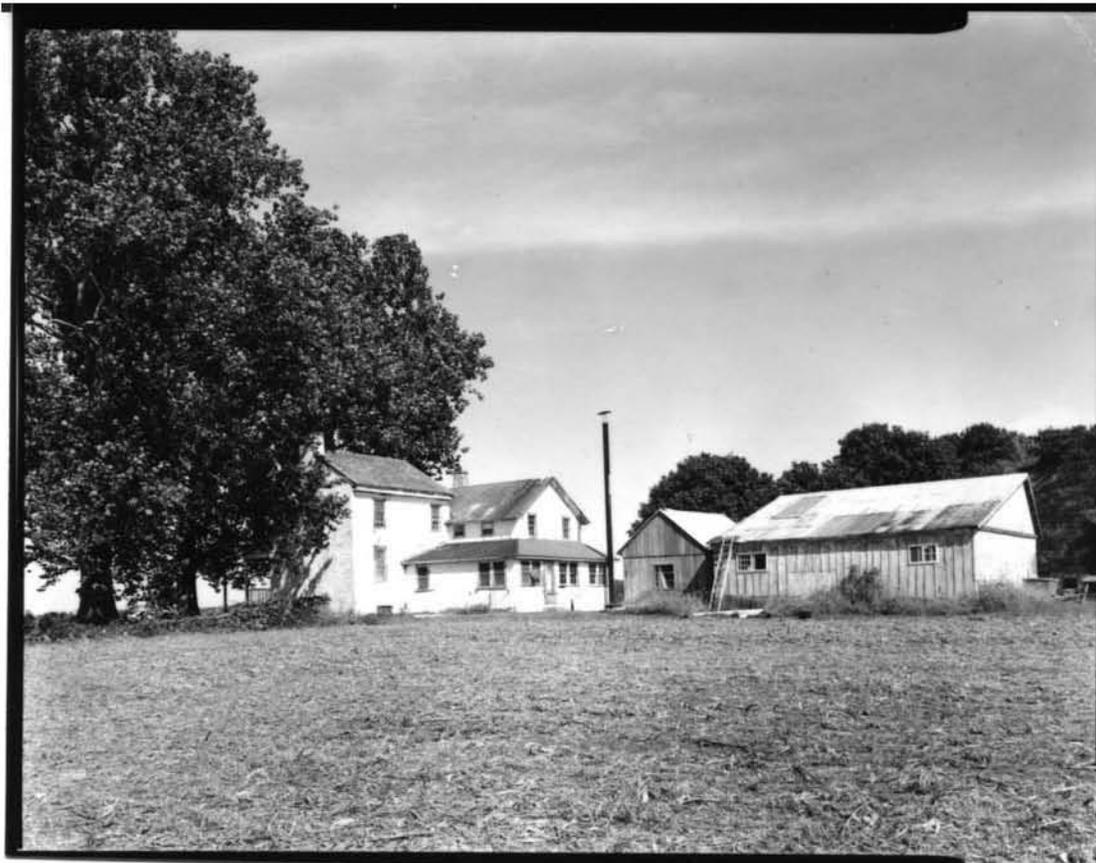
Figure 13: C. I. du Pont Tenant Farm, environmental view of dwelling, modern shed, and carriage shed, looking northeast.

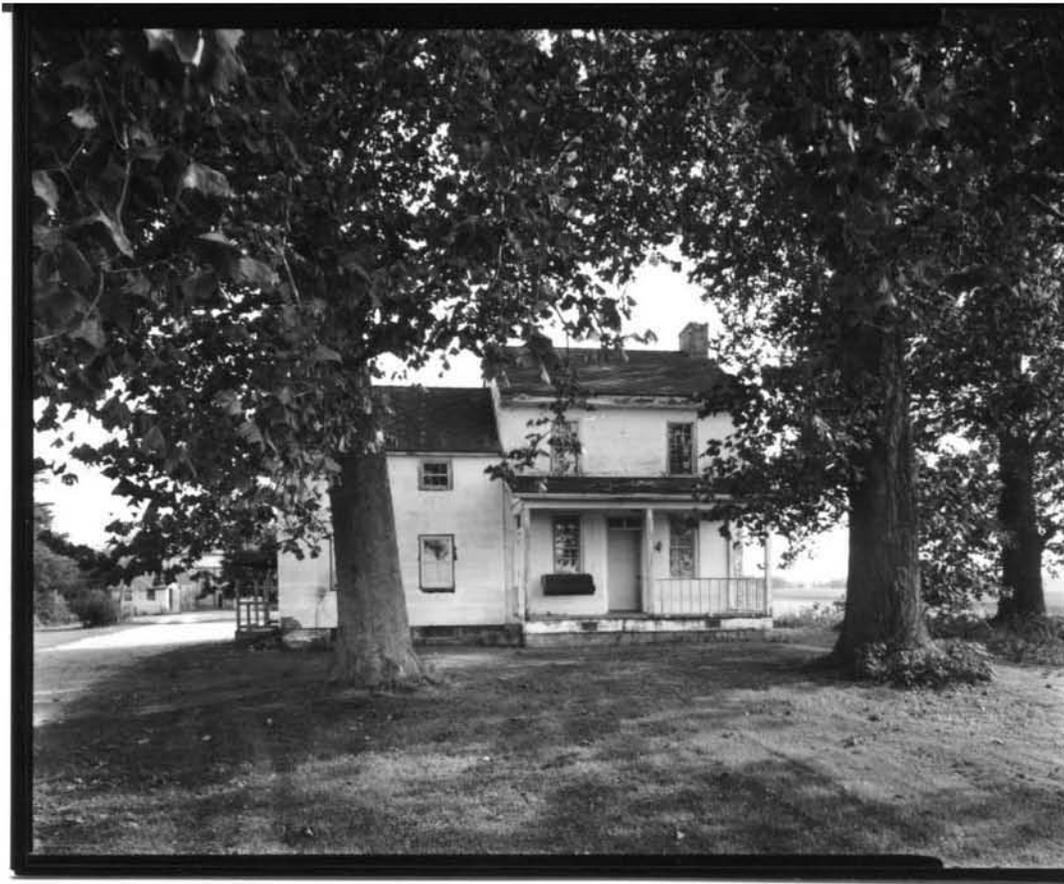
Figure 14: C. I. du Pont Tenant Farm House, view of the north elevation showing sycamore trees, looking south.

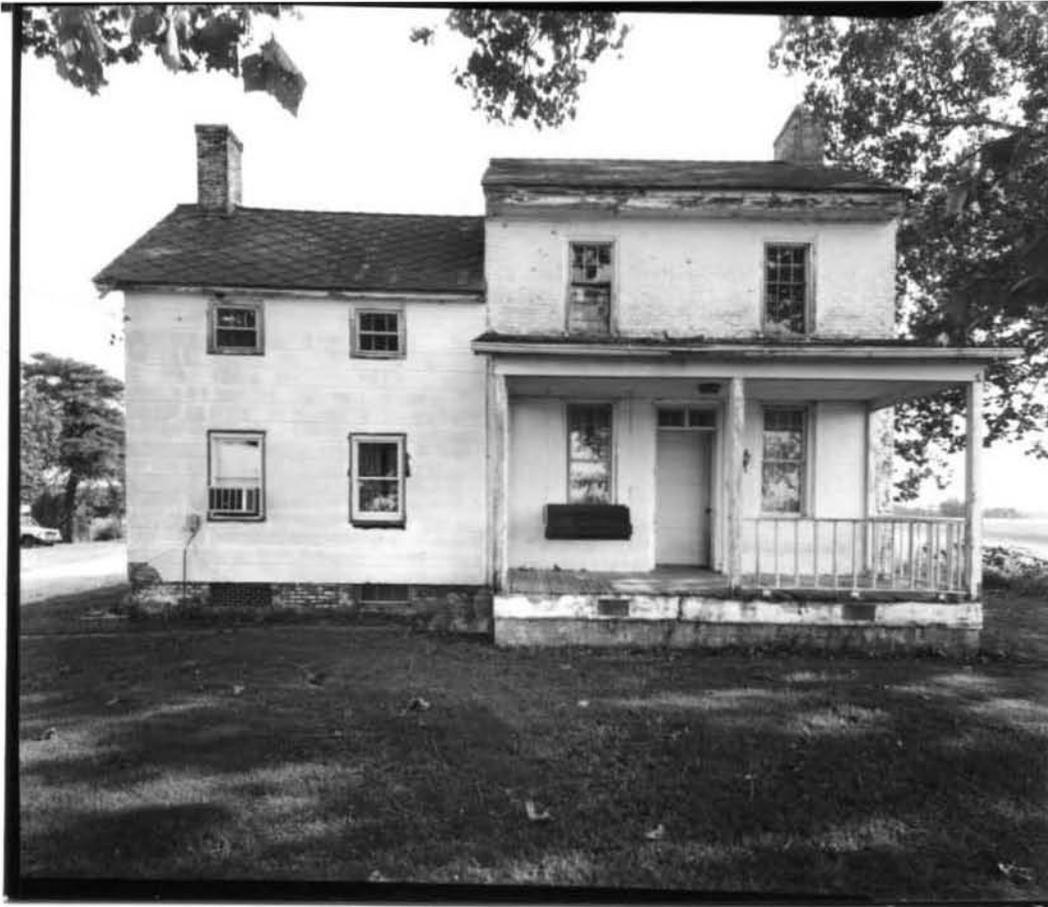
Figure 15: C. I. du Pont Tenant Farm House, view of the north elevation looking south.

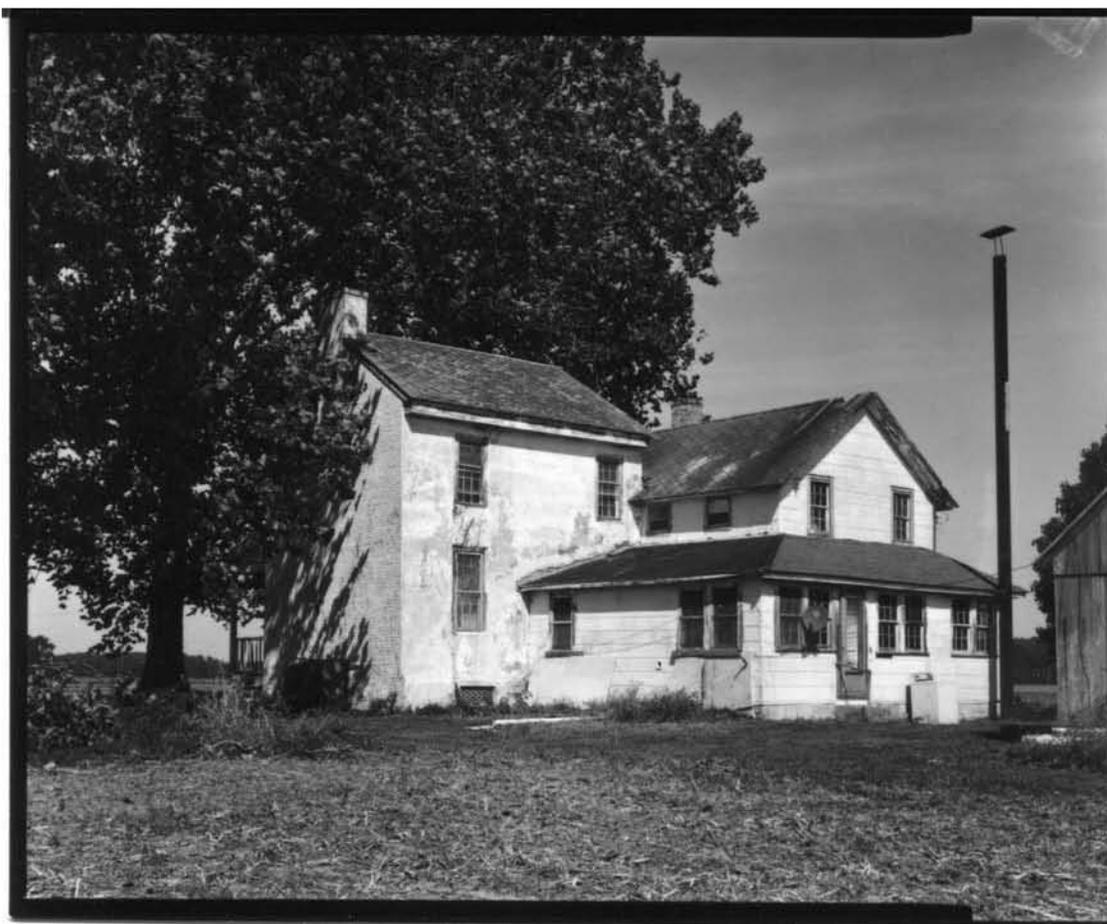
Figure 16: C. I. du Pont Tenant Farm House, perspective of the west and south elevations, looking northeast.

The west side of the Period I block is common bond brick, with two two-over-two-light sash windows in the gable, flanking the chimney. The rear (or south) elevation is also common bond brick, two bays wide, with nine-over-nine-light sash windows at the first story, and six-over-nine-light sash windows at the second story. The window at the east end of the first floor has been obscured by the one-story, shed-roofed porch addition. The east elevation of the Period I block is mostly obscured by the Period II addition.

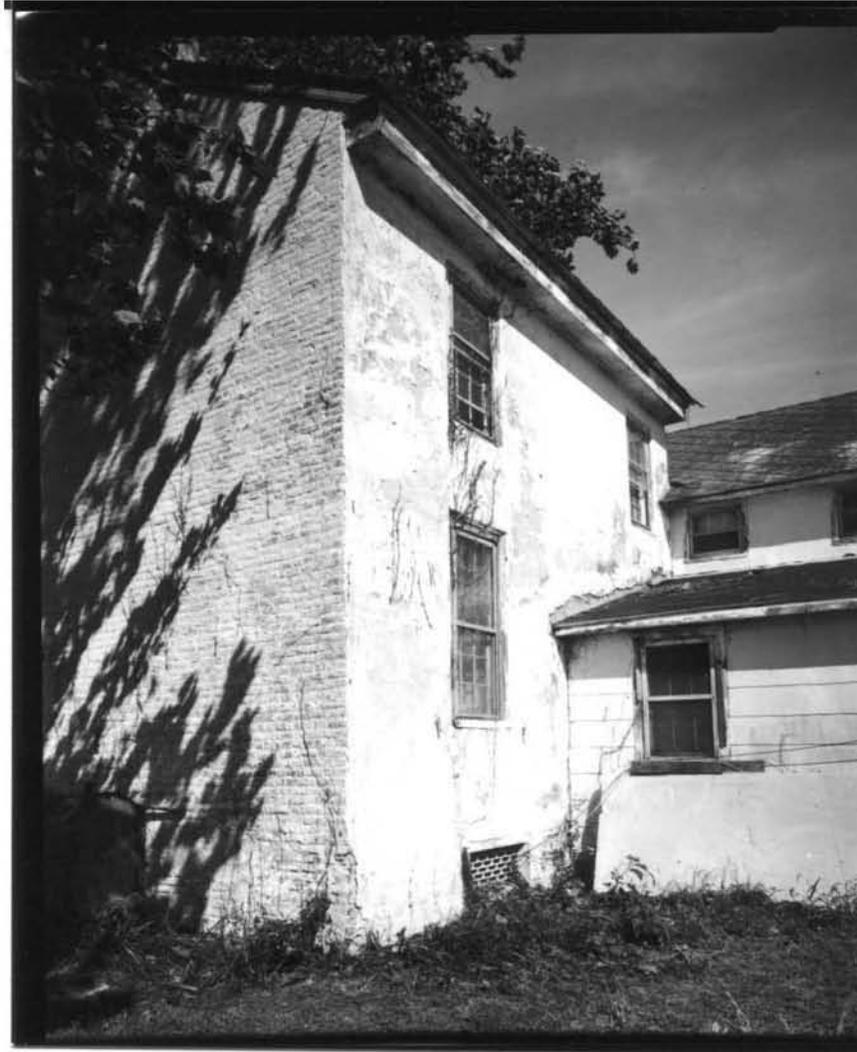
Figure 17: C. I. du Pont Tenant Farm House, detail of the west and south elevations of the Period I block showing juncture with rear additions.

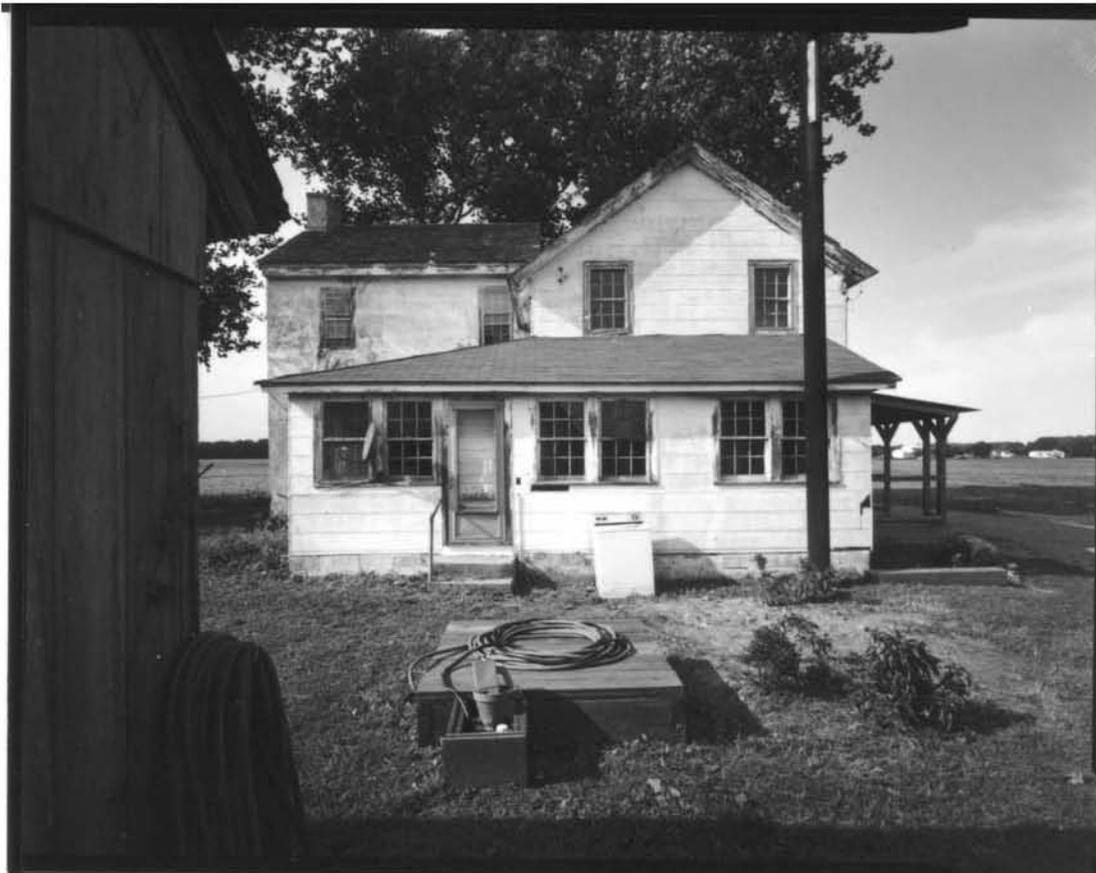
Figure 18: C. I. du Pont Farm Tenant House, view of the south elevation looking north.

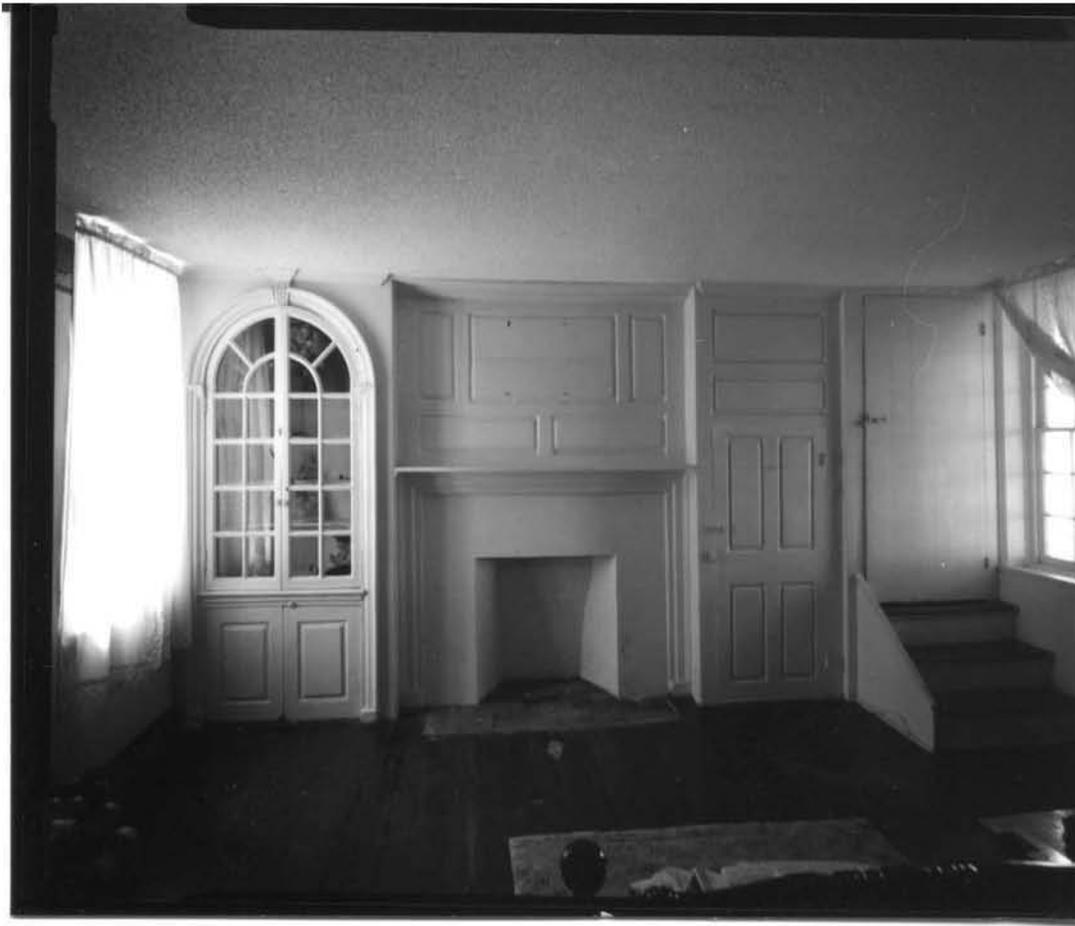
Figure 19: C. I. du Pont Tenant Farm House, interior: first floor (Period I), view of the west wall looking west.

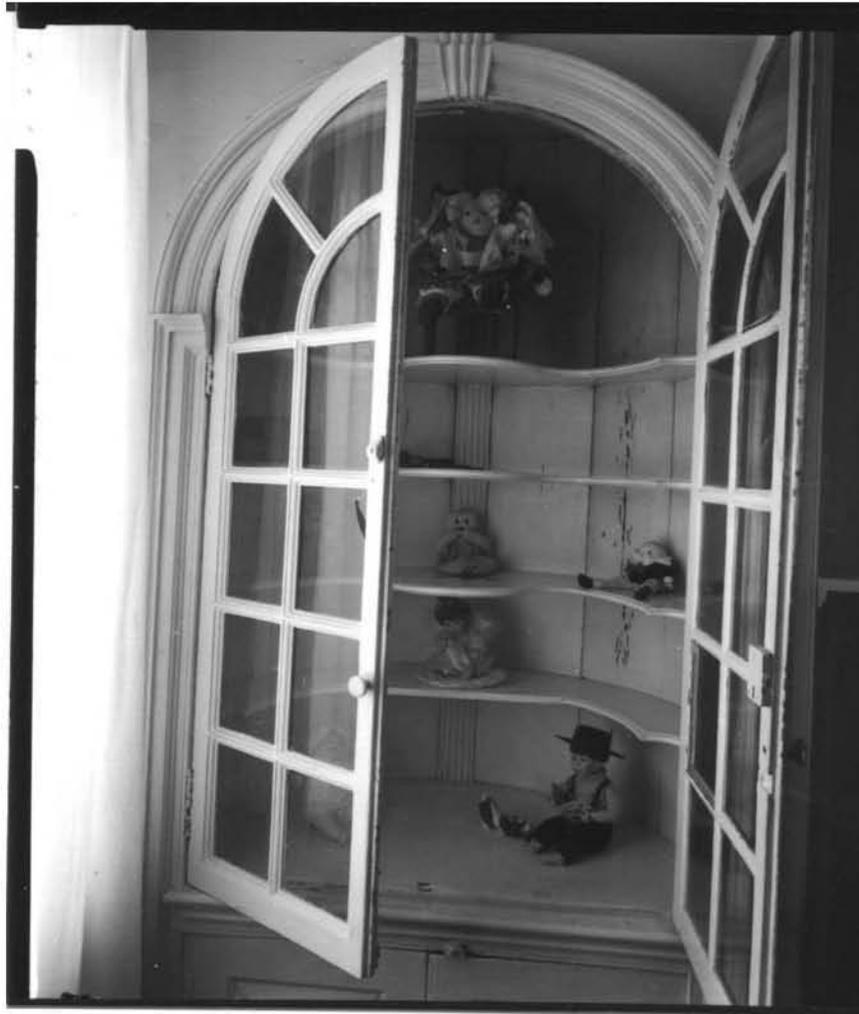
Figure 20: C. I. du Pont Tenant Farm House, interior: first floor (Period I), detail of built-in cabinet showing butterfly shelves, looking west.

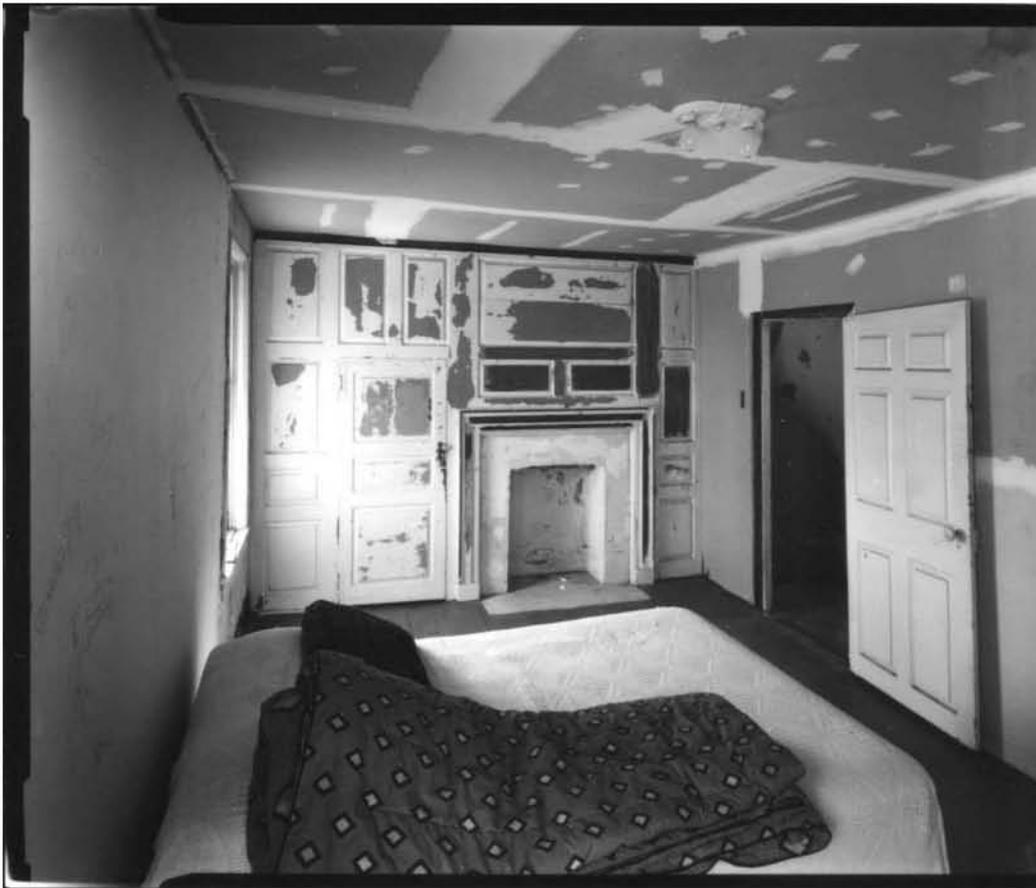
Figure 21: C. I. du Pont Tenant Farm House, interior: second floor (Period I), view of south, west, and north walls looking northwest.

The second floor room of the original brick structure, the 20 by 20 foot chamber, has been divided into two rooms by the insertion of a partition between the east and west walls. The west wall, running from the north to the south end, features a paneled door leading to a boxed winder stair to the attic, the landing for the winder stair from the first floor, a centrally-placed fireplace, and a door to a cedar-lined closet. Two steps to the attic winder protrude into the room. The west wall is completely paneled, and the door to the cedar closet is cut directly from the paneling. The symmetry of the original chamber has been upset by the partitioning of the room, which was done in order to create a landing area for both stair boxes separate from the living area of the chamber. The south wall of the landing (the added wall) has a paneled door that leads to the south chamber. A closet has been built along the full width of the east wall of the landing room, and two symmetrically placed windows pierce the north wall. Two symmetrically placed windows pierce the south wall of the chamber, and the east wall has a paneled door that leads to the second story of the Period II addition.

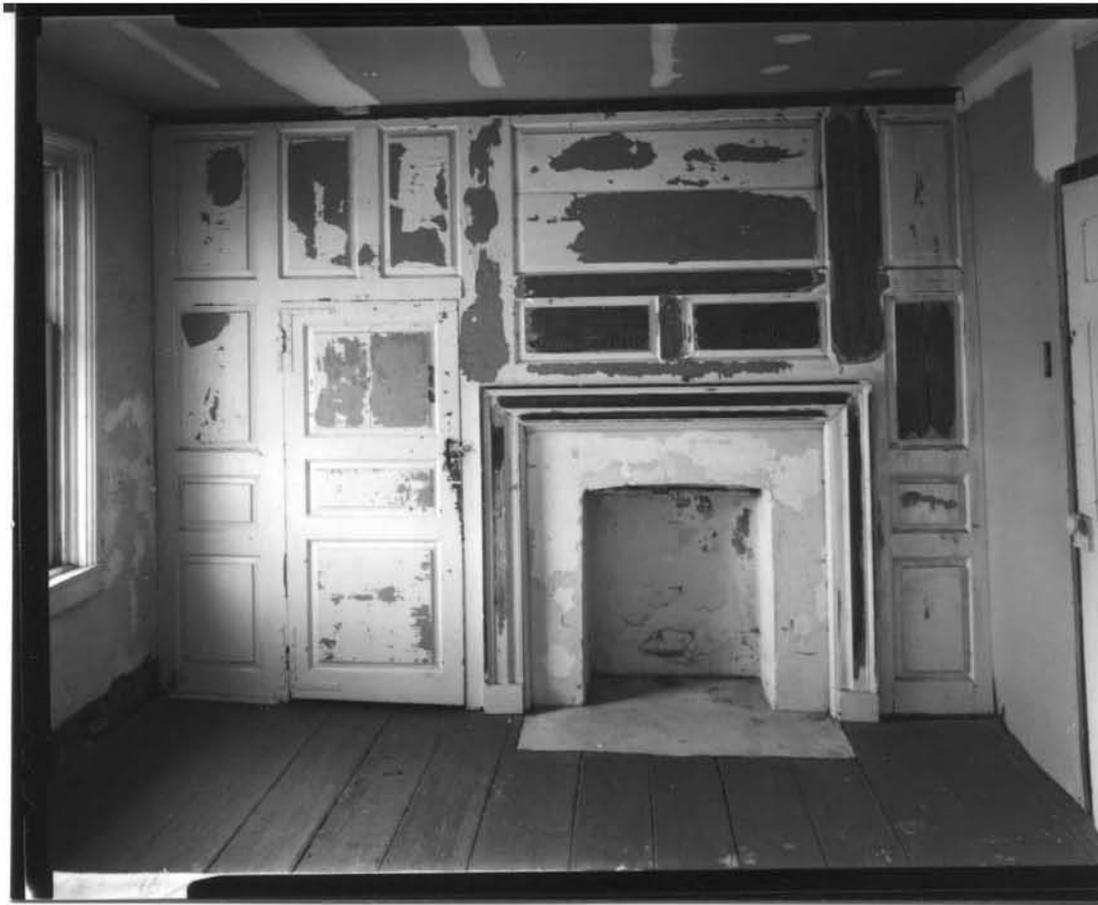
Figure 22: C. I. du Pont Tenant Farm House, interior: second floor (Period I), view of the west wall looking west.

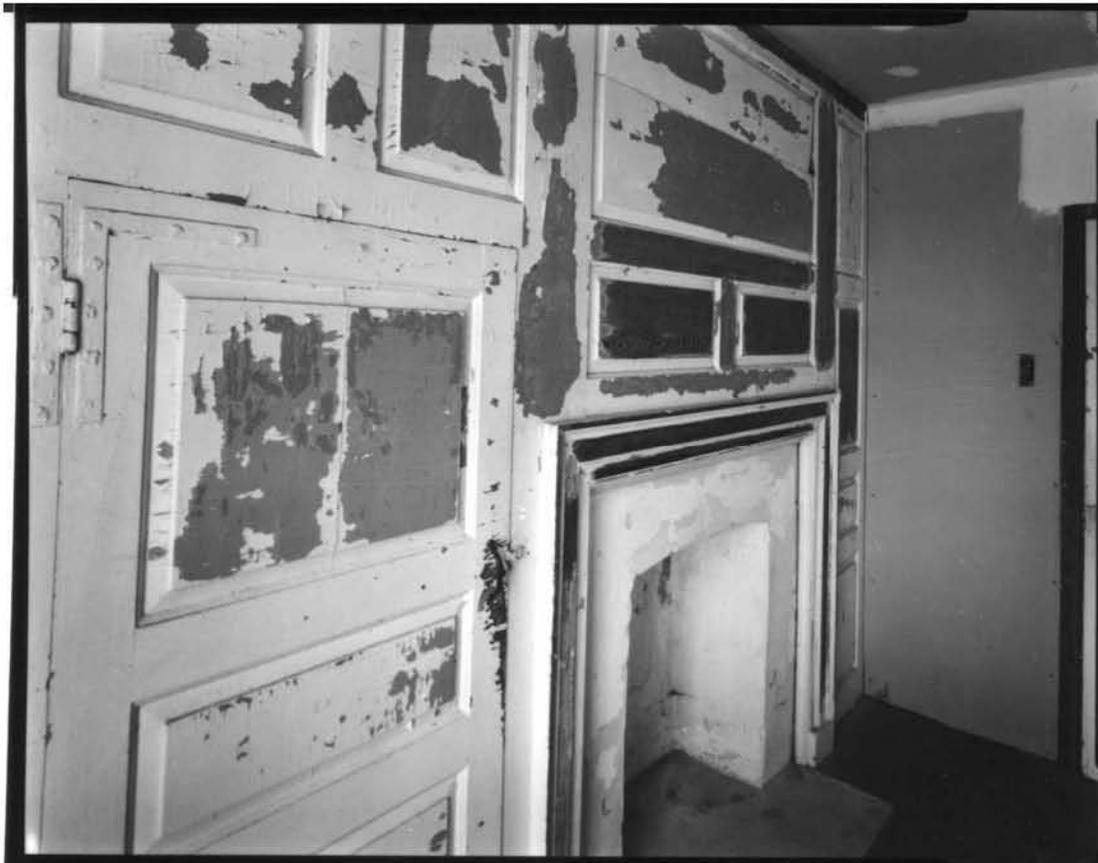
Figure 23: C. I. du Pont Tenant Farm House, interior: second floor (Period I), detail of paneling on west wall looking northwest.

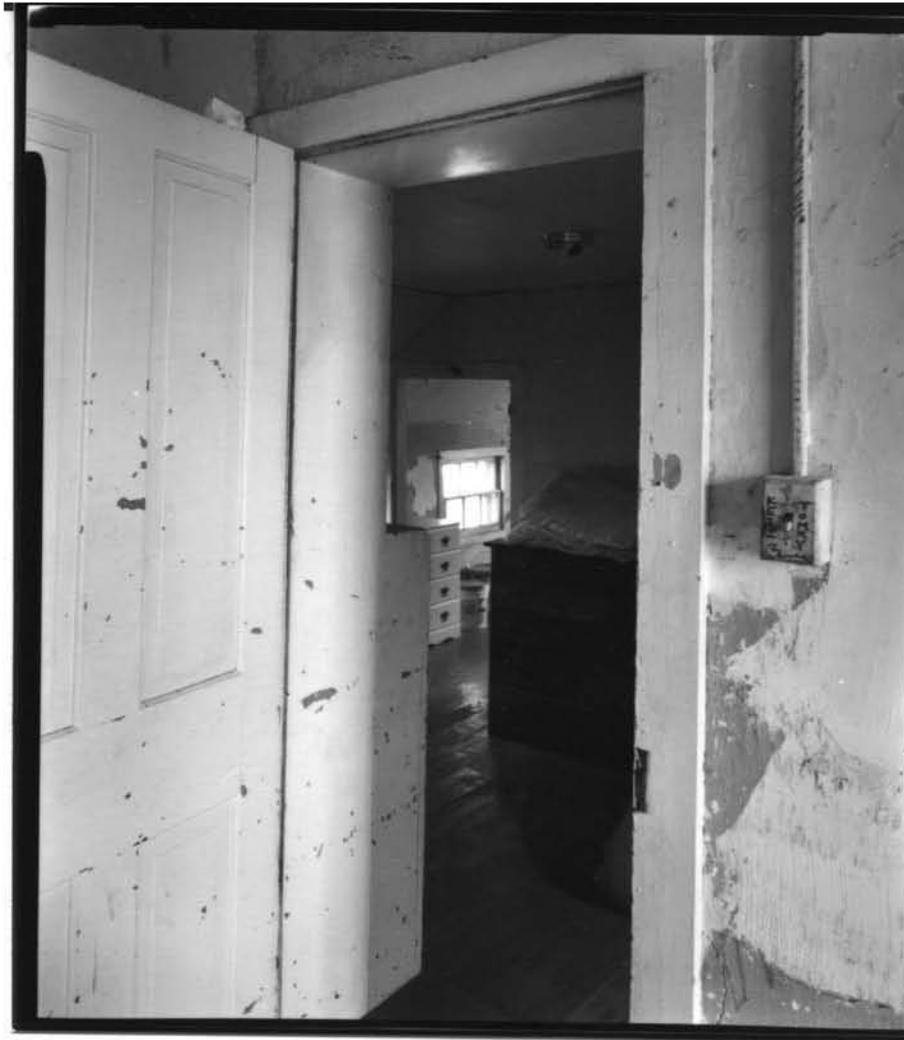
Figure 24: C. I. du Pont Tenant Farm House, interior: second floor (Period I), view through door on east wall looking northeast into the Period II section.

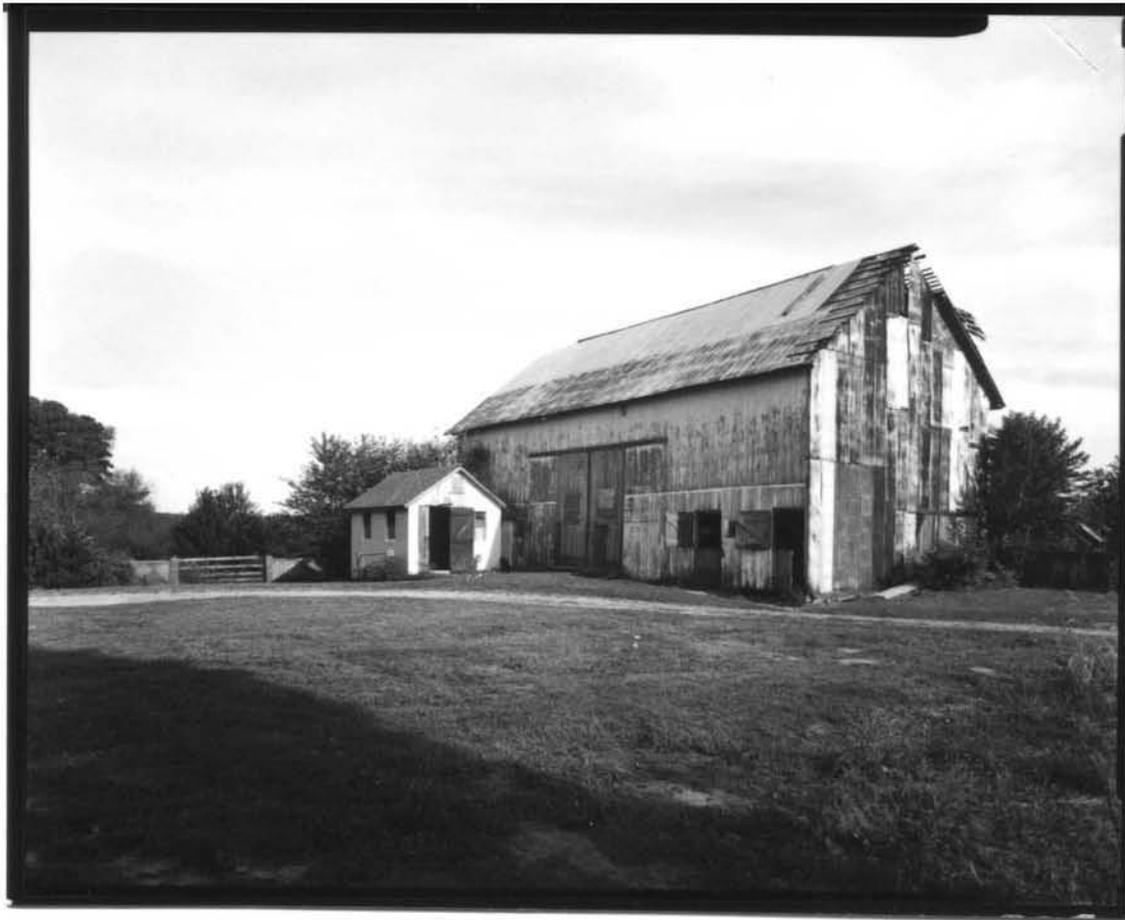
Figure 25: C. I. du Pont Tenant Farm, perspective of the north and west elevations of the dairy barn and attached milkhouse looking southeast.

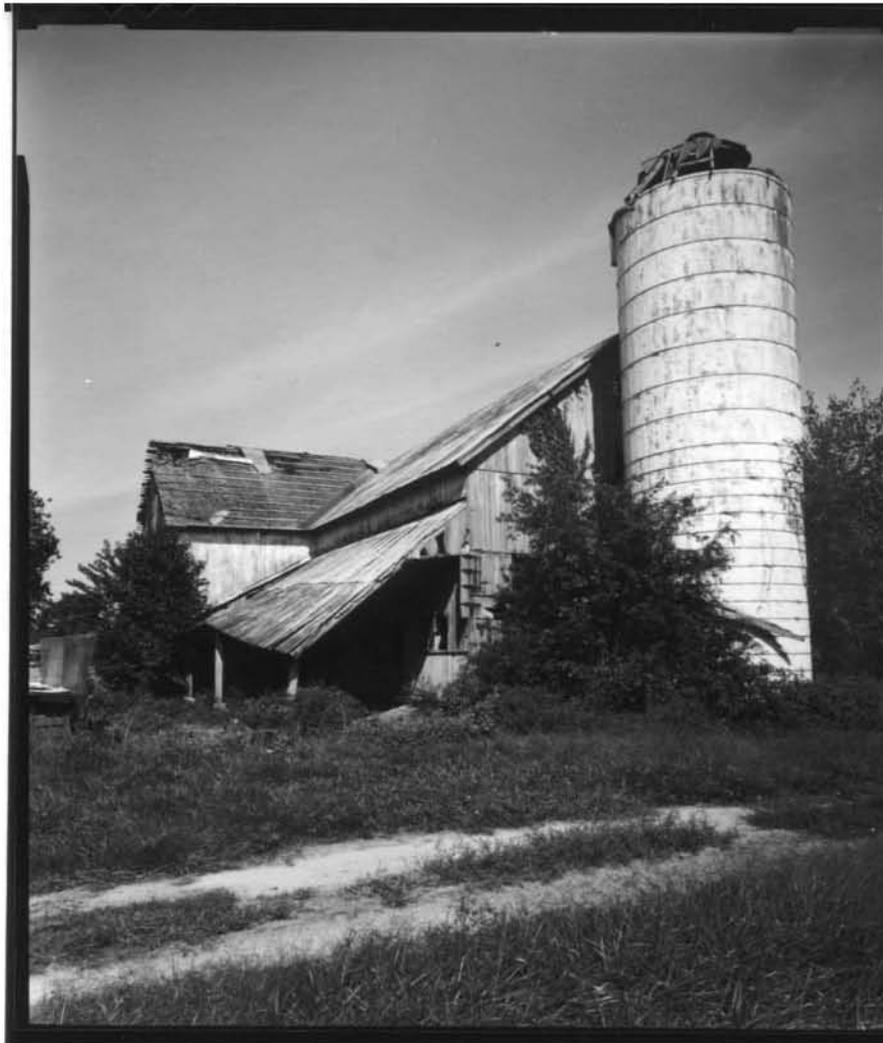
Figure 26: C. I. du Pont Tenant Farm, perspective of the west and south elevations of the dairy barn and attached silo looking northeast.

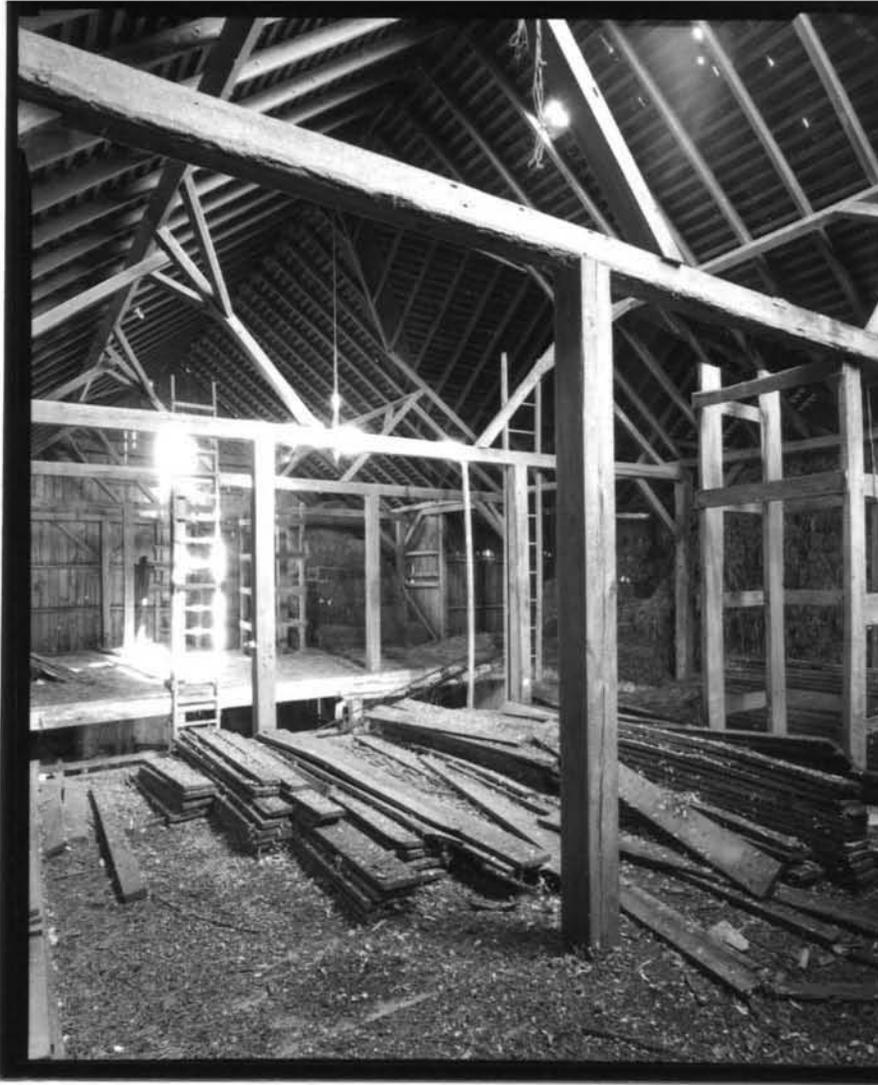
Figure 27: C. I. du Pont Tenant Farm, interior of dairy barn: second floor, showing framing looking southwest.

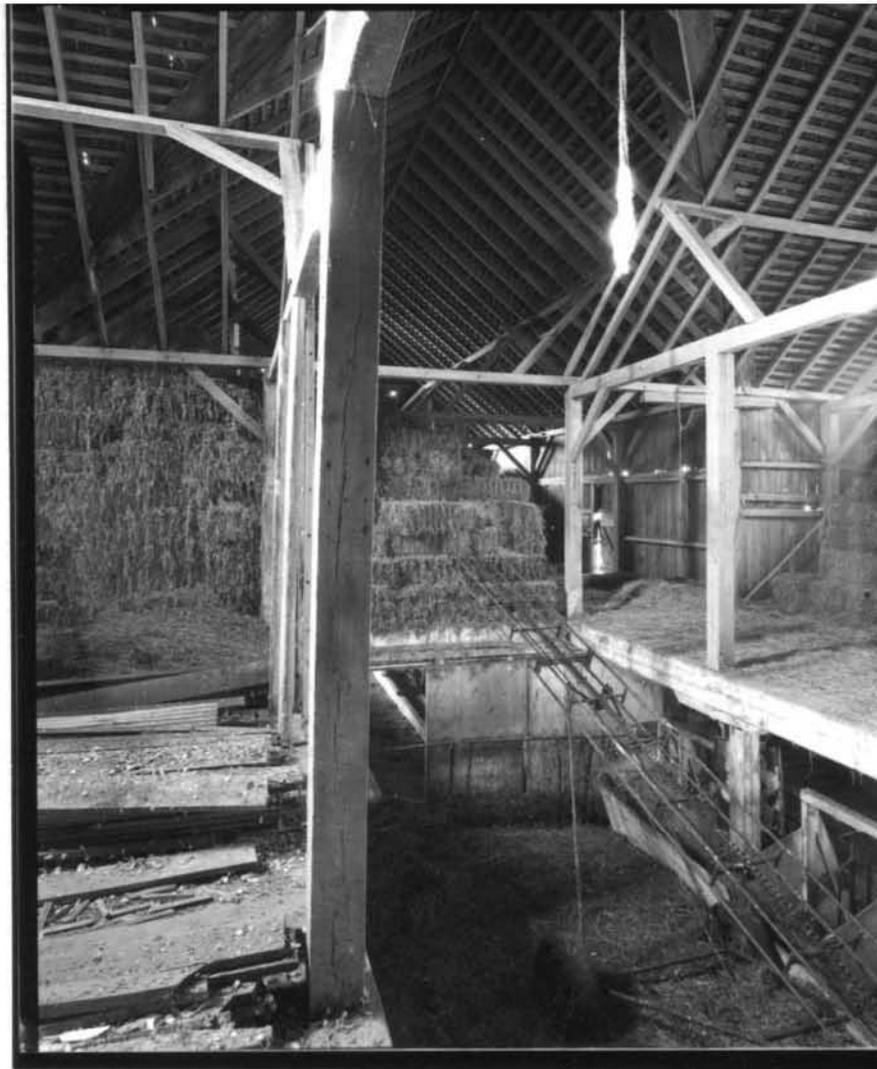
Figure 28: C. I. du Pont Tenant Farm, interior of dairy barn: second floor, showing framing and hay machinery looking south.

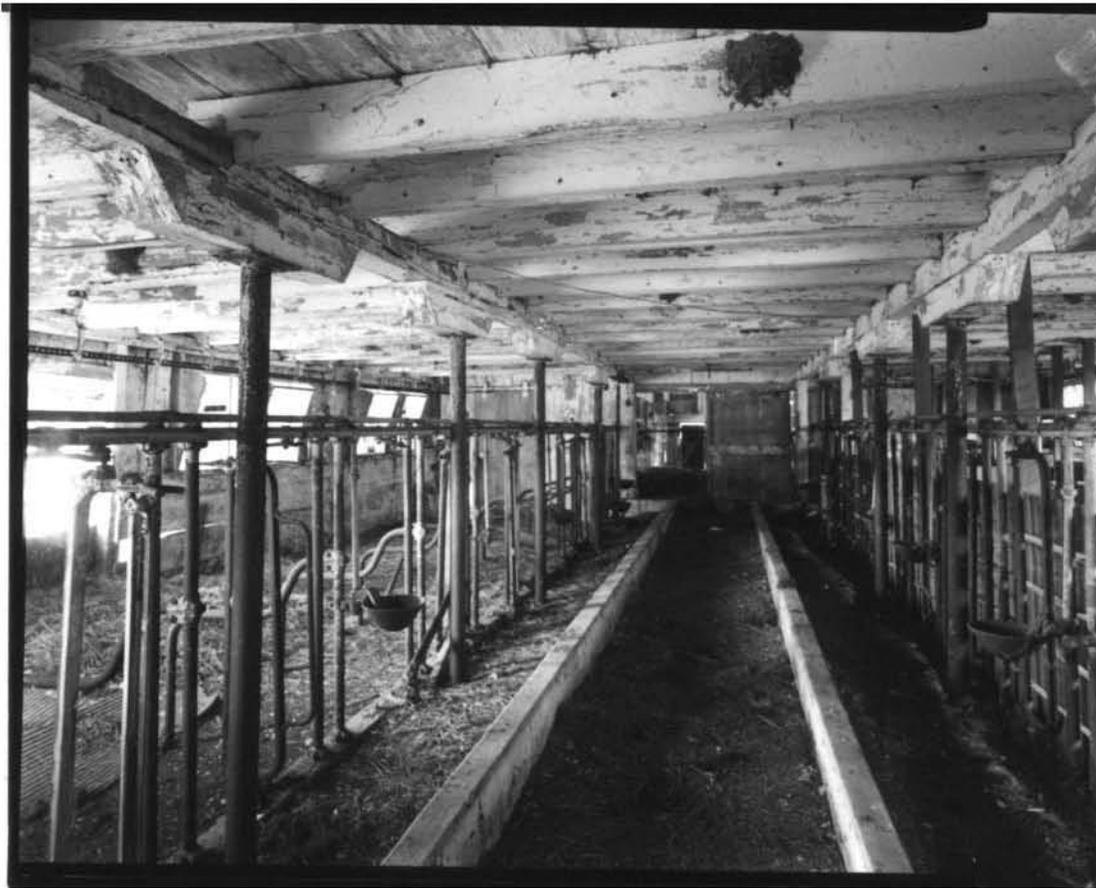
Figure 29: C. I. du Pont Tenant Farm, interior of south wing of dairy barn, showing stanchions looking south.

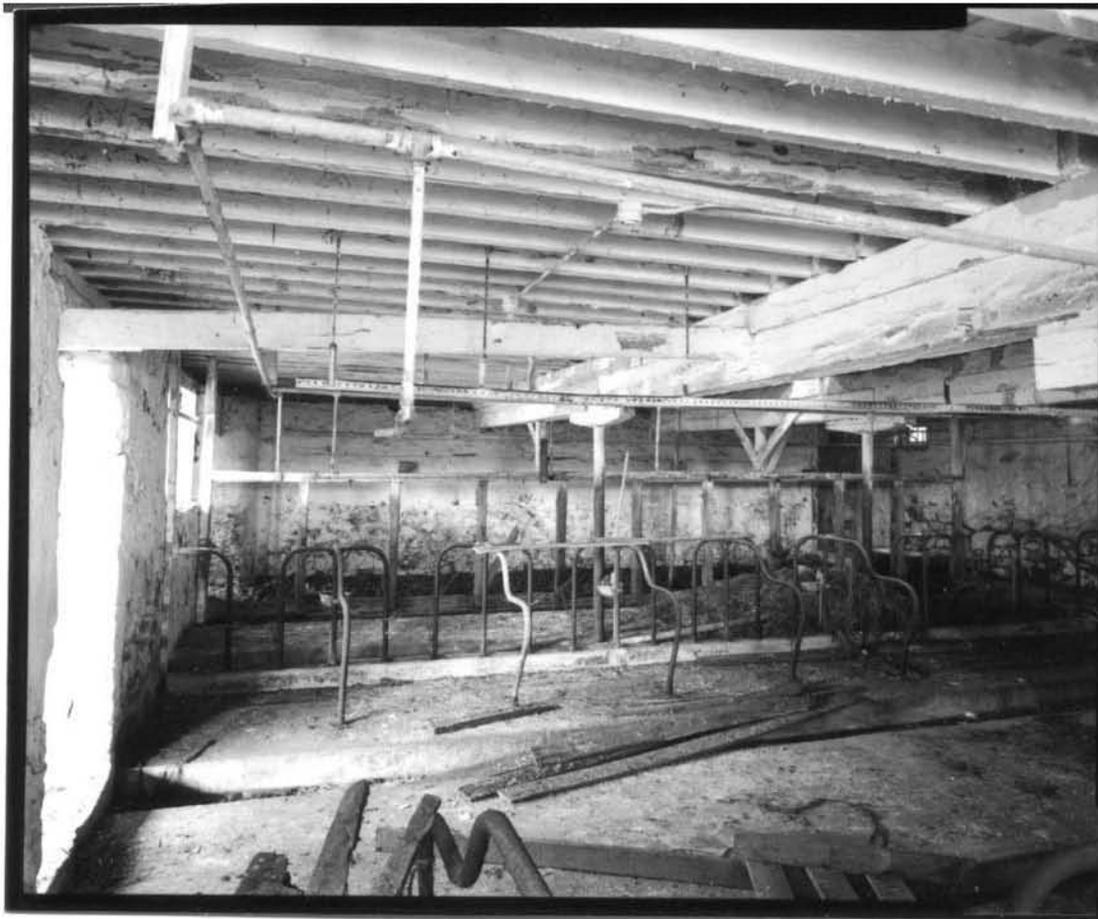
Figure 30: C. I. du Pont Tenant Farm, interior of south wing of dairy barn, showing stanchions looking northeast.
