MID ATLANTIC HISTORIC BUILDINGS SURVEY

PARK THEATER

305 North Union Street
City of Wilmington
New Castle County, Delaware

Center for Historic Architecture and Design
University of Delaware
Newark, Delaware
1999

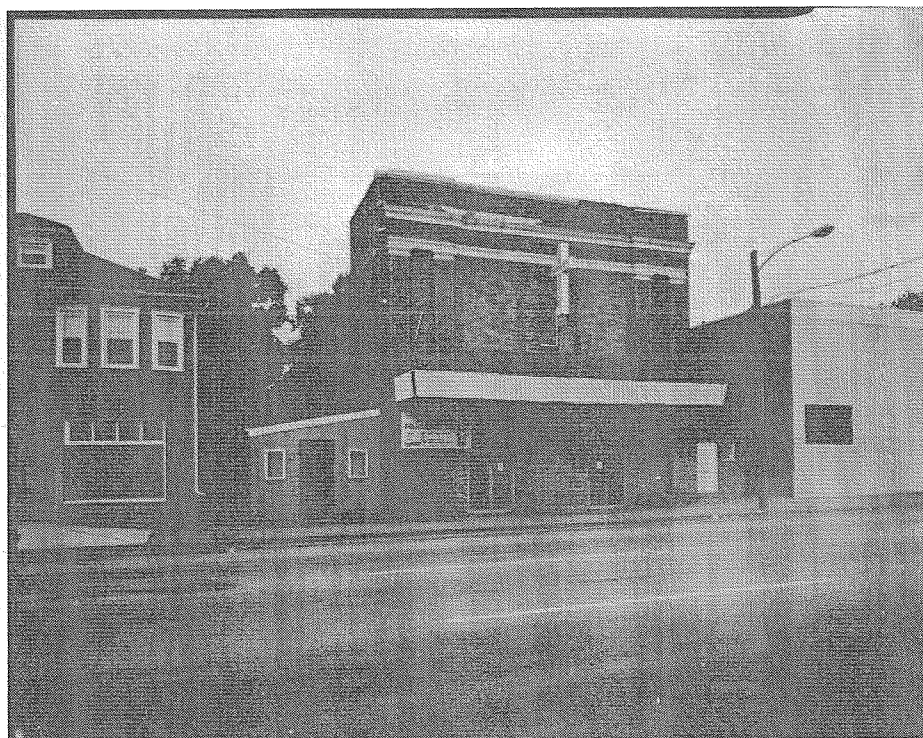
N-10328-1 Environmental perspective of east-southeast front and
west-southwest side looking north

Period III – 1967-Present: Shortly after the theater closed, the building was taken over by the Revival Fellowship Church in December 1967.⁸ The building's shape was altered by the addition of wings on the north and south sides of the front-east elevation. The left wing has a sloped roof with a molded cornice and a stuccoed facade. It has three bays, with two covered window openings flanking a solid door. The right wing has a flat roof and brick facade. It has two bays, with a modern door on the left bay and a window on the right bay. These additions probably occurred after the church took over the building. Other alterations include a reconfiguration of the first floor of the east elevation. Currently, there are two double leaf casement doors on the outer bays of the first floor. A cross of contrasting brick has been added in the center bay with a semicircular brick base projecting from the front of the building. There is evidence that the ticket booth stood at this location. There is also a tile sign on the floor of the lobby with the words "Park Theatre" directly behind the ticket booth location. The front entrance originally may have been at this location and may have been relocated during the 1937 renovation. The second floor arched windows have been bricked in. A small one-over-one pane casement

window has been added in the center bay on the second floor. Directly above it hangs a cross which is perpendicular to the front façade.

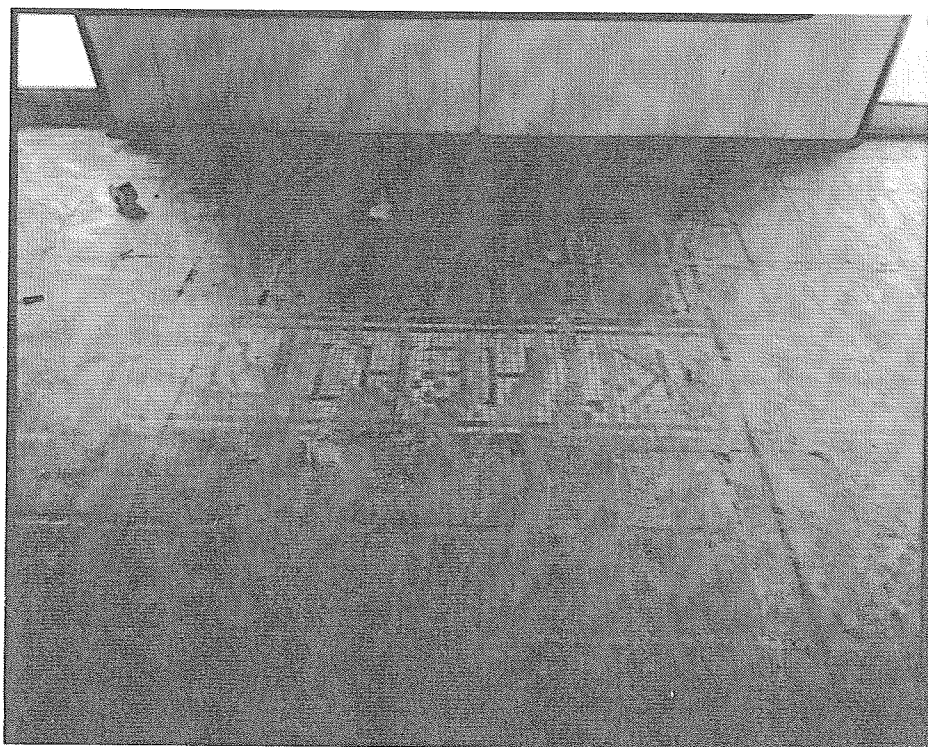
N-10328-4 First floor: detail of tile lettering on lobby floor looking east-southeast

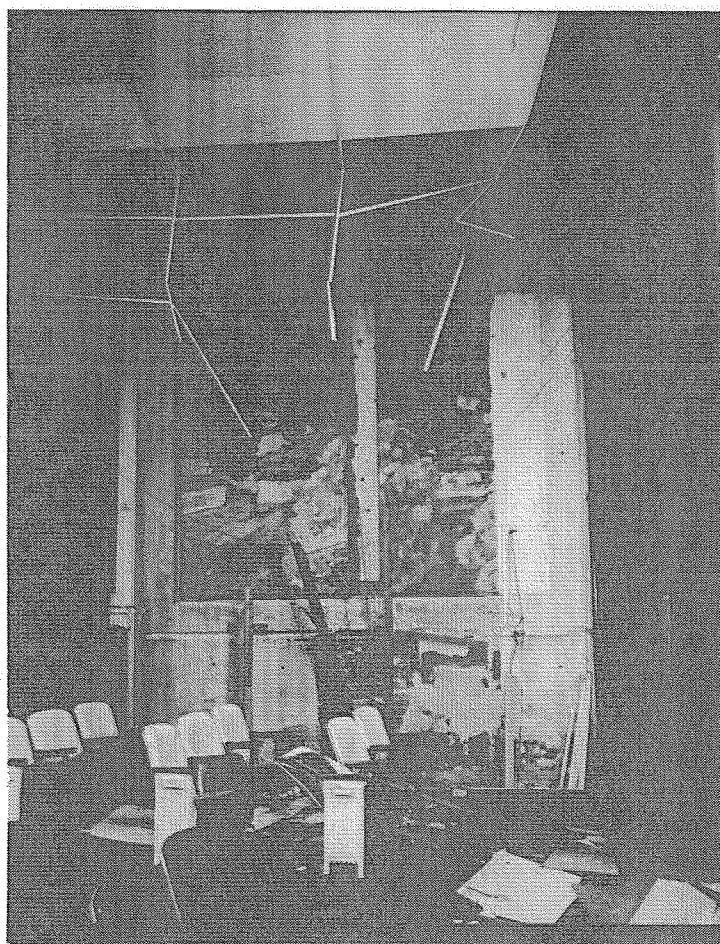
N-10328-7 First floor: view of revealed original
mural on west-southwest wall near the
stage

also added along with carpeting, air conditioning, screens with curtains, an acoustic system and the latest Simplex projection equipment. In addition to the new interior fixtures, the stage and orchestra pit were rebuilt. Interior murals by Philadelphia artist Grieco were added to the side and rear walls during this renovation.⁷
