**EVALUATION OF THE
BRANDYWINE VILLAGE HISTORIC DISTRICT
NATIONAL REGISTER NOMINATION**

**Center for Historic Architecture and Engineering
College of Urban Affairs and Public Policy
University of Delaware
Newark, Delaware**

March 1991

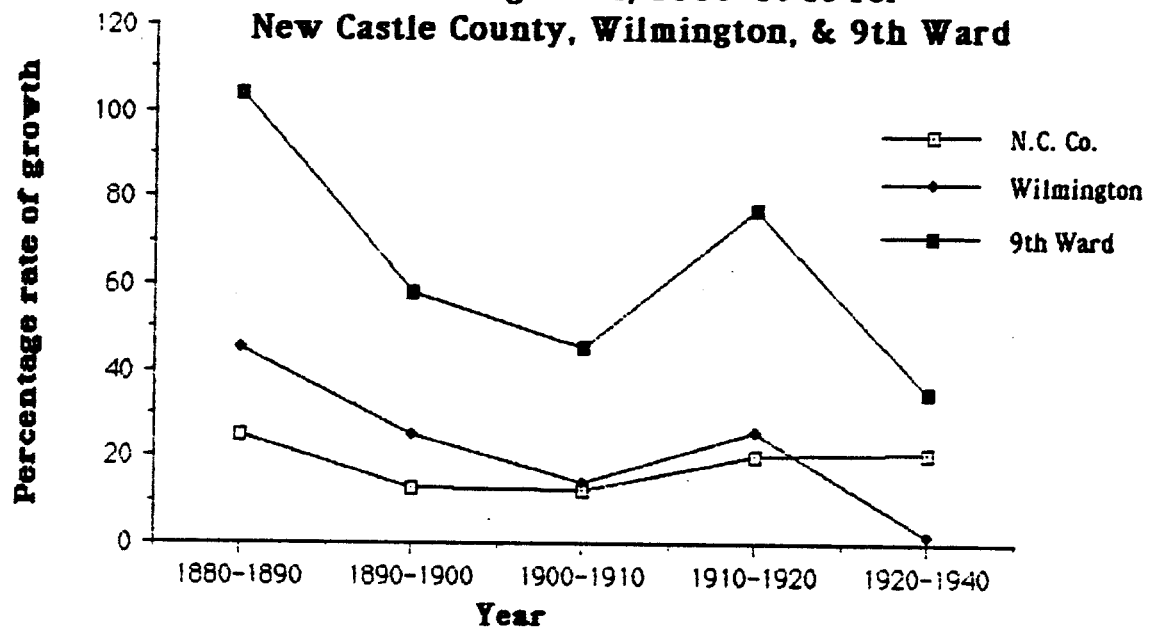
Figure 1:
Rate of growth, 1880-1940 for
New Castle County, Wilmington, & 9th Ward

One striking phenomenon which a survey of district occupations reveals is the intense activity in textile manufacturing at the turn of the century. In 1880, 5 percent of the district workers were engaged in some aspect of textile production and in 1940 that share was less than 1 percent. But in 1900, fully 17 percent of the village's employed people were working in some aspect of textile manufacturing.

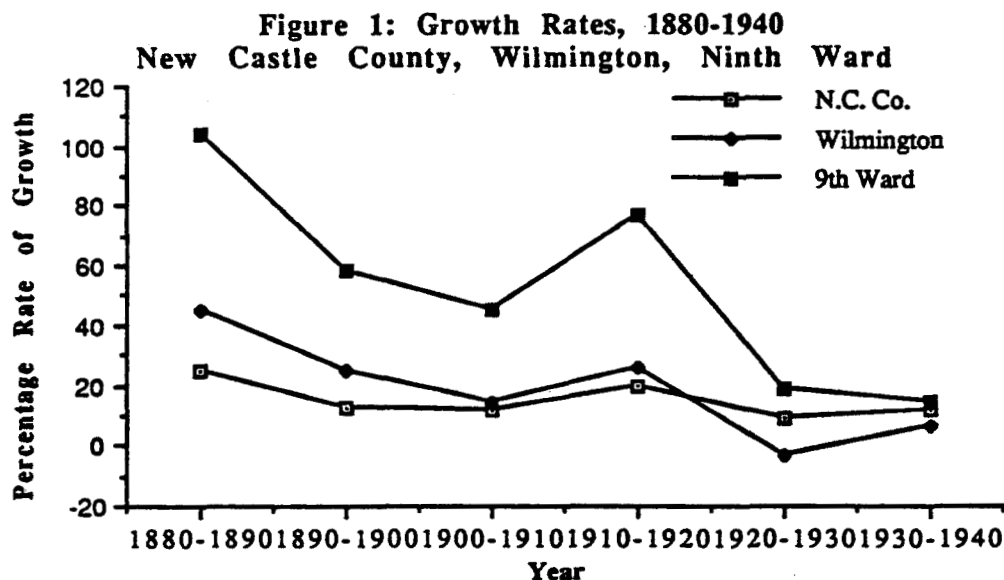
During the period 1880 to 1940, while New Castle County, the city of Wilmington, and the Ninth Ward, of which Brandywine Village is a part, all experienced population growth (Figure 1), the Ninth Ward grew at a faster

rate than the county or the city. From 1880 to 1890, as the county grew by 25 percent, the ward more than doubled its population. The

period 1910-1920 saw a 77 percent rate of growth in the ward, with 20 percent in the county and 26 percent in the city.
