Introduction

In August 1998, the Center for Historic Architecture & Design (CHAD) at the University of Delaware first contracted with the Delaware Agricultural Lands Preservation Foundation (DALPF) to document the farmsteads whose owners were currently applying for permanent protection through the purchase of development rights. Specifically, the goal of the project was to evaluate the level of historic significance of each farm complex;

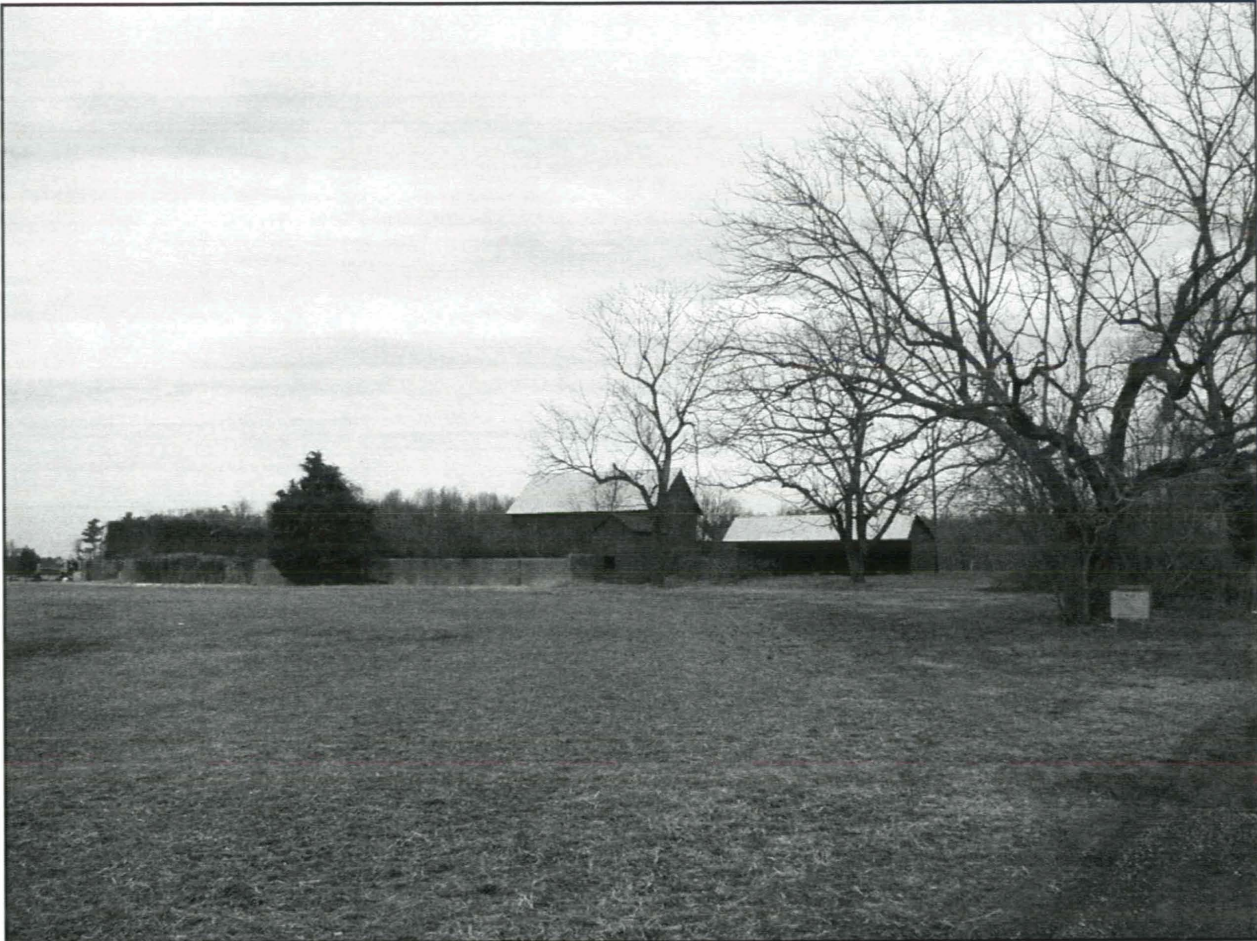
C. Smithers/Mary Emily Miller Farm
DALPF Project ID K-92-10-005

Even though the outbuildings are no longer in agricultural use, the complex has a high level of significance because of the intact complex, as well as the presence of eighteenth- through twentieth-century domestic and agricultural buildings. The main dwelling retains a high level of integrity and contributes to the historic significance of the entire complex, which is both a Century Farm and Bicentennial Farm.

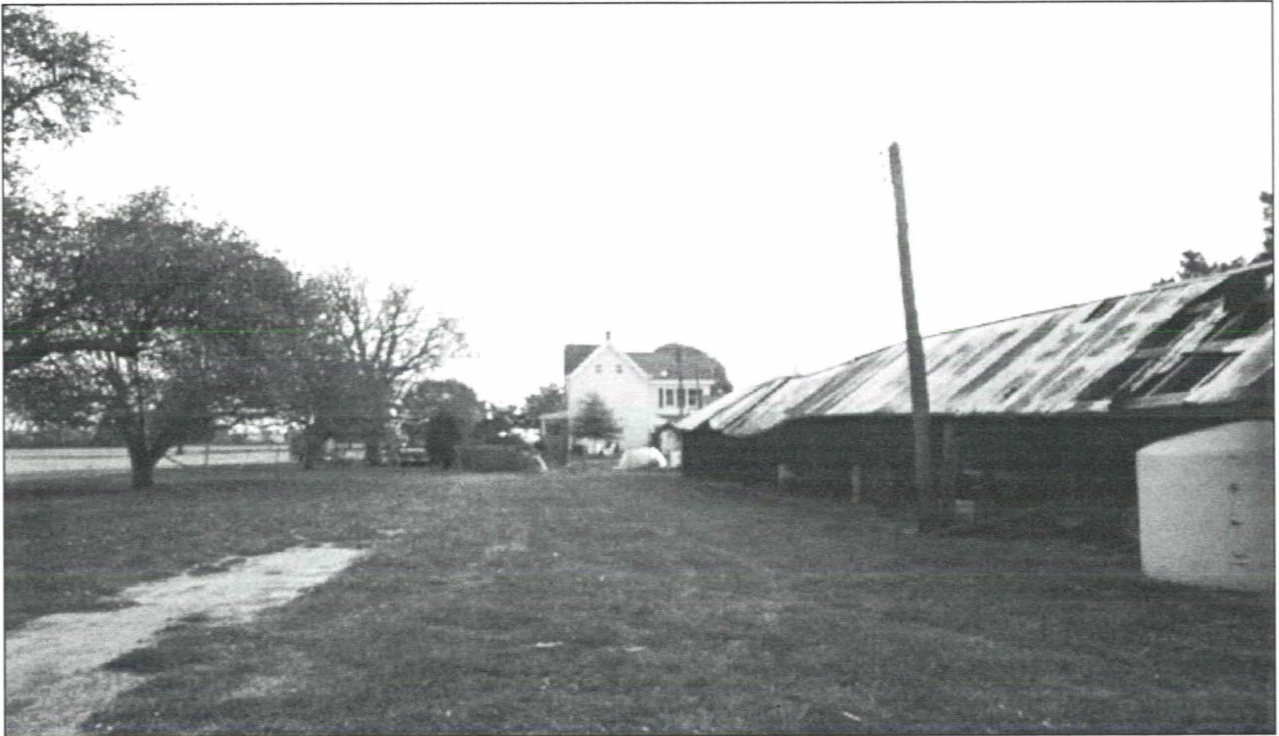
J. W. Spruance/Alfred Moor III Farm
DALPF Project ID K-92-11-007

property, the two complexes contribute to and share in the historic significance represented by

this once complete twentieth-century dairy complex.

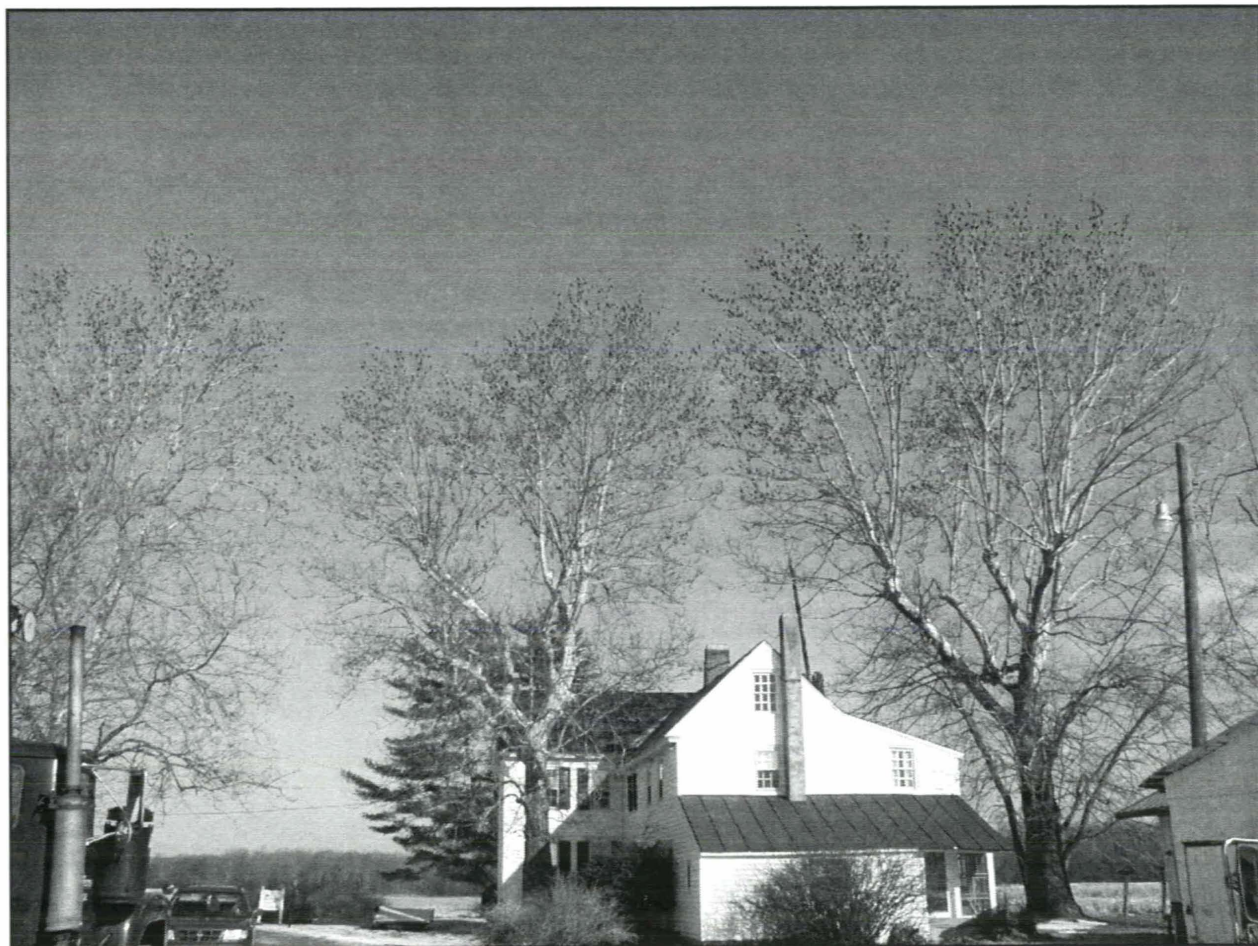
Charles Warren/Elva G. Warren Farm
DALPF Project ID K-92-11-008

farm has already attained recognition for its historic significance and the tenant house is Central Delaware, 1780-1930+/-." Even though the agricultural complex was built at a

included in the National Register of Historic Places Nomination, "The House and Garden in later date, it is intact, and its buildings remain in use in the farm's grain operations.

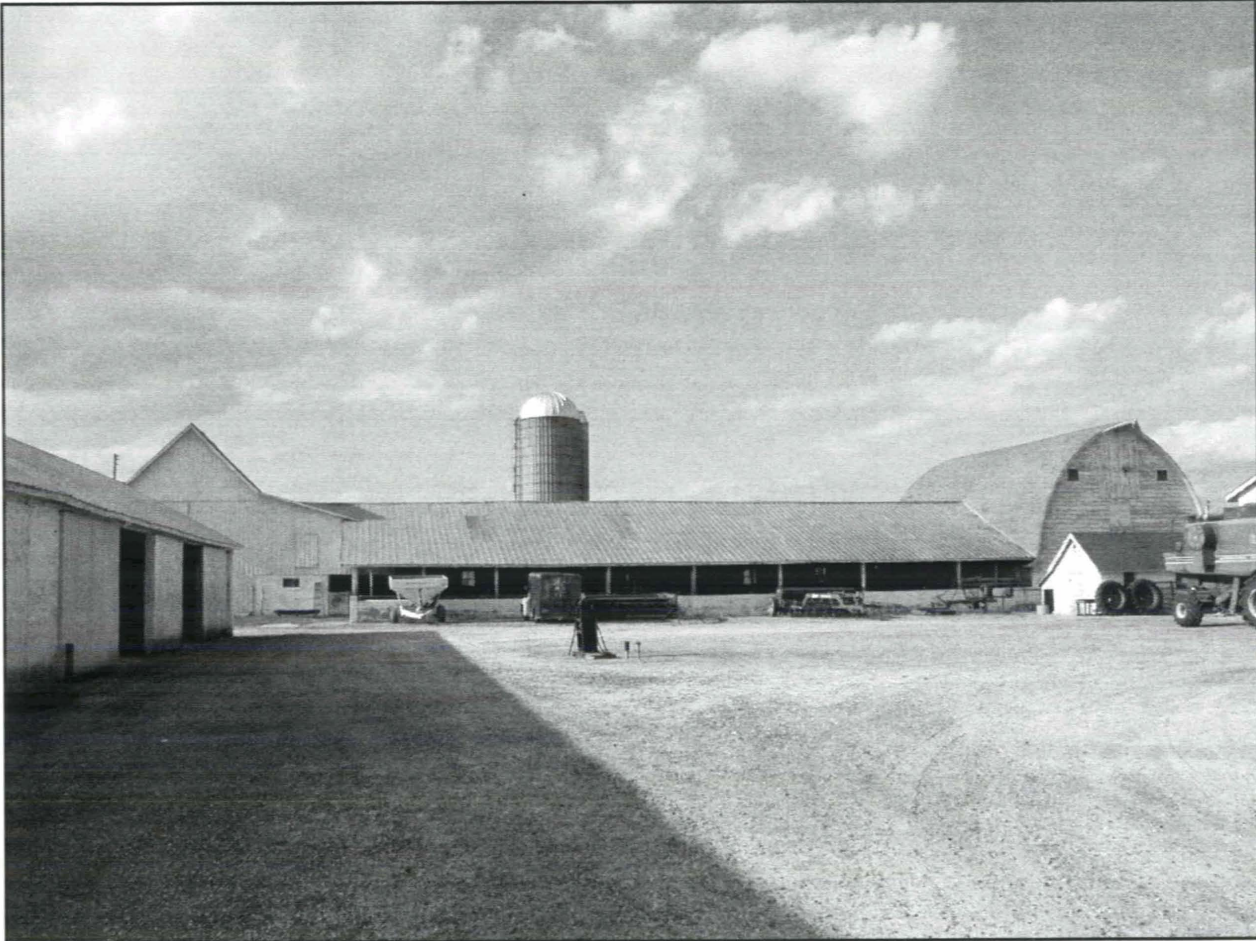
R.Melvin/William E. and Ruth M. Bullock Farm
DALPF Project ID K-93-03-018

incorporation of a Gothic roof with a hay hood, which is a rare design in the region. Other highly significant buildings include the crib barn and corn crib, which are both extremely large for their intended use.

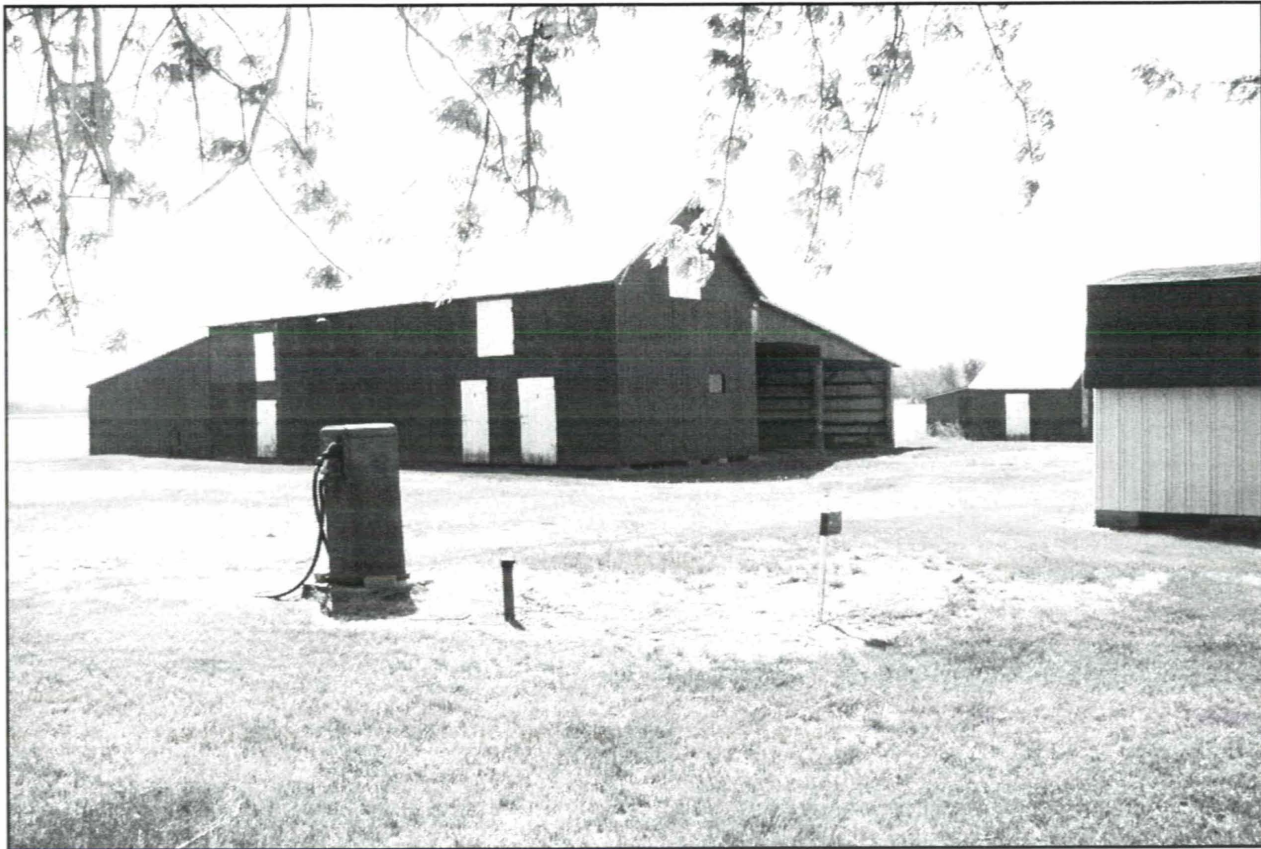
*Cathryn and Wayne Dill & Louis Dunn Farm
DALPF Project ID K-93-11-024 PDR*

replacements for the older buildings associated with its original 1920s operations. The multi-purpose barn is highly significant because of its

design, which portrays the diversification in agricultural practices that this farm once incorporated.

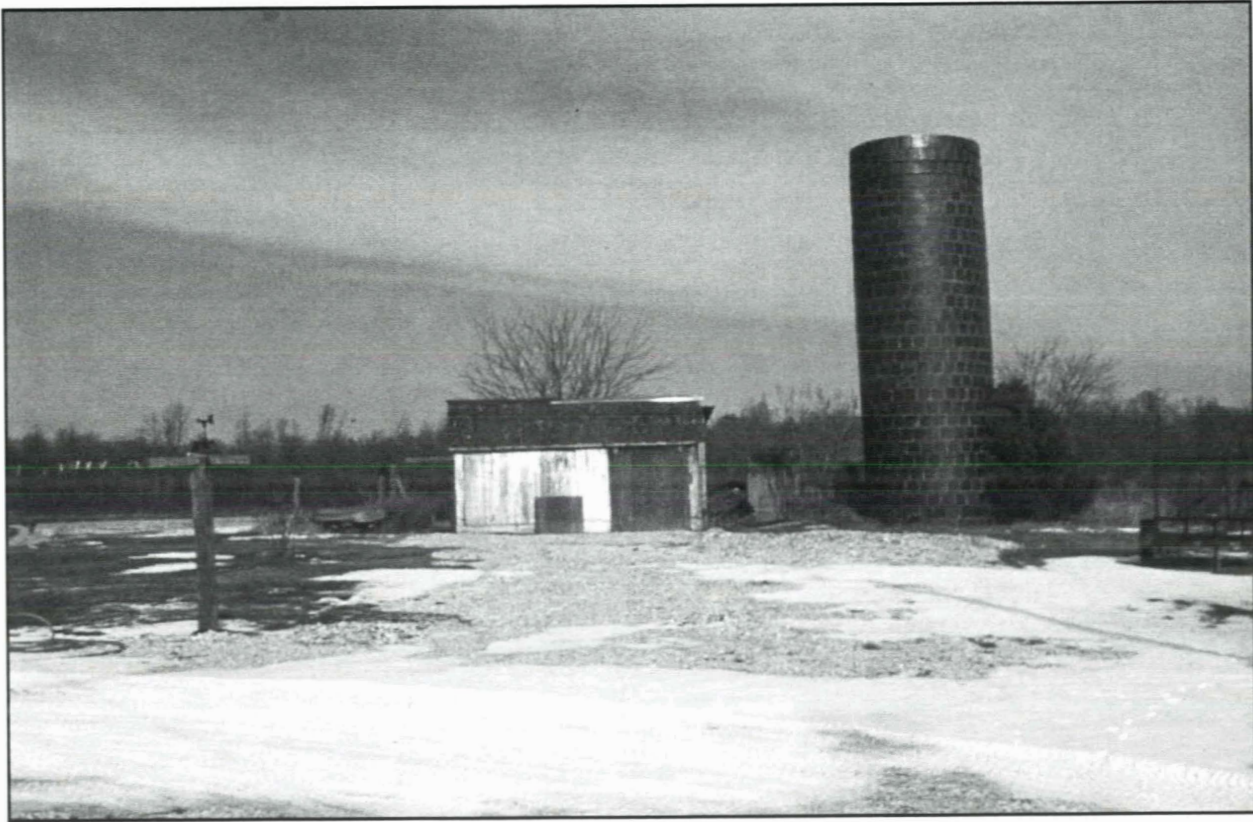
J. Barwick/Maurice M. Adams Farm
DALPF Project ID K-95-04-039**

The Adams farm complex is located on the north side of Layton Corners Road, near its intersection with Pear Tree Lane. The 157.05-acre complex contains a main dwelling, chicken house, machine shed, milkhouse, and foundation of a dairy barn, silo, tool shed, and remnants of a greenhouse. The circa 1910 main dwelling is typical of the Four-Square style popular in Delaware from approximately 1890-1920. The property includes remnants of a dairy barn and greenhouse, whose uses are no

The Adams farm has a medium level of significance even though it has a partially intact complex and a well-maintained Four-Square dwelling. Modern intrusions, primarily in the form of buildings associated with the chicken industry and the demolition of the earlier dairy buildings, detract from the farm's historic significance.

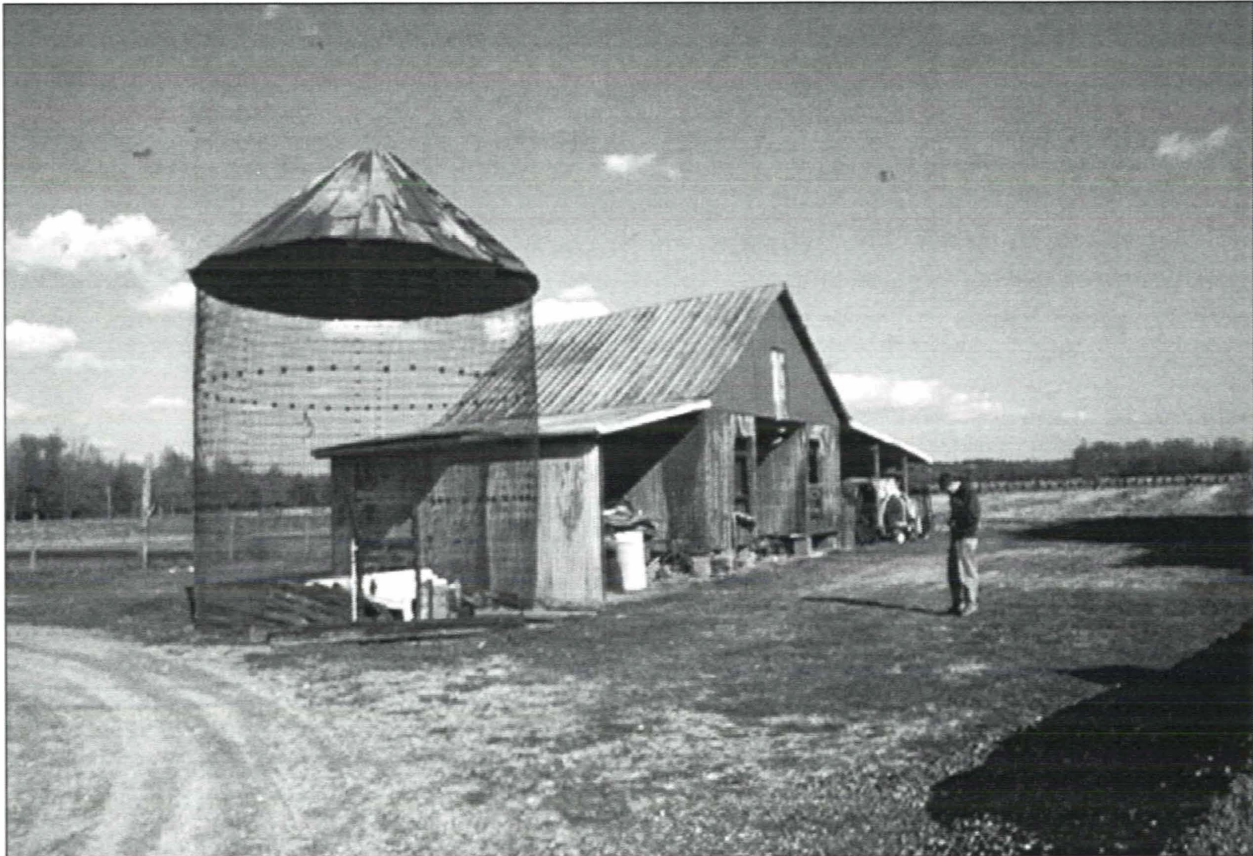
*Mrs. M. Darby/Vogl Brothers and Frances Vogl Farm
DALPF Project ID K-95-06-041***

The high significance of the Vogl farm complex is attributable to the gable-roofed

dairy barn, drive-through corn crib, milk house, and the main dwelling that has been heavily renovated. The modern buildings do not detract from this intact complex, which has an array of building types and periods of construction.

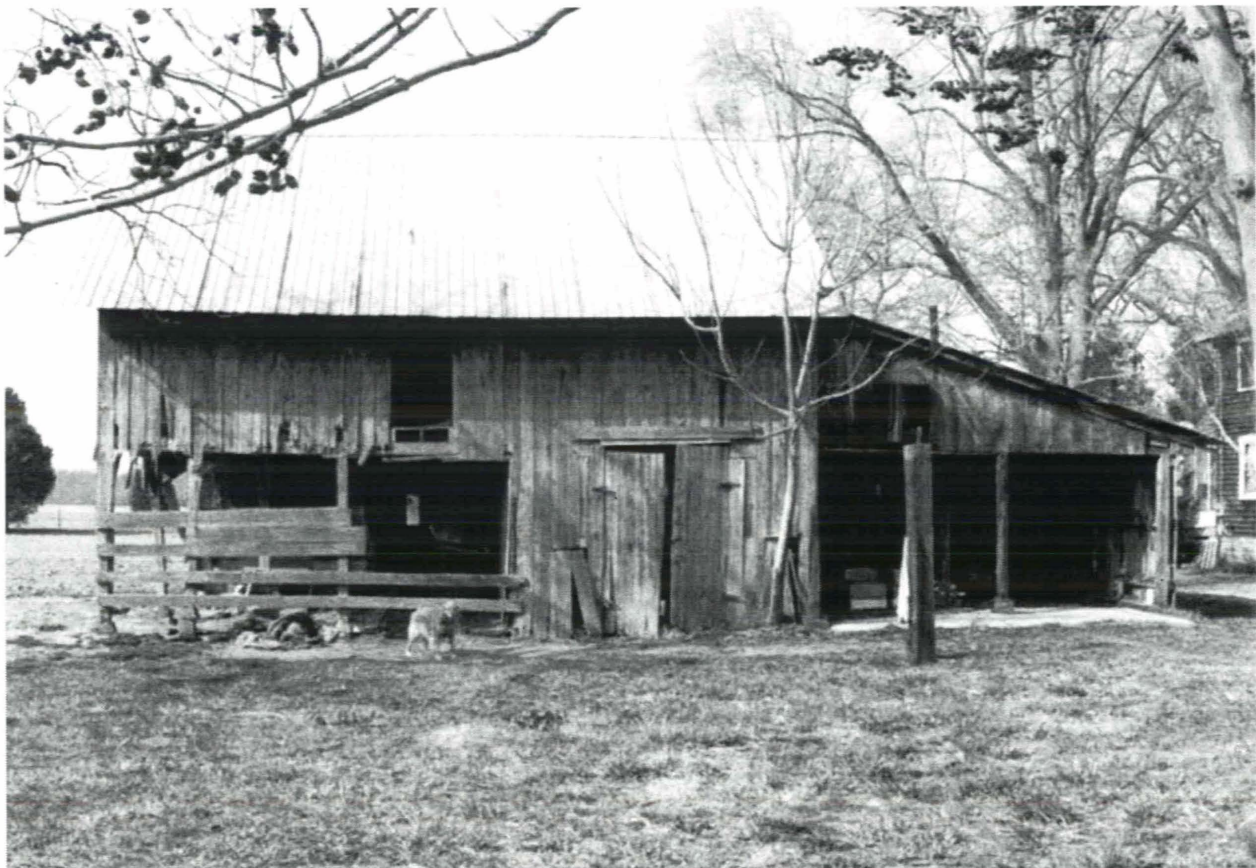
Elinor Davisson and Victor & Gilbert Fibelkorn
DALPF Project ID K-95-07-014E

sheathed in vertical board siding and create an agricultural complex with a multitude of uses. The circa 1920 main dwelling is a two-and-one-half story gable-roofed building sheathed in wood shingles and supported by a rockfaced concrete block foundation. The Appalachian style barn was converted for dairy purposes around 1940 and received a milking parlor addition. The small grain storage as well as chicken and pig houses portray the diversity of this complex, which operated primarily as a

The high level of historic significance for the Fibelkorn farm derives from its diverse range of agricultural buildings. The complex is considered a threatened resource because many of the historic buildings are in states of deterioration. All elements of the complex contribute to its historic significance.

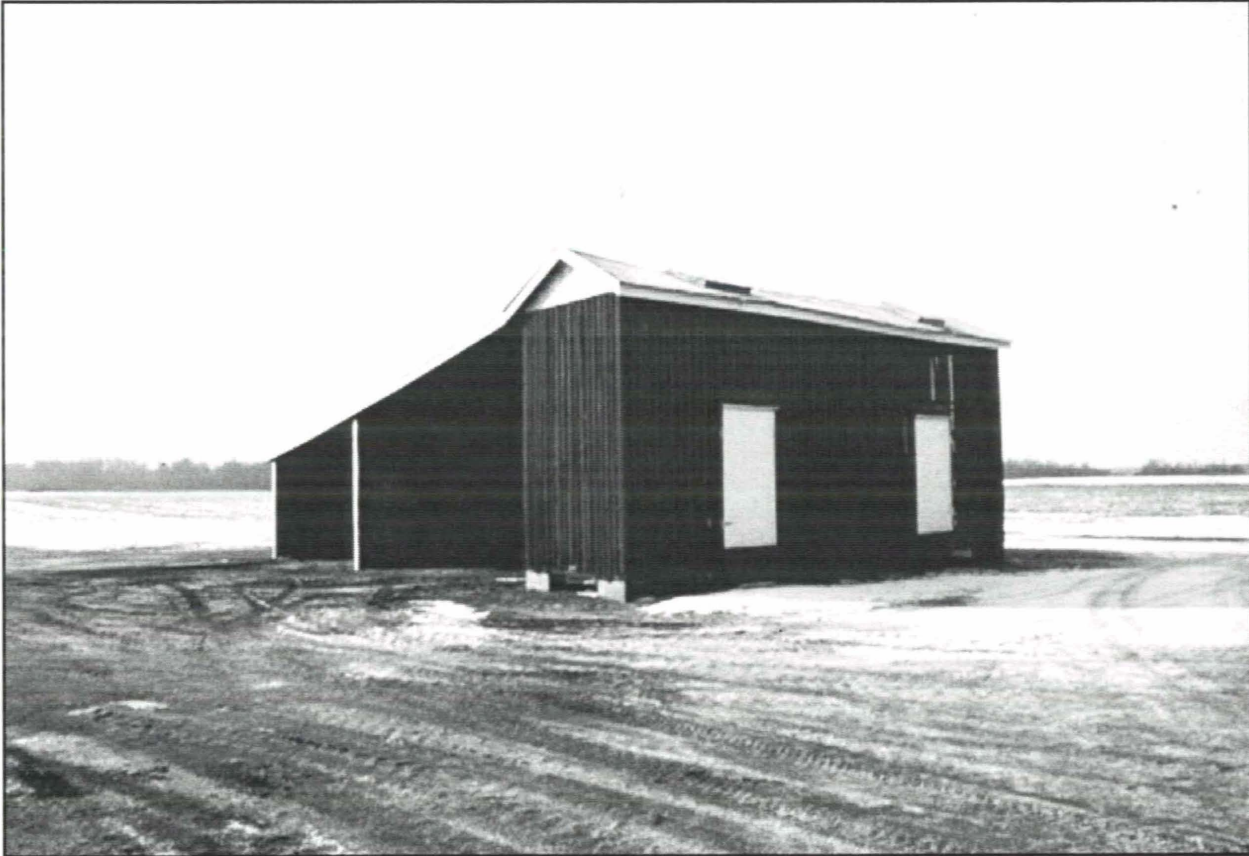
*A. T. Torbert/Walter F. and Barbara A. Hanson Farm
DALPF Project ID K-95-08-044*

nineteenth-century. Though there is little historic significance in the construction of the buildings, the Hanson farm exhibits its medium

level of historic significance through its intact complex and arrangement of buildings.

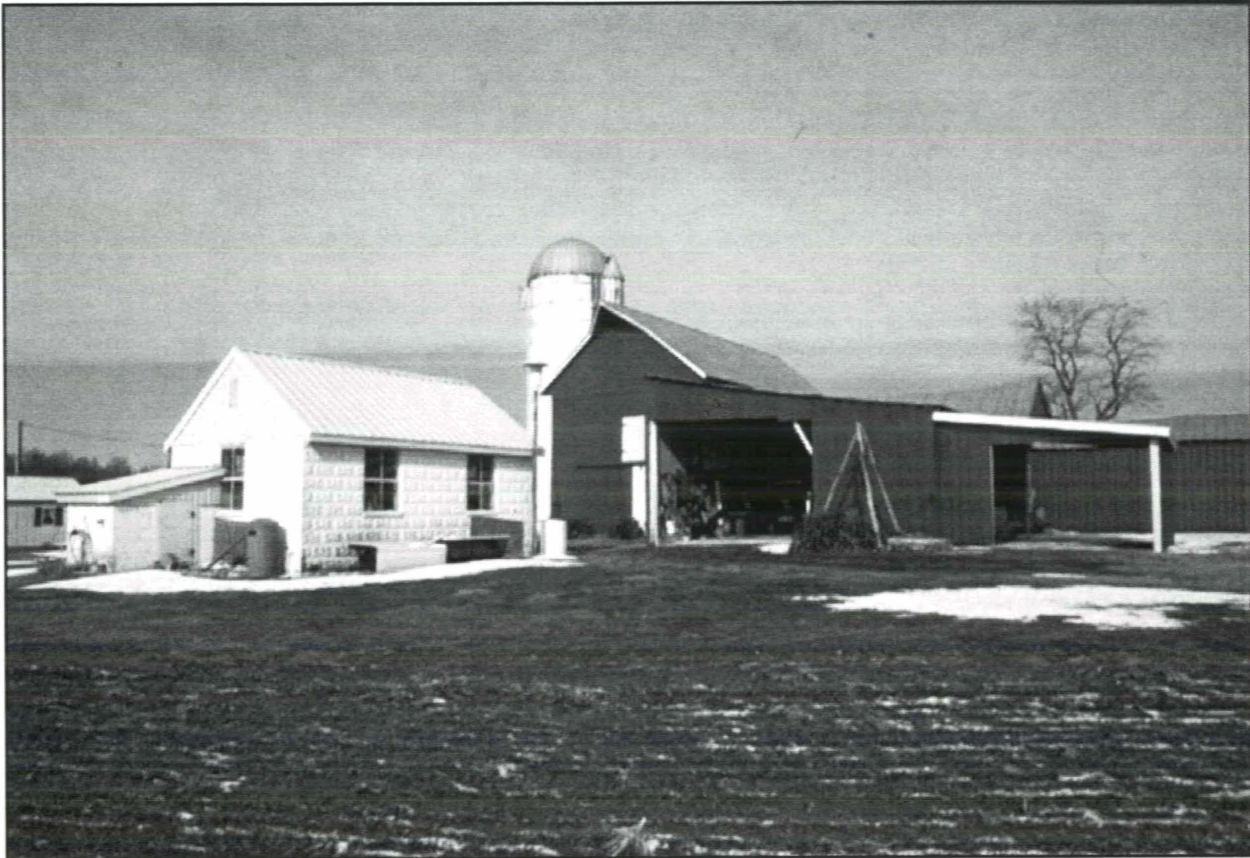
Carl M. and Audrey B. Wright Farm
DALPF Project ID K-95-08-044A

because of its division of interior spaces and various periods of construction. The most significant aspect of this complex's history is revealed through the arrangement of the buildings in a domestic agricultural complex

west of the 1900 dwelling and the dairy complex located at the north side of the complex, which illustrates the transition of this farm to a dairy-producing complex.

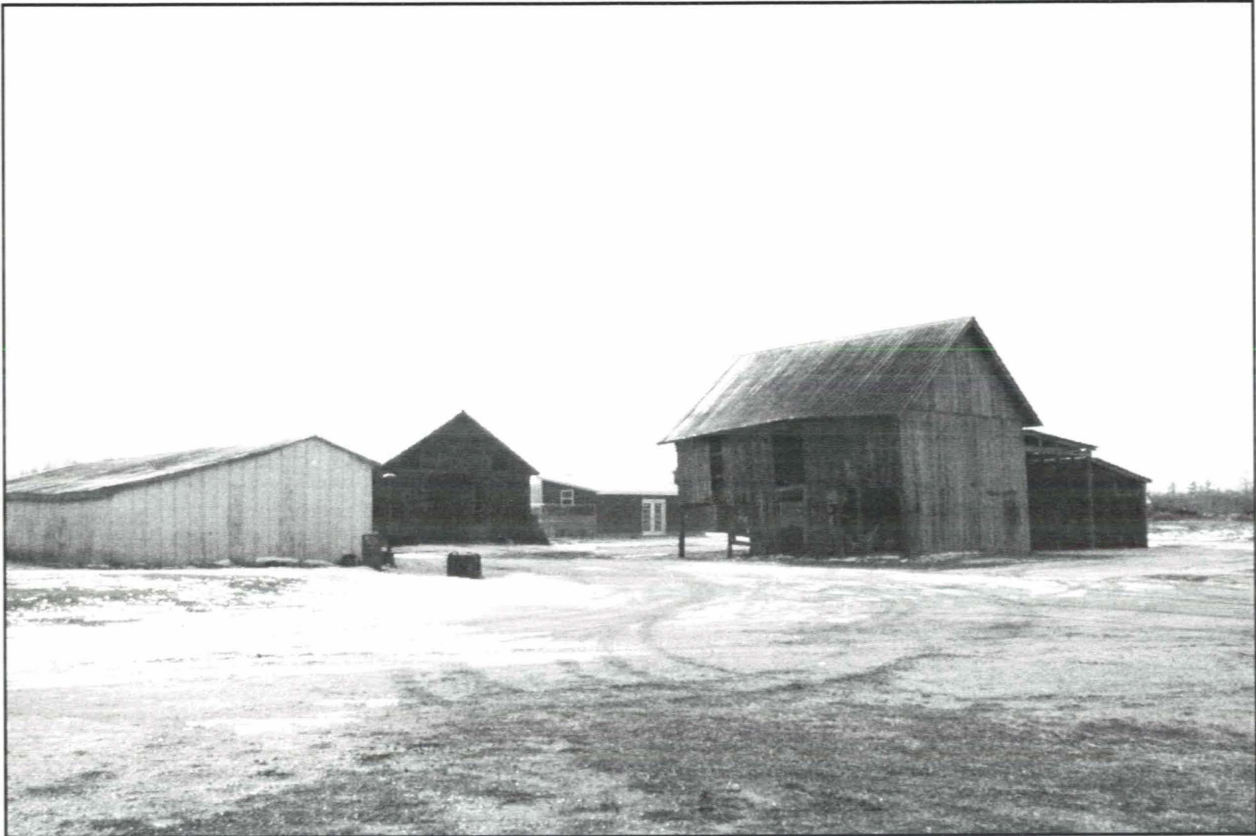
Christopher M. and Crystal L. Wyatt Farm
*DALPF Project ID K-95-08-048***

The Wyatt farm has a medium level of historic significance because only three buildings from the original farm complex survive today. This complex contains buildings related to dairy, grain, and beef industries, but the operation of

the farm is now solely focused on raising livestock.

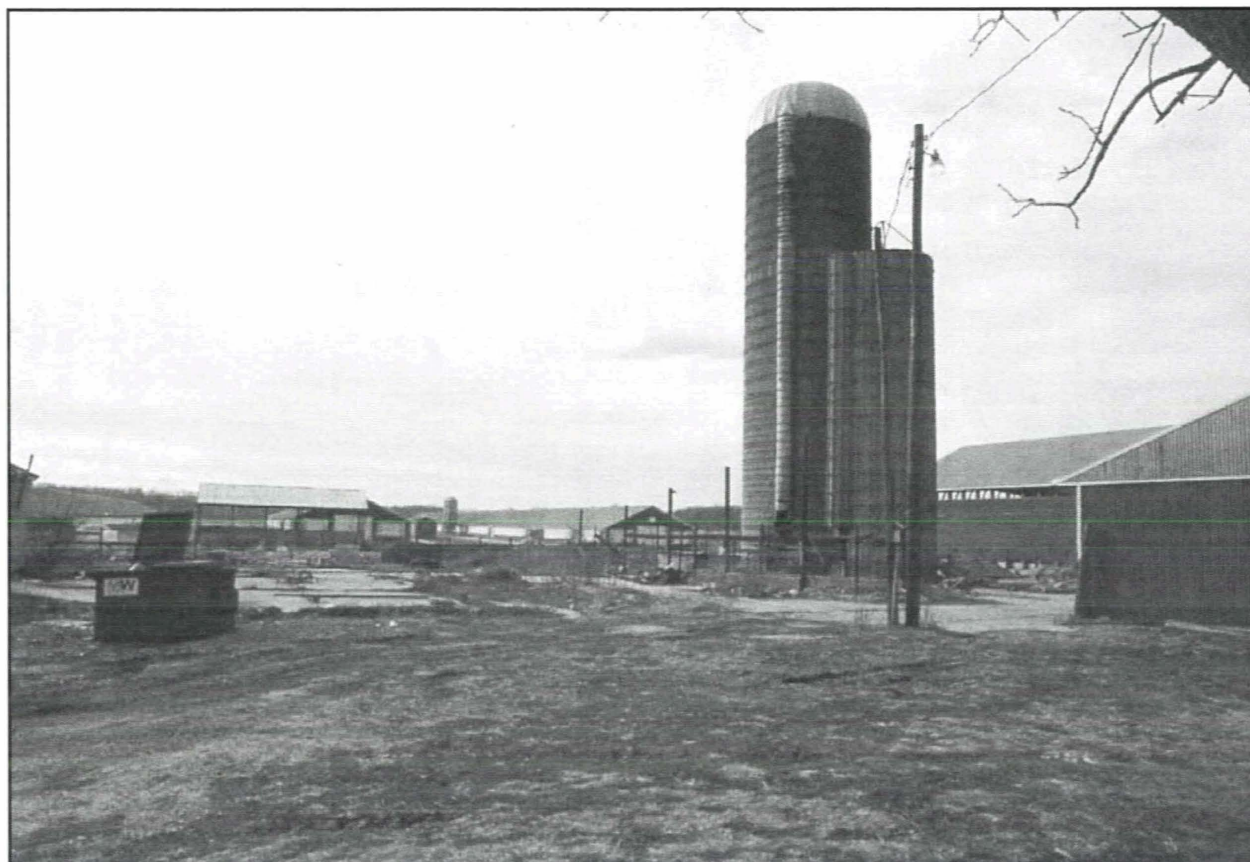
*Mrs. W. Hazel/William C. and Joyce A. Webber Farm
DALPF Project ID K-96-01-054**

The Webber farm complex has a medium level of significance because the main dwelling, milkhouse, and silos are the only buildings of historic value that remain from its original dairy operations. While the foundation of the dairy barn survives to mark the layout of the dairy operations, it is not enough to convey a sense of the full landscape of dairying.

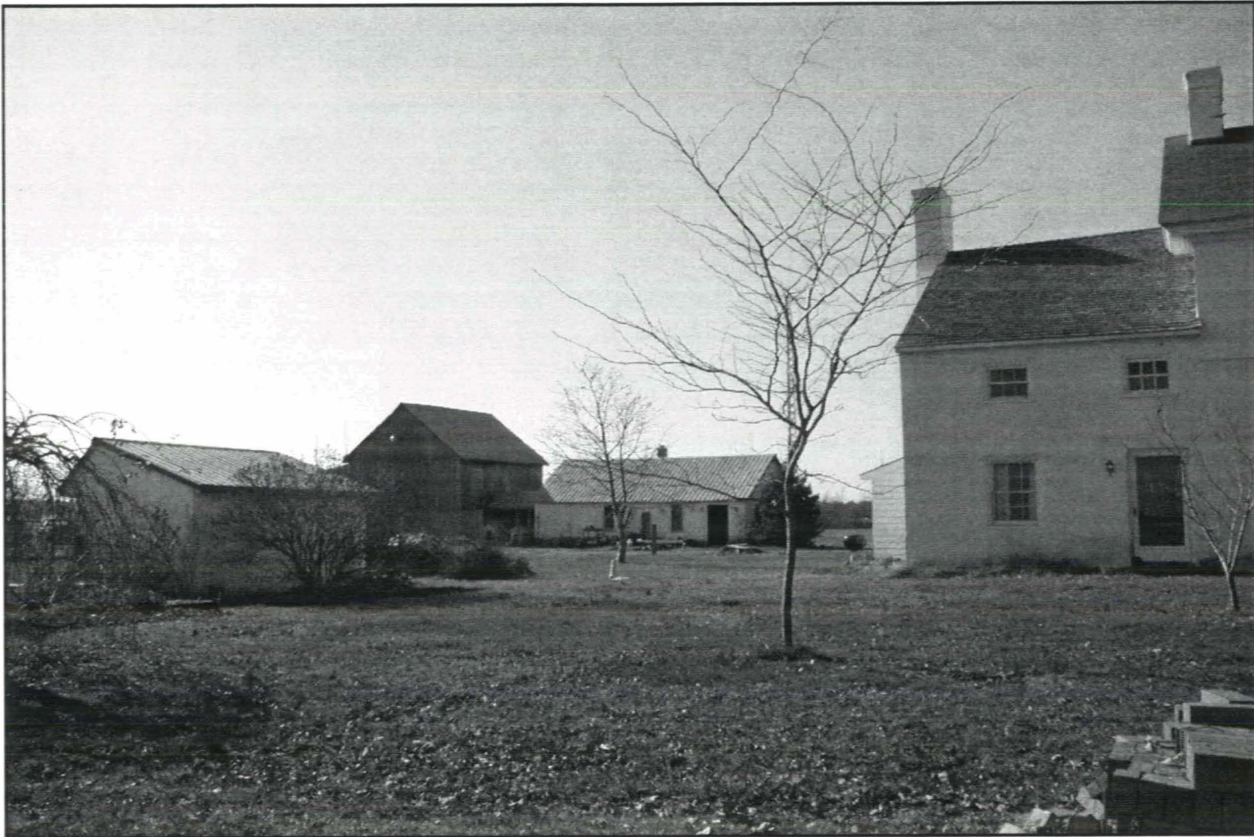
Coombe/Joseph S. Hughes Farm
DALPF Project ID K-96-02-060

The Hughes farm complex is located on the south side of Burnite Mill Road, approximately 2.5 miles west of Felton. The complex includes a main dwelling, wood shed, outhouse, cart shed, granary, and workshop. The circa 1770 Georgian style house is a two-and-one-half story, three-bay dwelling with a four-room plan that is of brick construction covered with stucco. A two-story brick kitchen wing extends

construction periods of the buildings on the complex. The evolution of this eighteenth-century farm complex into the twentieth-century is highly significant, for it portrays how the complex has grown throughout its history that began with the Coombe family.

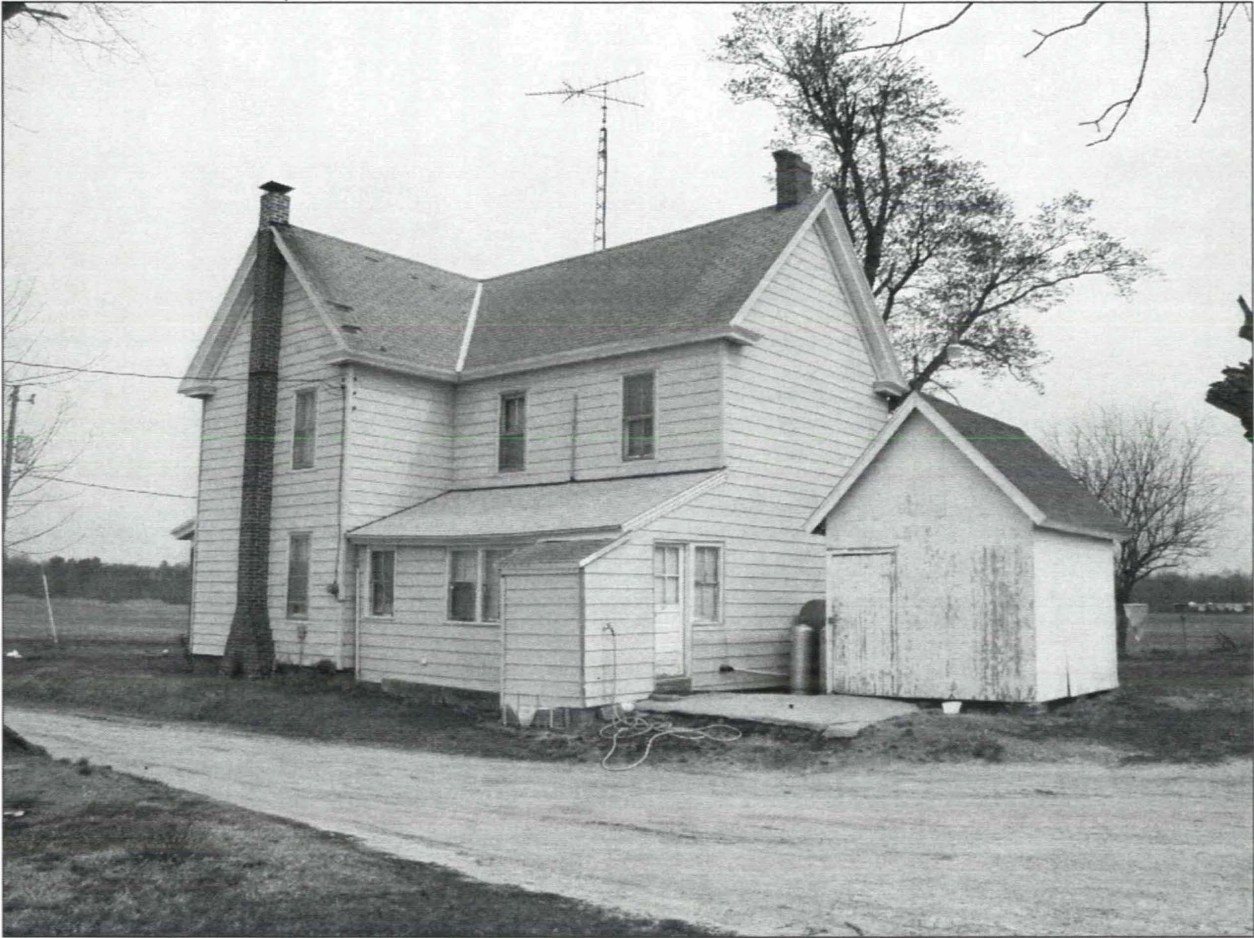
*T. Miller/Emil and Ruth Gallo Farm
DALPF Project ID K-96-03-040D*

building sheathed with a layer of plywood and supported by a brick pier foundation.

Although largely intact, the complex reflects only a medium level of significance. It contains only two buildings constructed prior to the mid-twentieth-century. The buildings that form the present farmstead portray the transition of this complex from the dairy industry to the mixed grain industry.

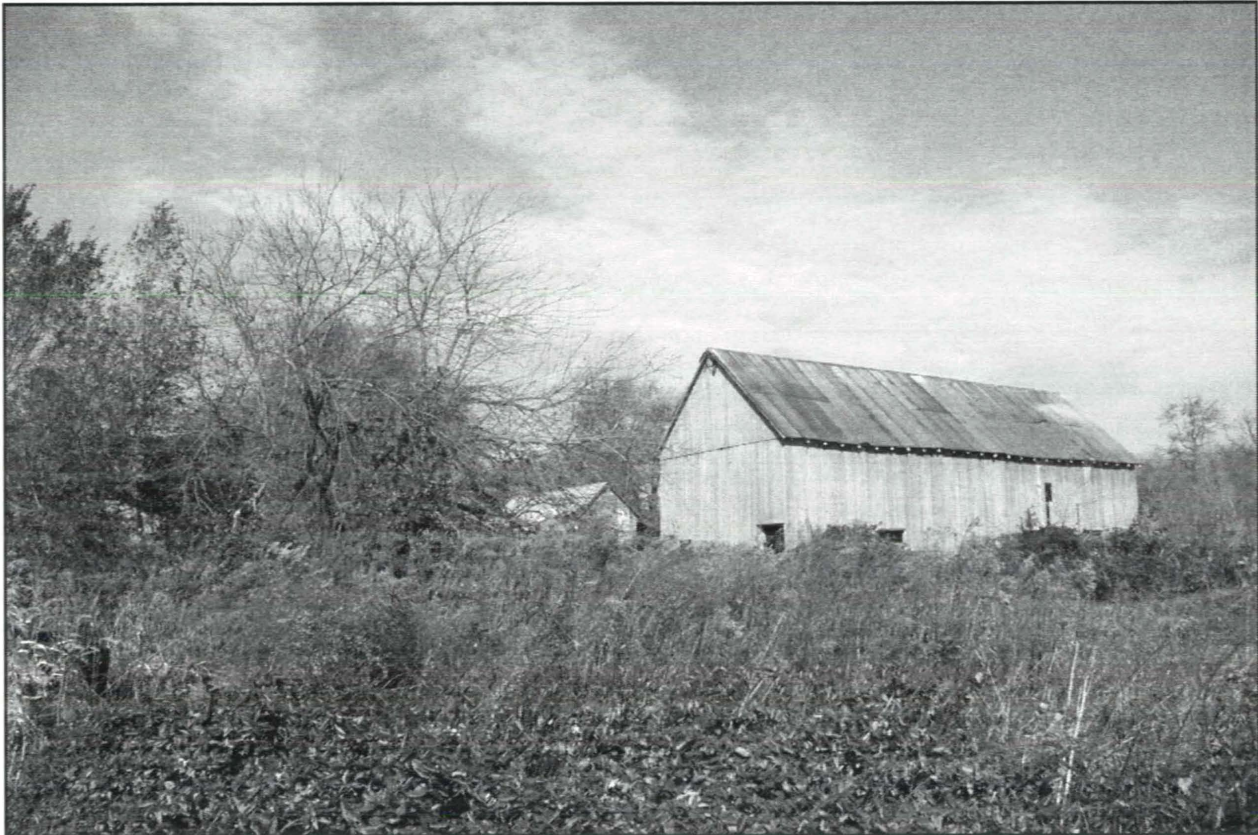
Rev. Warner & J. Hopkins/Mabel M. Woikoski Farm
*DALPF Project ID K-96-05-092***

five chicken houses, a machine shed, and a mobile home. Because the operation of this complex now focuses on poultry and pork, rather than its historic grain operations, the historic buildings, with the exception of the pigpen, are overgrown with brush and deteriorated. All of the historic buildings are sheathed with vertical board siding and have gable roofs sheathed in wood shingles that have been covered with metal.

on poultry production for the Perdue Farms Company, the Woikoski farm utilizes the more modern buildings, neglecting the historic buildings in the process.

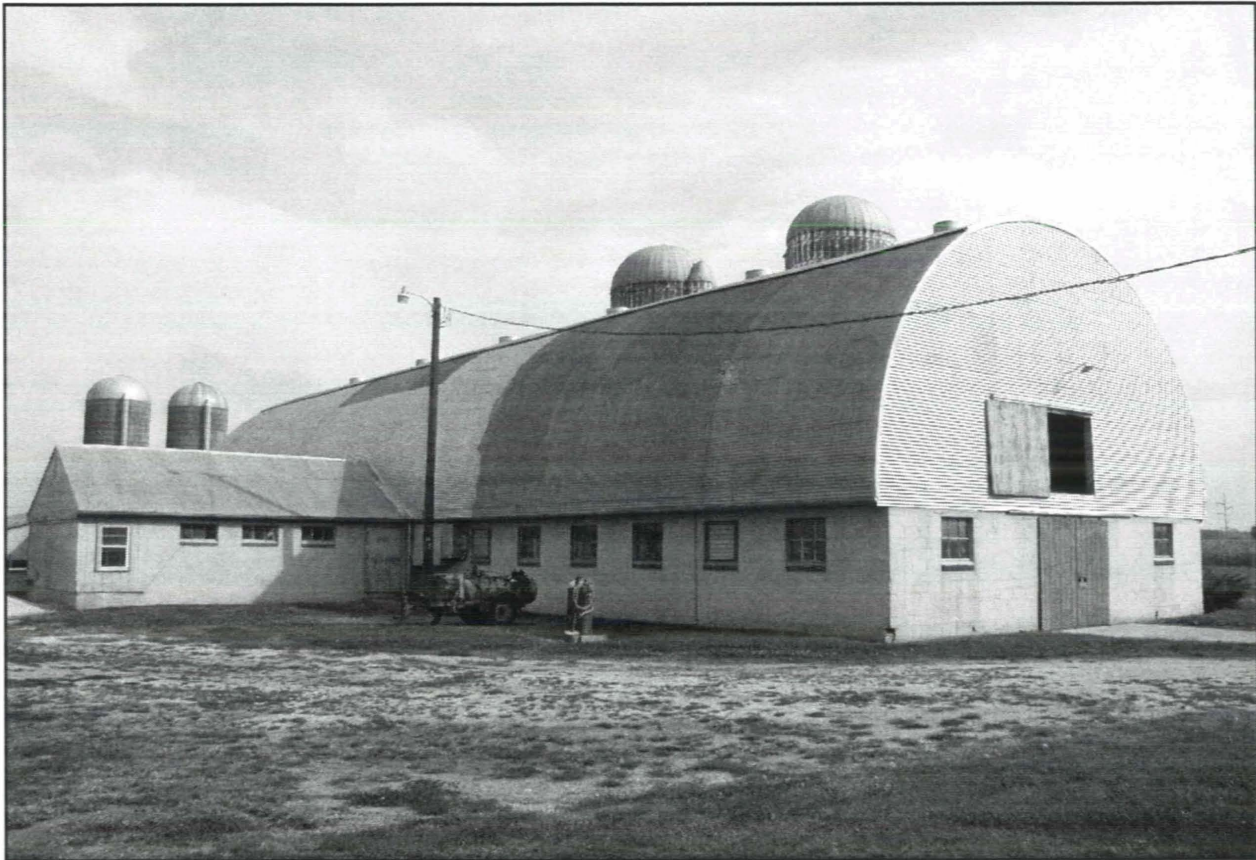
R. Lewis or J.P. Rees/Frank W. Ryan Farm
DALPF Project ID K-96-06-007B

building periods and their high degree of integrity, as well as the design and size of this dairy and grain-producing complex, contribute to the high level of historic significance of the Ryan farm.

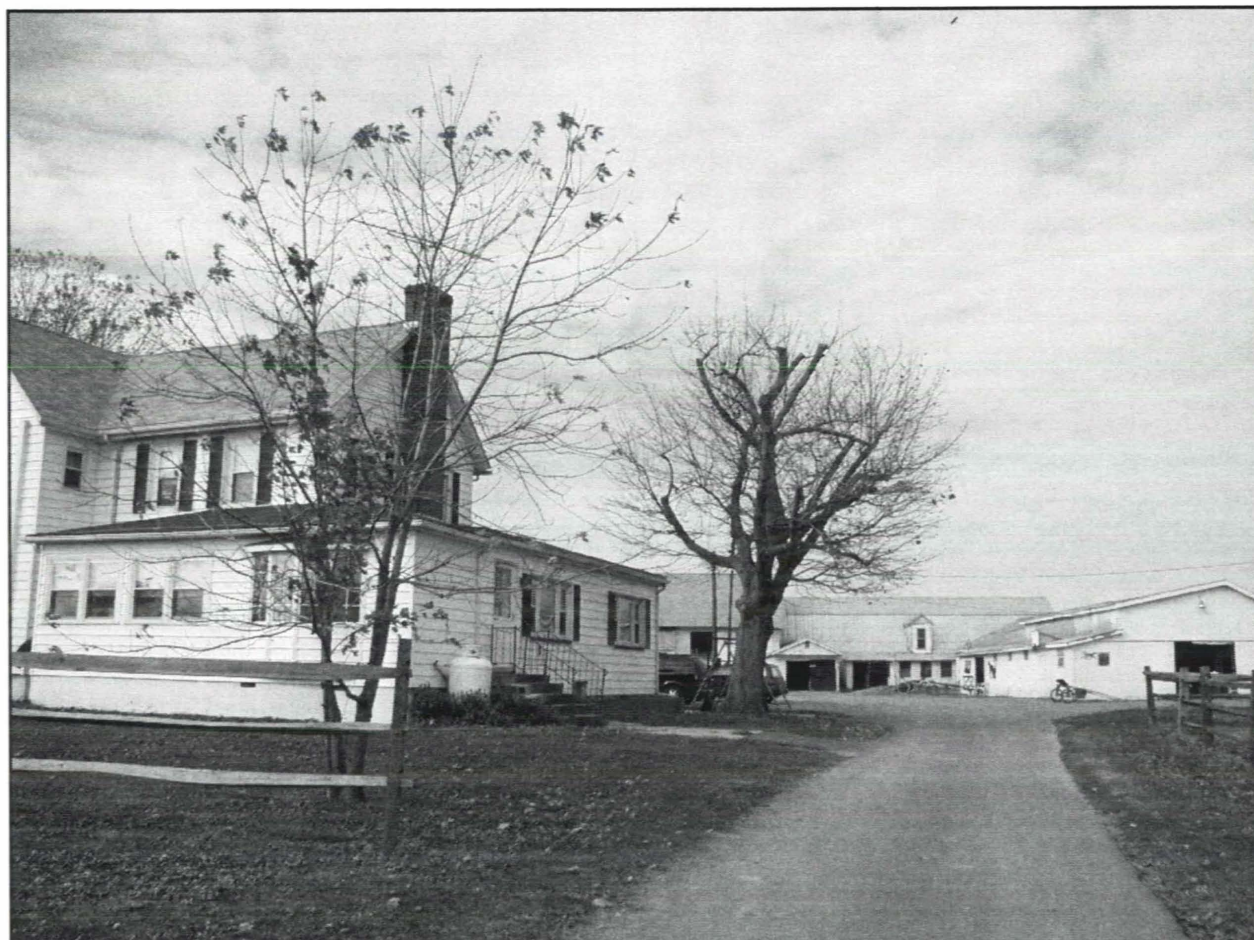
"Rippling Brook," T.L. Sutliff/Leland M. and Eleanor N. Davis Farm
DALPF Project ID K-96-06-007D

machine shed and a garage. These buildings exhibit high levels of integrity, but their level

of historic significance is set at medium due to the relatively recent age of the complex.

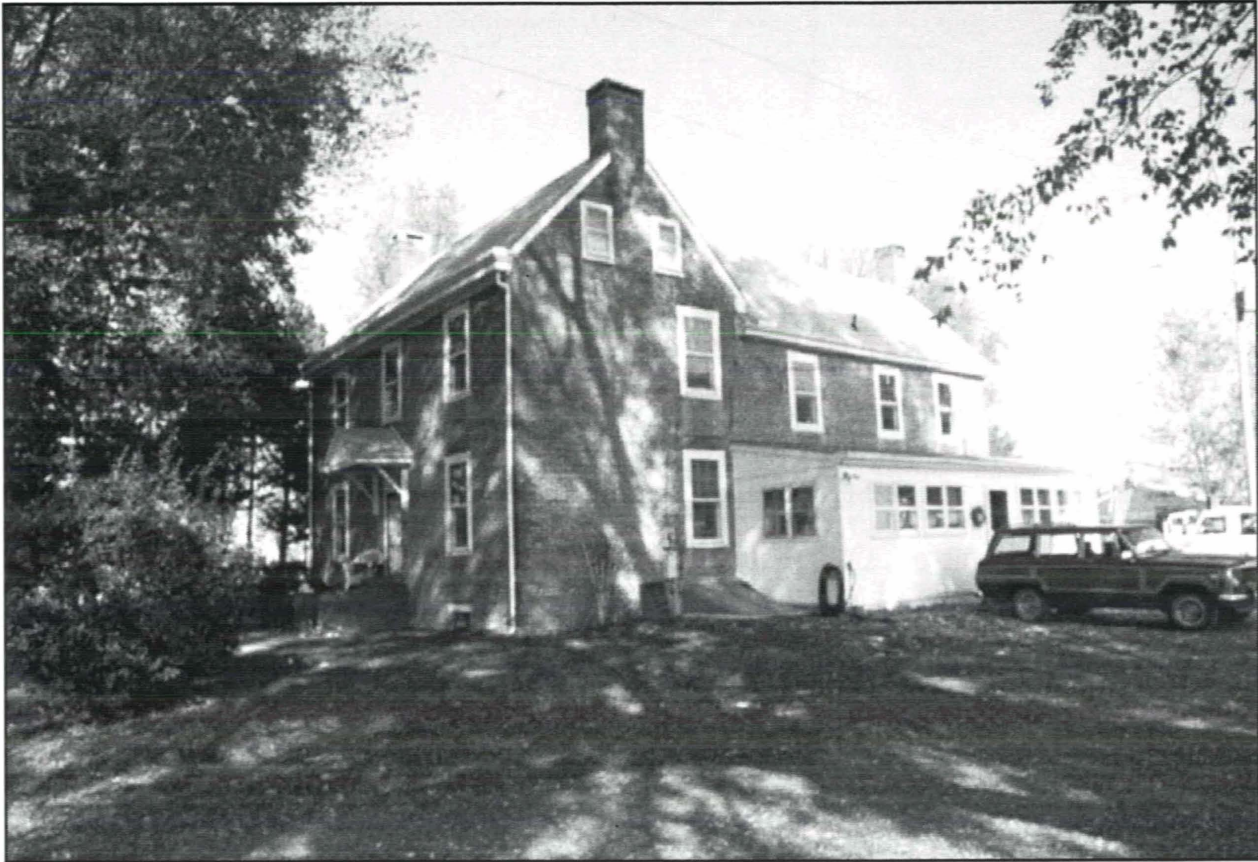
J. M. Voshell/Cathryn J. Cornelius Farm
DALPF Project ID K-96-08-081B

The medium-level significance of the Cornelius farm complex is portrayed through the well-maintained nineteenth-century main dwelling. The other buildings, except for the chicken houses, exhibit no significance related to the historic operations of this farm complex. The destruction of original agricultural outbuildings and construction of modern agricultural one

diminishes the historic significance of this nineteenth-century complex.
