Introduction

In August 1998, the Center for Historic Architecture & Design (CHAD) at the University of Delaware first contracted with the Delaware Agricultural Lands Preservation Foundation (DALPF) to document the farmsteads whose owners were currently applying for permanent protection through the purchase of development rights. Specifically, the goal of the project was to evaluate the level of historic significance of each farm complex;

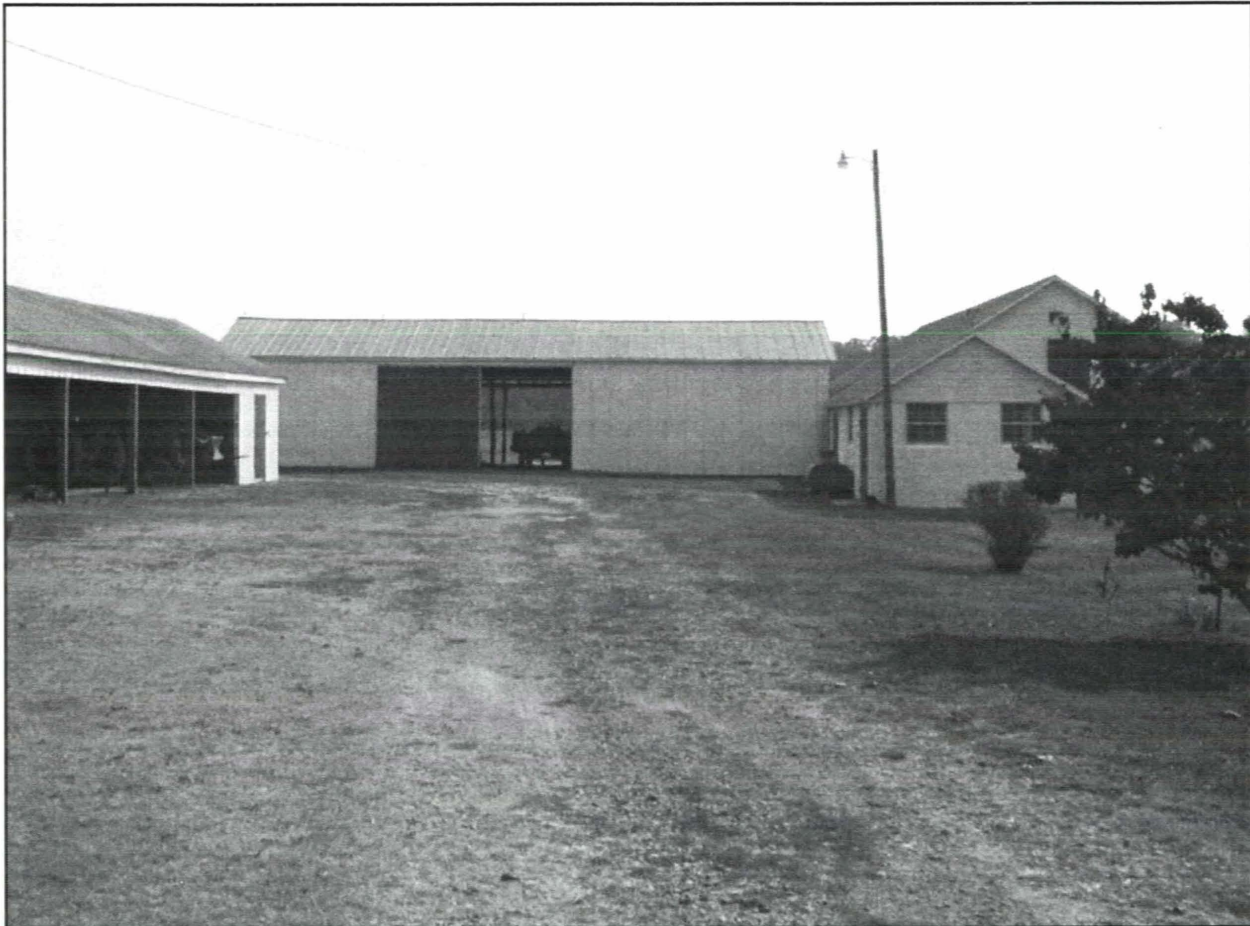
*E. Spruance/Charles B. and Alice T. Ross Farm
DALPF Project ID K-97-01-007E*

and retains little of its original materials. The wagon shed has a granary built into its west elevation, which is elevated from the ground on a pier foundation. The dairy barn and milkhouse are the only buildings that remain from the dairy practices that formerly occurred on this complex.

intrusion. The medium level of historic significance of this complex is a result of the main dwelling, whose renovation detracts from

the portrayal of this early twentieth-century grain-producing complex that also includes mid-twentieth-century dairy buildings.

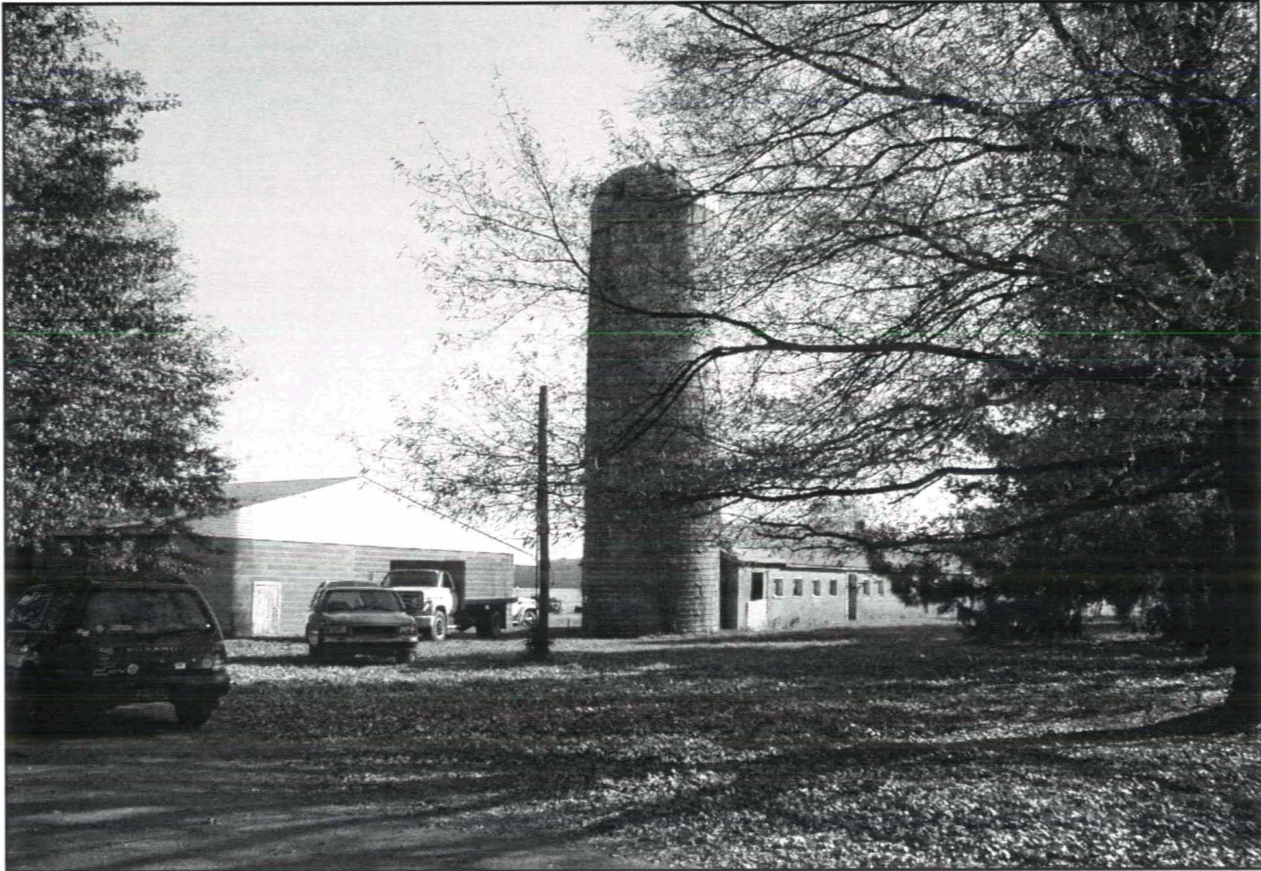
Dr. G. Emerson/Mary E. Cartanza Farm
DALPF Project ID K-97-01-147

craftsmanship by the masons who constructed it in the eighteenth-century. The original agricultural buildings have been replaced by

modern buildings adding no historic significance to the complex other than the creation of an intact modern farm complex.

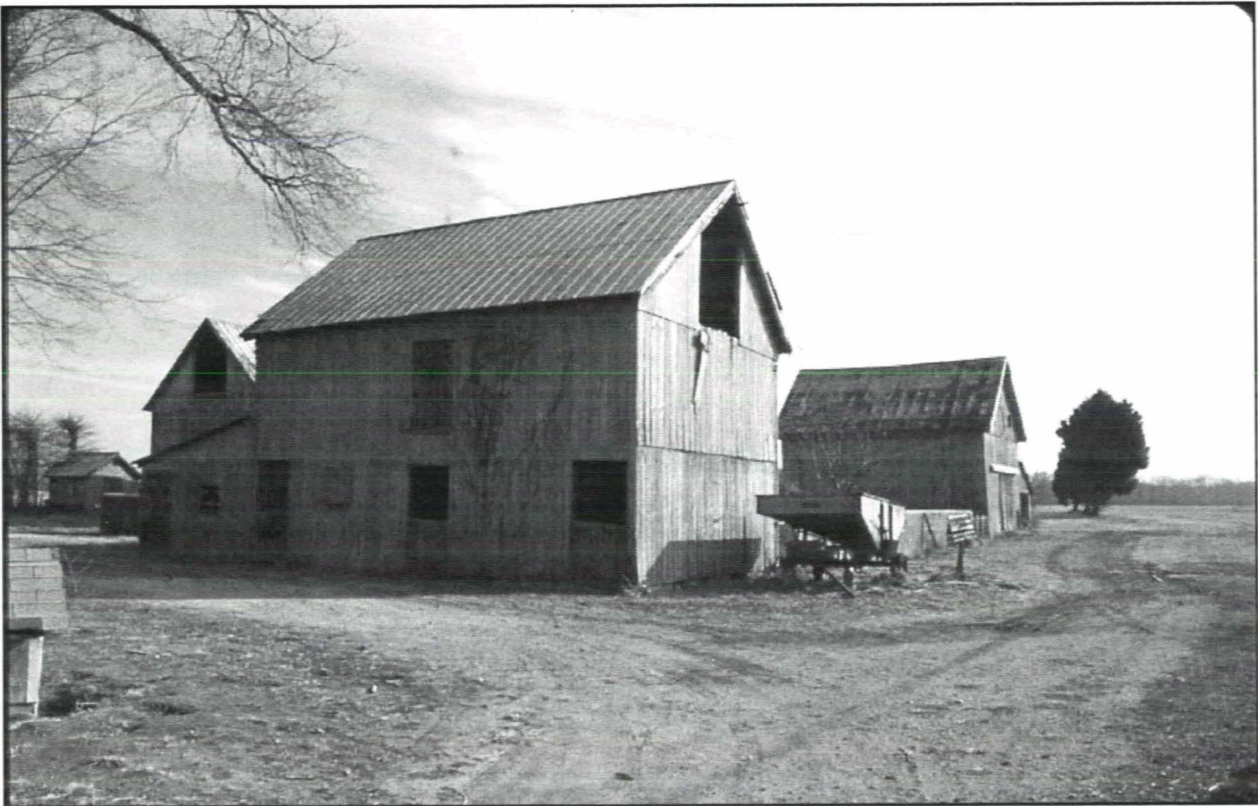
*T. Dane/Dorothy M. Jones Farm
DALPF Project ID K-97-09-0*

The Jones farm has a high level of historic significance because it is a fully intact complex with a variety of agricultural buildings. The buildings exhibit high levels of integrity, but are in poor condition except for the house,

which is the only building that continues to be used for its original purpose.

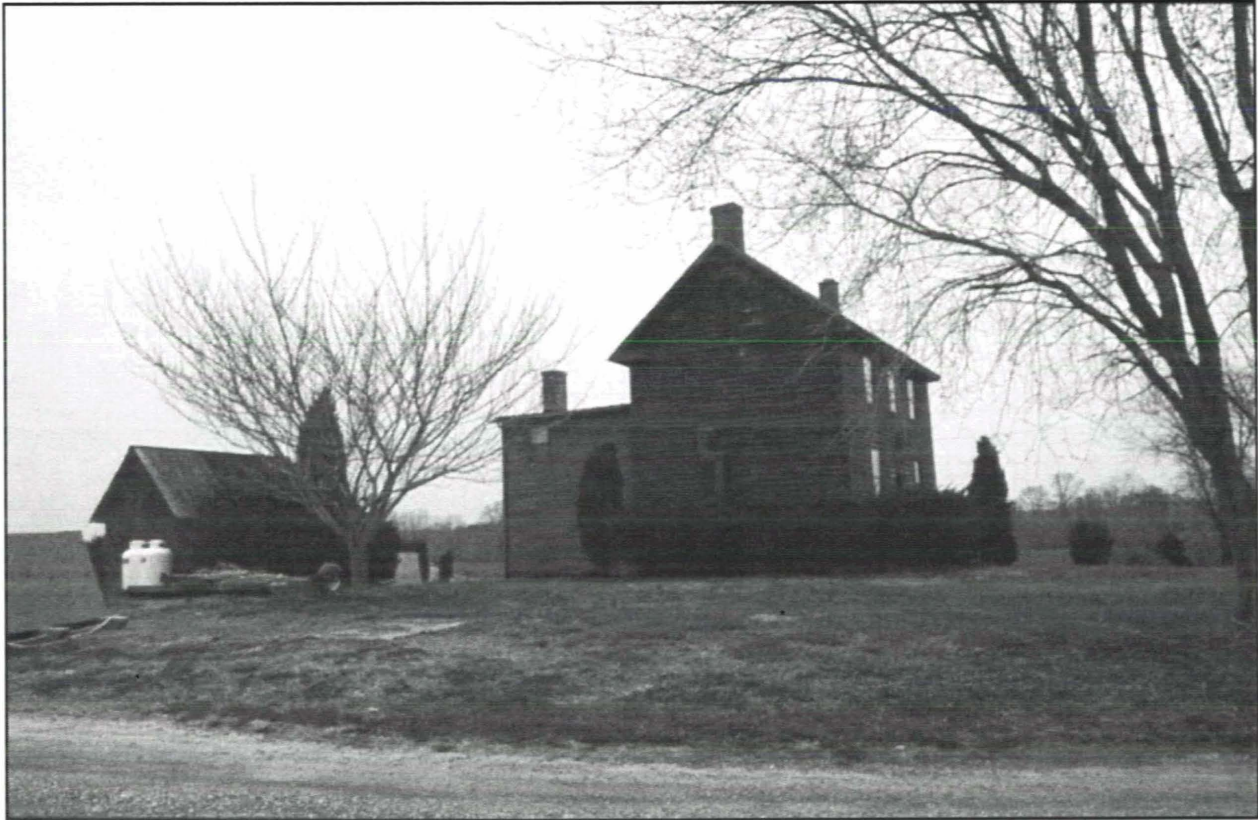
Slocum/Eric J. and Julia C. Hopkins Farm
DALPF Project ID N-92-09-00

The Hopkins farm has a medium level of significance because only two of the original buildings survive from this grain-producing complex. The main dwelling retains high levels of integrity and significance, but the addition of modern agricultural and domestic

outbuildings detracts from the significance of this agricultural complex.

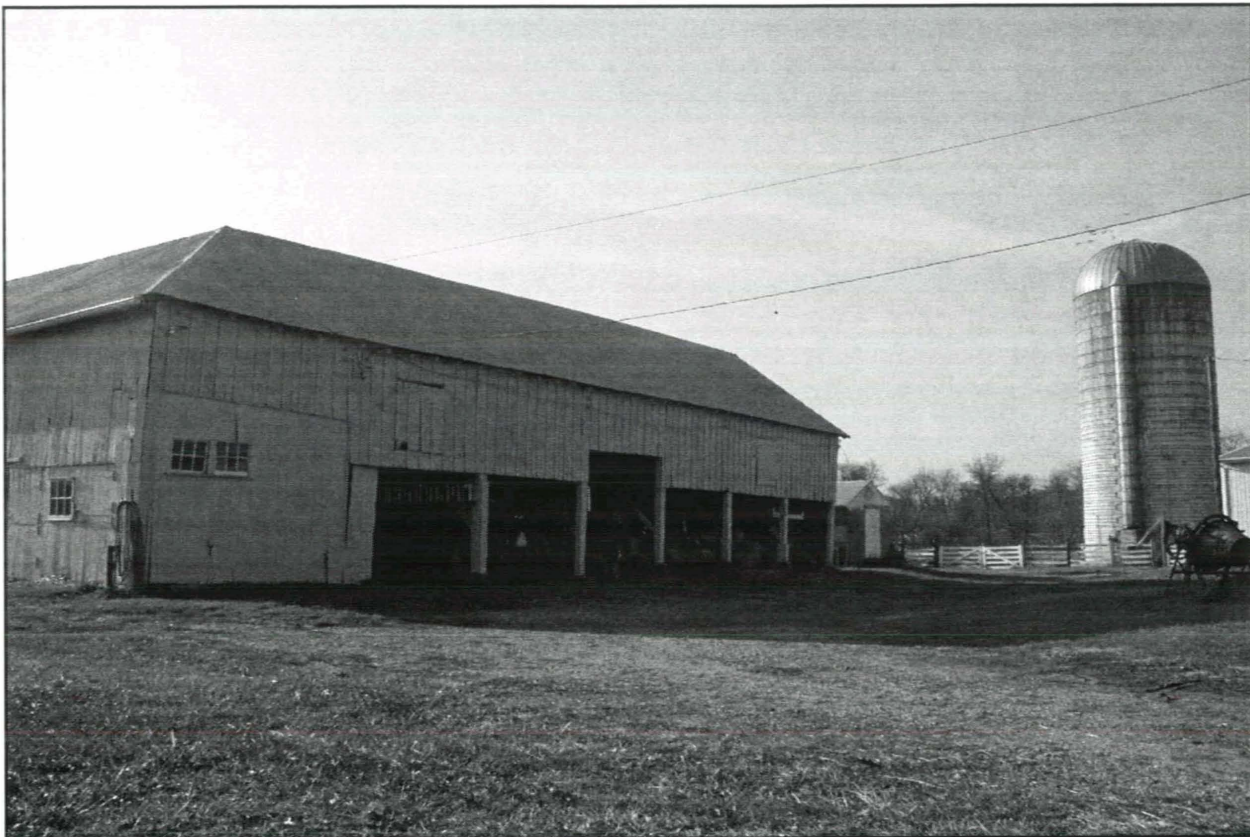
Cornelius Naudain/Will S. and Joanne O. Passmore Farm
DALPF Project ID N-93-01-012**

The Passmore farm complex has a high level of significance for several reasons. First is its association with the Naudain family, who escaped religious persecution in France and settled in Appoquinimink Hundred in the early-eighteenth-century. Second, and more important, is the survival of an agricultural complex that is intact from the early twentieth-century, along with elements from earlier centuries.

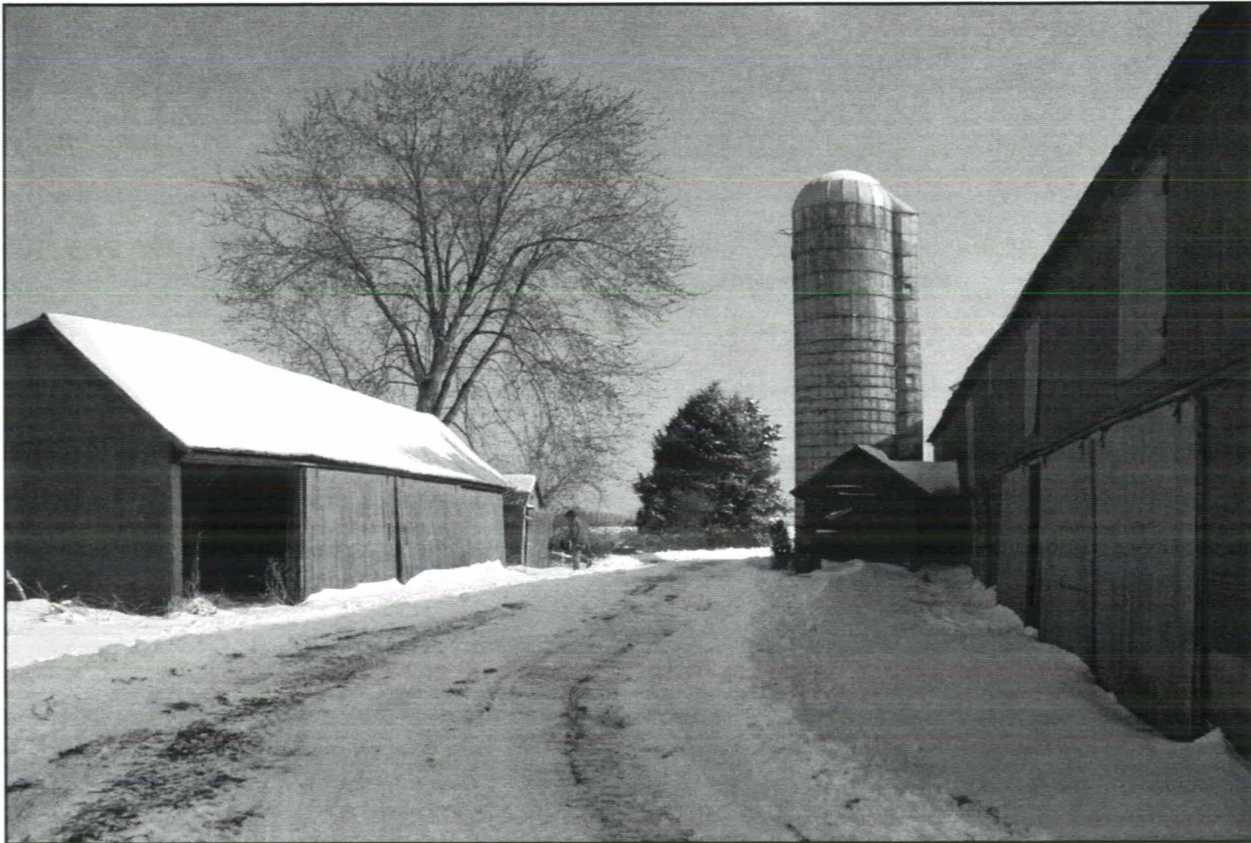
*A. Ennis Farm/ F. Thomas and June W. Unruh Farm
DALPF Project ID N-93-01-013**

pier foundation, were both constructed early in the twentieth-century.

The high level of historic significance for the Unruh farm is portrayed through the dairy barn, corn crib, and the layout of the buildings in a well-planned complex.

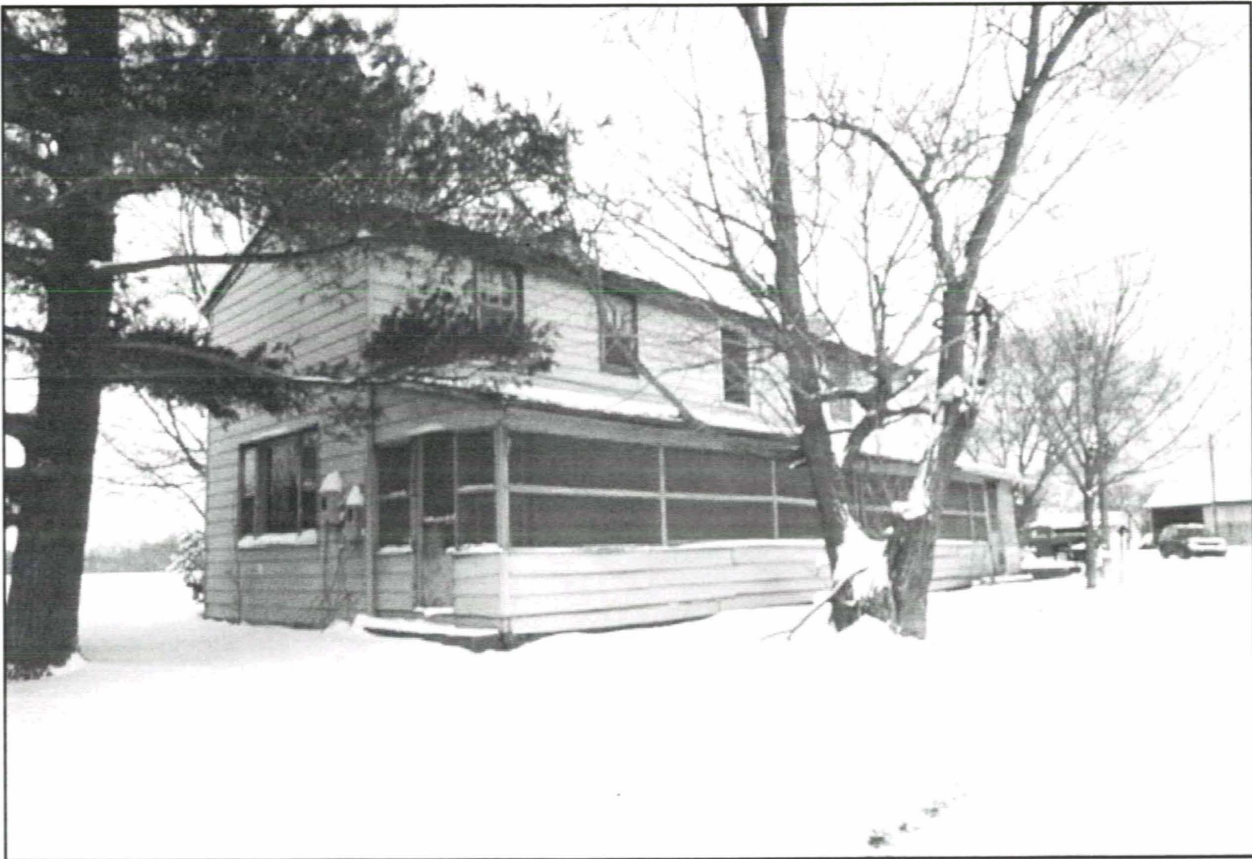
*Daniel Corbitt/F. Thomas and June W. Unruh Farm
DALPF Project ID N-93-01-12**

The Unruh farm complex has a high level of historical significance because of the mix of nineteenth- and twentieth-century farm

buildings that function in the daily operations of the dairy industry, which has struggled to stay alive in southern New Castle County.

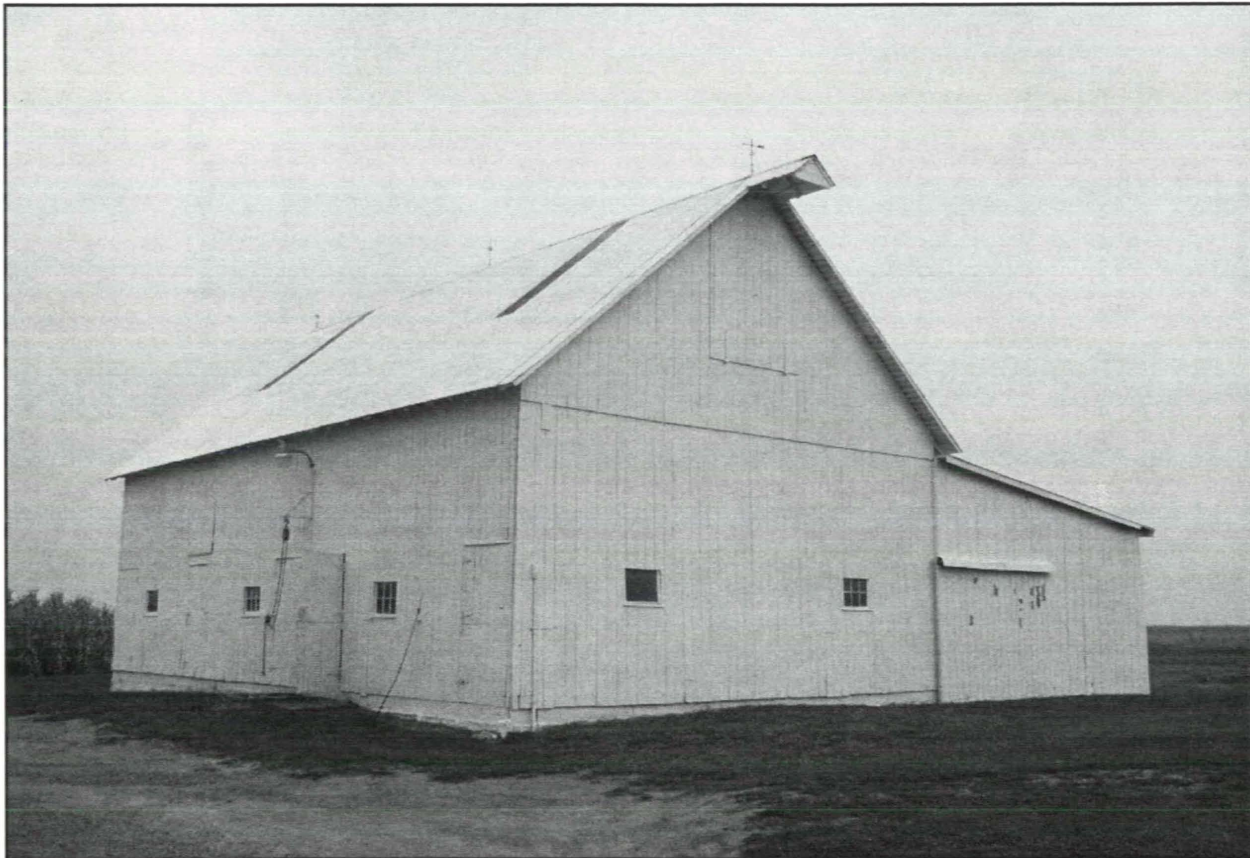
*I. Staats/Louisa H. and John W. Dukes Farm
DALPF Project ID N-95-08-047*

century, but its agricultural buildings from the first half of the twentieth-century remain intact. The dairy barn retains its original form, and is representative of the economic hardships, which forced New Castle County farmers to abandon the dairy industry when it proved too expensive to convert their buildings to meet evolving sanitary standards.

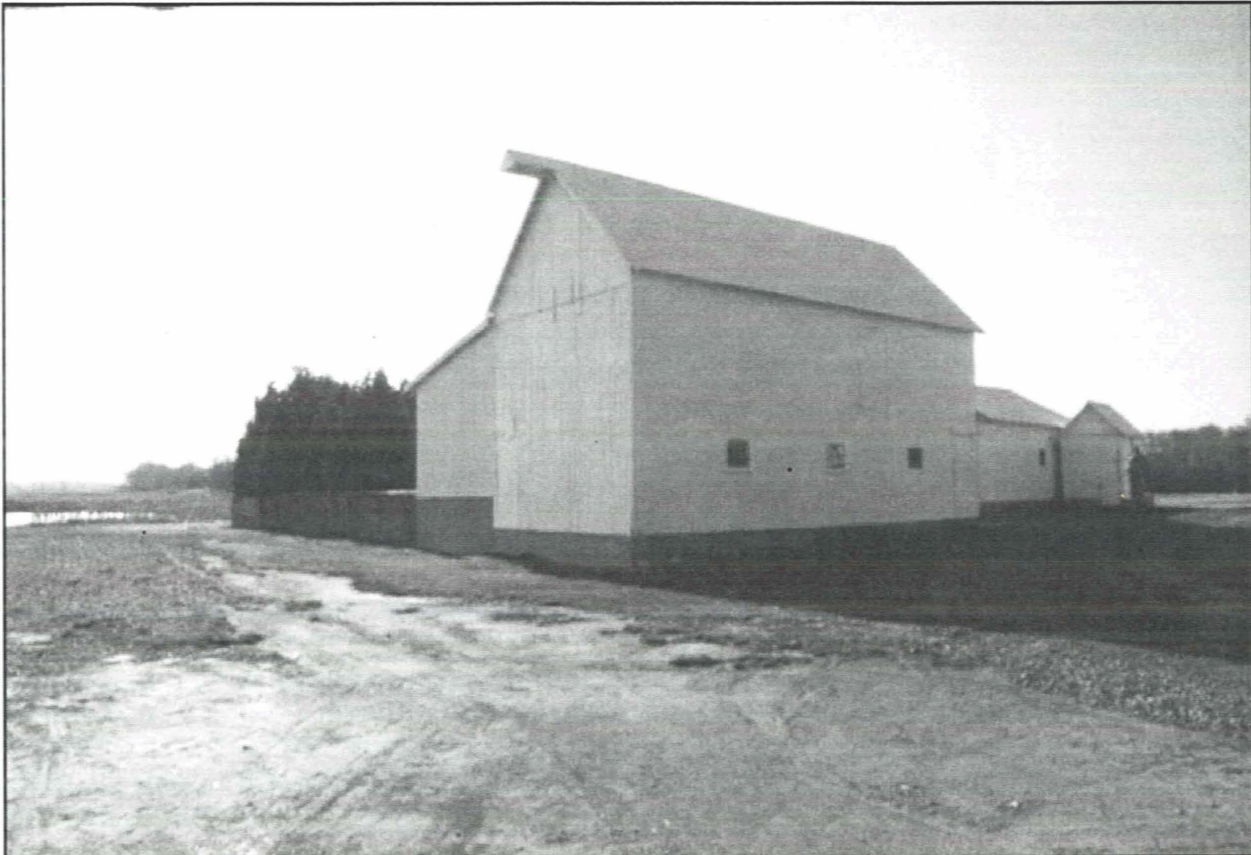
W. and R. Johnson/Louisa H. and John W. Dukes Farm
DALPF Project ID N-95-08-047

The Dukes Farm is located on the south side of Cedar Swamp Road, approximately one mile east of its intersection with Flemings Landing Road. This 154.6-acre farm complex contains a machine shed, milk house, dairy barn, equipment shed, pumphouse, and cart barn. A farm lane encircles the dairy barn, equipment shed, and pumphouse, while the other buildings are located outside of the farm lane. The original main dwelling burned in the 1990s and was replaced by a modern dwelling. The dairy

barn, pumphouse, milkhouse, and cart barn, all built in approximately 1930, are gable-roofed buildings, sheathed in vertical board siding, and supported by concrete foundations. These buildings are remnants from the dairy operations that have since been abandoned on this complex, and are now used for storage of machinery and equipment for its grain operations.

significance because of the intact agricultural buildings that remain. The buildings are well maintained and are situated in a planned complex.

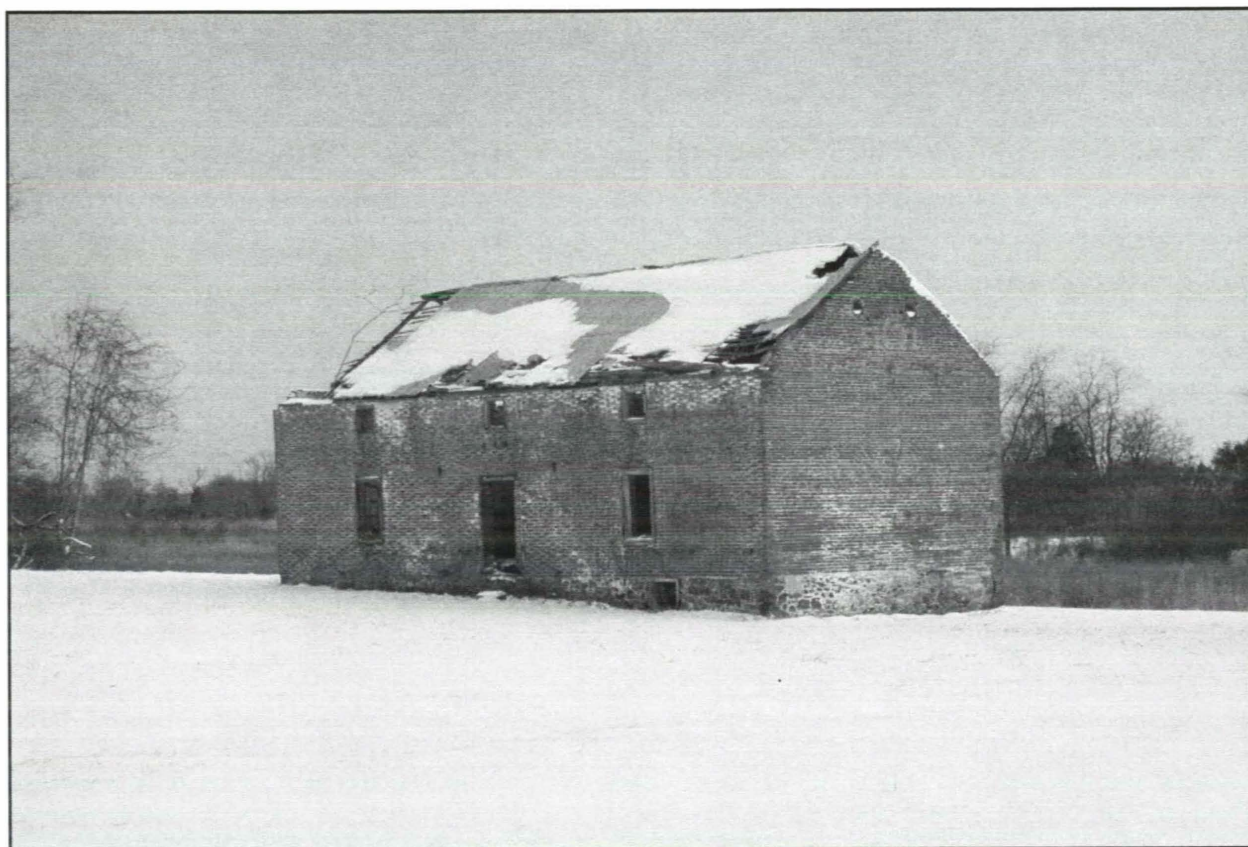
*Brick Store Landing/Bill Willis Farm
DALPF Project ID N-96-04-078*

The low level of significance for the Willis complex is exhibited by the poor condition of the brick store, the vacant main dwelling, and

integrity even though the building is deteriorating.

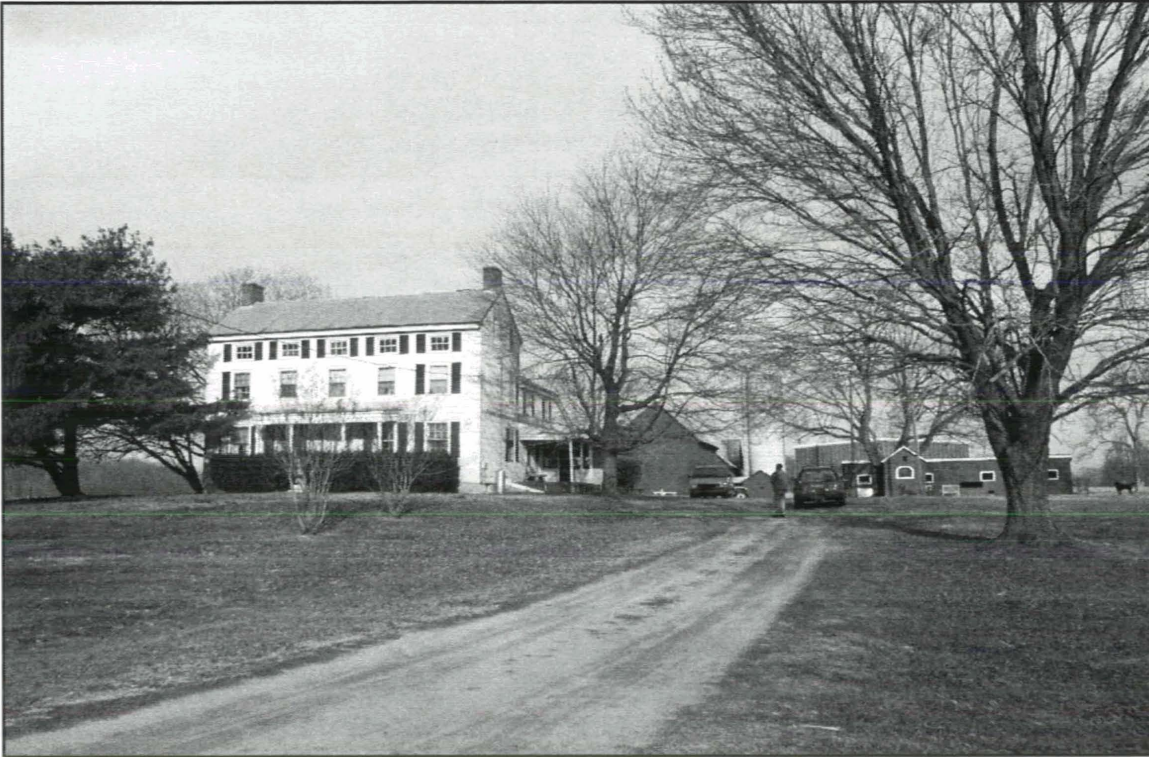
Daniel Corbitt/Claude D. Jr. and Margaret H. Haman Farm
*DALPF Project ID N-96-06-094***

The Haman Farm is located on the northwest side of the intersection of Old Corbit Road and Silver Road, east of the town of Odessa. This 295.1-acre farm complex contains a main dwelling, garage, machine shed, two chicken houses, three cow barns, cow barn/cart shed, dairy barn, and two silos, all located around a circular farm lane that is accessed from Silver Road. The early nineteenth-century main dwelling is a two-and-a-half-story center passage house with a rear ell, which sits on an uncoursed stone foundation. The house is clad

The high level of significance of this farm complex derives from the intact nature of the complex, as well as its intact arrangement of early twentieth-century buildings that relate to both the dairy and poultry industries. Chickens are no longer raised on this farm, but the

Haman Farm is one of New Castle County's few remaining operational dairy complexes, which continues to use its pre-World War II buildings to support a herd of approximately 200 cows.

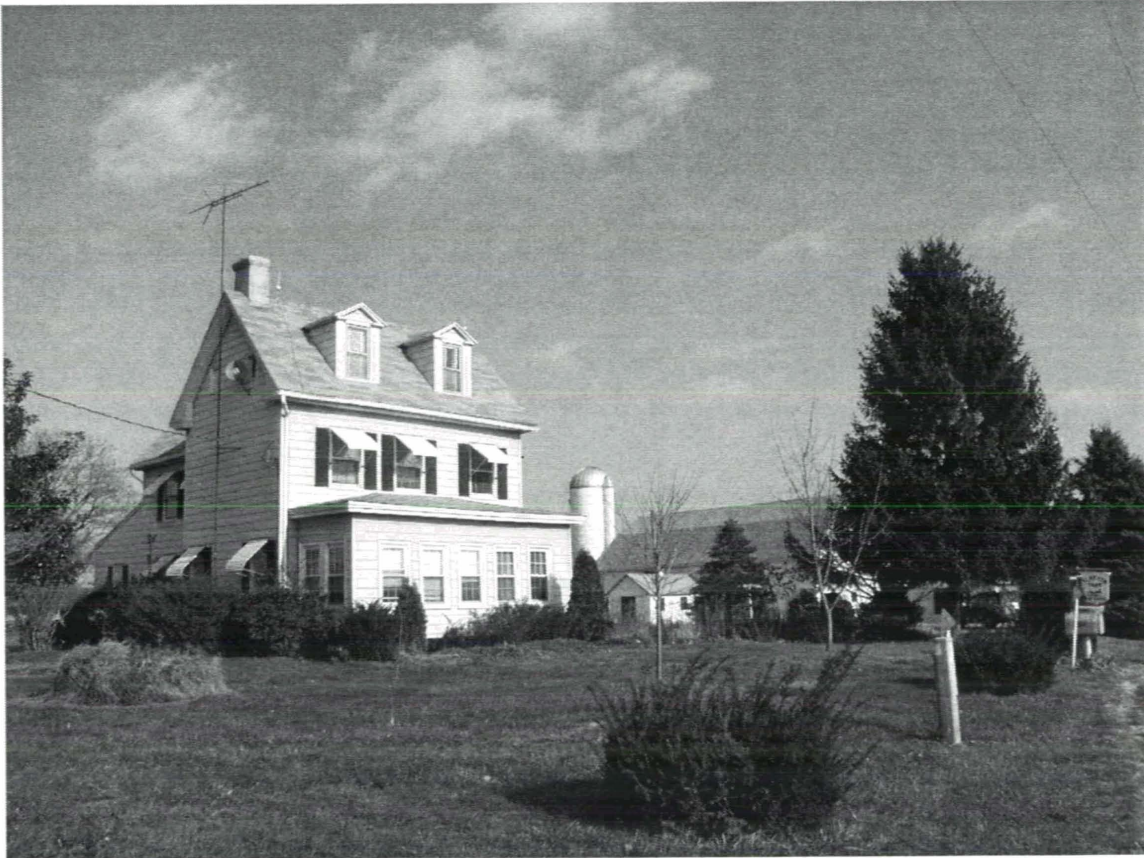
S. Armstrong/Vernon E. and Kenneth A. Kershaw Farm
DALPF Project ID N-96-08-100A

time supported a small-scale dairy operation and is now focused on grain and chickens. The intact complex, as well as the interesting construction techniques of the granary/cart shed

and main dwelling, are worthy of further architectural investigations into the significance of the complex, which has been overlooked in previous surveys.

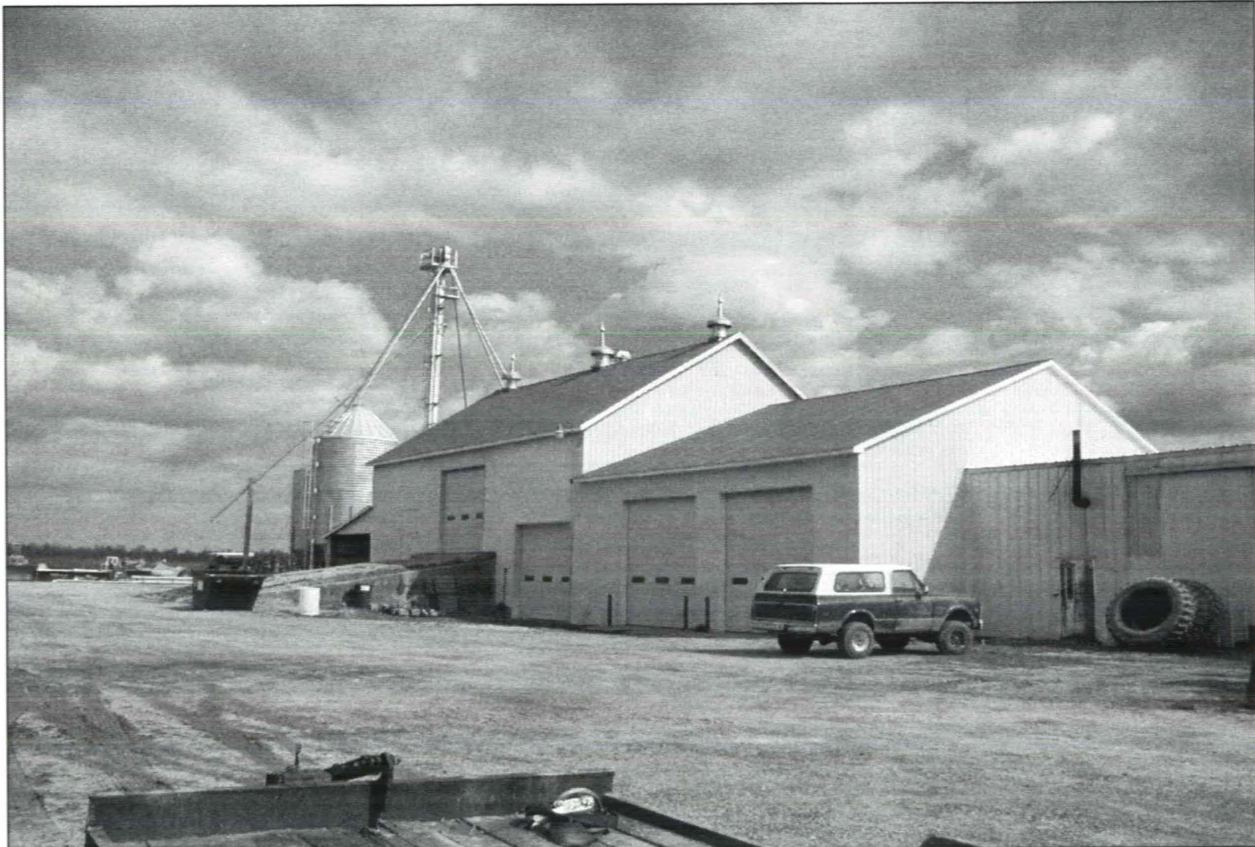
G. S. Layton/Wheatly Farms, Inc
DALPF Project ID S-95-04-036

granary/equipment shed, chicken house, and corn crib. While these historically significant buildings remain, they are in sharp contrast to

other modern buildings on the complex that are associated with its large-scale modern grain production.

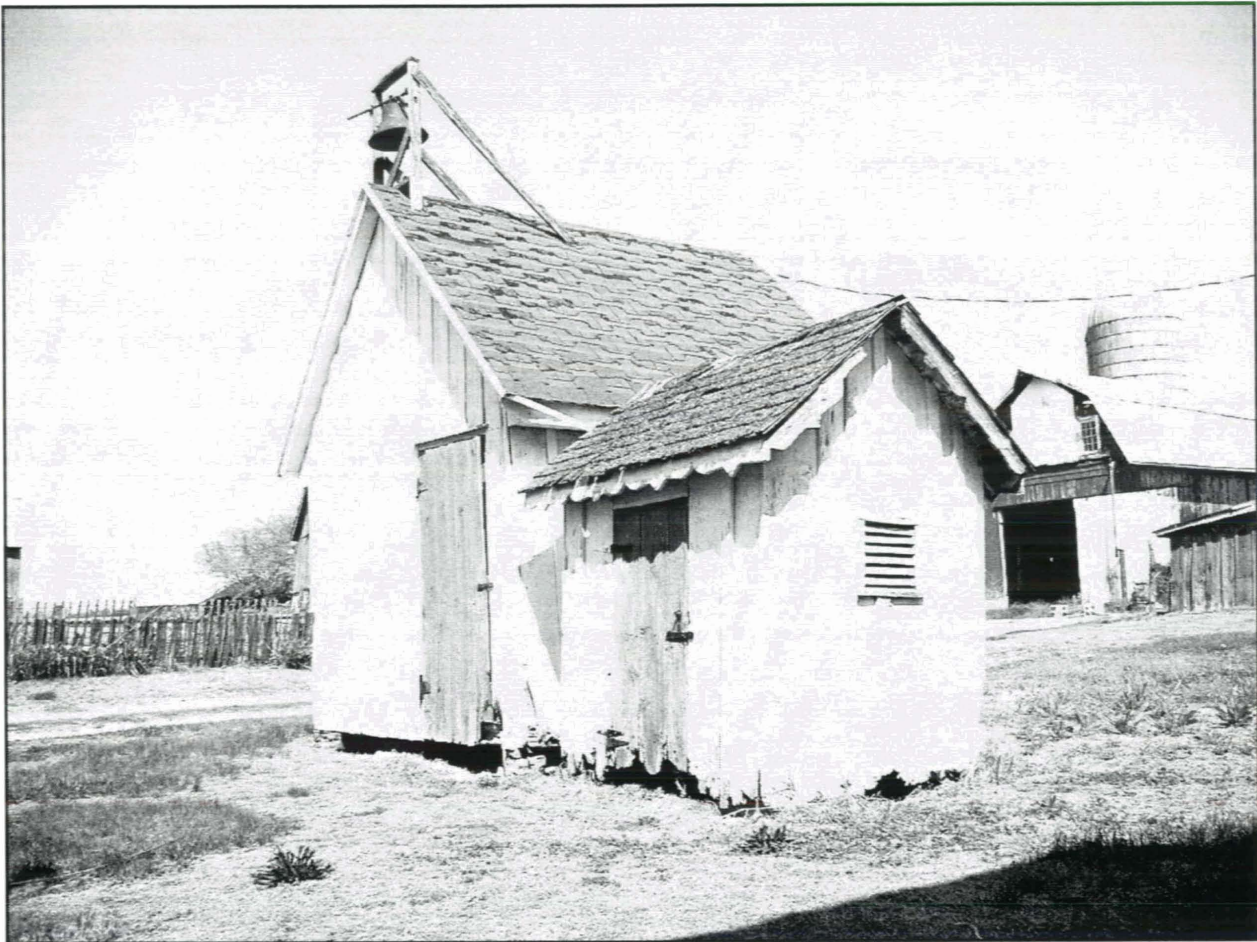
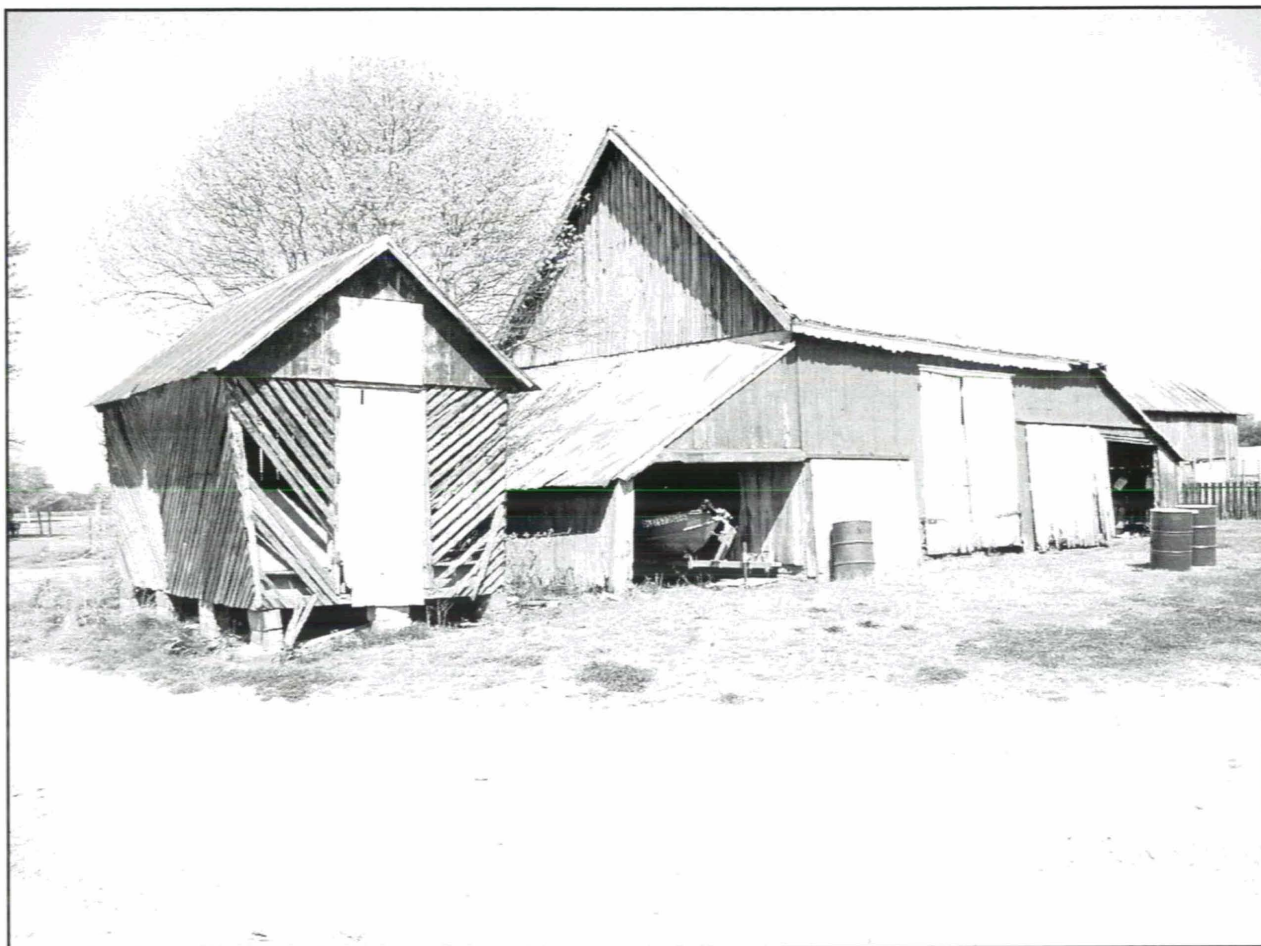
C. Warrington & Mrs. M. Richards/John Vincent Farm, west complex
DALPF Project ID S-95-08-049

and-one-half-story, three-bay, side-passage addition supported by a brick pier foundation.

The Vincent farm is a highly significant agricultural complex, as shown through the number and diversity of outbuildings situated in a well-planned complex. The complex continues to function as a highly diversified farm that uses its historic buildings in its current operations. Further research and documentation of the complex is highly recommended.

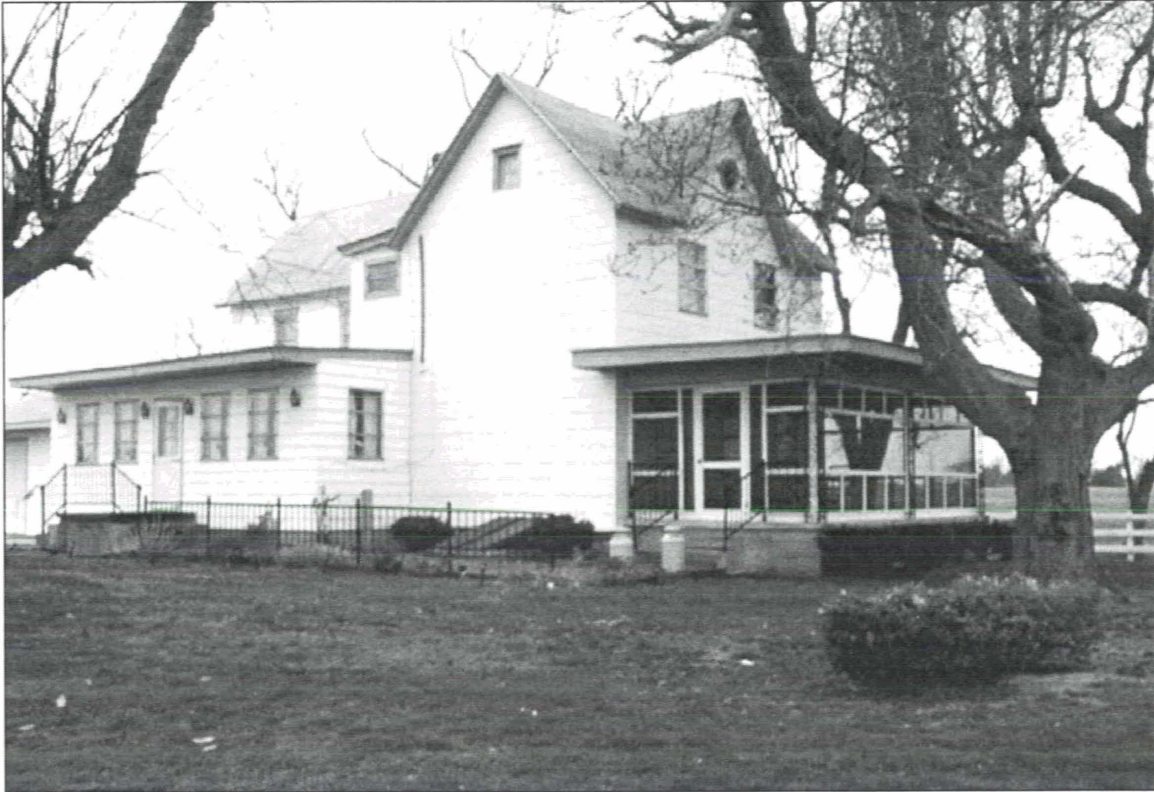
C. Houston/Catherine H. and Richard M. Morgan Farm
*DALPF Project ID S-96-01-028**

its time. The dairy barn has since been converted into a machine shed.

The low level of historic significance is attributed to the incomplete complex that includes only two of the complex's original buildings associated with its past dairy operations. The only building used for agricultural purposes is the dairy barn, which exhibits a low level of integrity because of its adaptation.

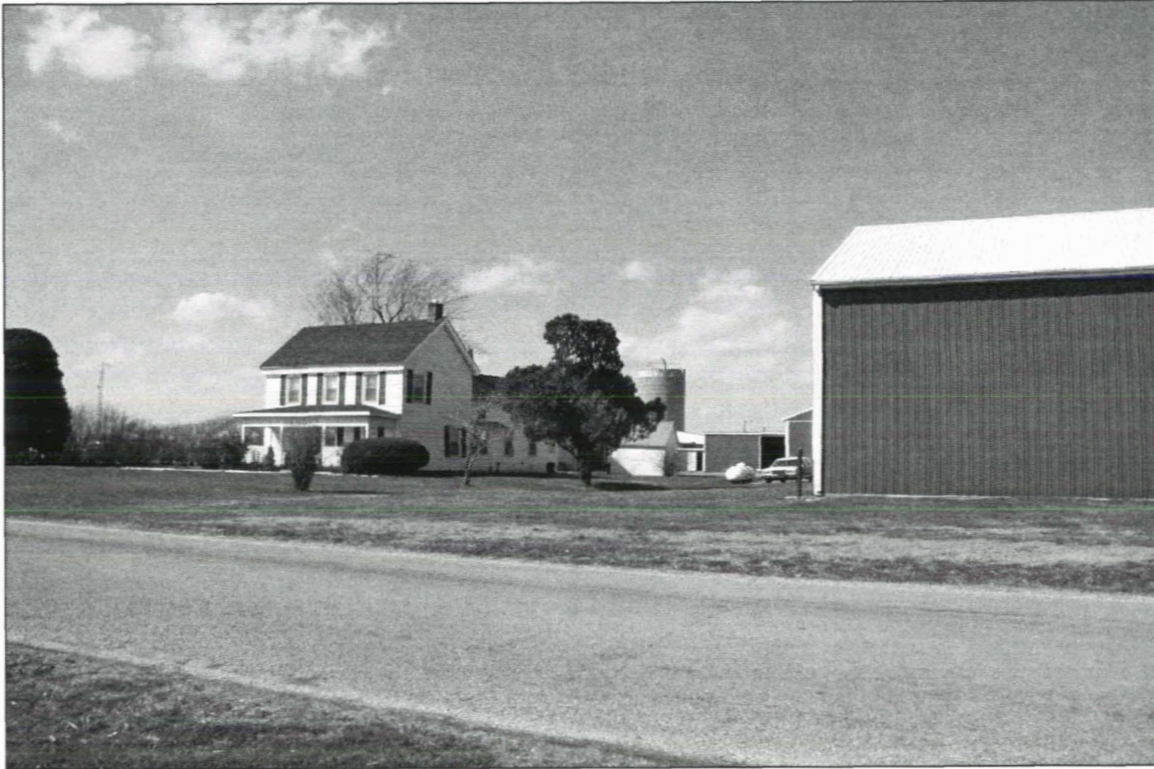
W. H. H. Dwyne/Richard M. Morgan Farm
DALPF Project ID S-96-01-028F

large-scale broiler houses that currently dominate the Sussex County landscape. The presence of U.S. 113 and tract housing further

detracts from this complex's level of significance.

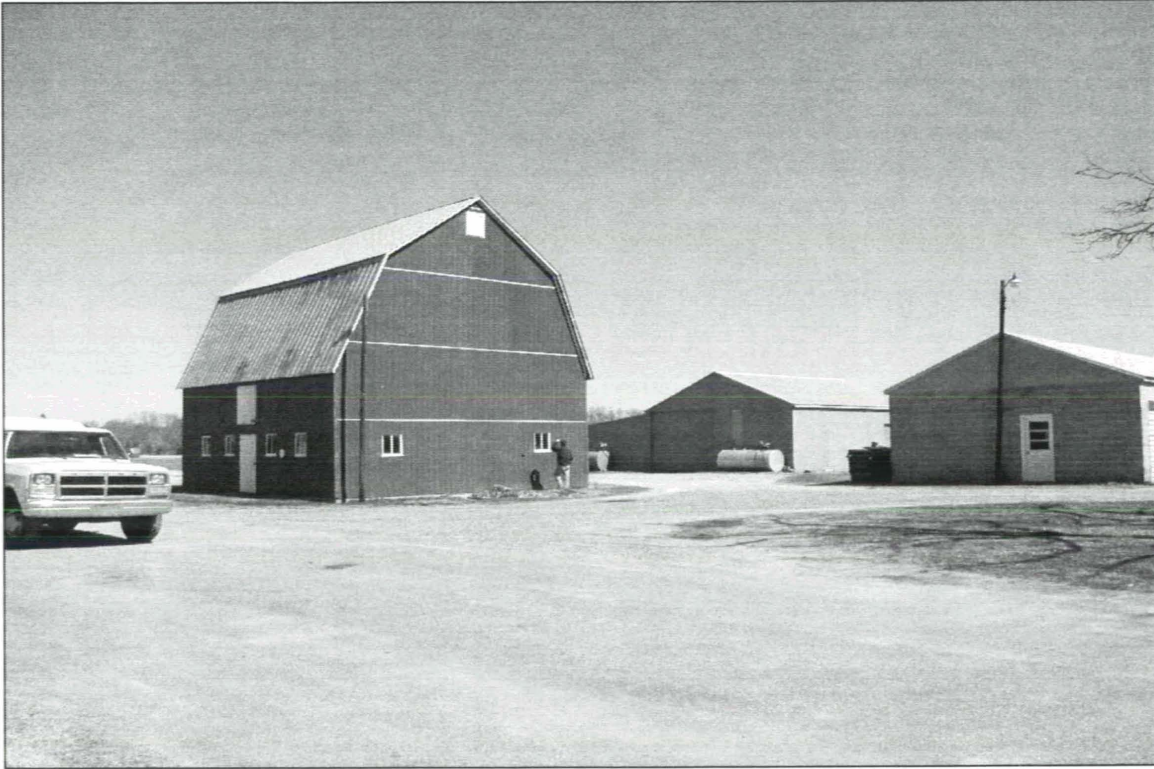
Carey Farms, Inc.
DALPF Project ID S-96-01-055

of the available land. The medium level of historic significance is attributed to its loss of historic buildings, which have been replaced by larger modern buildings required in the functions of this large complex.

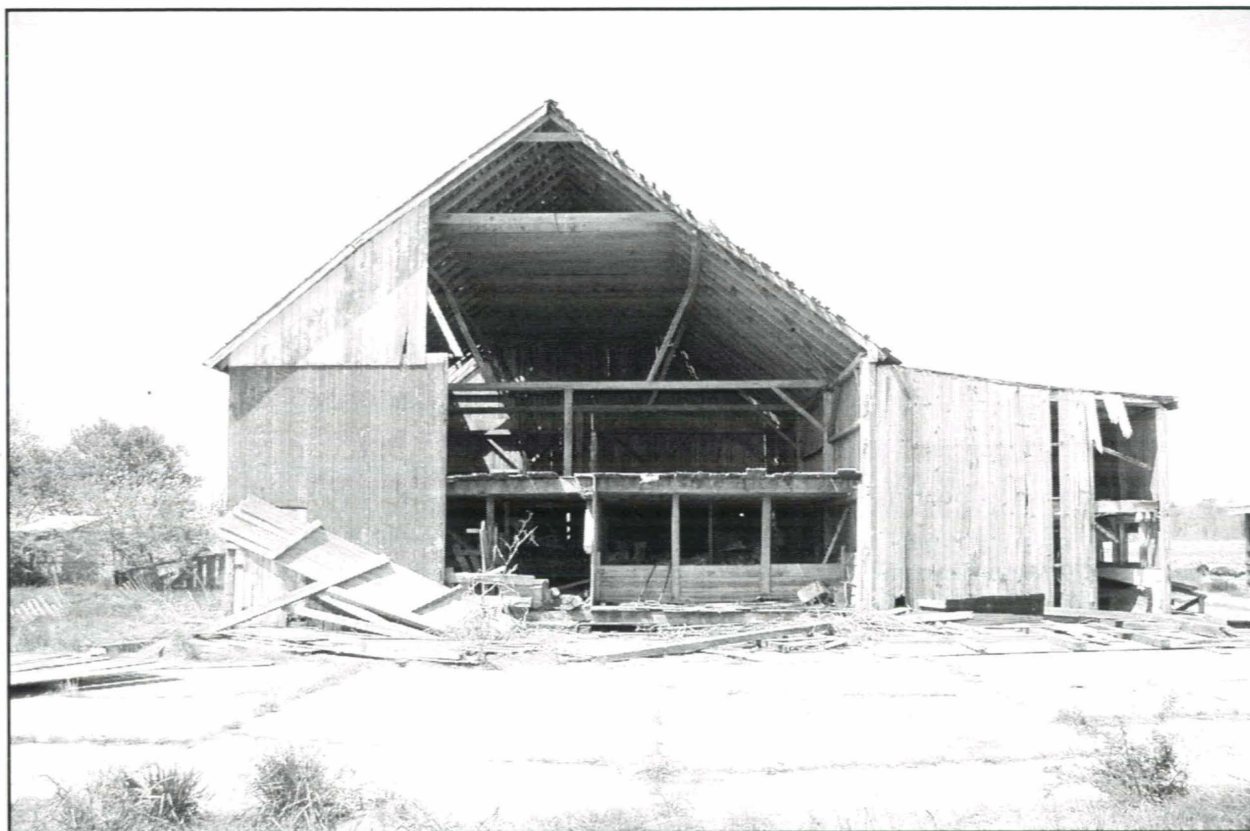
A. Short/Marie Smith Farm
DALPF Project ID S-97-02-028K

of construction. Period I is a one-and-one half-story three-bay building with a center-passage plan supported by a 3:1 common bond brick foundation. Period II is a two-story, three-bay addition supported by a brick pier foundation. The dwelling includes a kitchen addition on the Period I wing. The entire building is sheathed in clapboard. The smoke house has been
