## Documentation in New Castle County

**Site Name:** Mansion Farm Tenement

**CRS Number:** N-0000

**Type of Documentation:** Level II: Partial Intensive  
Annotated field notes (3 sheets)  
Measured drawings--CAD (3 sheets)  
Black and white 4" x 5" photographs (4)  
Architectural data narrative

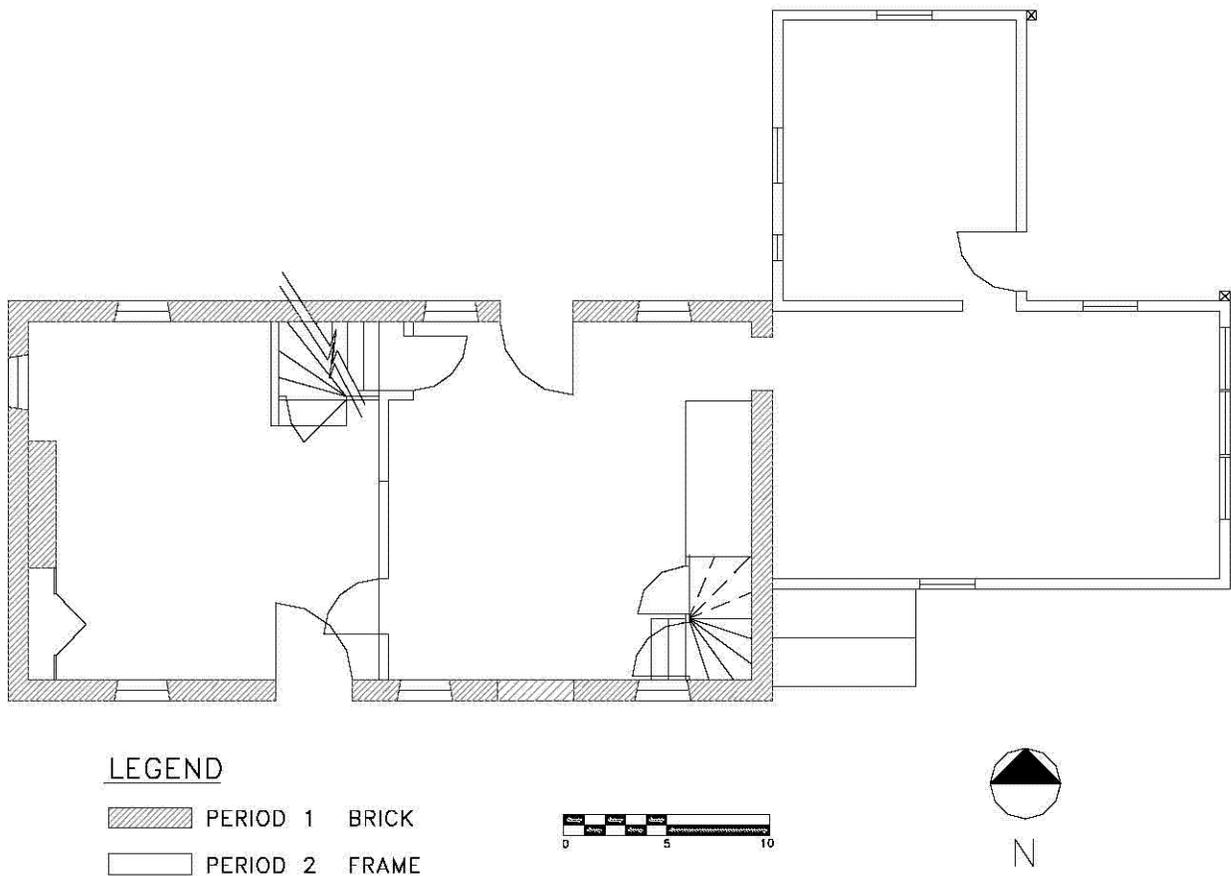
Figure 68: Mansion Farm Tenement, first floor plan.

Originally the doors on the south elevation opened into two rooms completely separated by a partition wall. The remaining door on the elevation opens into the western room. The partition wall stands immediately to the east of the entry door, with a modern door at the south end of this wall opening into the eastern room. The western room measures approximately 17 by 16 feet, with a modern fireplace centrally placed against the west wall. An enclosed winder stair occupies the northeast corner of the room. A simple vertical wood door with a porcelain knob provides access to the stairs, with one step extending beyond the stair box into the room. A cabinet is built into the southwest corner of the room, abutting the fireplace. The split cabinet

features wood panel doors and an iron knob. Three windows in splayed openings light the room, one on each of the south, west, and north walls.

The eastern room, which measures approximately 17 by 15 feet, has been highly altered and features largely modern materials. A fireplace is centrally located on the east wall, the face of which has been renovated. A winder stair with a closet underneath fills the southeast corner next to the fireplace. A modern hollow-core door provides access to the stair box. A second stair, located in the northwest corner under the stair box for the western room, leads down to the cellar. Four windows in splayed openings light the room, two on the north wall and two on the south wall. Modern architectural features include narrow wood floorboards, ceiling beams, and wood paneled walls.

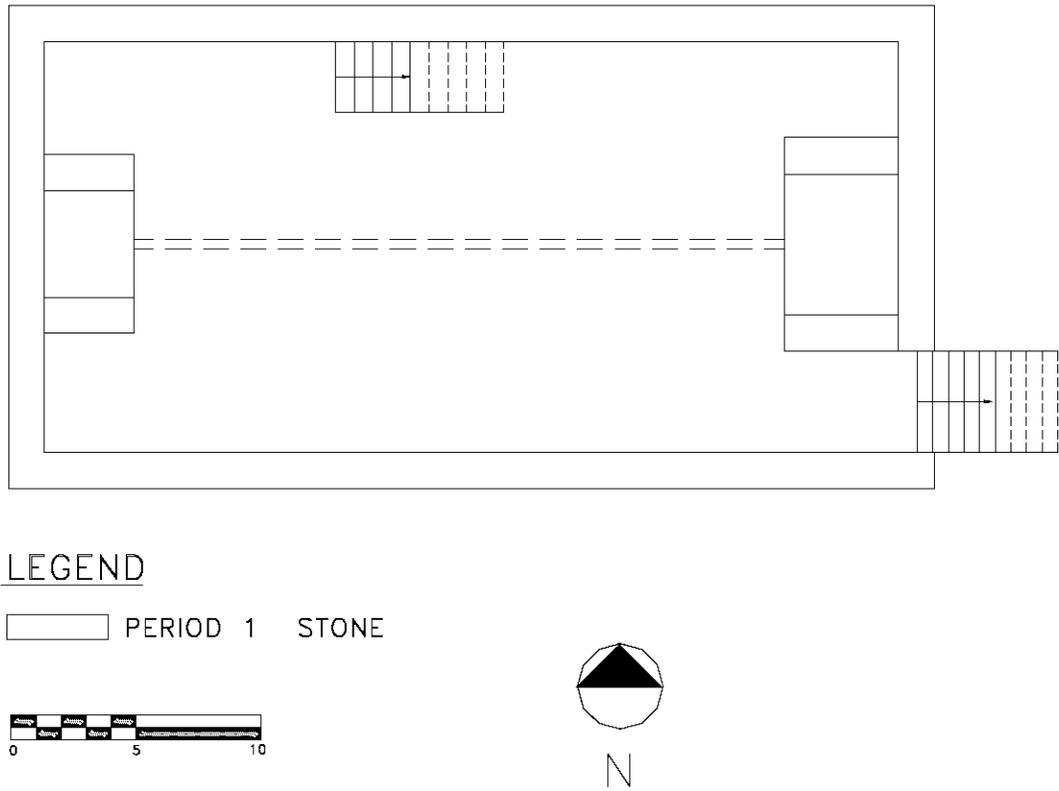
Figure69: Mansion Farm Tenement, cellar plan.

The cellar is also an undivided space, measuring 16 by 34 feet. The floor of the cellar is dirt while the walls are stone. Relieving arches stand against the west and east walls. The west arch contains two shelves. A summer beam extends east to west across the ceiling and terminates at the top of the arch stacks. A straight stair runs along the north wall to access the eastern portion of the first floor, while a second set of steps in the southeast corner of the cellar mark the exterior bulkhead entrance. The joists, summer beam, posts, and walls are whitewashed and sash-sawn. There is no visible evidence of partitions in the cellar, nor was there access to the cellar from the western portion of the tenement.

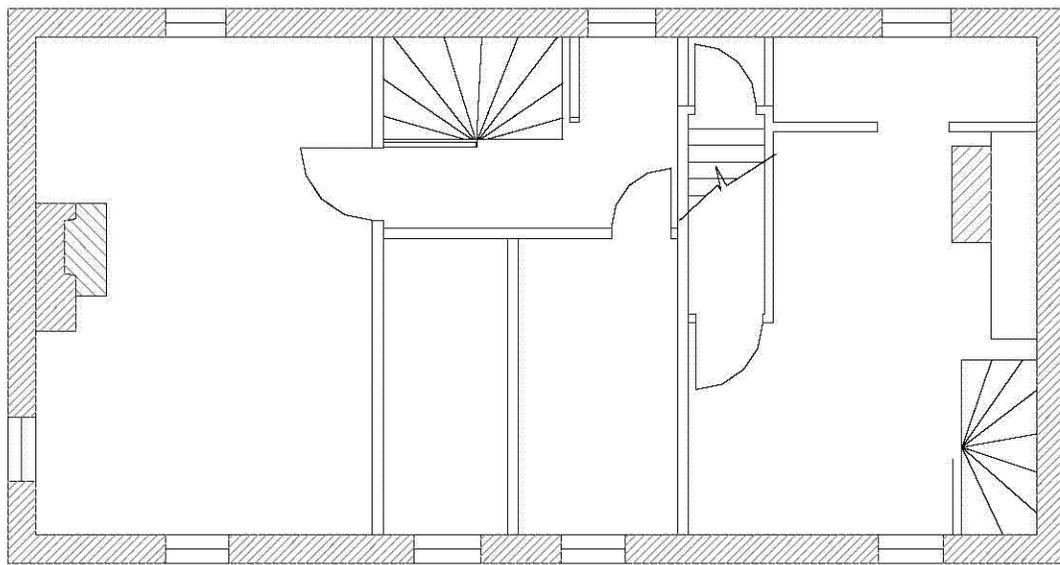
Figure 70: Mansion Farm Tenement, second floor plan.

The second floor is divided into three rooms across the front of the dwelling, with a hall along two-thirds of the rear wall. The two rooms to the west are accessed from the winder stair in the western room, which opens onto a small landing in the hall. The westernmost room is the largest of the three second-floor rooms, measuring 18 by 12 feet. A door from the hall opens into the room through the eastern wall and a fireplace is centered on the western wall. A single window on each of the north, west, and south walls light the room.

The central room on the second floor, also originally accessed from the landing at the top of the winder stair, has been subdivided into two modern bathrooms. This room measured 10 feet by 10 feet in its original configuration. Between the central room and the eastern room a straight stair rises to the attic. Originally two doors across the rear hallway controlled access from the two sections of the tenement to the attic, allowing both sets of tenants access to the attic but not to the other's private space.

The easternmost room on the second floor measures approximately 14 by 11 feet. A single window on the south wall lights the room. The winder stair leading to the first floor is located at the southeast corner of this room. A closet occupies the northwest corner of the room, making use of the space located underneath the attic stair.

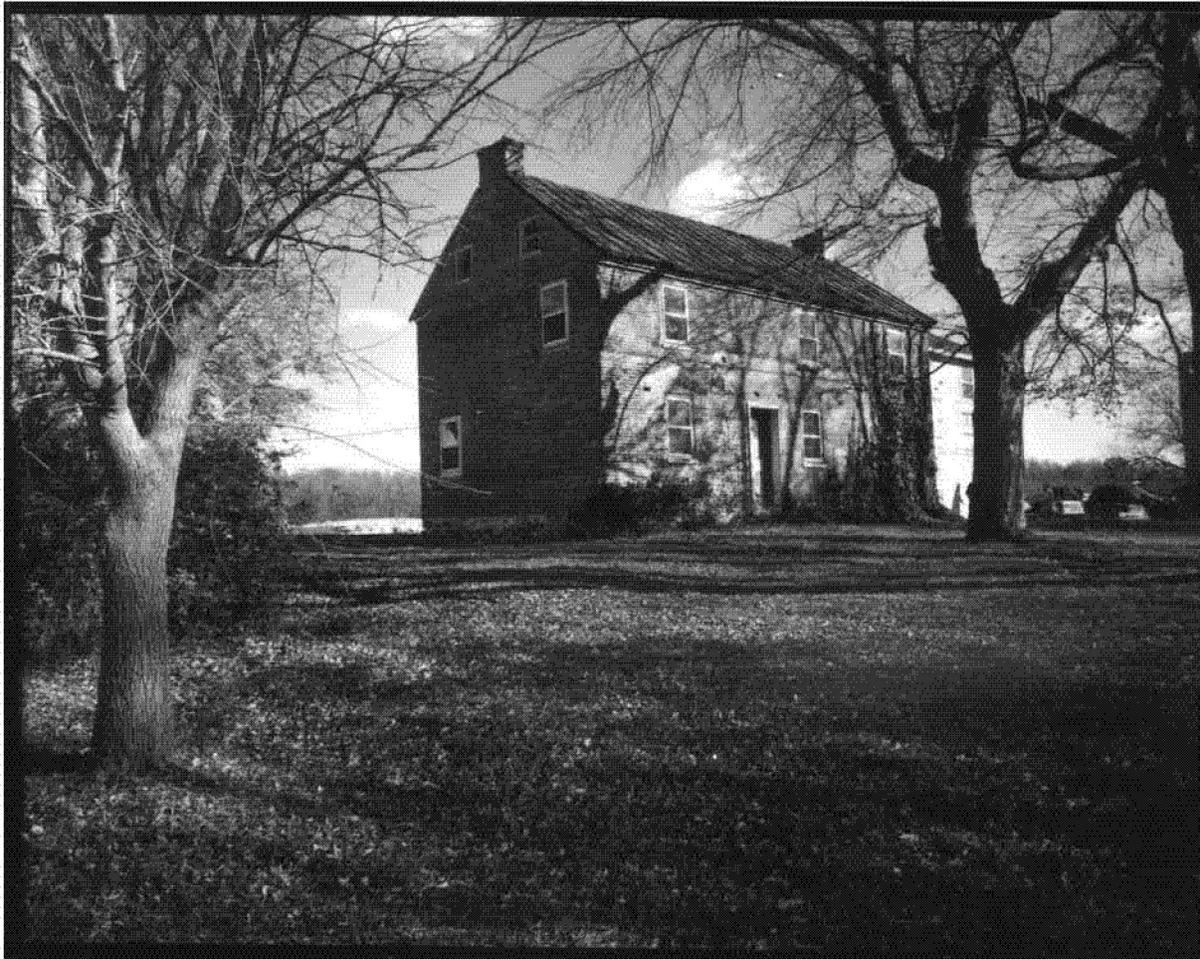
Figure 71: Mansion Farm Tenement, environmental view of the south and west elevations, looking northeast.

The main (or south) elevation was originally divided asymmetrically into five bays, with two primary entrances in the second and fourth bays. The eastern door was later bricked over. The remaining primary entrance is recessed and contains a single, six-panel wood door with simple wood surrounds. Six-over-six-light windows fill the other three bays. The second floor is visually separated from the first floor by a simple brick belt course. The second floor contains three one-over-one-light windows aligned above the first-floor windows.

The west elevation of the main block has one window on the first floor, located in the northern bay. The single window on the second floor is not aligned with the first-floor window, but is located in the southern bay. Two square windows light the attic and flank the interior chimneystack.

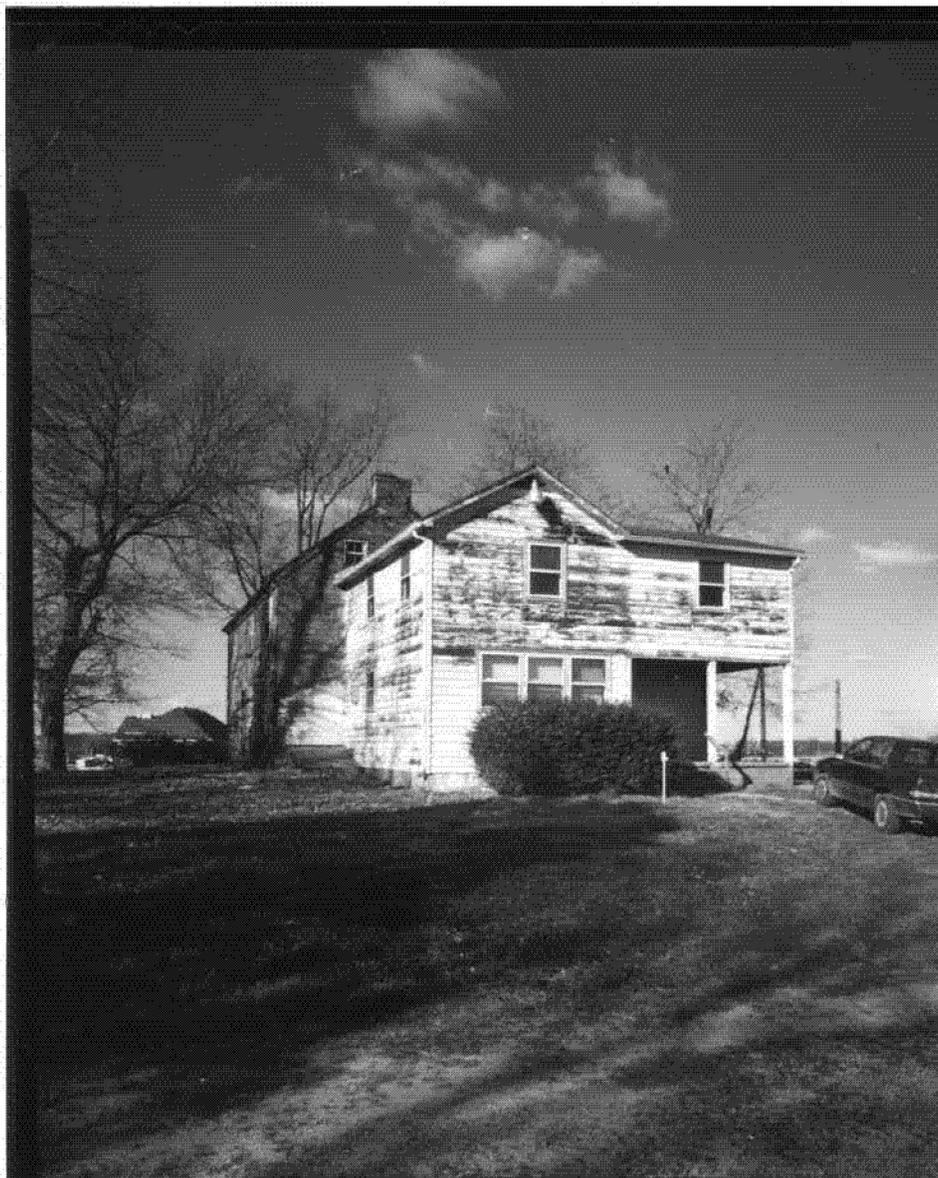
Figure 72: Mansion Farm Tenement, perspective of the east elevation looking northwest.

The building is composed of two main sections: a two-and-a-half-story, five-bay, brick main block (measuring 19 by 39 feet) constructed *circa* 1850 and a modern two-story frame addition off the east elevation (measuring 28 by 22 feet). Annotated field notes were made only for the main block, or Period I section.

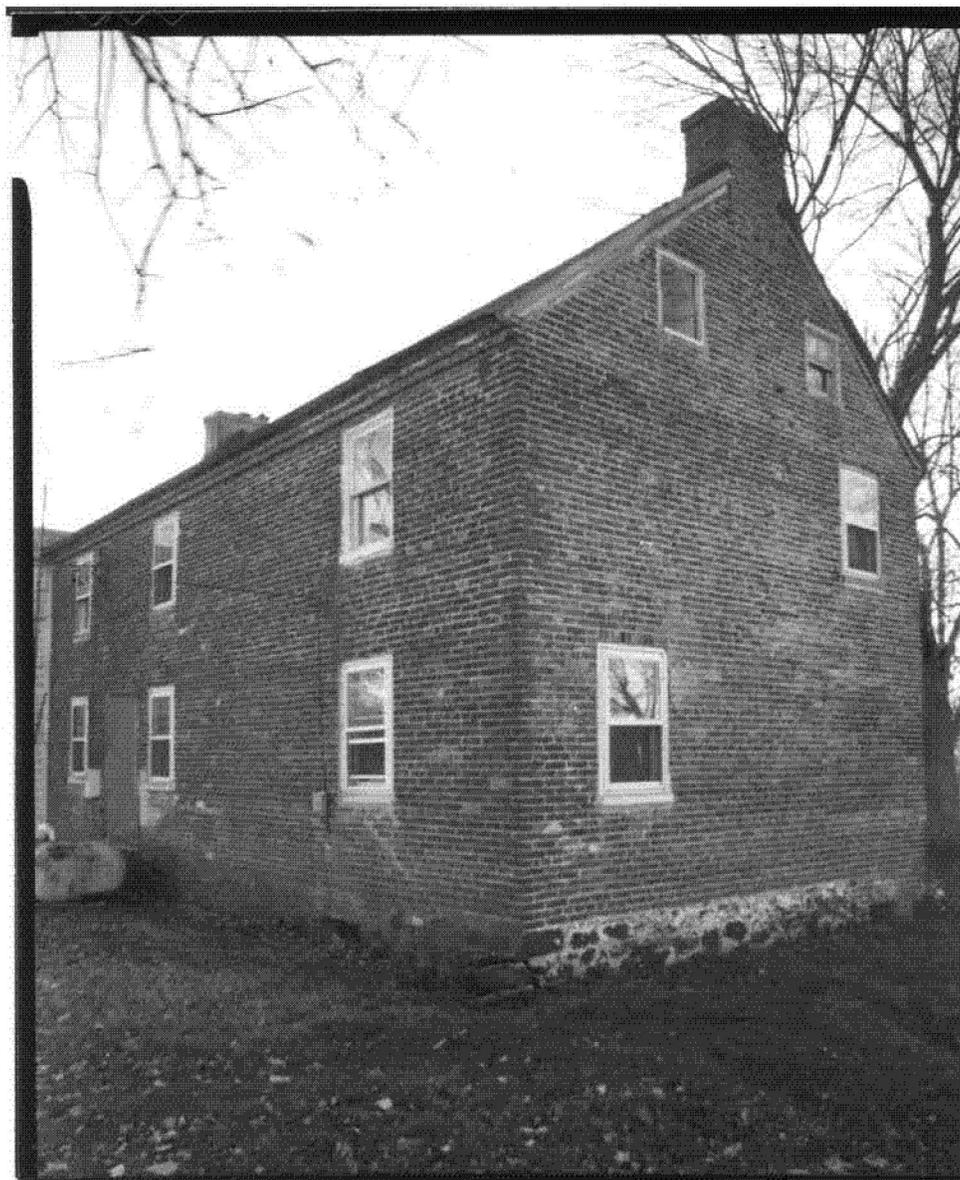
Figure 74: Mansion Farm Tenement, perspective of the north and west elevations, looking southeast.

The rear, or north, elevation is divided asymmetrically into four bays. The rear entrance is no longer in use and is concealed by a plastic membrane. A one-over-one-light window to the east and two one-over-one-light windows to the west flank the covered entrance. The second floor contains three one-over-one-light windows aligned over the first-floor windows. The east elevation of the tenement is largely concealed by the modern addition. A bulkhead projects from the south corner of the elevation, providing access to the cellar.
