APPENDIX A:
INVENTORY OF SURVEYED
PROPERTIES

MILTON • DELAWARE

APPENDIX A

This appendix begins with a chart of all the resources surveyed in Milton. The chart includes CRS numbers, address, function, style of architecture, the date the property first appears on a historic map, and whether or not the property should be considered contributing or non-contributing to a potential expanded National Register of Historic Places District in Milton or a local historic zone. Following the chart, descriptions of the surveyed resources provide more detailed information on the historic name of the property, function, a brief history, and a physical description of the property. The description also provides a short rationale for the property's recommendation for inclusion or exclusion to the National Register District. Photographs of each main building or resource appear with the descriptions.

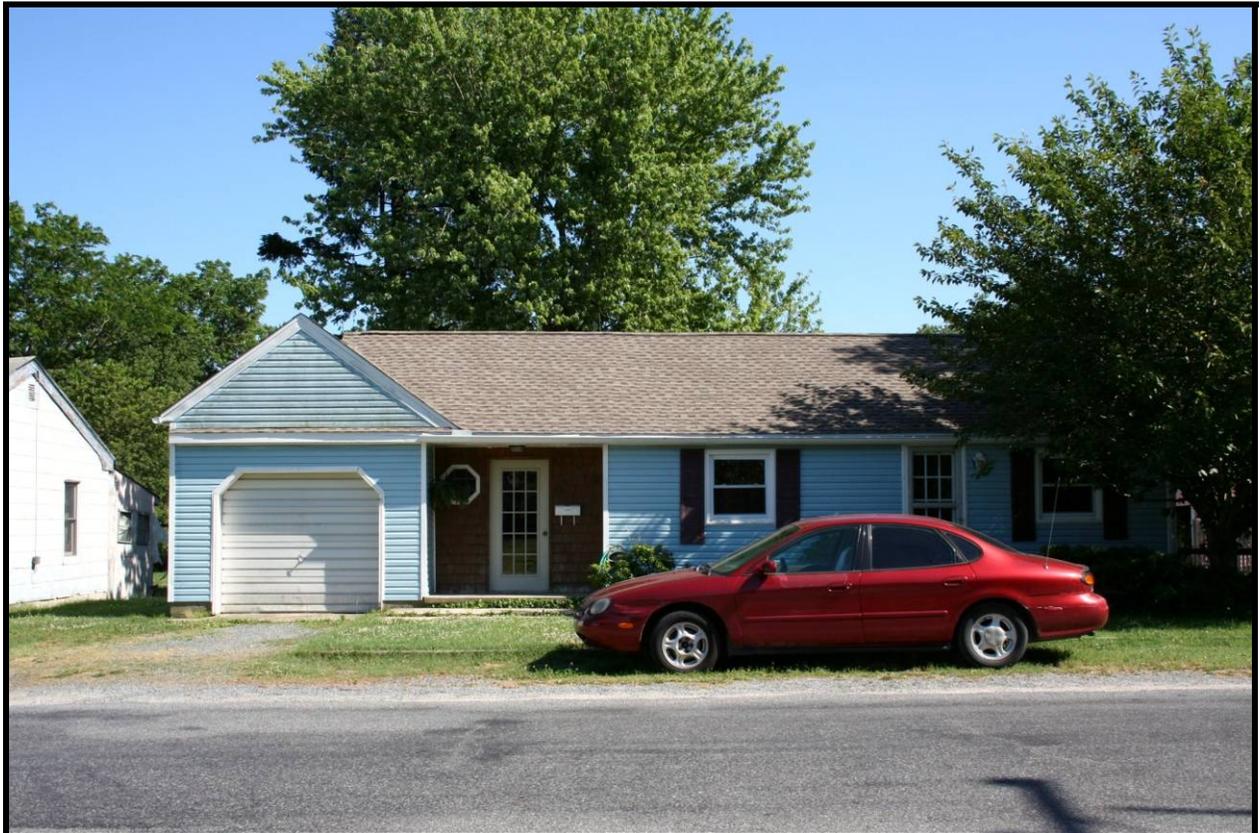
S-11998
106 Atlantic Avenue (1954 Aerial Map)
Property Type: Single-Family Dwelling, Ranch Style

This five-bay, one-story, frame Ranch was built between 1937 and 1950. The main block of the dwelling is side-gabled with an attached one-story, front-gabled, single-car garage on the northeast gable end, forming a cross-gabled T-shaped plan. Two fifteen-pane doors are located in the second and fourth bays from the northeast gable end, while single one-over-one sash windows with oversized louvered shutters and a garage door fill the remaining bays. A single octagonal casement window is located to the left of the first door, situated in the recessed main entry porch. The exterior walls are covered in aluminum siding and the roof is clad in asphalt shingles. Due to its early 1950s construction date, this home is one of the earliest examples of a Ranch-style dwelling constructed in Milton and therefore part of a select few to be considered a contributing property for the expanded Milton Historic District. This dwelling also retains integrity of design, materials, workmanship, location, and setting, further supporting the recommendation.

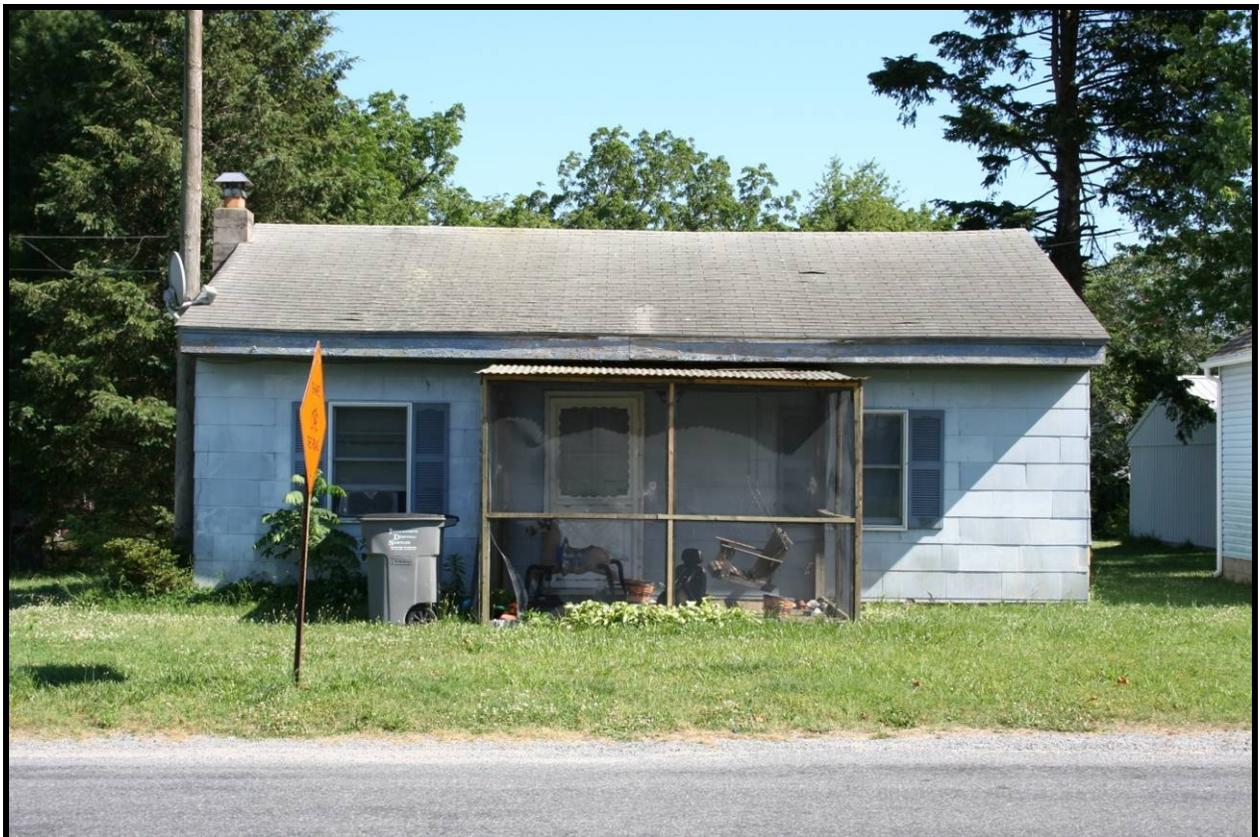
S-11997

108 Atlantic Avenue (1954 Aerial Map)

Property Type: Single-Family Dwelling, Minimal Ranch Style

This three-bay, one-story frame house with a side-gabled roof was built between 1937 and 1950 in the Minimal Ranch style. A small, frame porch with screen-covered walls and a corrugated sheet metal roof has been added to the northwest façade of the dwelling to shield the main entry door and a shed roof addition has also been built on the rear (southeast) elevation. A four-light door occupies the central bay on the front elevation while two single one-over-one sash windows with louvered shutters fill the adjacent bays on either side of the door. An exterior end-wall chimney constructed with concrete blocks is located on the northeast gable end on the main block. Both the gable-roofed main block and the shed-roofed addition have boxed cornices and are covered by asphalt shingles. The exterior walls are covered in asbestos shingle siding. Due to its early 1950s construction date, this home is one of the earliest examples of a Ranch-style dwelling constructed in Milton and therefore part of a select few to be considered a contributing property for the expanded Milton Historic District. This dwelling also retains integrity of design, materials, workmanship, location, and setting, further supporting the recommendation.

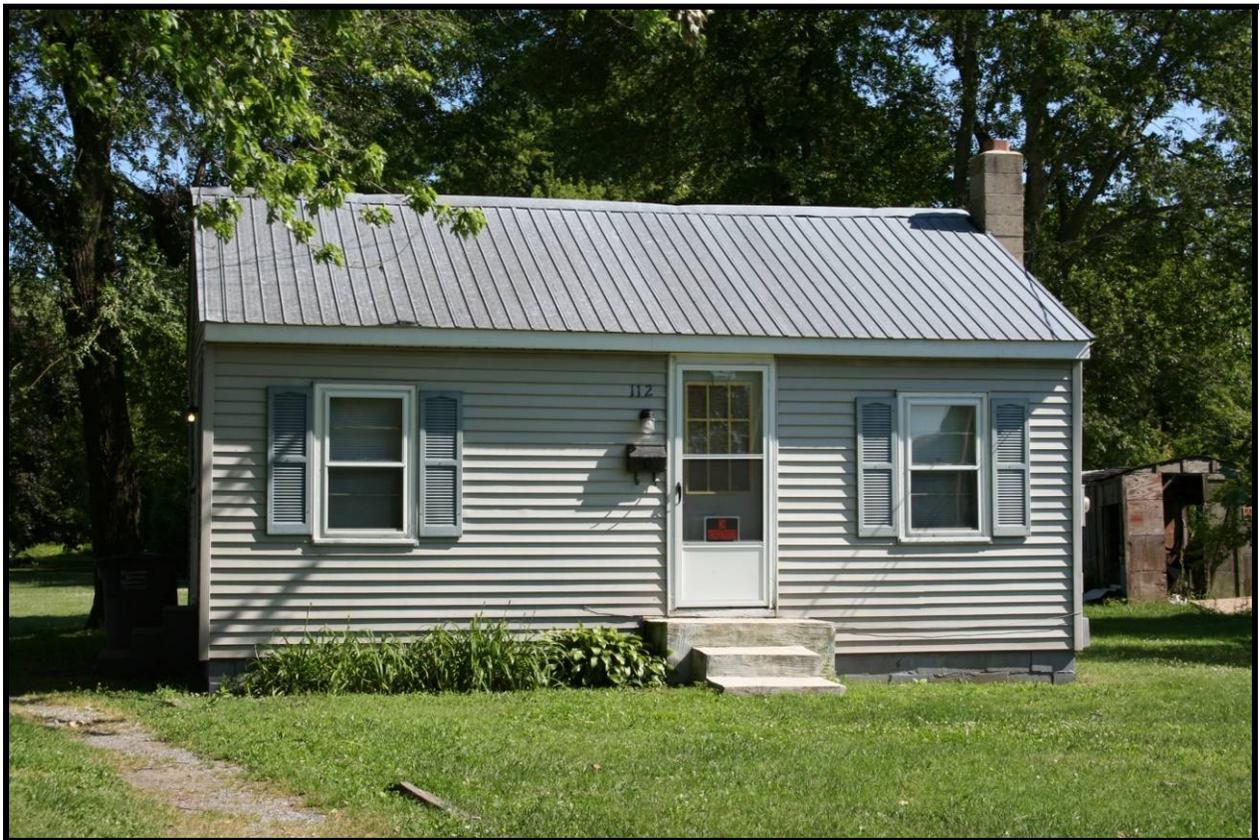
S-11996

112 Atlantic Avenue (1954 Aerial Map)

Property Type: Single-Family Dwelling, Minimal Ranch Style

This three-bay, one-story frame house with a side-gabled roof was built between 1937 and 1954 in the Minimal Ranch style. A nine-light raised-panel door serves as the main entryway in the central bay of the northwest elevation while two single two-over-two sash windows with louvered shutters occupy the adjacent bays on either side of the door. An exterior end-wall chimney constructed with concrete blocks is located on the southwest gable end on the dwelling. The standing seam sheet metal roof ends with a boxed cornice and the exterior walls are covered in aluminum siding. Due to its early 1950s construction date, this home is one of the earliest examples of a Ranch-style dwelling constructed in Milton and therefore part of a select few to be considered a contributing property for the expanded Milton Historic District. This dwelling also retains integrity of design, materials, workmanship, location, and setting, further supporting the recommendation.

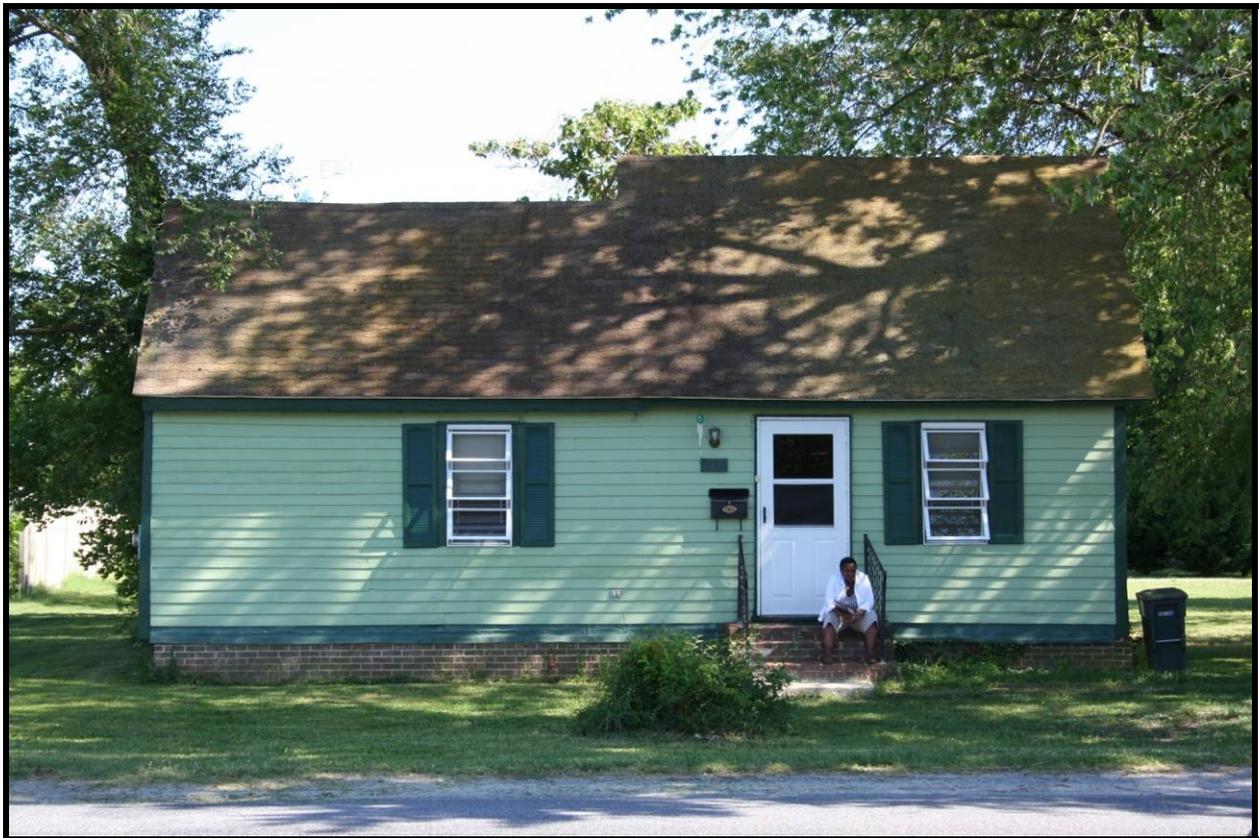
S-11995

114 Atlantic Avenue (1954 Aerial Map)

Property Type: Single-Family Dwelling, Minimal Ranch Style

This three-bay, one-and-a-half story frame dwelling with a staggered-height side-gabled roof was built between 1937 and 1950 in the Minimal Ranch style. A single door occupies the central bay of the northwest facade, while two vertical tripartite casement windows with louvered shutters fill the adjacent bays on either side of the door. The exterior walls are adorned in clapboard and the staggered-height roof is covered in asphalt shingles. Due to its early 1950s construction date, this home is one of the earliest examples of a Ranch-style dwelling constructed in Milton and therefore part of a select few to be considered a contributing property for the expanded Milton Historic District. This dwelling also retains integrity of design, materials, workmanship, location, and setting, further supporting the recommendation.

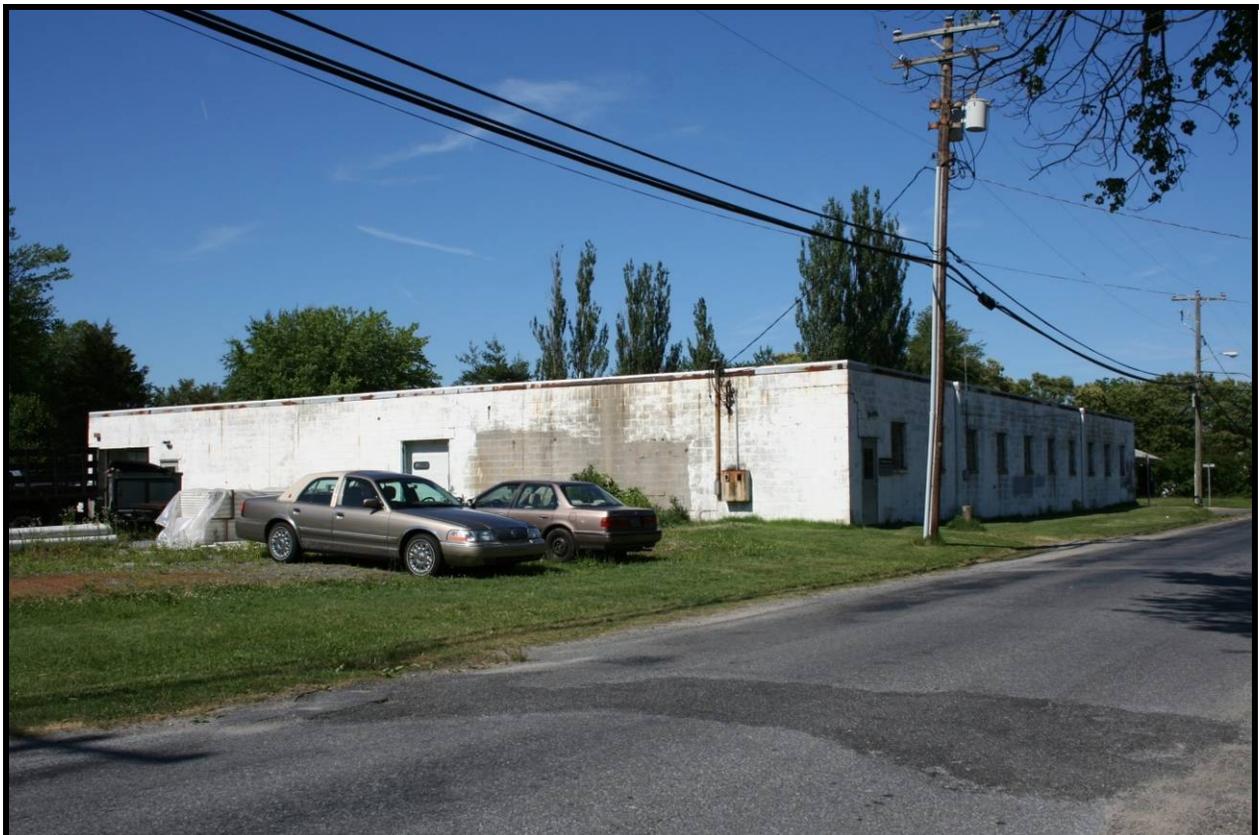
S-11994

115 Atlantic Avenue (The Douglas White Company: 1911/1923 Sanborn Maps)

Property Type: Commercial Building

This one-story commercial building with a flat roof was built between 1911 and 1923 using concrete blocks. The structure resembles a large square box, with an eleven-bay front (southeast) facade and an eight-bay northeast side. A single door occupies the first bay near the southern corner on the front elevation, while the rest of the bays are filled with vertical tripartite casement windows. Two large garage door openings located on the southwest side of the building lead to the large gravel parking lot. This building may have been a part of the Douglas-White Company complex, which manufactured shirts and overalls in the early twentieth century. The 1911 Sanborn map indicates that the company owned the property across the street, but unfortunately the map cuts off directly before 115 Atlantic Avenue so there is no way to determine from maps whether or not the current commercial building existed at that time. By 1923, however, the current structure appears on the maps. This commercial property retains integrity of design, materials, workmanship, location, and setting, making it a contributing historic property for the expanded Milton Historic District; its potential relation to the early 20th century shirt making industry in Milton also provides a strong argument for its historic significance.

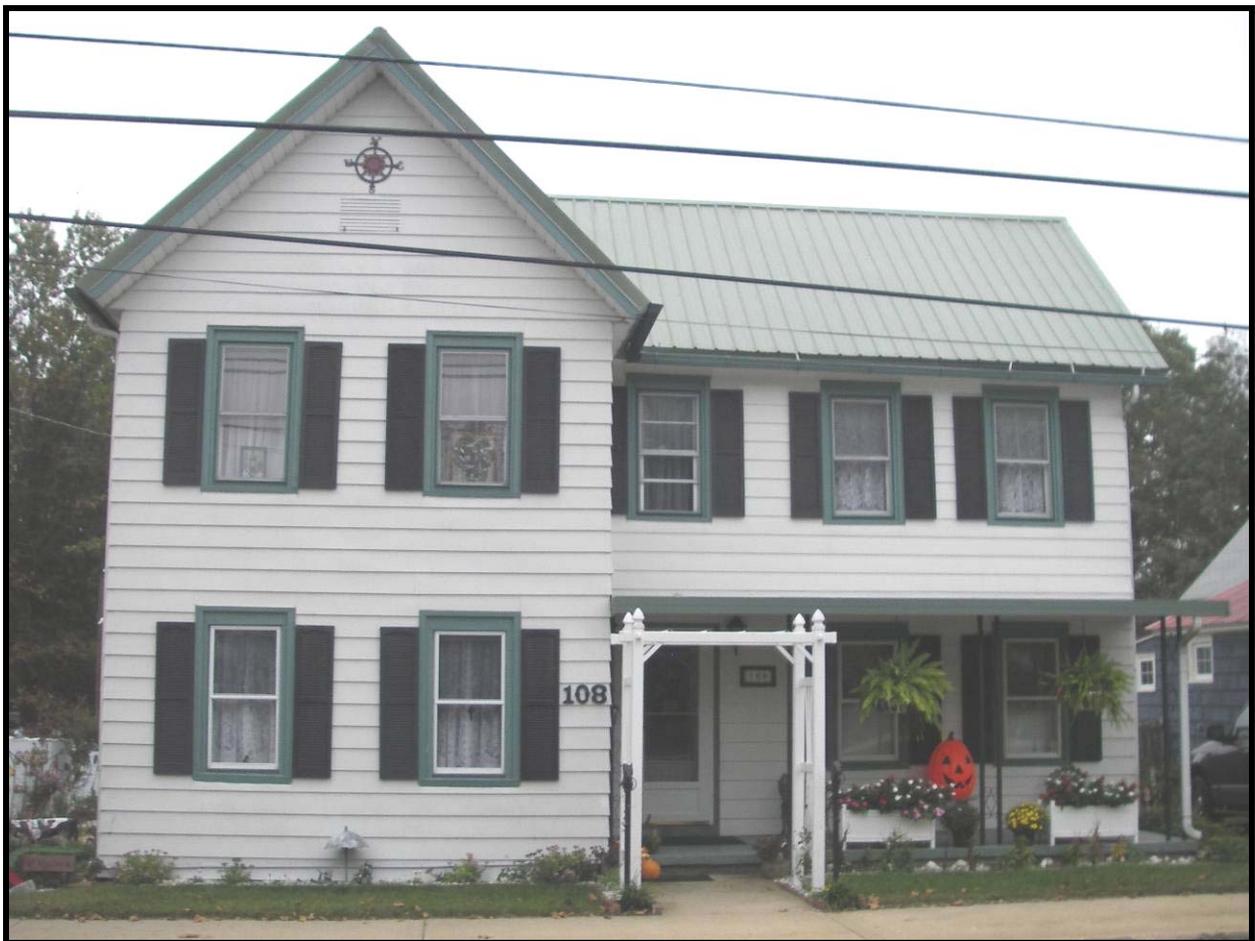
S-12087

108 Atlantic Street (1911 Sanborn Map)

Property Type: Single-Family Dwelling, Queen Anne Style

This five-bay, two-story, L-shaped, gable-roofed house was built between 1887 and 1911 in the Queen Anne style. The front (northeast) elevation is divided into two sections: a two-bay, front-gabled portion and a three-bay side-gabled portion covered by a one-story flat-roofed porch supported by decorative metal frames. A one-story, shed-roofed addition extends along the rear (southwest) elevation. A single exterior brick chimney rises along the southeast elevation. Aluminum siding sheathes the entire dwelling, which is topped by a standing seam sheet metal roof. Modern replacement windows fill the original openings, surrounded by original wood frames. The dwelling is an excellent example of the conservative interpretation of the Queen Anne style which was popular in Milton from the late 1860s to the early 1920s; it retains integrity of design, materials, workmanship, location, and setting, making it a contributing historic property for the expanded Milton Historic District.

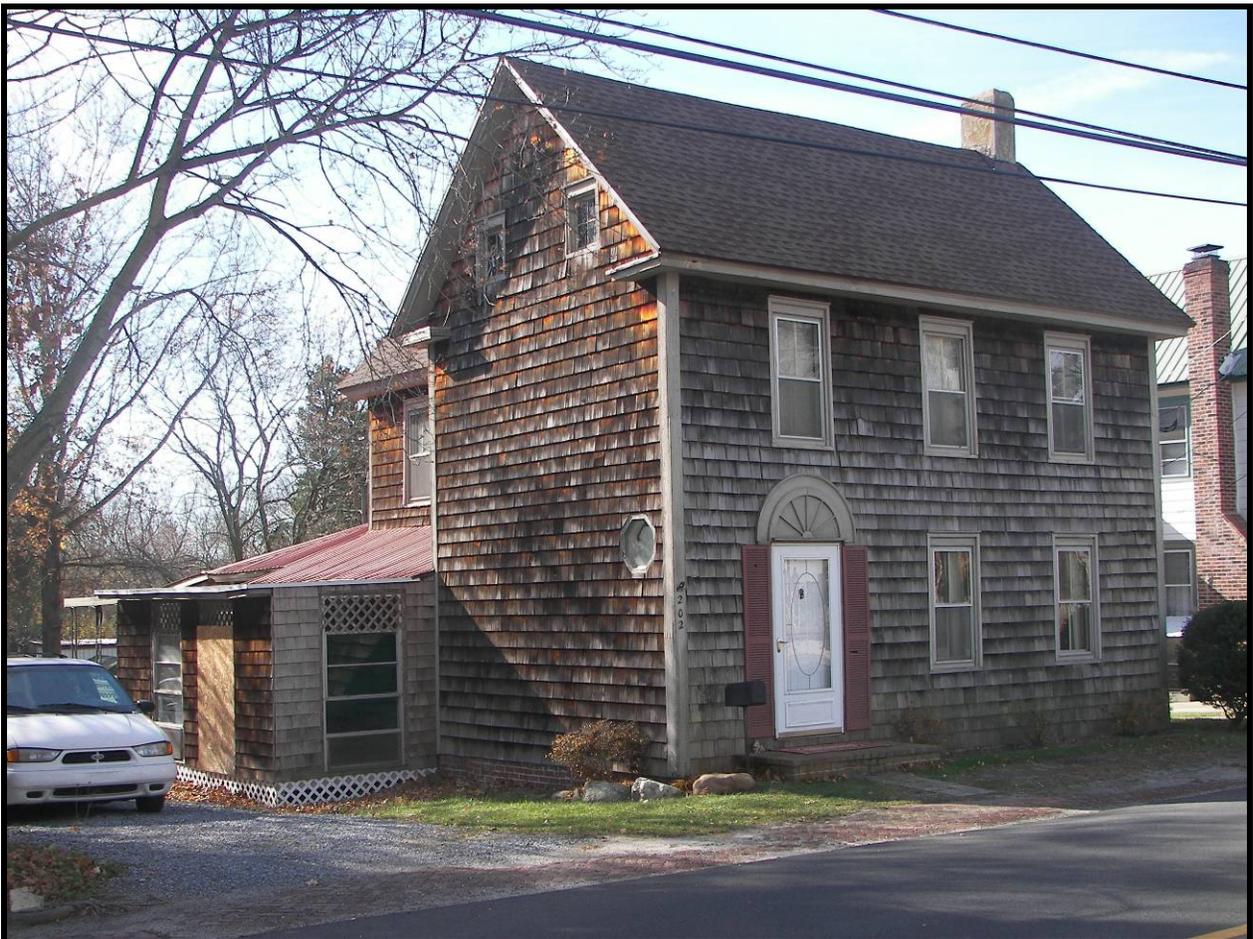
S-12088

202 Atlantic Street (1911 Sanborn Map)

Property Type: Single-Family Dwelling, Three-bay Colonial Revival

This three-bay, two-and-a-half-story, gable-roofed, T-shaped dwelling was built between 1887 and 1911 in the Colonial Revival Style. There are one-story shed-roofed additions with asphalt shingles extending off the northwest, southwest, and southeast elevations. The main roof is covered with asphalt shingles and terminates in a boxed cornice with partially returning eaves. There is one interior brick chimney rising near the northwest gable end. Most of the windows are two-over-two light sash windows with original wood frames. Two four-over-four-light fixed windows are located in the upper story of each gable end and flank the chimney on the northwest end. A small modern octagonal fixed-light window is located in the southwest gable end. Openings in the shed additions are filled with modern sash windows. The exterior of the main block, as well as the shed-roofed additions, is clad in cedar-shake siding. The dwelling is an excellent example of the Three-Bay Vernacular dwellings with Colonial Revival details constructed in Milton from the late 1880s to the mid 1930s; it retains integrity of design, materials, workmanship, location, and setting, making it a contributing historic property for the expanded Milton Historic District.

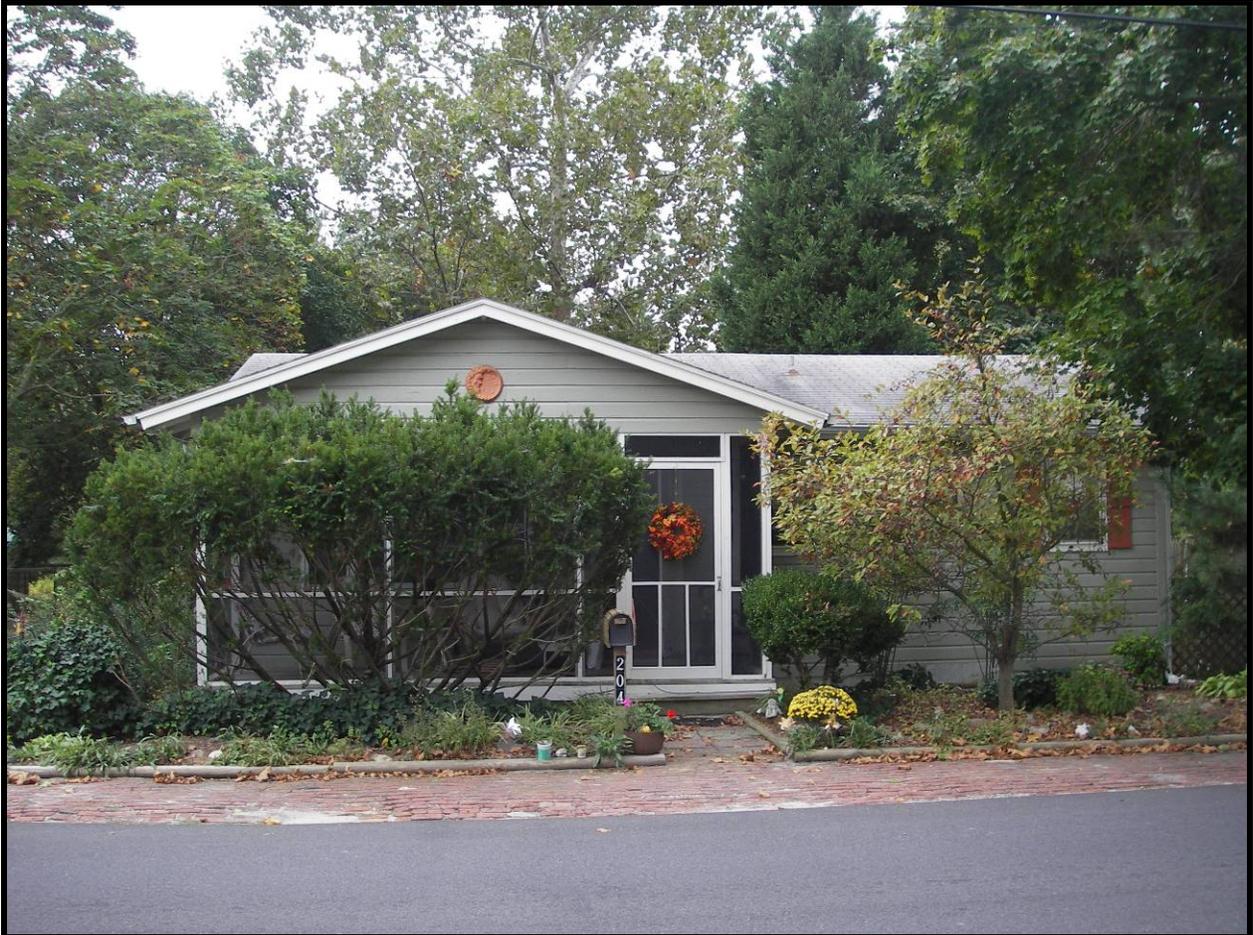
S-12101

204 Atlantic Street (1968 Aerial Map)

Property Type: Single-Family Dwelling, Ranch Style

This four-bay, one-story house was built between 1961 and 1968 in the Ranch style. The main block of the dwelling is side-gabled with a front-facing cross gable covering the two easternmost bays of the front (northeast) elevation which houses a screened-in porch. One-over-one sash windows are present in most openings and the dwelling is covered with vinyl siding. This dwelling is considered a non-contributing property for the expanded Milton Historic District due to its date of construction.

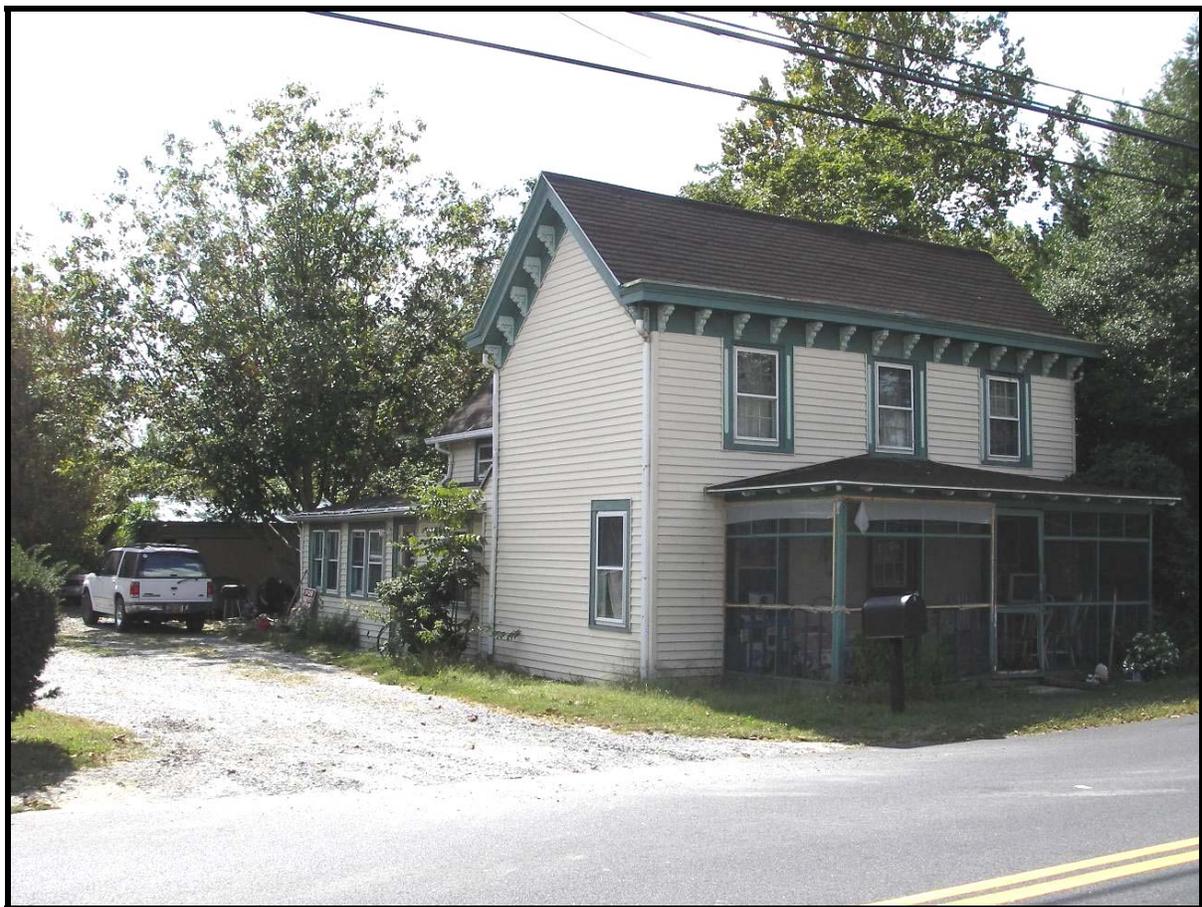
S-12089

206 Atlantic Street (Jno(?) Short: 1868 Beers Map; A. Johnson House: 1887 Map of Milton)

Property Type: Single-Family Dwelling, Vernacular Italianate Style

This three-bay, two-story, side-gabled house was built prior to 1868 in the Vernacular Italianate style. The main roof is covered in asphalt shingles and terminates in a flared, boxed cornice supported with cutwork brackets. Covering all three bays of the front (northeast) elevation is a one-story, hipped-roof screened-in porch. A series of additions are present off the rear (southwest) elevation, the most significant of which is a one-and-half-story ell extending from the middle bay of the original block forming an overall T-shaped plan. Several other shed-roofed additions extend to the southeast, southwest, and northwest sides of the rear ell appendage. In addition, a two-story bay window was added to the northwest gable end of the main block. All the windows on the front (southeast) elevation are six-over-six sash windows fitted in their original wood frames with decorative wooden trim. Windows on the remaining elevations of the main block and those in the additions are varied and not original. The main block and additions are covered with vinyl siding. The dwelling is an excellent example of the Three-Bay Vernacular Italianate style which was popular from the late 1860s to the early 1920s; it retains integrity of materials, workmanship, location, and setting, making it a contributing historic property for the expanded Milton Historic District.

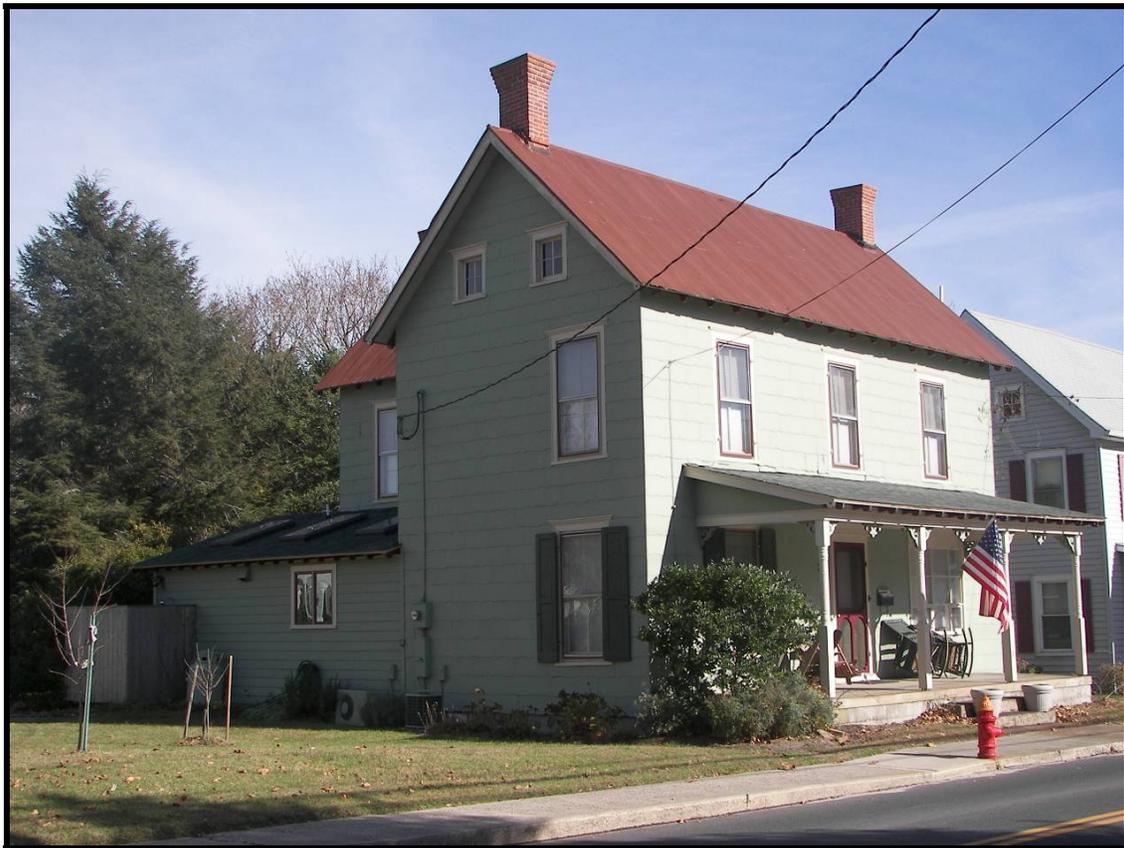
S-12090

**207 Atlantic Street (David Hudson House: 1868 Beers Map; Hudson House: 1887 Map of Milton)
Property Type: Single-Family Dwelling, Three-bay T-shaped Vernacular**

This three-bay, two-and-a-half-story, T-shaped dwelling was built prior to 1868 with minimal Italianate detailing. The main roof is covered with standing-seam sheet metal with exposed and decoratively trimmed rafters in the cornice. All three bays on the front (southwest) elevation are covered by a one-story, shed-roofed porch supported by turned posts and decorative brackets. Most of the windows in the main block are original two-over-two-light sash with molded wood trim. The southernmost bay on the first floor front (southwest) elevation contains a nine-light replacement bay window. All of the original first floor windows retain louvered shutters. Two small four-light fixed windows flank the chimney in each gable end. Three interior brick chimneys with corbelled caps rise through the northwest, southeast and northeast gable ends. Two one-story, shed-roofed additions extend from the northeast and southeast elevations in the corners of the T-shape. David L. Hudson, a thirty-eight year old white male sailor and Delaware native, owned the house from 1868 through at least 1887 (the name "Hudson" is still associated with the property on the 1887 map). This dwelling is representative of the classic Three-Bay Vernacular style which was prevalent in Milton from the mid 19th to the early 20th centuries; it retains integrity of materials, design, workmanship, location, and setting, making it a contributing historic property for the expanded Milton Historic District.

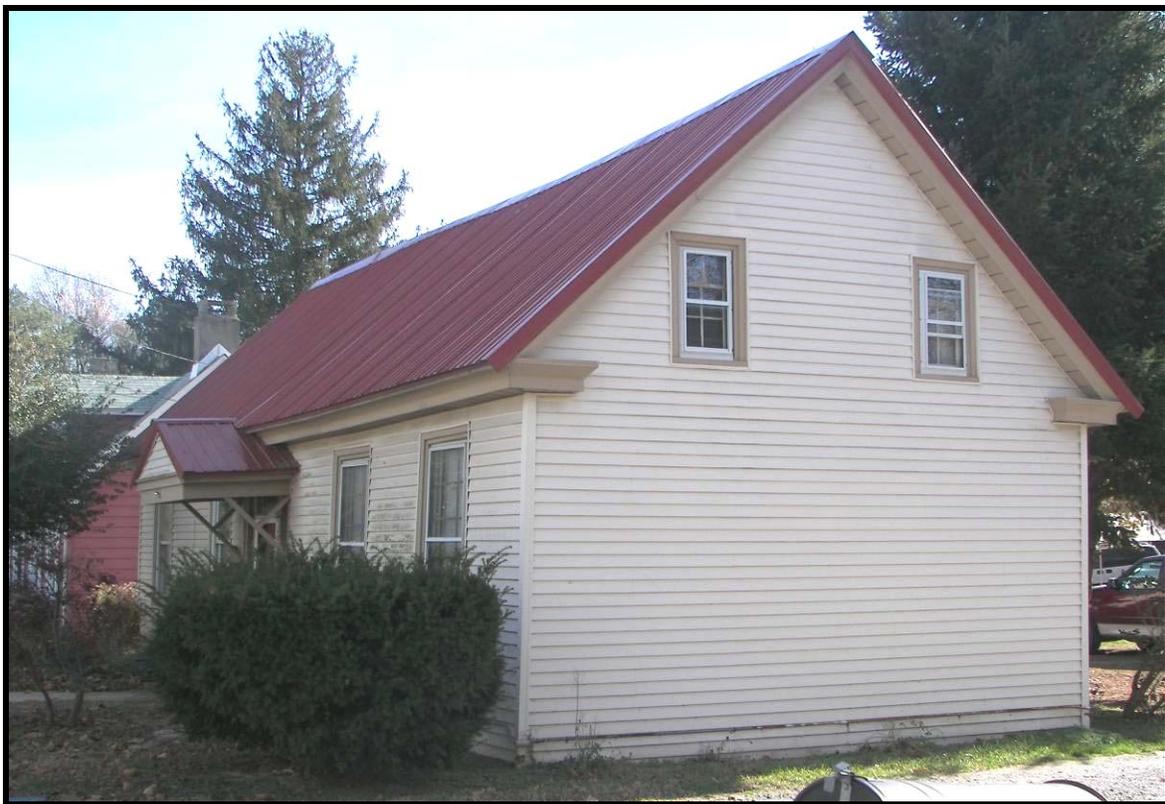
S-12091**208 Atlantic Street (Jno(?) Short: 1868 Beers Map; J.L. Collins House: 1887 Map)****Property Type: Single-Family Dwelling, Federal Style**

This five-bay, one-and-a-half-story, Federal style dwelling was built prior to 1868, most likely in the first quarter of the nineteenth century. Documentary evidence suggests this dwelling was originally four-bays wide with some alterations to the bay openings. Evidence also places chimneys on either gable end, however no sign of these is currently present. The northernmost two bays on the front (northeast) elevation are filled with nine-over-six sash windows. The southernmost two bays on this same elevation are filled with one-over-one-light replacement sashes. A pedimented portico extends over the central bay on the front (northeast) elevation. This central bay is filled by a door which is surrounded by a two-light transom and three-light vertical sidelights. The northwest and southeast elevations each have a pair of small one-over-one-light replacement sashes in the gable ends. A rear front-gable outbuilding was incorporated into the dwelling by the southeast gable-end extension. The standing-seam metal roof covers the entire dwelling and terminates in a boxed cornice with partially returning eaves on the main block. The dwelling is covered with vinyl siding. An individual with the last name Short owned the property in 1868 and J.L. Collins owned the property in 1887. Though there is no census data for Short and no direct matches for Collins, there was a man named John A. Collins, a forty-one year old white male Delaware native and former retail merchant, who could have potentially been the owner. The dwelling is an excellent example of a very early Milton residence; further investigation is needed, however, to fully assess its original configuration and age. It retains integrity of materials, design, workmanship, location, and setting, making it a contributing historic property for the expanded Milton Historic District.

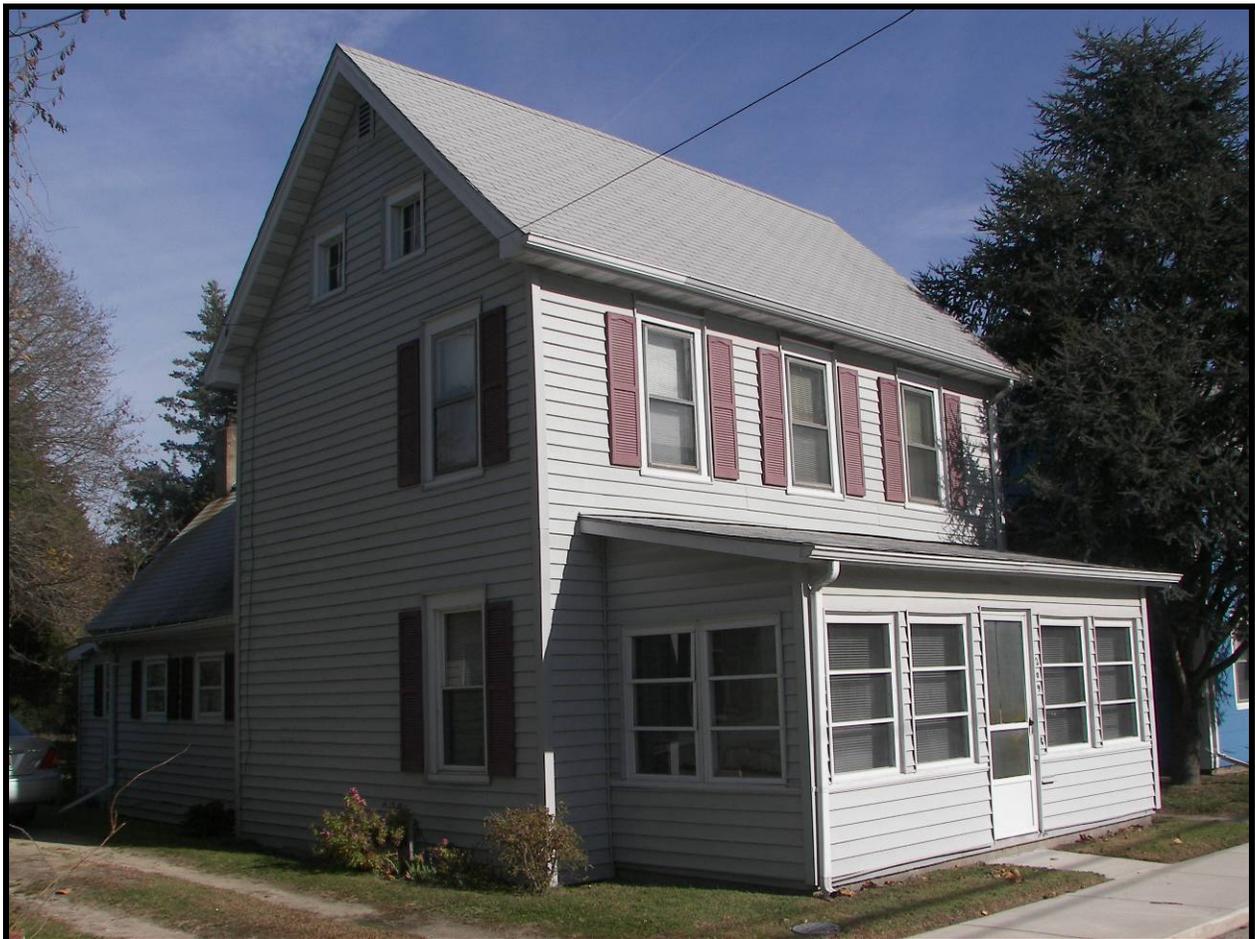
S-12094

209 Atlantic Street (1911 Sanborn Map)

Property Type: Single-Family Dwelling, Three-Bay Vernacular

This three-bay, two-and-a-half-story, side-gabled dwelling was built between 1887 and 1911. The main block has a one-story enclosed porch covering all three bays on the front (southwest) elevation. There is a very early, if not original, one-story kitchen ell extending from the northern end of the rear (northeastern) elevation. One interior concrete block chimney rises through the northeast gable end of this kitchen ell. A modern shed-roofed addition fills the corner created by the main block and rear ell. Another small shed-roofed addition stretches across the northeast elevation of the dwelling, spanning both the modern addition and the rear ell. The main roof is covered with asphalt shingles and terminates in a boxed cornice. Windows throughout the main block are one-over-one-light replacement sashes. A pair of small, original four-light fixed windows fills each gable end of the main block. The exterior walls of the dwelling are covered with vinyl siding. The dwelling is a good example of the classic Three-Bay Vernacular style which was prevalent in Milton from the mid 19th to the early 20th centuries; it retains integrity of materials, workmanship, location, and setting, making it a contributing historic property for the expanded Milton Historic District.

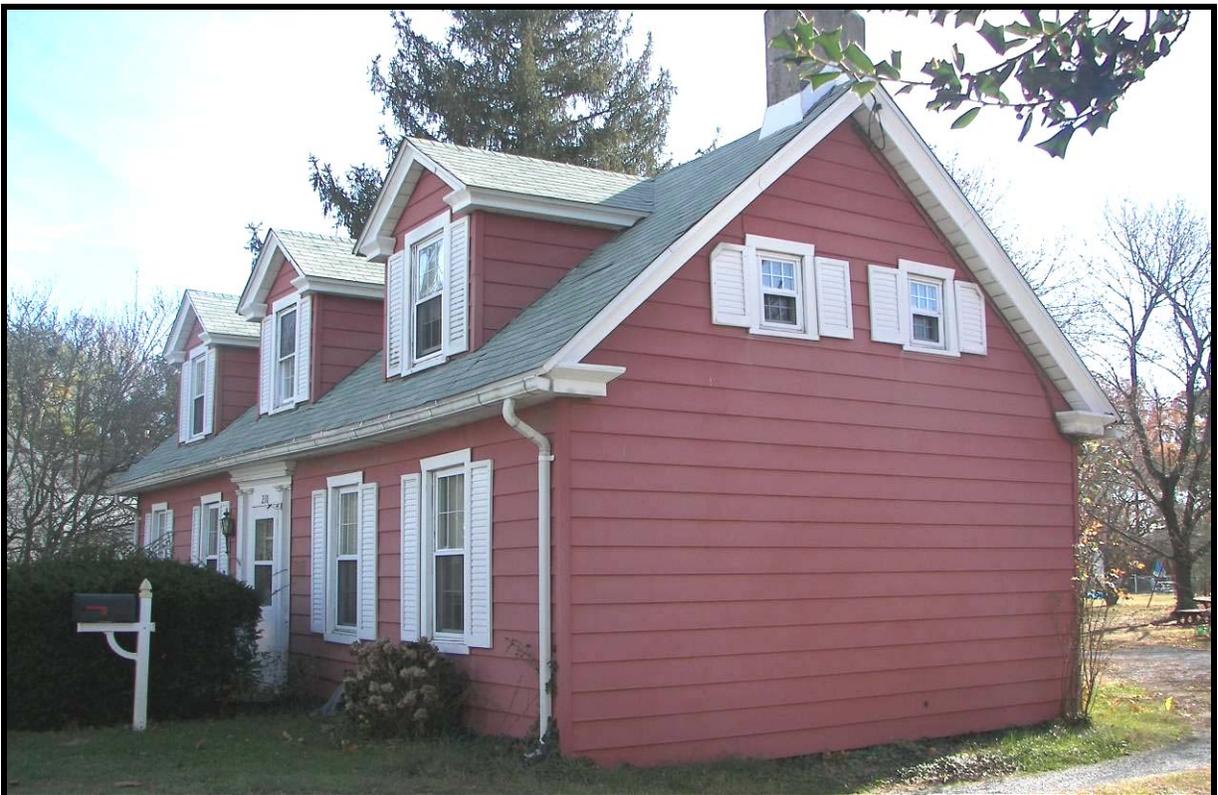
S-12092

210 Atlantic Street (J.C. Baynum House: 1868 Beers Map & 1887 Map of Milton)

Property Type: Single-Family Dwelling, Federal Style

This five-bay, one-and-a-half story, Federal style dwelling was built prior to 1868 and likely within the first quarter of the nineteenth century. Documentary evidence suggests this dwelling was originally a six-bay duplex configuration, since two of the bays could have been doors. Three dormer windows that currently protrude from the side-gabled dwelling were added after 1887. A one-story ell-addition extends from the southern end of the rear (southwest) elevation, possibly built to contain a kitchen. Three interior chimneys rise through the main block's northwest and southeast gable ends as well as the southwest gable end of the ell addition. Attached to the southeast side of the rear ell is another side ell which is now an enclosed sunroom. The front (northeast) elevation has been significantly updated from its original appearance; the bays have been reconfigured so that now only one door exists, located in the central bay. A colonial-revival door surround as well as inoperable shutters have been applied to this front elevation. Throughout the main block windows are six-over-six replacement sashes in metal replacement frames. In each gable end of the main block there is a pair of small six-over-six replacement sash windows flanking the interior chimney stack. The main roof is covered in asphalt shingles and terminates in a boxed cornice with partially returning eaves. Vinyl siding covers the main block and additions. John C. Baynum, a fifty-seven year old white male sea captain and Delaware native, owned the property from 1868 until at least 1887. The dwelling is an excellent example of a very early Milton home and yields important research potential; further investigation is needed, however, to fully assess its original configuration and age. It retains integrity of design, workmanship, location, and setting, making it a contributing historic property for the expanded Milton Historic District.

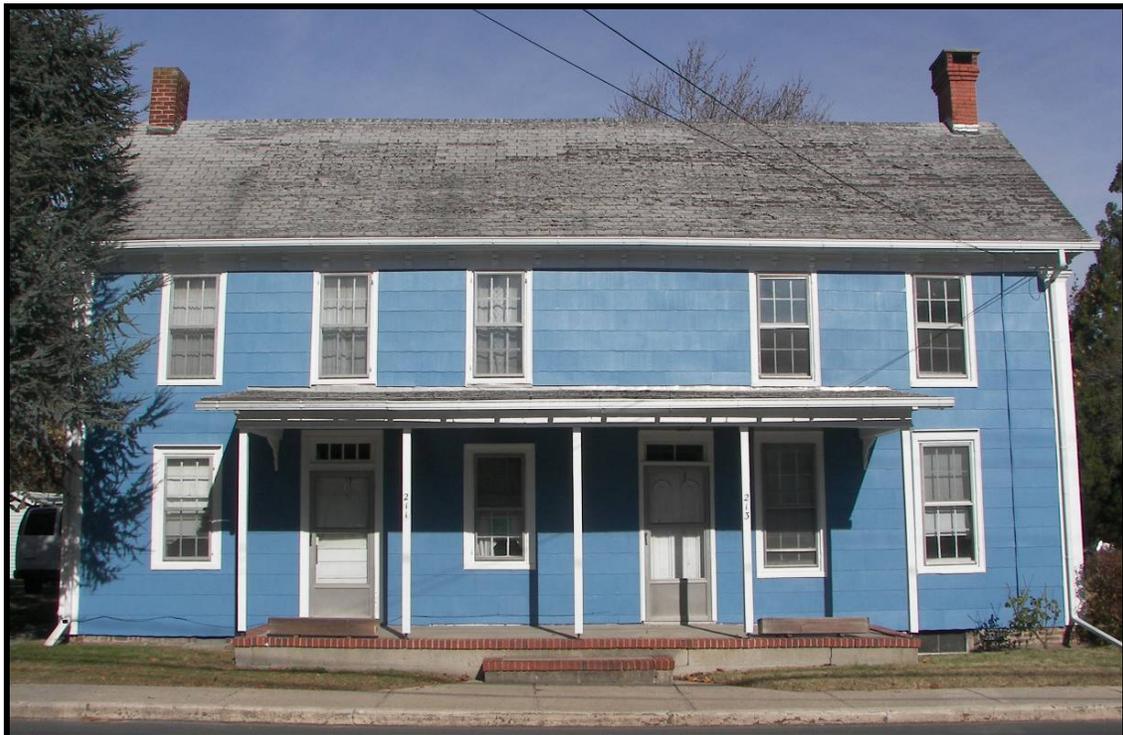
S-12095

211-213 Atlantic Street (H. Lank House: 1868 Beers Map)

Property Type: Duplex dwelling, Three-Bay Vernacular Federal

This six-bay, gable-roofed, two-and-a-half story dwelling was built prior to 1868 and exhibits several periods of construction, with the original section being the three northernmost bays at the end of side-gabled block likely dating to the first quarter of the nineteenth century or earlier. Later additions include a three-bay second story onto the original section, a three-bay, two-story section on the southern gable end of the original block, two one-story, gable-roofed blocks forming two ells off the west and east ends of the rear (northeast) elevation, and an enclosed shed-roofed addition extending off the northeast elevation spanning the void between the two ells. The various additions on the northeast elevation of the main block resemble a U-shape. The gable roof of the main block is covered in asphalt shingles and terminates in a boxed cornice supported by Italianate brackets. A one-story, shed-roofed porch covers the central four bays of the front (southwest) elevation supported by plain posts and minimal decorative brackets. Fenestration on the front (southwest) elevation includes one door in the second bay from the western end with a four-light transom and one door in the third bay from the eastern end with a two-light transom. Six-over-six-light sash windows fill the remaining bays on the front elevation. A pair of small four-light fixed windows flanks the chimney stack on the gable ends of the main block. Similar openings filled with metal grates flank the chimney on the southernmost ell gable end. Three interior brick chimneys rise through the dwelling, one the northwest gable end of the main block, and one in each of the northeast gable ends of the ell additions. One partially exterior chimney rises on the southeast gable end of the main block. Asbestos shingles cover all sections of the building. This house was owned by a man named H. Lank in 1868; unfortunately, no census data is available for this individual. The dwelling displays features relating to several periods of Milton's architectural development, such as the Three-Bay Vernacular blocks popular during the mid 19th & early 20th centuries as well as the later Federal-style windows; it retains integrity of materials, workmanship, design, location, and setting, making it a contributing historic property for the expanded Milton Historic District.

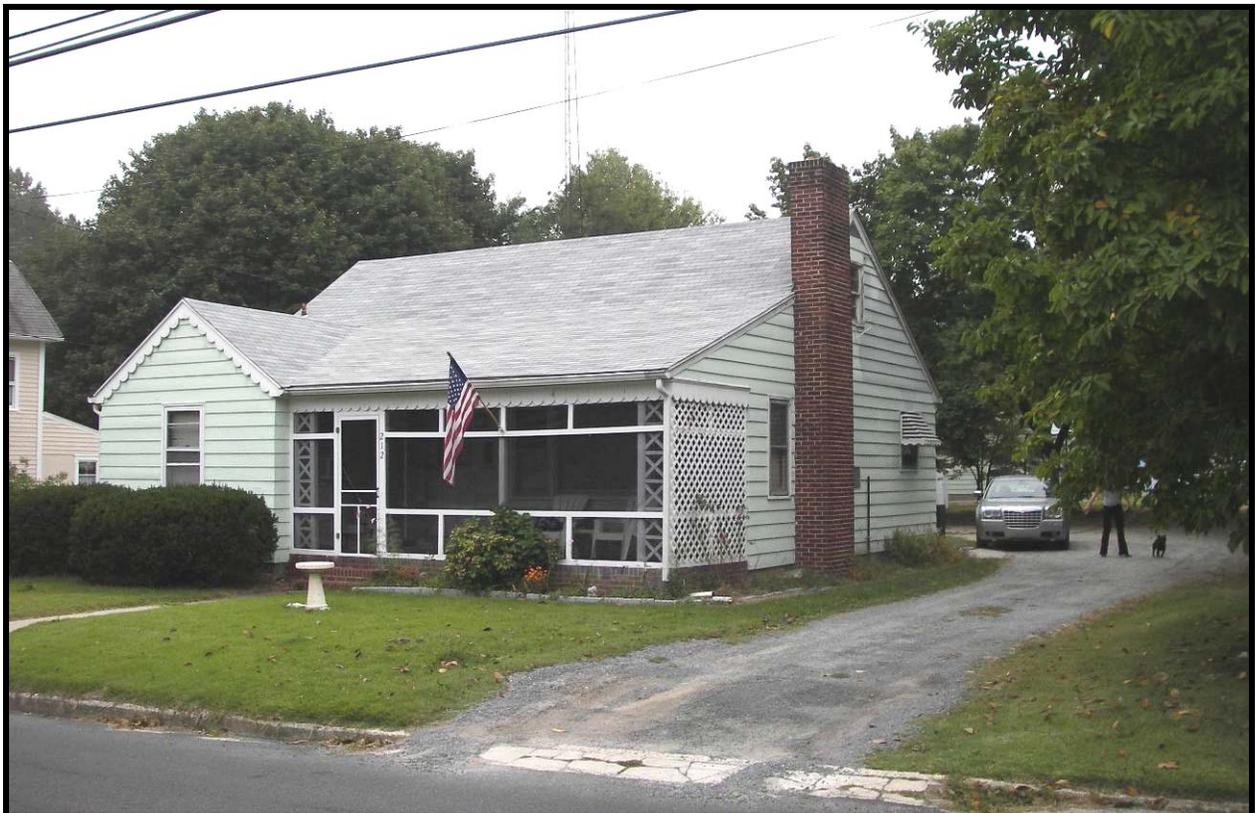
S-12093

212 Atlantic Street (1961 Aerial Map)

Property Type: Single-Family Dwelling, Minimal Traditional Style

This three-bay, one-and-a-half story dwelling was built between 1954 and 1961 in the Minimal Traditional style. A front-gabled roof covers the easternmost bay of the front (northeast) elevation creating an overall L-shaped dwelling. A screened-in porch covers the remaining two bays on front elevation. An exterior brick chimney rises on the northern side of the northwest gable end. All the windows on the dwelling are one-over-one sash; the entire dwelling is sheathed with vinyl siding. The minimal traditional style of this dwelling became a popular design from the mid 1950s to the early 1960s. This dwelling retains integrity of location, setting, design, workmanship, materials, and feeling, making it a contributing historic property for the expanded Milton Historic District.
