APPENDIX A:
INVENTORY OF SURVEYED
PROPERTIES

MILTON • DELAWARE

APPENDIX A

This appendix begins with a chart of all the resources surveyed in Milton. The chart includes CRS numbers, address, function, style of architecture, the date the property first appears on a historic map, and whether or not the property should be considered contributing or non-contributing to a potential expanded National Register of Historic Places District in Milton or a local historic zone. Following the chart, descriptions of the surveyed resources provide more detailed information on the historic name of the property, function, a brief history, and a physical description of the property. The description also provides a short rationale for the property's recommendation for inclusion or exclusion to the National Register District. Photographs of each main building or resource appear with the descriptions.

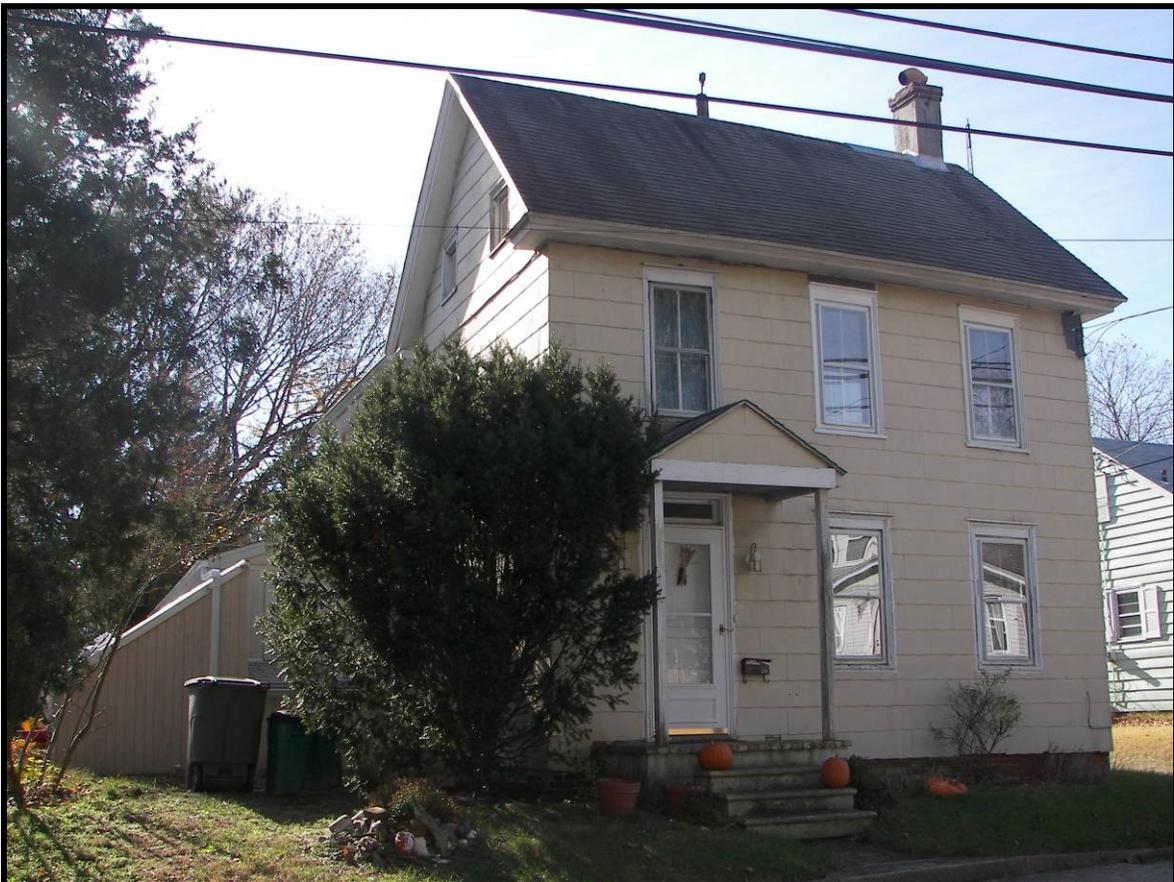
S-12097

214 Atlantic Street (1911 Sanborn Map)

Property Type: Single-Family Dwelling, Three-bay T-shaped Vernacular Italianate

This three-bay, two-and-a-half-story, T-shaped, gable-roofed dwelling with Italianate detailing was built between 1887 and 1911. A one-story shed-roofed addition extends off the rear (southwest) gable end of the main block, wraps around the southern corner, and extends to the corner of the T-shape on the southeast elevation. The asphalt-shingled roof on the T-shaped section terminates in a boxed cornice with a partially returning eave. The side-gabled block of the dwelling is sheathed in asbestos shingles while the adjoining ell block is sheathed in vinyl siding. Interior brick chimneys rise in two locations: one in the northwest gable end and the other in the southwest gable end. A door with a single-light transom is located in the easternmost bay of the front (northeast) elevation, suggesting a side-passage plan; two-over-two-light sash windows fill all the remaining openings on side-gabled block. A pair of small openings appears in both gable ends of the side-gabled front block containing metal vents. Windows in the rear ell block are one-over-one light replacement sashes. A one-story pedimented portico is located in the easternmost bay on the front elevation. An excellent example of the classic Three-Bay Vernacular Italianate style popular in Milton from the mid 19th to the early 20th centuries, this dwelling retains integrity of location, setting, design, workmanship, materials, and feeling, making it a contributing historic property for the expanded Milton Historic District.

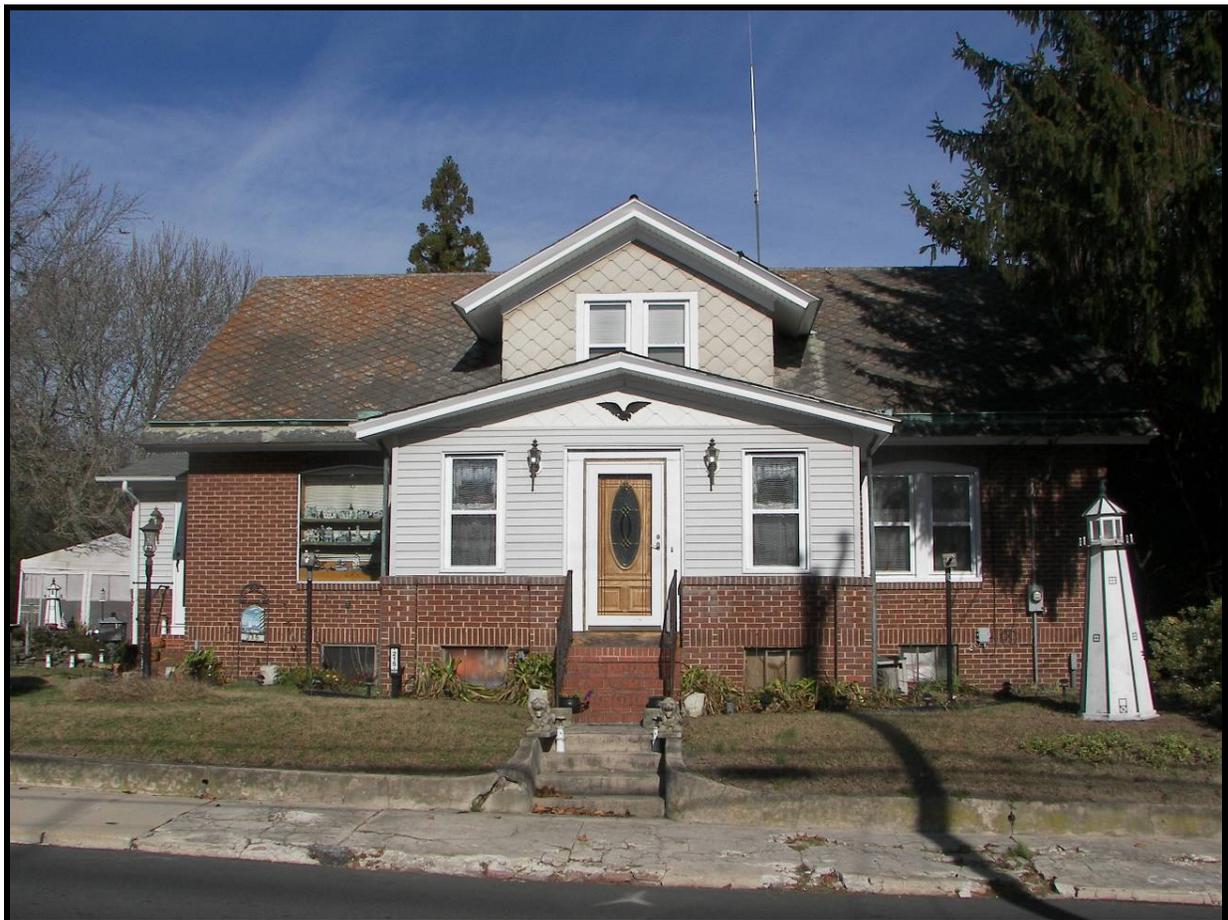
This six-bay, one-and-a-half story, side-gabled dwelling was built in the Craftsman style between the years of 1923 and 1937. A one-bay, gable-roofed, one-story enclosed porch projects from the northwest gable end. A prominent one-bay, gable-roofed dormer extends over the central bay on the front (southwest) and rear (northeast) elevations. A gable-roofed one-story enclosed porch covers the central three bays of the main block's front (southwest) elevation. An exterior brick chimney rises on the south end of the southeast gable end. The main block of the dwelling is brick laid in an American-bond with a brick stretcher boarder at water table level. The dormers and gable ends are sheathed with decorative fish-scale shingles. The enclosed porches are a combination of brick to waist level and vinyl siding to the roofline. Asphalt shingles laid in a diagonal fish-scale pattern cover the roof which terminates in a vinyl, boxed cornice. Fenestration throughout the dwelling is a combination of replacement doors, single, and paired windows with one-over-one-light sashes. Basement level fenestration aligns with the first story bays on the front elevation. The dwelling is a good example of the Craftsman style which was popular in Milton from the early 1920s to the late 1930s; it retains integrity of materials, workmanship, design, location, and setting, making it a contributing historic property for the expanded Milton Historic District.

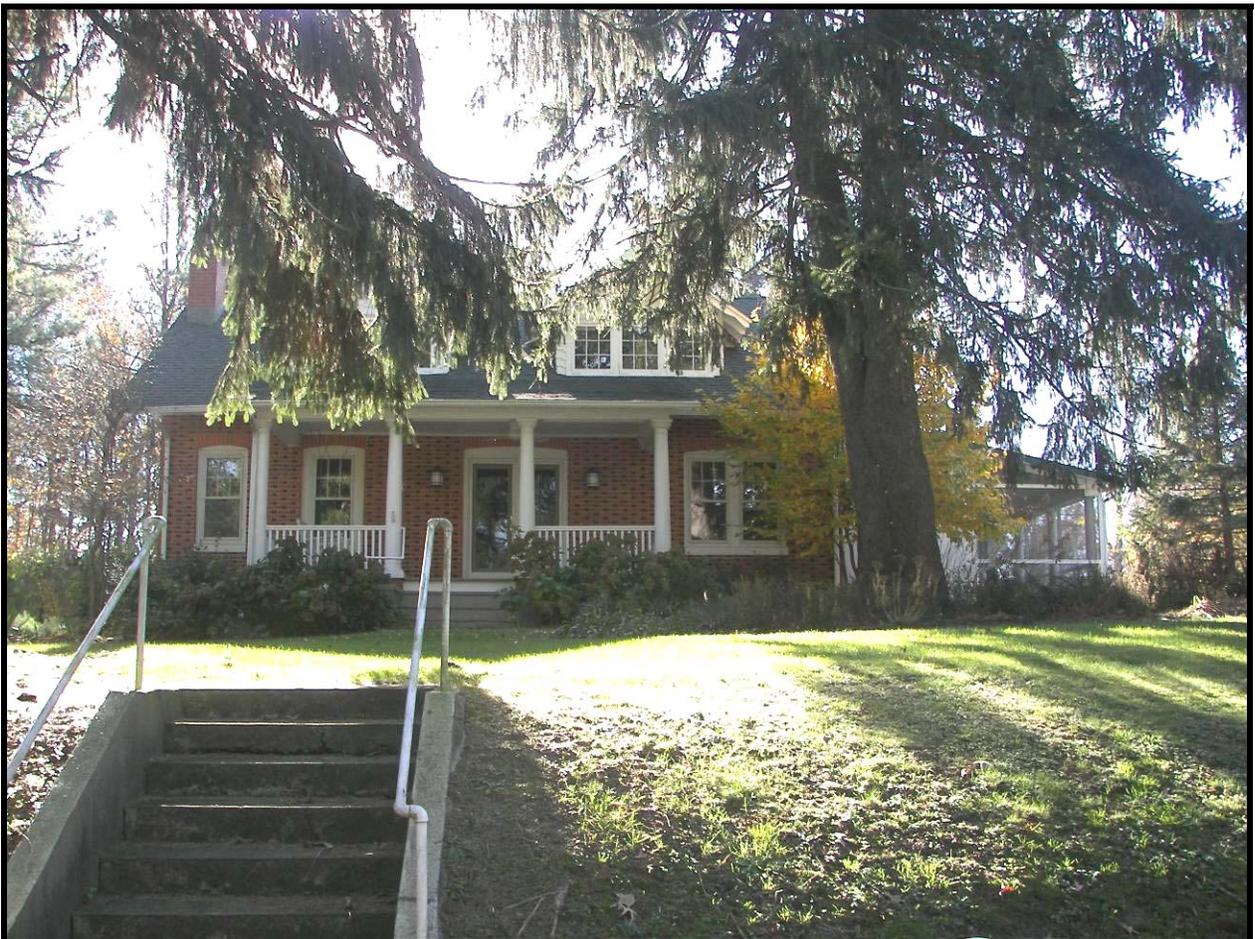
S-12098

This five-bay, one-and-a-half story, side-gabled Bungalow was constructed between the years of 1911 and 1923 in the Craftsman style. The main block of the brick dwelling is laid in a glazed-header Flemish bond, while the dormers and gable ends of the main block are sheathed in a decorative shingle pattern. An original or very early shed-roofed addition projects off the southeast elevation of the roof which has been extended to create an open porch. Two large gable-roofed dormers are centered on the northeast side of the gable roof. Fenestration on the front (northeast) elevation consists of a double replacement door in the central bay and six-over-one replacement sash windows in either a single or paired configuration. Each dormer contains one tripartite replacement sash with nine-lights in each part. Interior chimneys rise in two locations: one on the northern end of the northwest gable end and the other on the eastern end of the southeast gable end. The dwelling is an excellent example of the Craftsman style which was popular in Milton from the early 1920s to the late 1930s; it retains integrity of materials, workmanship, design, location, and setting, making it a contributing historic property for the expanded Milton Historic District.

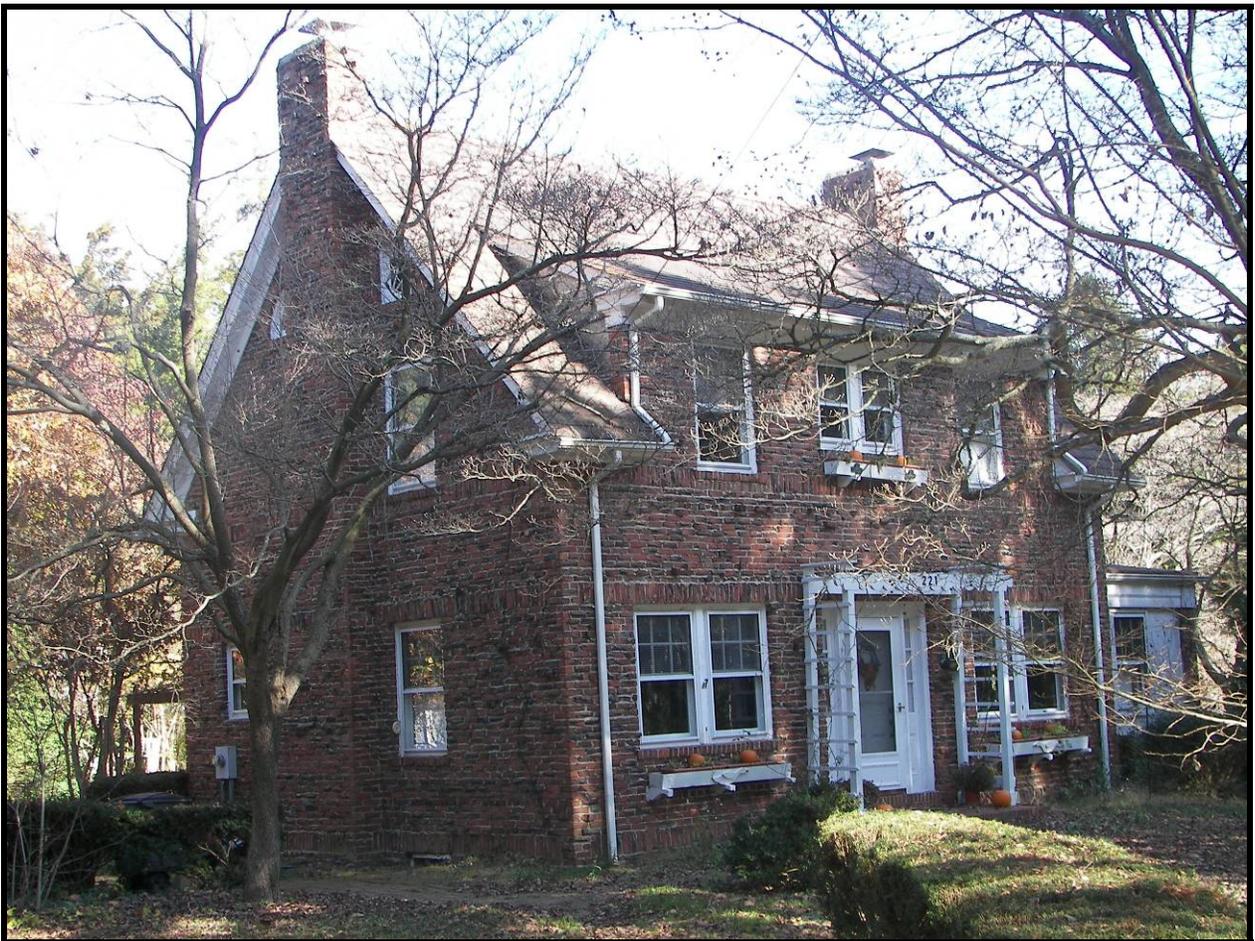
S-12099

This four-bay, two-and-a-half story, gable-roofed dwelling was built between 1923 and 1937 in the Colonial-Revival style. The three-bay, side-gabled main block of the brick dwelling is roughly laid in American bond with decorative brick stretcher borders on all elevations. A shed-roofed wall dormer on each side of the main block's gable roof contains three bays and extends flush with the front (southwest) and rear (northeast) elevations. Fenestration on the front (southwest) elevation is comprised of a door in the central bay of the main block flanked by three-pane side lights. The remaining openings are filled single and paired six-over-one-light replacement sash windows. The southernmost bay on the front (southwest) elevation is filled with a half-hipped, enclosed porch that spans two bays on the main block's southeast gable end. An exterior chimney rises on each gable end. The shingle-covered roof of the main block terminates in a boxed cornice with partially returning eaves. A pair of quarter-circle fanlights flank the chimney stack on each gable end. The dwelling serves as a rare example of the few Colonial-Revival style homes constructed in Milton from the late 1880s to the mid 1930s; it retains integrity of materials, workmanship, design, location, and setting, making it a contributing historic property for the expanded Milton Historic District.

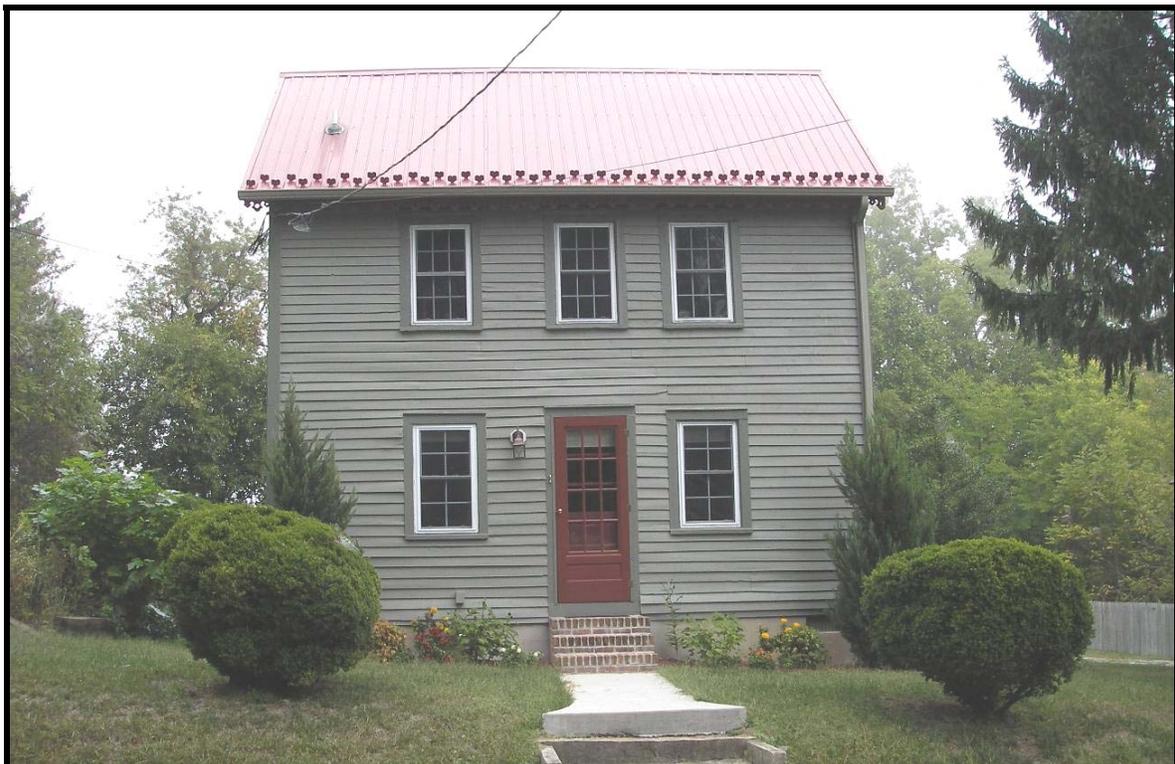
Property Type: Single-Family Dwelling, Three-Bay Vernacular

This three-bay, two-and-a-half story, side-gabled dwelling was built by the year 1923 and possibly was constructed in the mid to late-nineteenth century. There are a series of additions on the rear (northeast) elevation that span several eras of construction. A one-story, gable-roofed ell addition extends from the northernmost bay of this rear addition and may have contained a kitchen. A more recent flat-roofed, one-story addition fills the corner created by the intersecting ell addition and main block visible on the southeast elevation. A one-story, shed-roofed addition spans the ell addition gable end and the more recent flat-roofed addition on the northeast elevation. The north corner of this shed-roofed addition abuts a one-story front-gabled outbuilding attributed in oral history to button-making. Any evidence of original chimneys in the main block and additions has been removed. Wood clapboard covers the main block of the dwelling while vinyl siding covers the rear additions. A standing-seam sheet metal roof covers all sections of the dwelling and terminates on the main roof in a decorative verge board. Fenestration on the front (southwest) elevation consists of a door in the central first-story bay flanked by four-over-four sash replacement windows in metal frames. The second floor bays align with the first-story bays and are filled with six-over-six-light replacement sashes in replacement metal frames. A pair of small four-light fixed windows appears in each gable end of the main block. A new foundation was put under the dwelling in the last ten years. Paris Connor, a fifty-three year old black male laborer and Delaware native, potentially owned the property in 1887. The dwelling is an excellent example of the Three-Bay Vernacular style which was prevalent in Milton from the mid 19th to the early 20th centuries; it retains integrity of materials, workmanship, design, location, and setting, making it a contributing historic property for the expanded Milton Historic District.

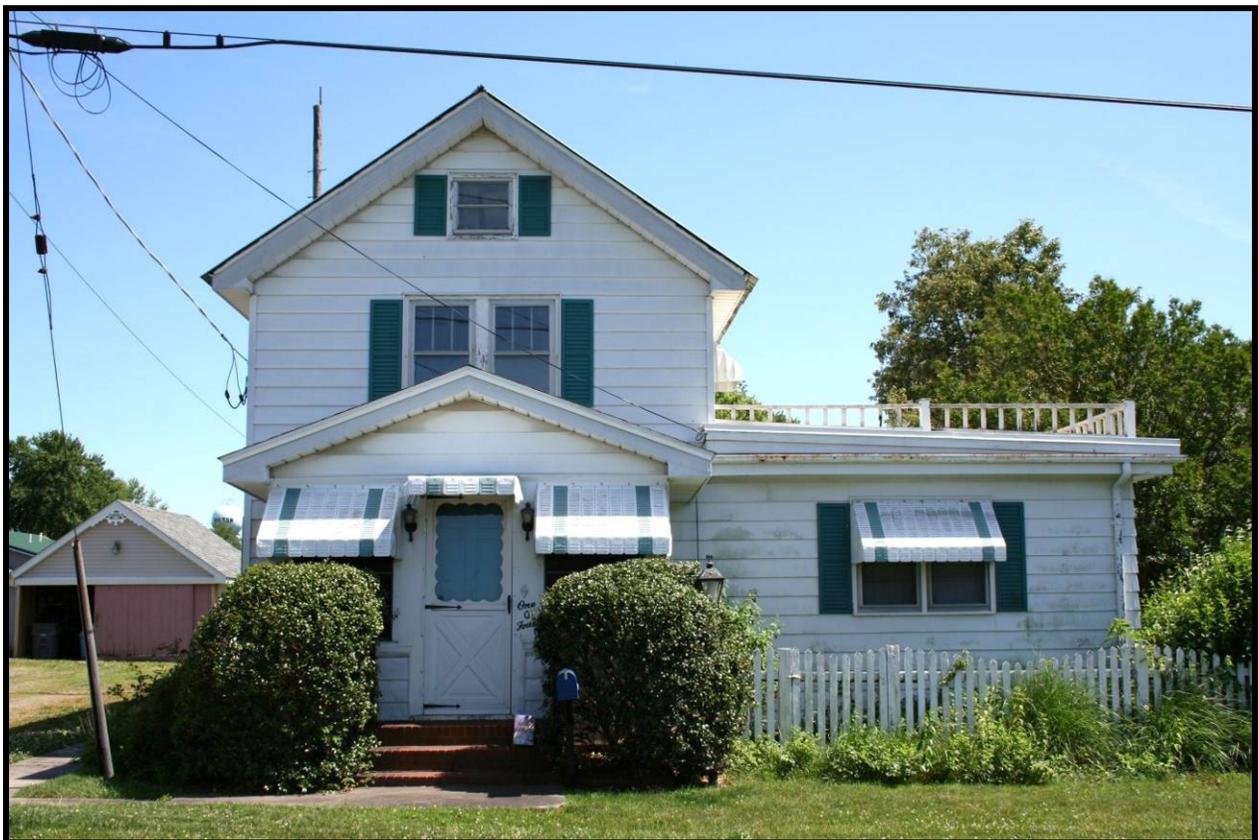
This four-bay, two-and-a-half story, frame dwelling with a front-gabled roof and an attached shed-roofed block was built between 1937 and 1950. The house cannot be classified as one distinct style due to its eclectic mix of additions, irregular fenestration, and styles. A gable-roofed porch with a boxed cornice is attached to the front of the main rectangular front-gabled block, serving as the main entrance to the dwelling. A raised six-panel door is centered between two four-pane casement windows on the front (northwest) side of the entry porch. Three-over-one sash windows with louvered shutters occupy the remaining bays of the front elevation as well as the other elevations of the dwelling, with the exception of a one-over-one sash window located in the upper story of the northwest elevation and a pair of single-pane casement windows near the rear end of the northeast side. A single interior brick chimney is centrally positioned along the ridge of the main front-gable block. The roof is clad in asphalt shingles and the exterior walls are covered in vinyl/aluminum siding. This dwelling is considered a non-contributing property for the expanded Milton Historic District due to its loss of integrity in design and materials.

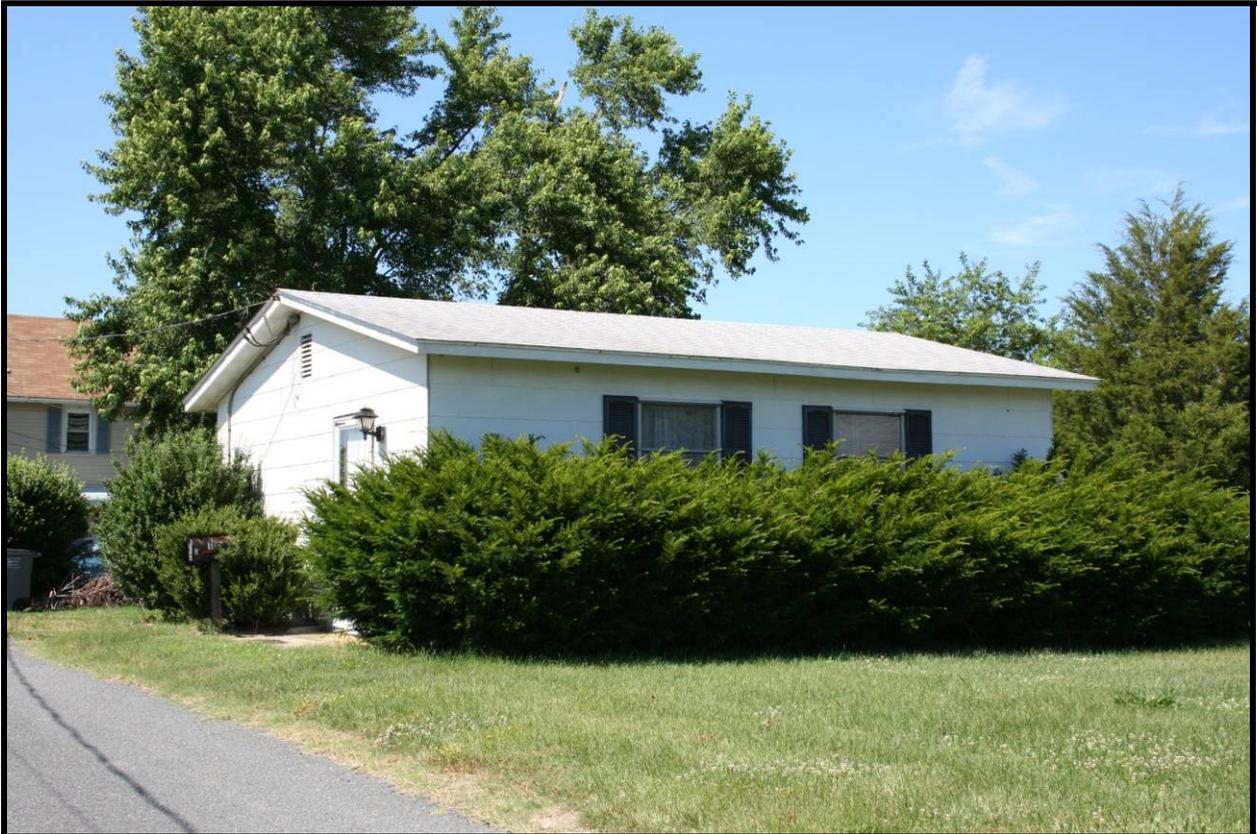
Property Type: Single-Family Dwelling, Shotgun Plan

This one-story, frame, Shotgun-plan dwelling with a front-gabled roof was constructed between 1968 and 1992. The southwest façade features only a single off-center door, while the southeast façade has two double-hung sash windows with inoperable louvered shutters on either side. The northwest façade has no fenestration. The roof is covered in gray asphalt shingles and the exterior of the dwelling is sheathed in asbestos shingles. This dwelling is considered a non-contributing property for the expanded Milton Historic District due to its recent construction date.

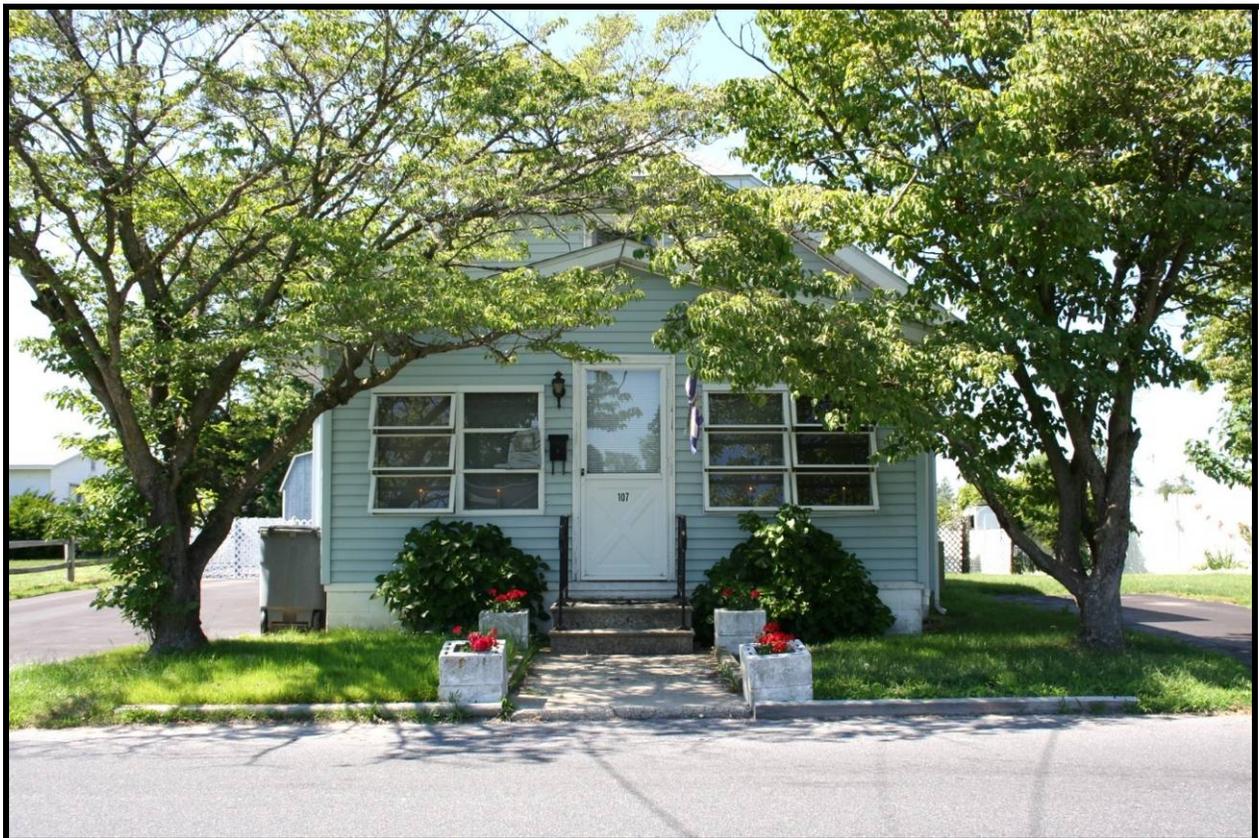
This three-bay, one-and-a-half story Shotgun-plan frame dwelling was built between 1923 and 1937 and exhibits Craftsman detailing. The main block has a front-gabled roof with a clipped end, while the rear addition and enclosed front porch have regular front-gabled roofs with boxed cornices. The main entry door located in the enclosed front porch on the southeast side of the dwelling is centered between two paired sets of tripartite casement windows. The majority of the windows are one-over-one sash with louvered shutters. A single interior brick chimney is centrally-positioned along the ridge of the main front-gable block with the hip end. The roofs are all clad in asphalt shingles and the exterior walls are covered with vinyl/aluminum siding. The dwelling is one of two Craftsman style shotgun-plan homes built on this street between the mid 1930s to the mid 1950s. It retains integrity of design, location, and setting, making it a contributing historic property for the expanded Milton Historic District.

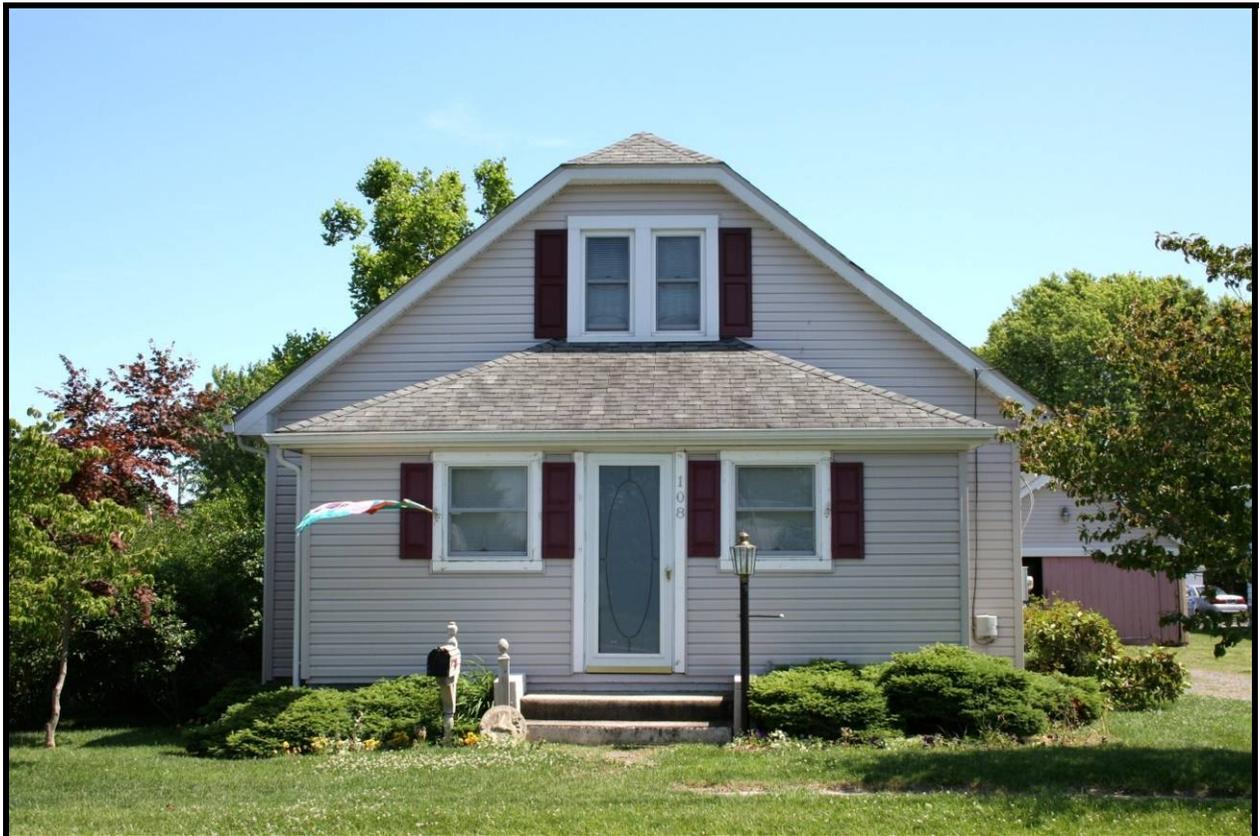
Property Type: Single-Family Dwelling, Shotgun plan with Craftsman detailing

This three-bay, one-and-a-half story, Shotgun-plan frame dwelling with Craftsman detailing was built between 1937 and 1954. The main block has a front-gabled roof with a clipped end, while the enclosed front porch has a hipped-roof and the rear block has a plain front-gabled roof. The main entryway located in the enclosed front porch on the northwest side of the dwelling is centered between two one-over-one sash windows with louvered shutters. All windows are one-over-one sash, with the exception of a pair of single-pane casement windows on the southwest elevation. A single interior brick chimney is positioned next to the ridge of the main front-gable block with the hip end. The roofs are all clad in asphalt shingles and the exterior walls are covered with vinyl/aluminum siding. The dwelling is one of two Craftsman style shotgun-plan homes built on this street from the mid 1930s to the mid 1950s. It retains integrity of design, materials, location, and setting, making it a contributing historic property for the expanded Milton Historic District.

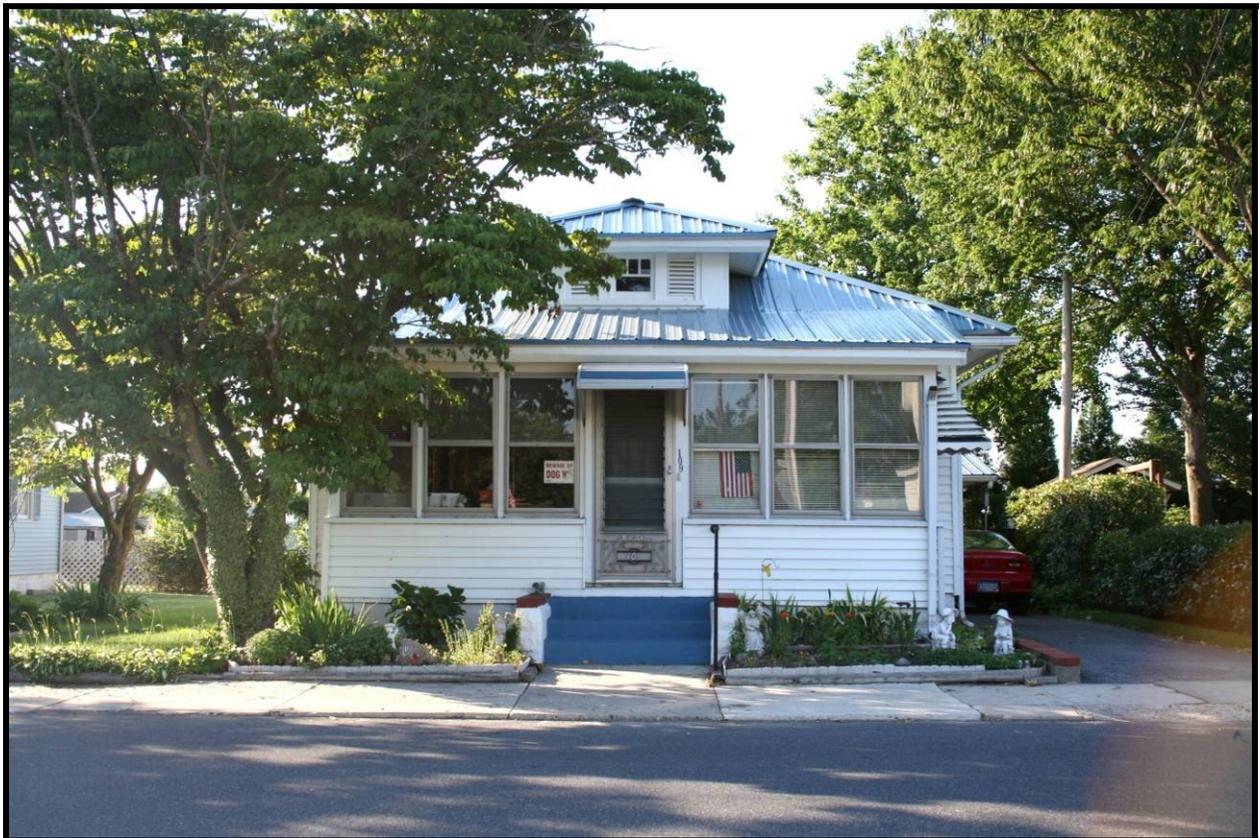
This three-bay, one-and-a-half story, frame dwelling was built between 1923 and 1937 in the Craftsman Bungalow style. The roof is hipped with a shed-roofed enclosed front porch on the southeast façade and a shed-roofed addition on the rear. The main entry door located in the enclosed front porch is centered between two sets of three one-over-one sash windows. The windows on the remaining elevations are all one-over-one sash with louvered shutters and aluminum awnings. A single interior brick chimney with a decorative cap is located on the northwest end hip of the main block. A hipped-roof dormer with a three-over-one fixed window and two louvered vents is also located on the front of the main building. The roof is covered with standing-seam sheet metal and the exterior walls are covered with vinyl/aluminum siding. Bungalows became a popular housing style during the mid 1930s in Milton, but significantly declined in construction rates during the following years. The characteristics of Milton's bungalows vary considerably, from large, elaborate homes made from high-quality materials to much smaller and simpler dwellings, such as this property. This dwelling retains integrity of design, materials, location, and setting, making it a contributing historic property for the expanded Milton Historic District.

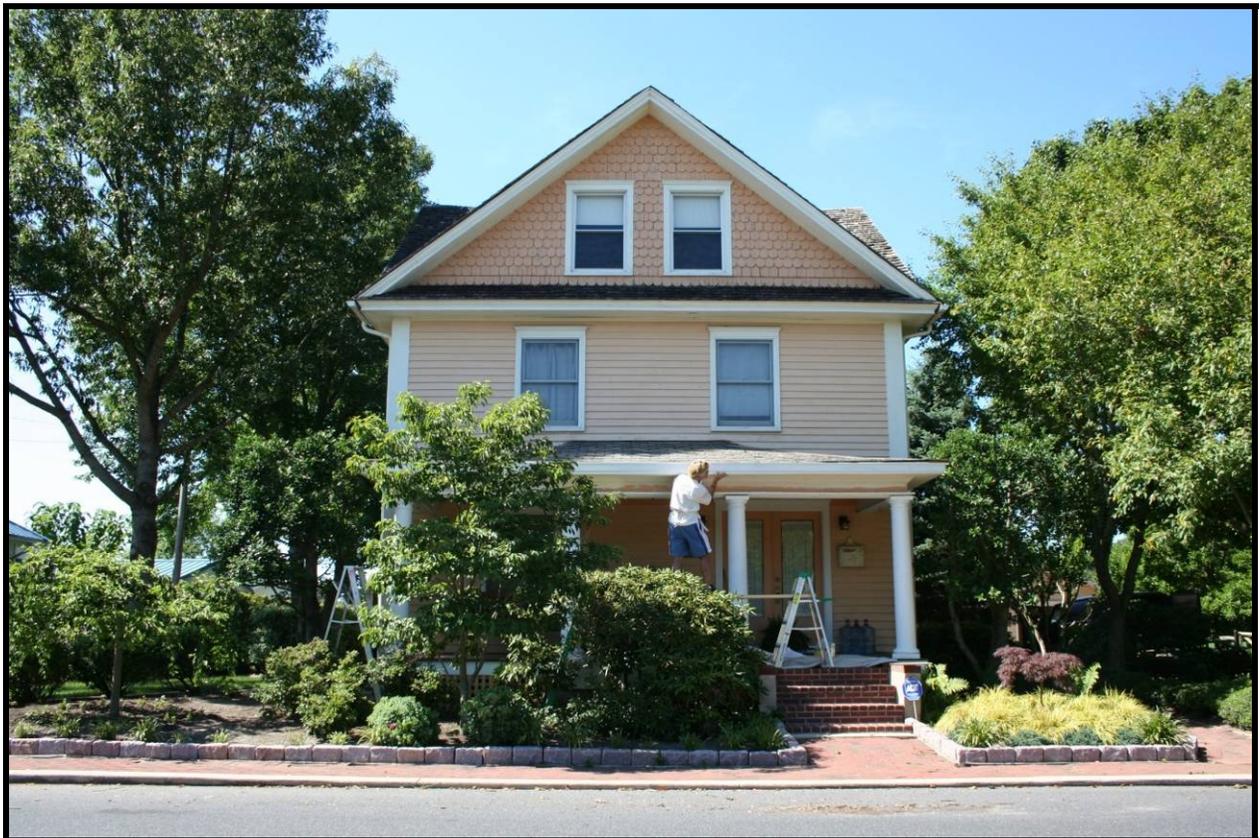
S-11981

This two-bay, two-and-a-half story, frame dwelling with Queen Anne decorative detailing was built between 1911 and 1923. The main block has four full-sized cross-gable dormers, with a hipped-roof open front porch and a shed-roofed addition at the northwest rear of the dwelling. The porch is located on the southeast façade and has four evenly spaced Doric columns supporting the roof. Paired entry doors with large glass panes are located in the second bay under the covered porch and the windows are all one-over-one sash. A single interior brick chimney is located along the peak of the roof on the southwest gable. The roof of the main block has returning eaves on all sides and is covered in wooden shingles, while the hipped-roof porch has asphalt shingles. The exterior walls are covered in clapboard and wooden-shingles decorate the gable aprons. This dwelling, with its Queen Anne style ornamental details, exemplifies the master craftsmanship of the Victorian homes built in Milton from the late 1860s to the early 1920s. It retains integrity of design, materials, workmanship, location, and setting, making it a contributing historic property for the expanded Milton Historic District.

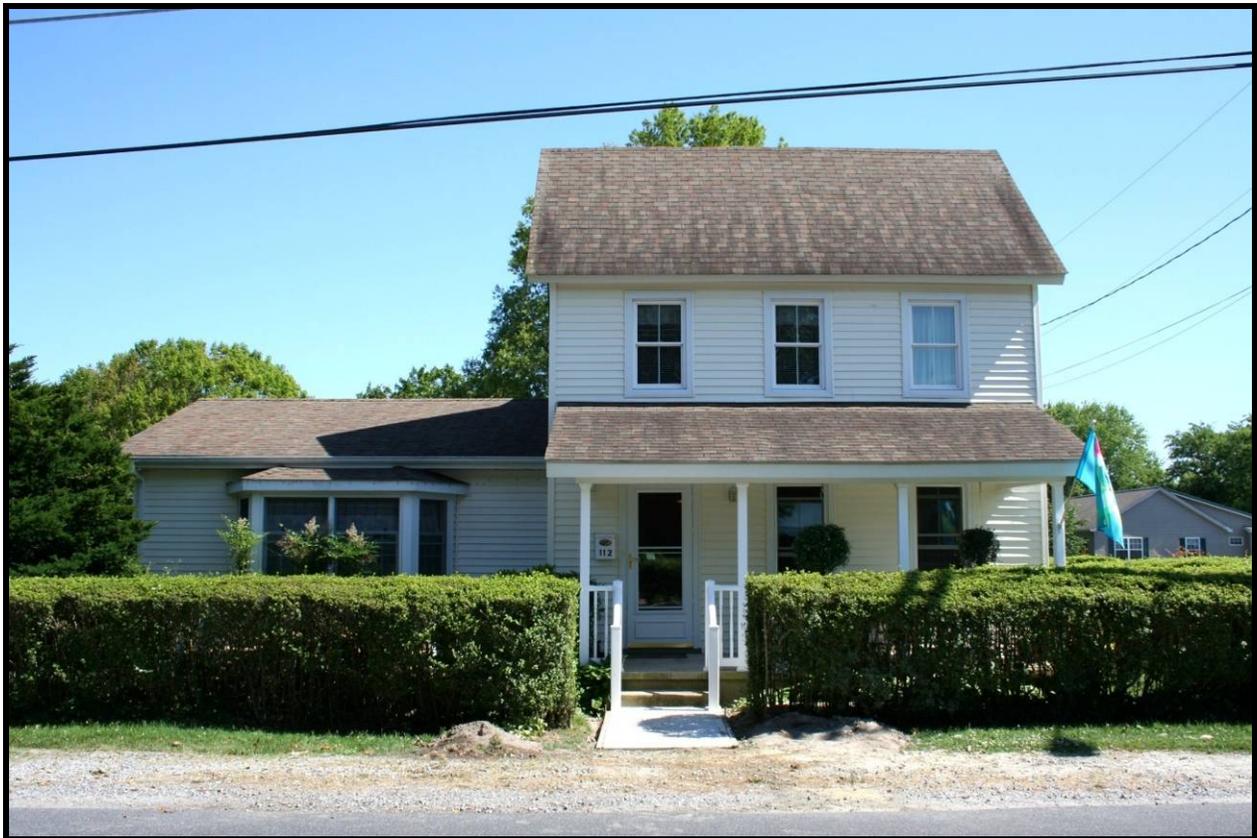
Property Type: Single-Family Dwelling, Three-Bay Vernacular with Italianate Detailing

This three-bay, two-story, vernacular house with Italianate detailing was originally constructed between 1911 and 1923 and has had several additions. The frame dwelling currently has an overall L-shape due to its L-shaped cross-gabled main block, a shed-roofed addition on the southwest façade, an asymmetrical gable-roofed southeast addition, and a gable-roofed northeast addition. A shed-roofed open porch with four square-post supports is located on the northwest façade. A single door is located in the second bay next to a large bay window with a half-hipped roof. The majority of the windows are two-over-two double-hung sash, with the exception of the two one-over-eight and two one-over-six sash windows which compose the bay window, two double-pane casement windows which are located in the upper story of the southwest elevation, and a decorative square casement window consisting of a large pane surrounded by small square panes located on the northeast elevation. The roof is clad in asphalt shingles and the exterior walls are covered with vinyl/aluminum siding. The two-over-two sash windows of this dwelling are characteristic of the Italianate style homes constructed in Milton from the late 1860s to the early 1920s. This dwelling retains integrity of design, materials, workmanship, location, and setting, making it a contributing historic property for the expanded Milton Historic District.

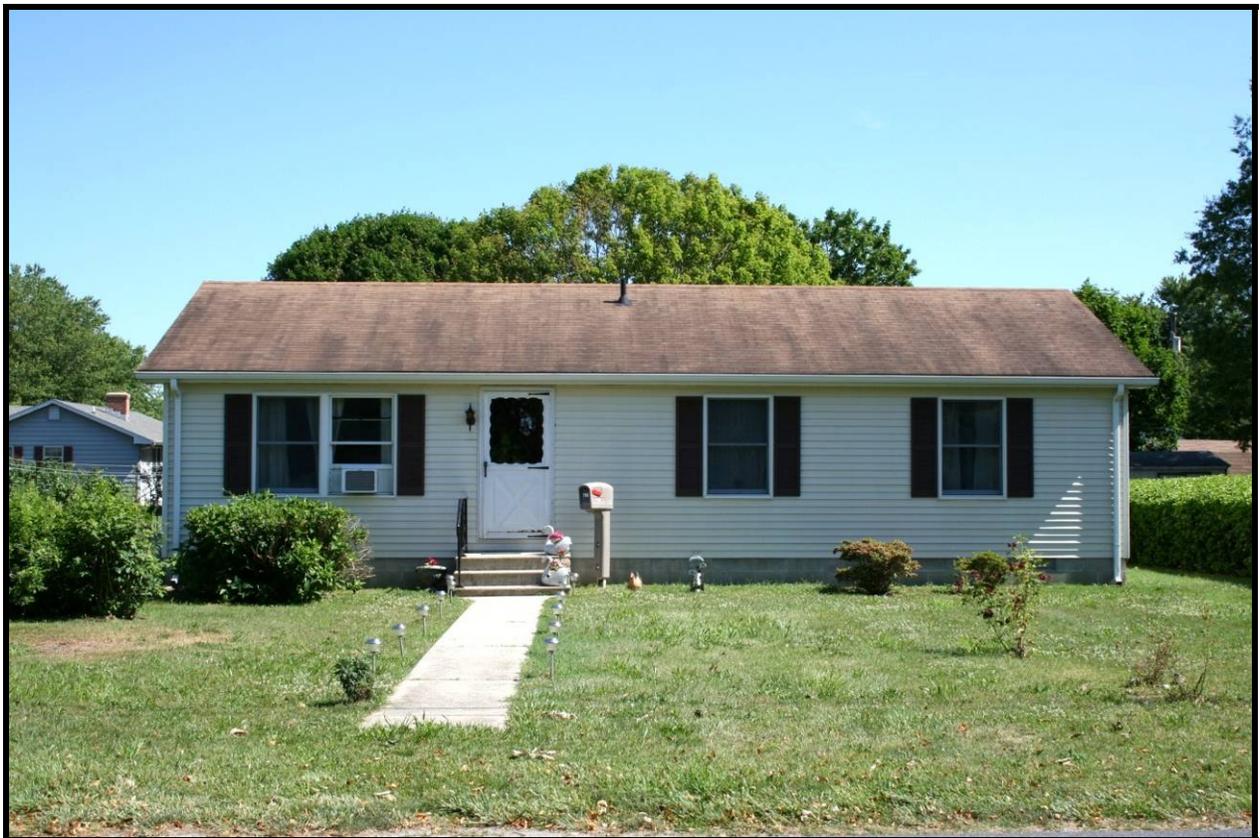
This four-bay, one-story, frame dwelling is an example of the Ranch style with a linear plan and was built between 1968 and 1992. A single door is located in the second bay from the northern corner on the northwest façade, directly to the right of a paired set of one-over-one sash windows; the remaining two bays to the right of the door are occupied with single one-over-one sash windows with louvered shutters. Another side entrance consisting of a single door is located on the northeast elevation of the house. Its gable roof is clad in asphalt shingles and the exterior walls are covered with vinyl/aluminum siding. This dwelling is considered a non-contributing property for the expanded Milton Historic District due to its recent construction date.

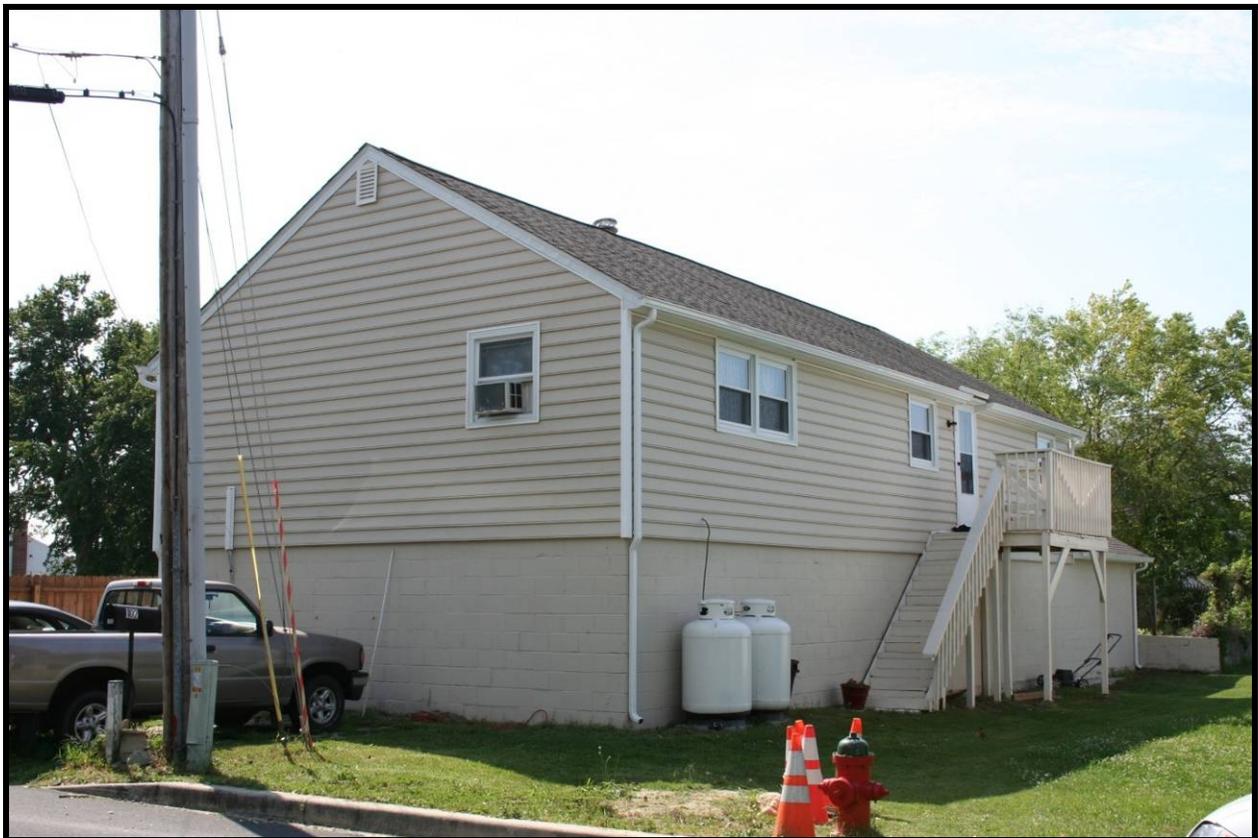
S-11952

This two-story, four-bay, side-gabled Ranch was built between 1968 and 1992. A one-story gable addition is attached to the south/southeast gable end of the main block. This house is unique in that the main entrance and living space is elevated one story, with a tall, practically window-less cinderblock foundation beneath. A wooden staircase leads to the elevated entrance porch and door which is positioned in the third bay from the western corner on the west/southwest side of the house (away from the street). All windows are single one-over-one sash, except for a paired set of windows in the first bay from the western corner on the southwest side. The exterior walls of the second story are covered in vinyl/aluminum siding, while the first story is composed of painted concrete blocks. This dwelling is considered a non-contributing property for the expanded Milton Historic District due to its recent construction date.

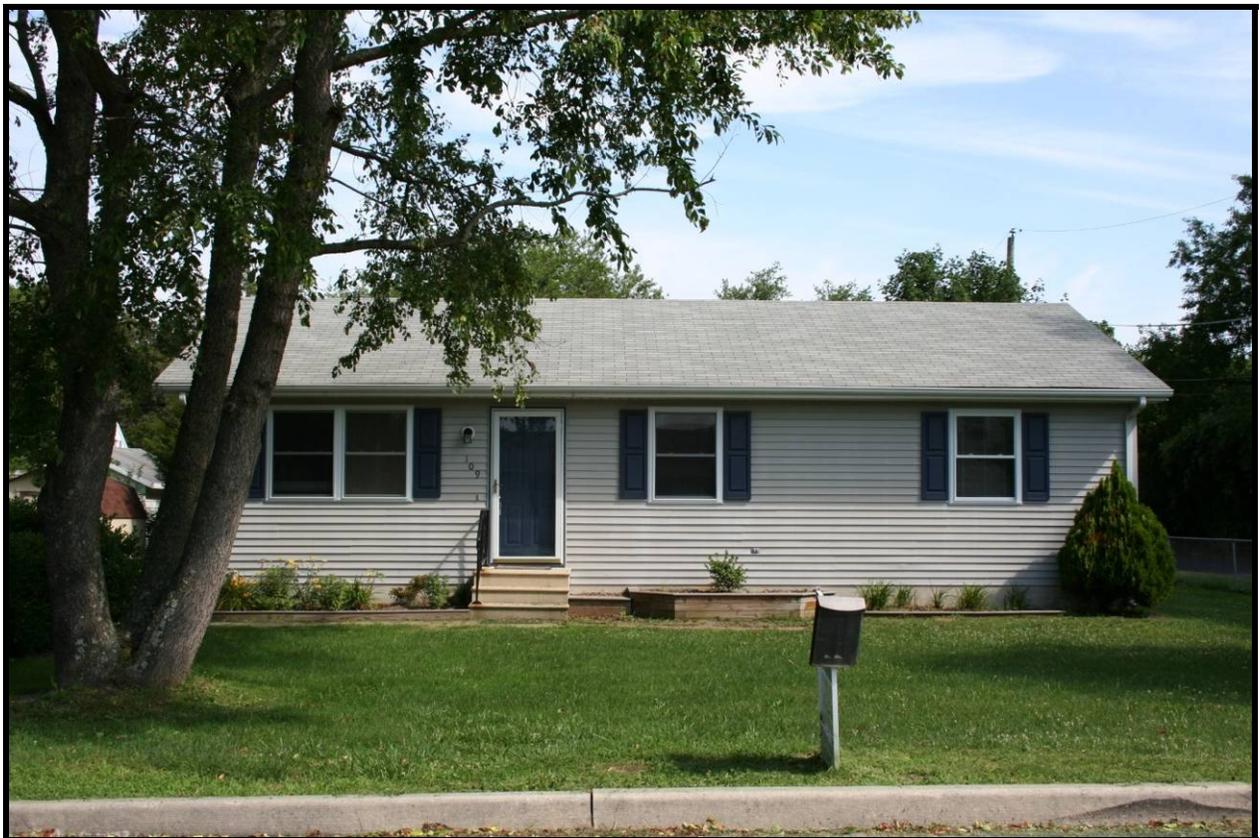
S-11948

This four-bay, one-story, frame dwelling was built between 1992 and 1997 and represents the Ranch style. The main side-gabled block is rectangular in shape and has no visible additions. The raised six-panel front entrance door is located in the second bay from the south corner on the southeast façade. The windows are all single one-over-one sash with raised-panel inoperable shutters, with the exception of a paired set of one-over one sash windows in the first bay from the south corner of the southeast façade and a small one-over-one sash window near the western end of the southwest side which have no decorative shutters. The roof is covered in asphalt shingles and the exterior walls are clad in vinyl/aluminum siding. This dwelling is considered a non-contributing property for the expanded Milton Historic District due to its recent construction date.

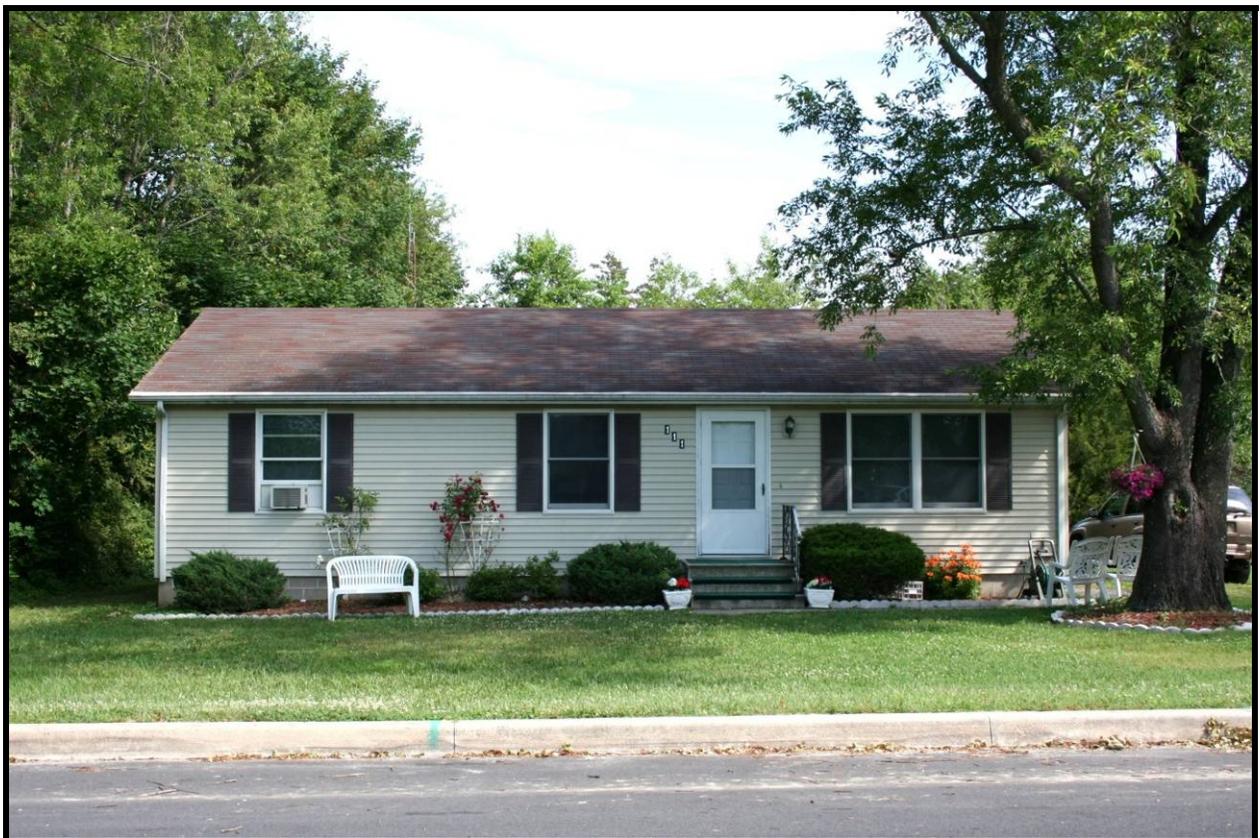
S-11947

This four-bay, one-story, frame Ranch was built between 1992 and 1997. The main side-gabled block is rectangular in shape and has no visible additions. The raised six-panel wooden main entrance door is located in the second bay from the eastern corner of the southeast façade. An additional side entrance occupies the lone bay on the northeast side near the northern corner. The windows are all single one-over-one sash with louvered inoperable shutters, with the exception of a paired set of one-over-one sash windows in the first bay from the eastern corner of the southeast façade. The roof is covered in asphalt shingles and the exterior walls are clad in vinyl/aluminum siding. This dwelling is considered a non-contributing property for the expanded Milton Historic District due to its recent construction date.
