APPENDIX A:
INVENTORY OF SURVEYED
PROPERTIES

MILTON • DELAWARE

APPENDIX A

This appendix begins with a chart of all the resources surveyed in Milton. The chart includes CRS numbers, address, function, style of architecture, the date the property first appears on a historic map, and whether or not the property should be considered contributing or non-contributing to a potential expanded National Register of Historic Places District in Milton or a local historic zone. Following the chart, descriptions of the surveyed resources provide more detailed information on the historic name of the property, function, a brief history, and a physical description of the property. The description also provides a short rationale for the property's recommendation for inclusion or exclusion to the National Register District. Photographs of each main building or resource appear with the descriptions.

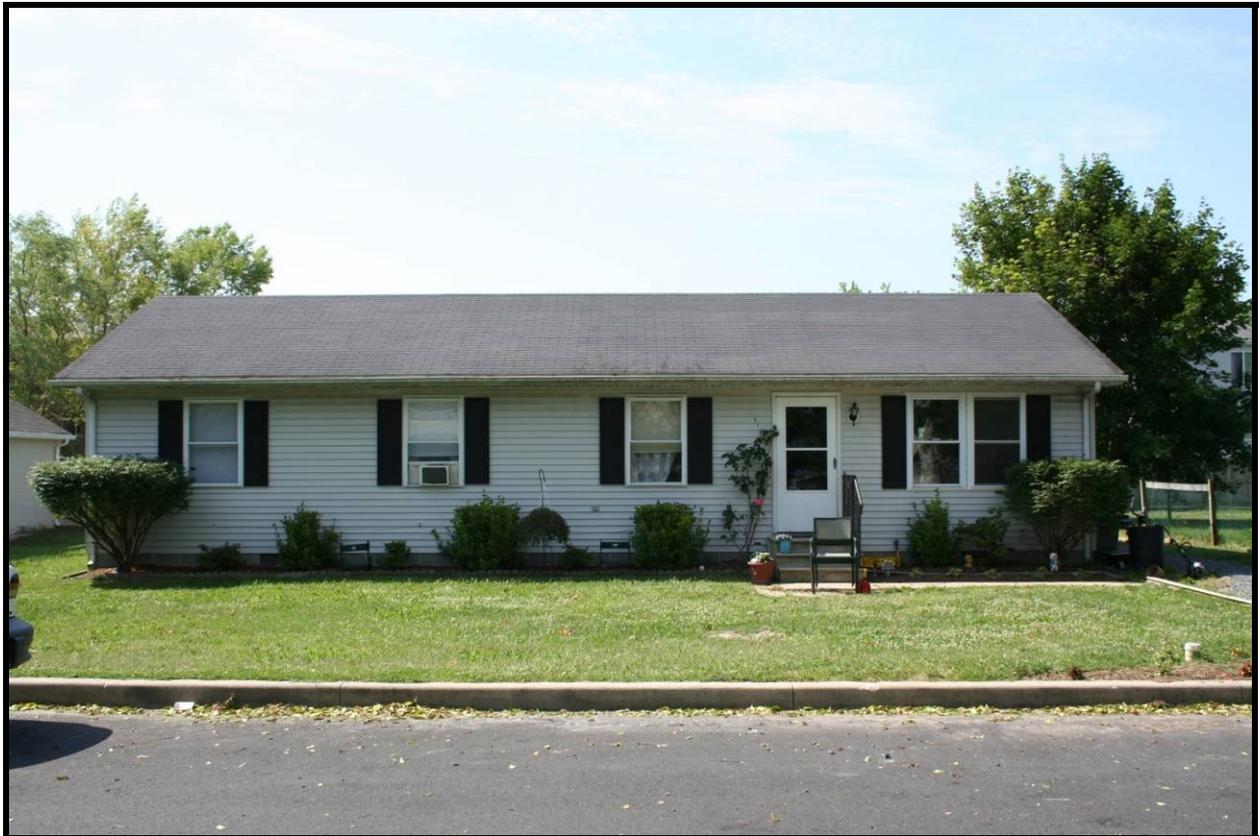
Property Type: Single-Family Dwelling, Ranch style

This five-bay, one-story, frame Ranch was built between 1992 and 1997. The main side-gabled block is rectangular in shape and has no visible additions. The front door located in the second bay from the western corner of the house on the northwest façade is covered by a glazed aluminum storm door. An additional side entrance occupies the second bay on the southwest side near the southern corner. The windows are all single one-over-one sash, with the exception of a paired set of one-over-one sash windows in the first bay from the western corner of the northwest façade. The windows located on the northwest façade are all decorated with louvered inoperable shutters, while the windows on the gable ends are plain. The roof is clad in asphalt shingles and the exterior walls are covered in vinyl/aluminum siding. This dwelling is considered a non-contributing property for the expanded Milton Historic District due to its recent construction date.

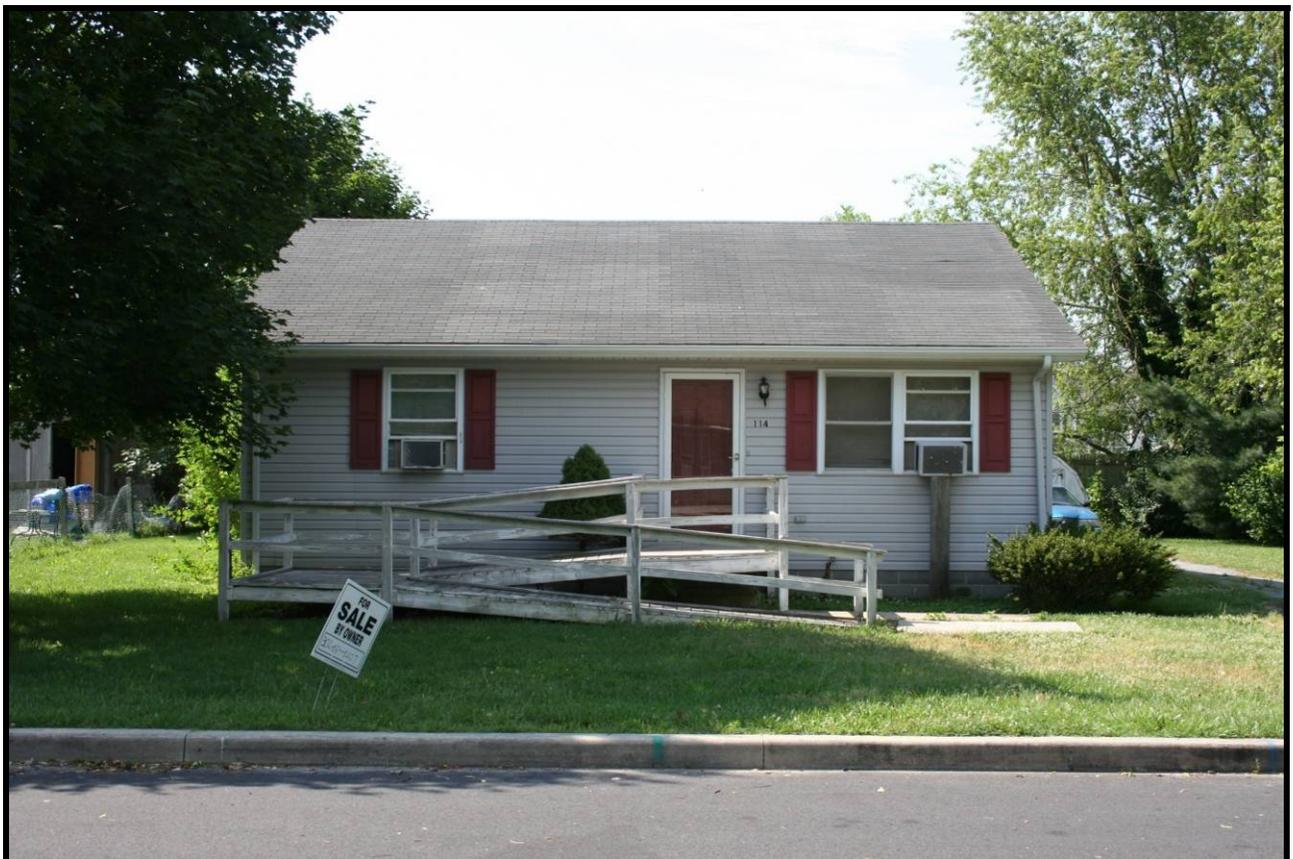
This three-bay, one-story, frame Ranch was built between 1968 and 1992. The main side-gabled block is rectangular in shape and has no visible additions. The front door located in second bay from the northern corner of the house on the northwest façade is covered by a glazed storm door and has a wooden handicapped-accessible ramp. The windows are all single one-over-one sash, with the exception of a paired set of one-over-one sash windows in the first bay from the western corner of the northwest façade. The windows located on the northwest façade are all decorated with louvered inoperable shutters, while the windows on the gable ends are plain. The roof is covered in asphalt shingles and the exterior walls are clad in vinyl/aluminum siding. This dwelling is considered a non-contributing property for the expanded Milton Historic District due to its recent construction date.

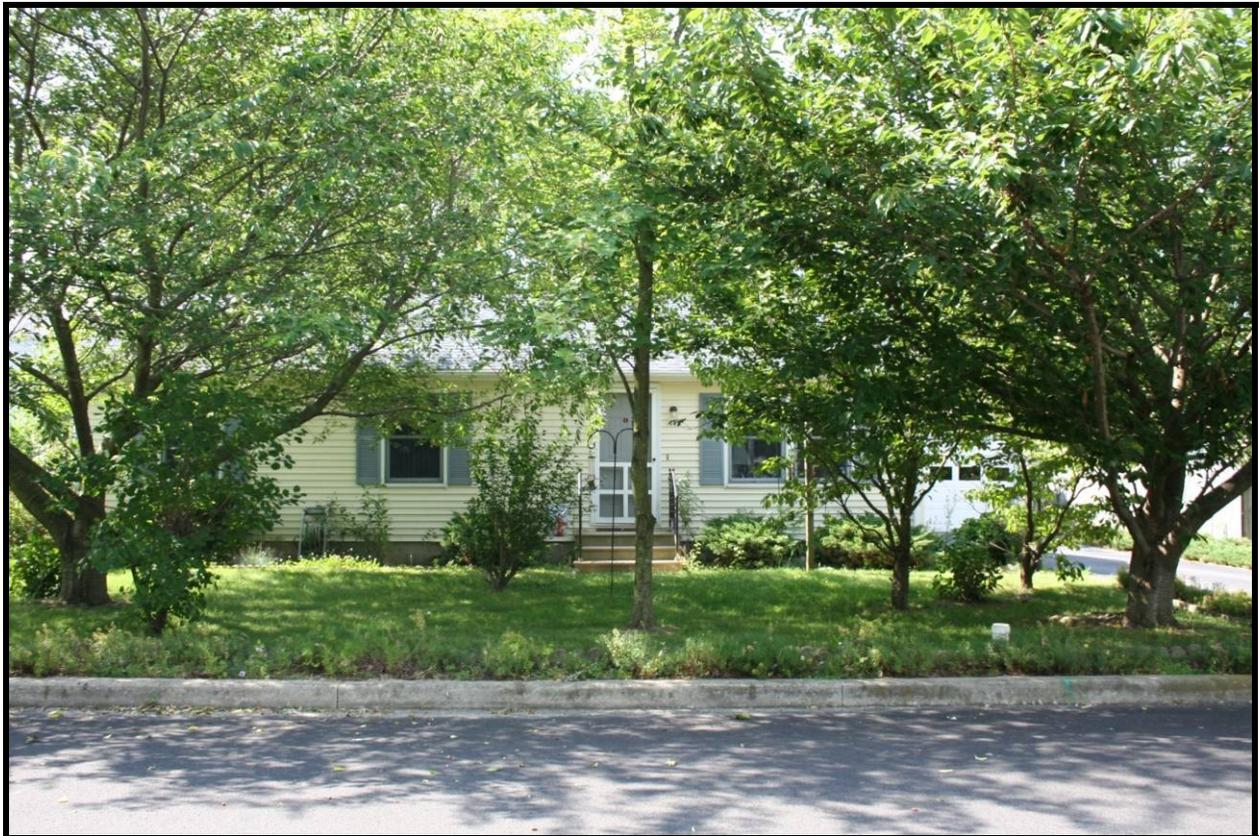
Property Type: Single-Family Dwelling, Ranch Style

This four-bay, one-story frame Ranch was built between 1968 and 1992. The side-gabled main block is rectangular in shape and has no visible additions. The raised six-panel wooden front door with a decorative screen door cover is located in the second bay from the western corner of the house on the northwest façade. The gable ends are plain, except for an additional entrance on the southwest side of the building. The windows are all single one-over-one sash with louvered inoperable shutters, with the exception of a paired set of one-over-one sash windows in the first bay from the western corner of the northwest façade. The roof is clad in asphalt shingles and the exterior walls are covered in vinyl/aluminum siding. This dwelling is considered a non-contributing property for the expanded Milton Historic District due to its recent construction date.

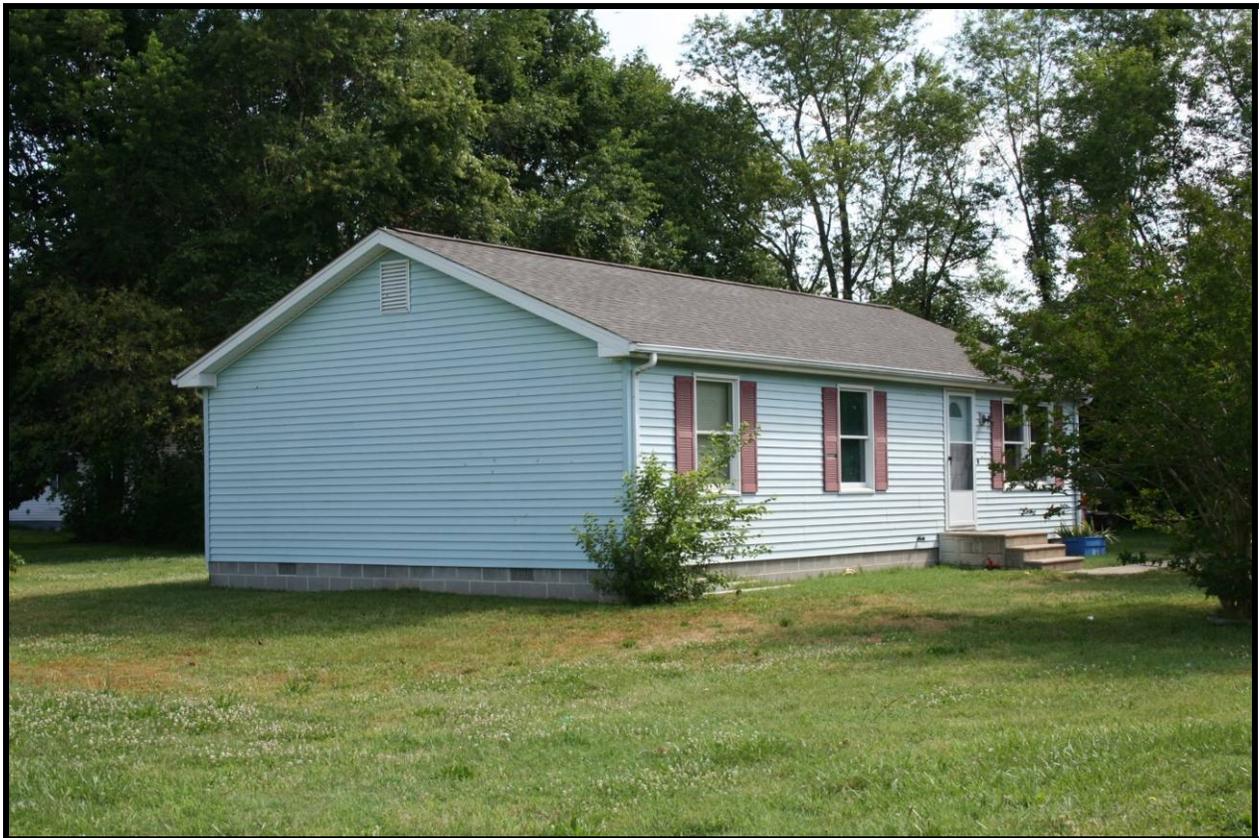
This four-bay, one-story, frame Ranch was built between 1968 and 1992. The side-gabled dwelling is rectangular in shape and has no additions. The raised-panel main entrance door with a decorative fanlight located in the second bay from the eastern corner of the southeast façade is covered by a glazed aluminum storm door. An additional side entrance occupies the lone bay on the northeast side near the northern corner. The windows are all single one-over-one sash with louvered inoperable shutters, with the exception of a paired set of one-over-one sash windows in the first bay from the eastern corner of the southeast façade. The roof is clad in asphalt shingles and the exterior walls are covered in vinyl/aluminum siding. This dwelling is considered a non-contributing property for the expanded Milton Historic District due to its recent construction date.

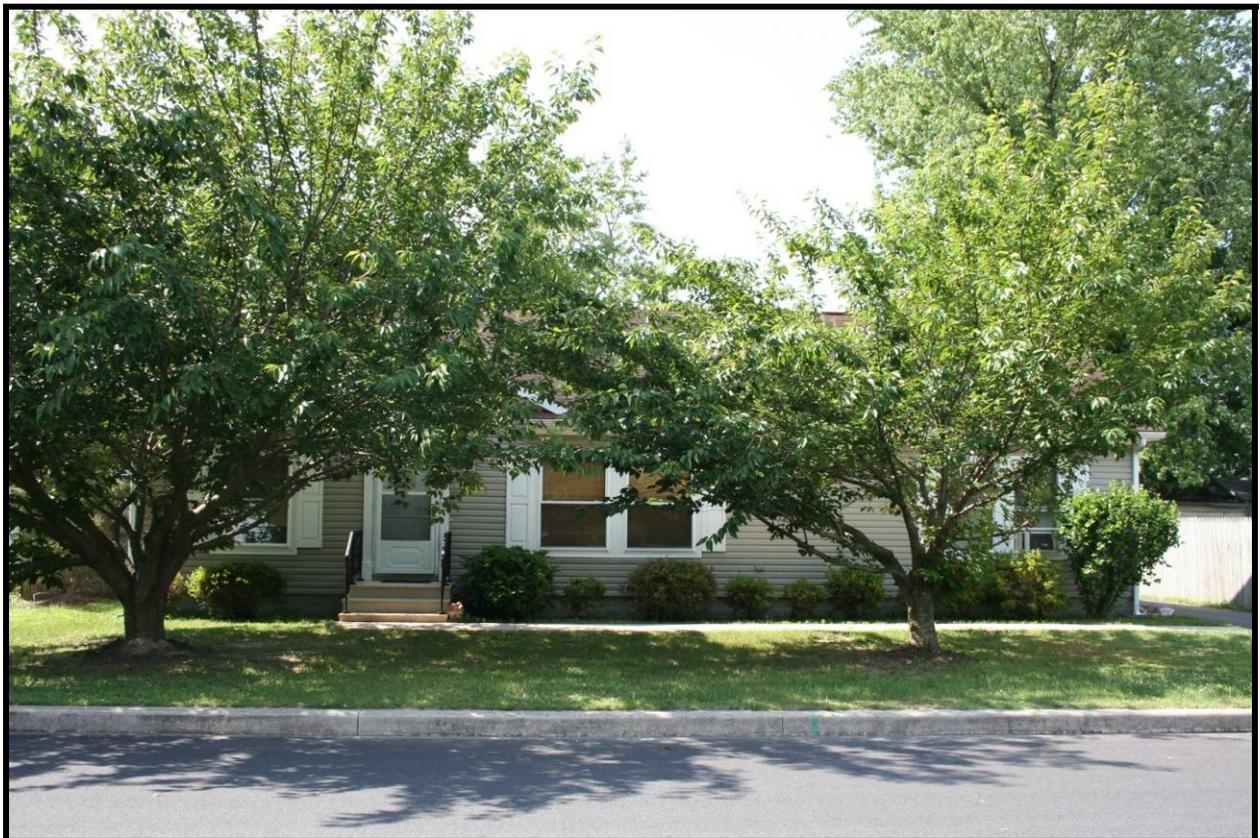
S-11956

This four-bay, one-story, frame Ranch was built between 1992 and 1997. The main side-gabled rectangular block has a centrally positioned cross-gabled addition on the southeast rear as well as a small cross gable roof detail toward the northern corner of the northwest façade. The raised-panel front door is located in the second bay from the northern corner of the house on the northwest façade, directly beneath a small cross gable. A side entrance is located near the southern corner of the house on the southwest side. Two paired sets of one-over-one sash windows with inoperable raised-panel shutters are positioned in the second and third bay from the northern corner of the northwest façade; the remaining windows are one-over-one sash. The roof is clad in asphalt shingles and the exterior walls are covered in vinyl/aluminum siding. This dwelling is considered a non-contributing property for the expanded Milton Historic District due to its recent construction date.

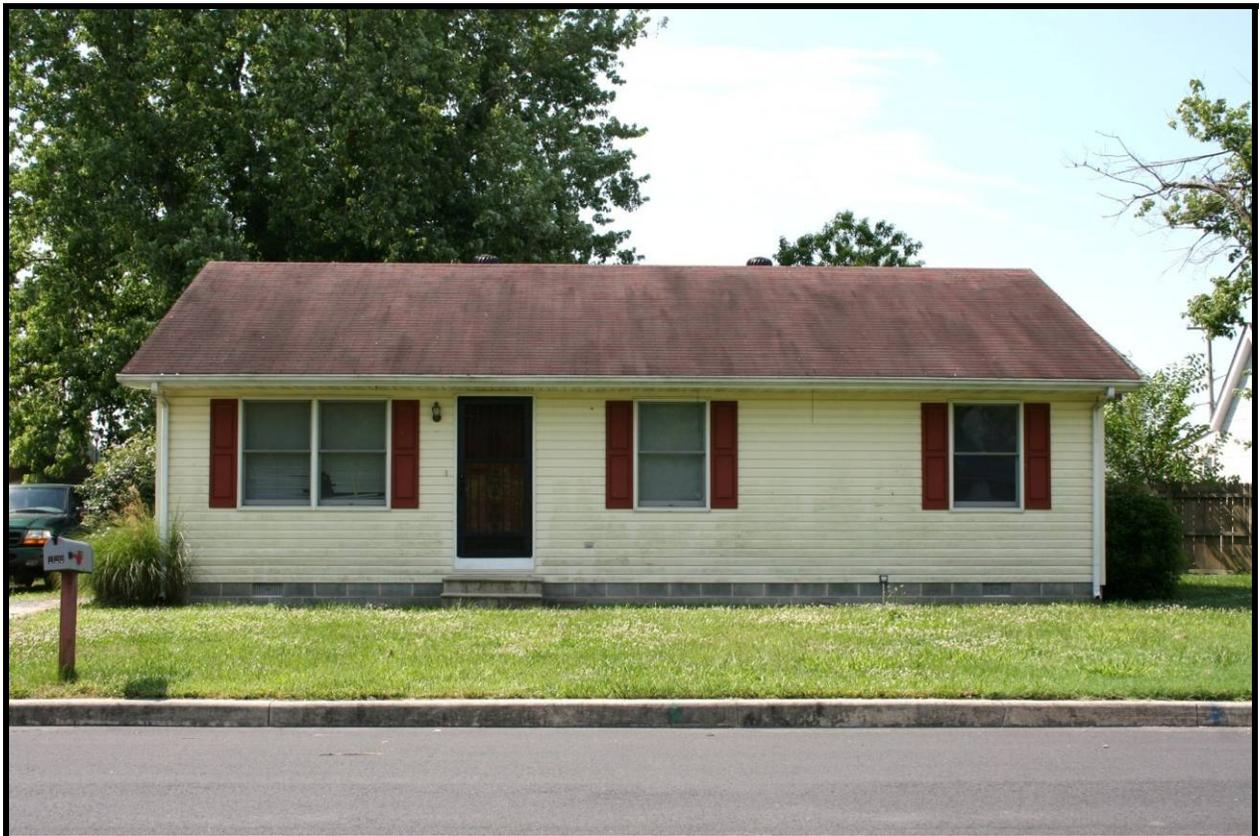
Property Type: Single-Family Dwelling, Ranch Style

This four-bay, one-story, frame Ranch was built between 1992 and 1997. The side-gabled structure is rectangular in shape and has no visible additions. The raised-panel front door located in the second bay from the northern corner on the northwest façade is covered by a protective wrought-iron storm door. An additional entrance occupies the lone bay on the northeast side of the dwelling. The windows are all single one-over-one sash with raised-panel inoperable shutters. The roof is clad in asphalt shingles and the exterior walls are covered in vinyl/aluminum siding. This dwelling is considered a non-contributing property for the expanded Milton Historic District due to its recent construction date.

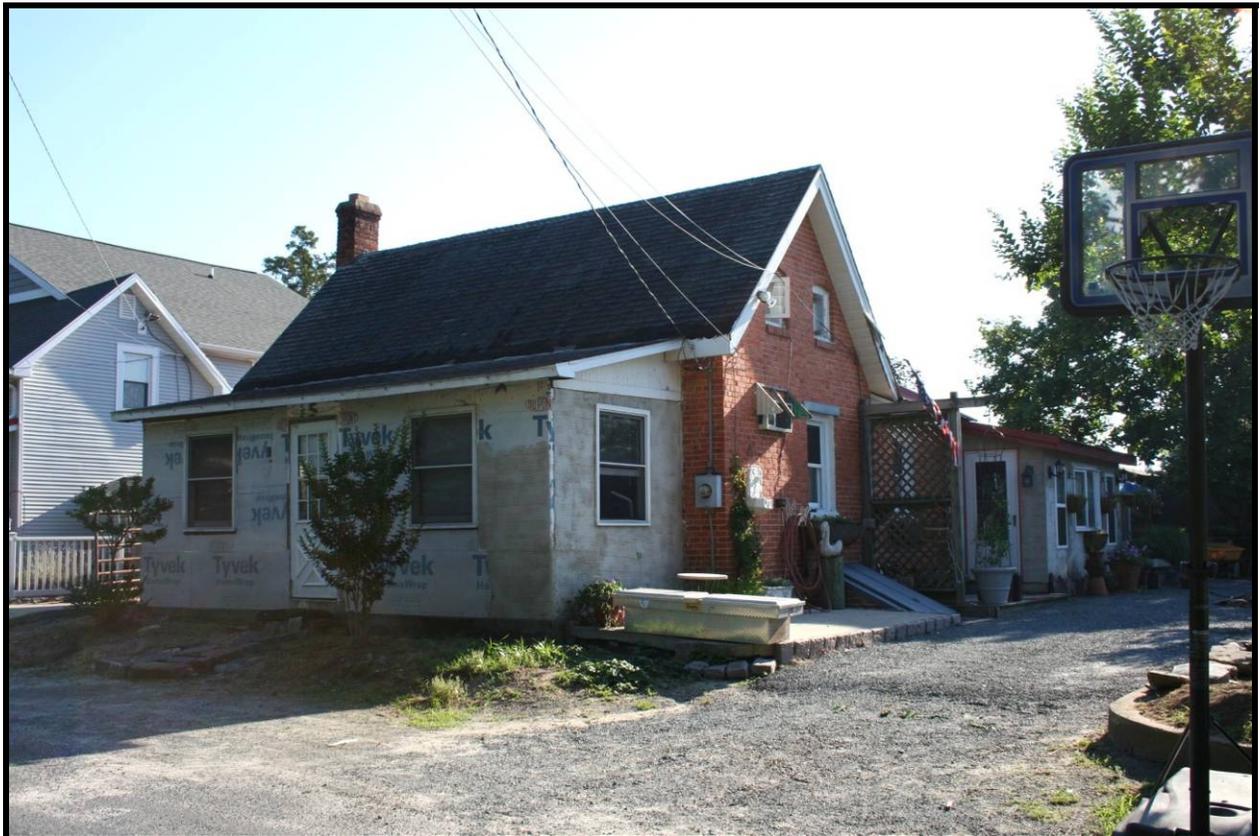
S-12039

205 Carey Street (Parcel #12.00) (1923 Sanborn Map)

Property Type: Single-Family Dwelling, Three-Bay Vernacular

This three-bay, one-and-a-half story home is an example of the Three-Bay Vernacular style and was built between 1911 and 1923. Additions to the home include a large gable block and shed-roofed addition attached to the northeast rear, as well as a recently added shed-roofed entrance which is connected to the southwest front of the main brick side-gable block. A twelve-light door occupies the central bay of the façade and is flanked by a one-over-one sash window on either side. There is a single-door side entrance located on the southwest side of the rear shed roof addition as well as an additional entrance located near the eastern corner of the brick main block. One-over-one sash windows are located on all sides of the house and a single, exterior end-wall brick chimney is centrally positioned on the northwest side of the main block. The exterior walls of the additions are covered in stucco, while the main block has an unpainted red-brick exterior. This dwelling is considered a non-contributing property for the expanded Milton Historic District due to loss of integrity of design and materials.

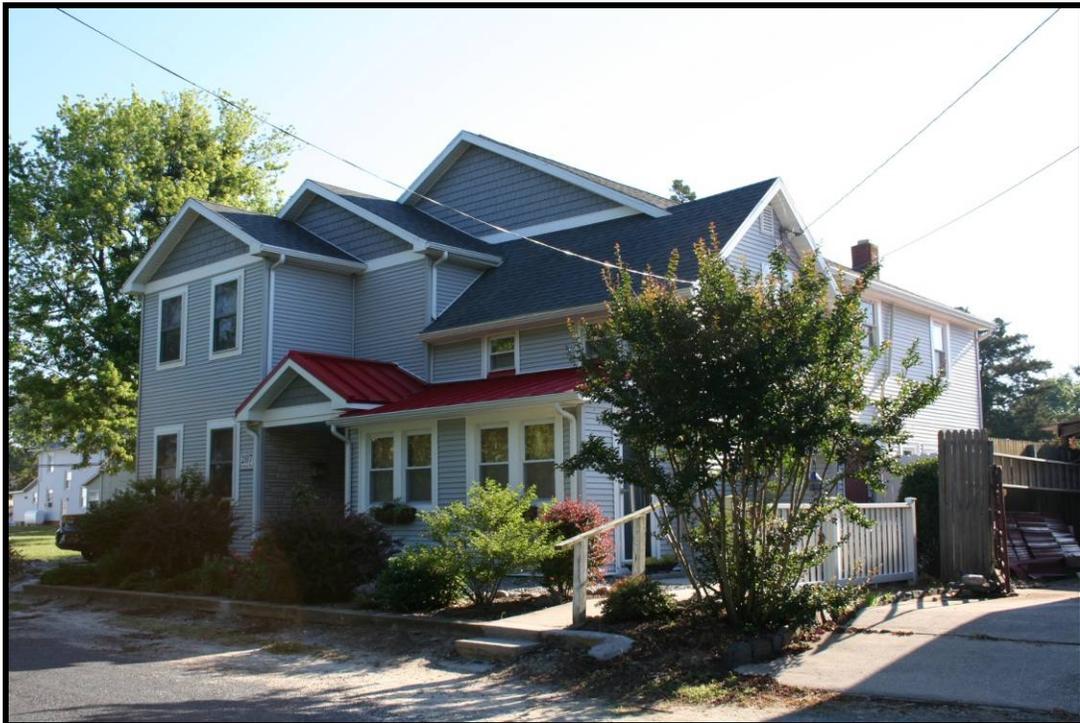
S-12038

207 Carey Street (1954-1992 Aerials, 2007 Aerial)

Property Type: Single-Family Dwelling, Originally a Three-Bay Vernacular Style

This two-story, five-bay, frame dwelling may have originally represented the three-bay architectural style. The house was potentially built circa 1954, since the house on the property between 1954 and 1992 visible in the Datamil Aerial maps resembles the two-story, two-bay (potentially three-bay), side-gabled section connected at the southern corner of the house. This home is either a new house built in 2007, or the older structure was incorporated into the existing house during a renovation. The house has a complex roofline composed of consecutive three-tier front gable ends, a small front-gable entrance porch, a side-gable extension on the southeast side, and a shed-roofed section connected to the southwest side of the side-gable extension. In addition to all of these components, a one-story front-gable wing is connected at the northern corner of the house and wraps around to the northwest rear. All windows are one over one sash, with two paired sets of windows on the southwest side of the shed-roof section and two smaller one-over-one sash windows above on the southwest side of the side-gable wing. The front door has full-length glazing as well as sidelights, while a less elaborate side entrance located on the southeast side of the shed-roof section is solid wood with a glass storm door. The majority of the roof is covered with asphalt shingles, with the exception of the gable entrance porch and the shed roof addition which are covered in standing-seam sheet metal. A single interior chimney is located along the ridge of the main gable block near the northeast end. The four gable aprons on the southwest façade are covered with shaker-style shingles and the exterior walls are covered in vinyl/aluminum siding. This dwelling is considered a non-contributing property for the expanded Milton Historic District due to loss of integrity and the potentially recent construction date.

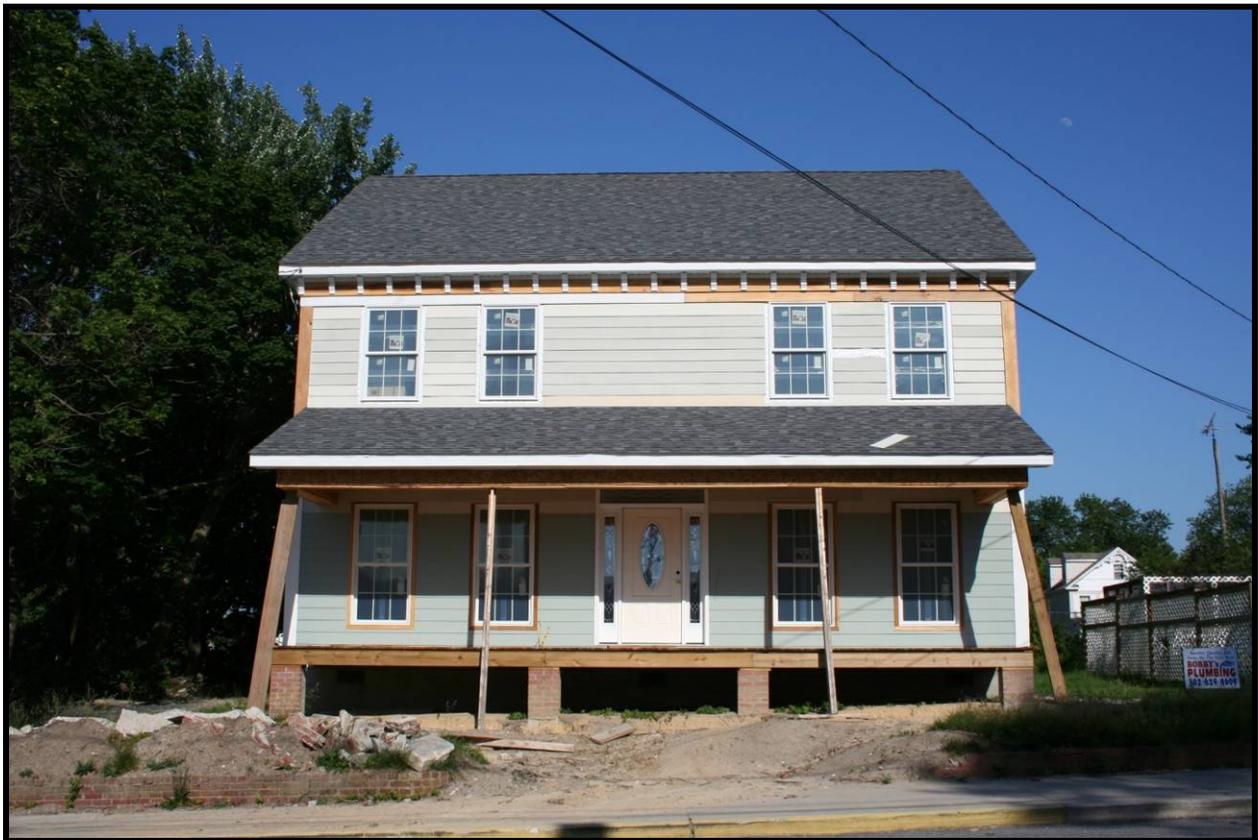
This five-bay, two-and-a-half story home was built in 2008 and resembles the Georgian Revival style. The main side-gable block with returning eaves has a full-width shed-roofed front porch and a shed-roofed wing, which extends off the southeast rear of the building. The windows are all six-over-six double-hung sash, with smaller six-over-six sash windows in the second floor and a paired set of six-over-six sash windows in the uppermost floor on each gable end. The wood-paneled front door with a decorative leaded-glass oval light as well as matching sidelights and transom is centrally positioned on the northwest façade. The boxed cornice is accented with cutwork brackets which extend around all sides of the home. The exterior walls are covered in new clapboard siding and the roof is protected by asphalt shingles. This dwelling is considered to a non-contributing property for the expanded Milton Historic District because it is a new building which is currently under construction.

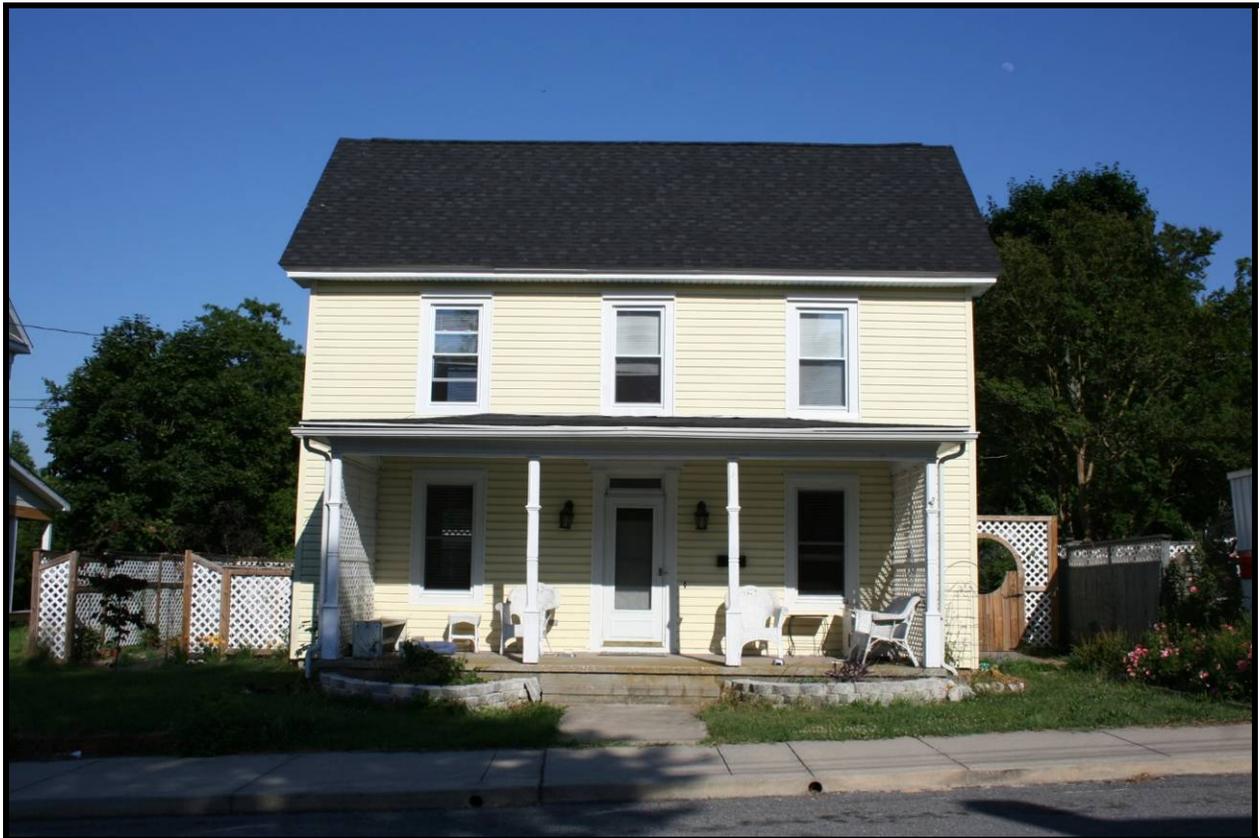
S-12057

This three-bay, two-story frame dwelling was built between 1868 and 1887. The main building features a side-gabled roof and a hipped-roof front porch with four turned-post supports. Two consecutive front-gabled additions have been attached to the rear (southeast) side of the building and a shed-roofed structure is connected to the southwest side of the gable additions. The windows are all one-over-one sash, with two smaller one-over-one sash windows located in the upper story of the gable ends. A single door with a transom is located in the central bay on the northwest façade. The chimney is located toward the northeast end of the larger gable addition directly connected to the main house. The external walls are covered in aluminum siding, with decorative gable aprons composed of wooden shingles on the northeast and southwest gable ends of the main block. This dwelling is representative of the classic Three-Bay Vernacular style which was prevalent in Milton from the mid 19th to the early 20th centuries; it retains integrity of design, location, and setting, making it a contributing historic property for the expanded Milton Historic District.

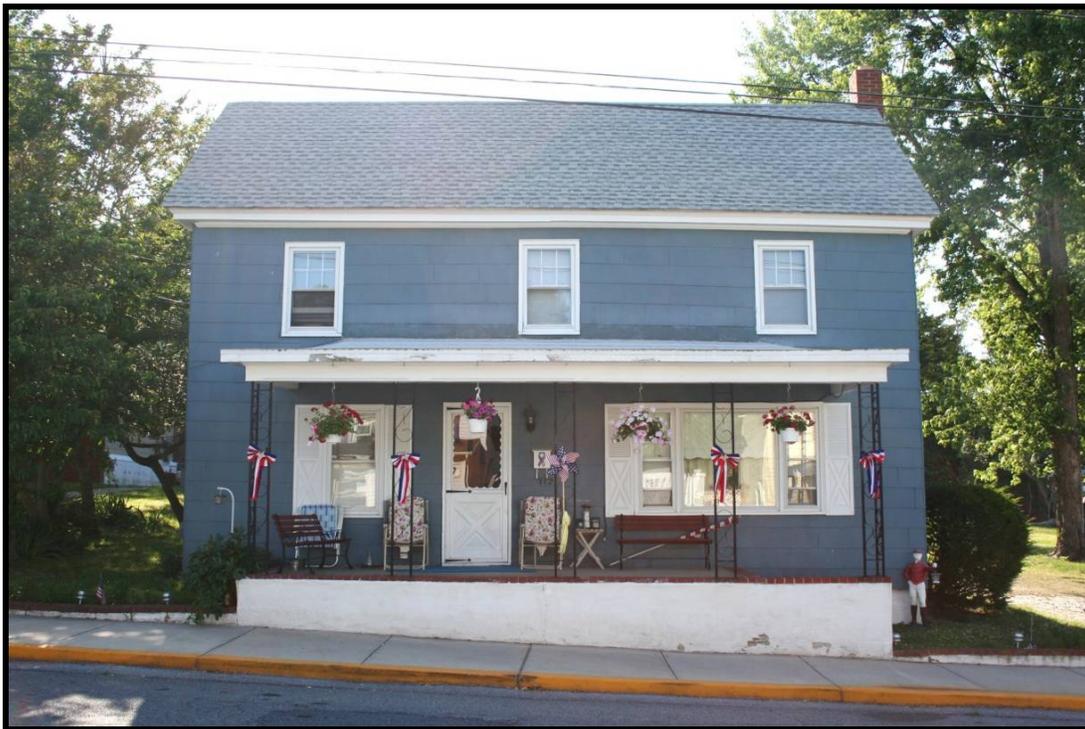
**112 Chestnut Street (W. Fowler House: 1868 Beers Map; J.C. Wilson House: 1887 Map of Milton)
Property Type: Single-Family Dwelling, Three-Bay Vernacular Federal Style**

This three-bay, two-story, frame dwelling was built prior to 1868 and resembles the Federal style. A shed-roofed addition projects off the rear (northwest) side of the house and a hipped-roof porch with five decorative ironwork supports is attached to the southeast façade of the main building. The first floor of the southeast elevation has been altered from its original three-bay configuration to include an off-centered door, a single one-over-one sash window to the south, and a tripartite window to the north (two four-over-one sash windows with a single fixed pane in the middle). The three openings on the second floor remain in their original symmetrical locations and contain six-over-one sash windows. Two small casement windows are located in the upper story on both gable ends of the main building. A single brick end-wall chimney is located on the northeast gable end of the house. The exterior walls are covered with asbestos shingle siding and the roof is covered in asphalt shingles. A one-and-a-half story garage with several windows, louvered shutters, and a corrugated sheet metal roof is located at the rear of the property. A man named W. Fowler owned the property in 1868; there are several men by the name "W. Fowler" listed in the census records during this time. William J. Fowler, who would have been a thirty-year-old white sailor and Delaware native in 1868, and William Fowler, a thirty-nine year old white blacksmith and Delaware native, are the two most probable individuals. By 1887, John C. Wilson, a forty-four year old white Delaware native, former sailor, and house carpenter, owned the home. The dwelling displays features relating to several periods of Milton's architectural development, such as the Three-Bay Vernacular blocks popular during the mid 19th & early 20th centuries as well as the later Federal-style windows; it retains integrity of design, materials, workmanship, location, and setting, making it a contributing historic property for the expanded Milton Historic District.

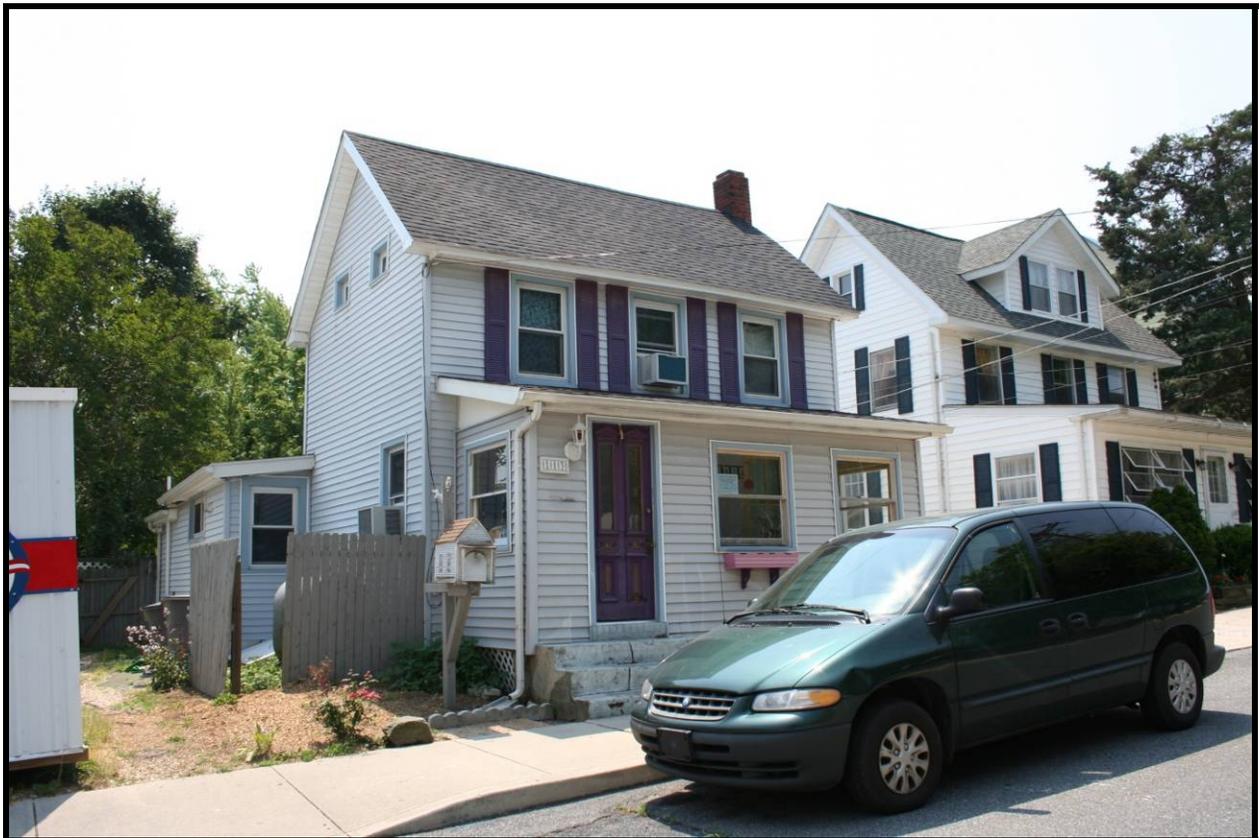
This three-bay, two-and-a-half story frame dwelling was built between 1887 and 1911. The side-gabled main block has an enclosed shed-roofed porch on its west/northwest façade and a two-story gable addition connected to the east/southeast rear. Another smaller shed-roofed addition along with an attached flat-roofed portion is connected at the eastern corner of the rear gable addition, while another shed-roofed addition is attached at the south corner. A decorative four-panel door with Victorian details and glazed upper panels is located in the northwest bay of the façade in the enclosed porch next to two one-over-one sash windows, which are positioned directly to the right of the door. All windows are one-over-one sash, with the exception of small, single-pane upper-story casement windows on the north/northeast and south/southwest gable ends of the main block and another casement window in the north/northeast side of the shed-roofed addition. A brick end-wall chimney is centrally positioned on the southwest gable end and the exterior walls are covered with vinyl/aluminum siding. This dwelling is representative of the classic Three-Bay Vernacular style which was prevalent in Milton from the mid 19th to the early 20th centuries; it retains integrity of design, materials, workmanship, location, and setting, making it a contributing historic property for the expanded Milton Historic District.

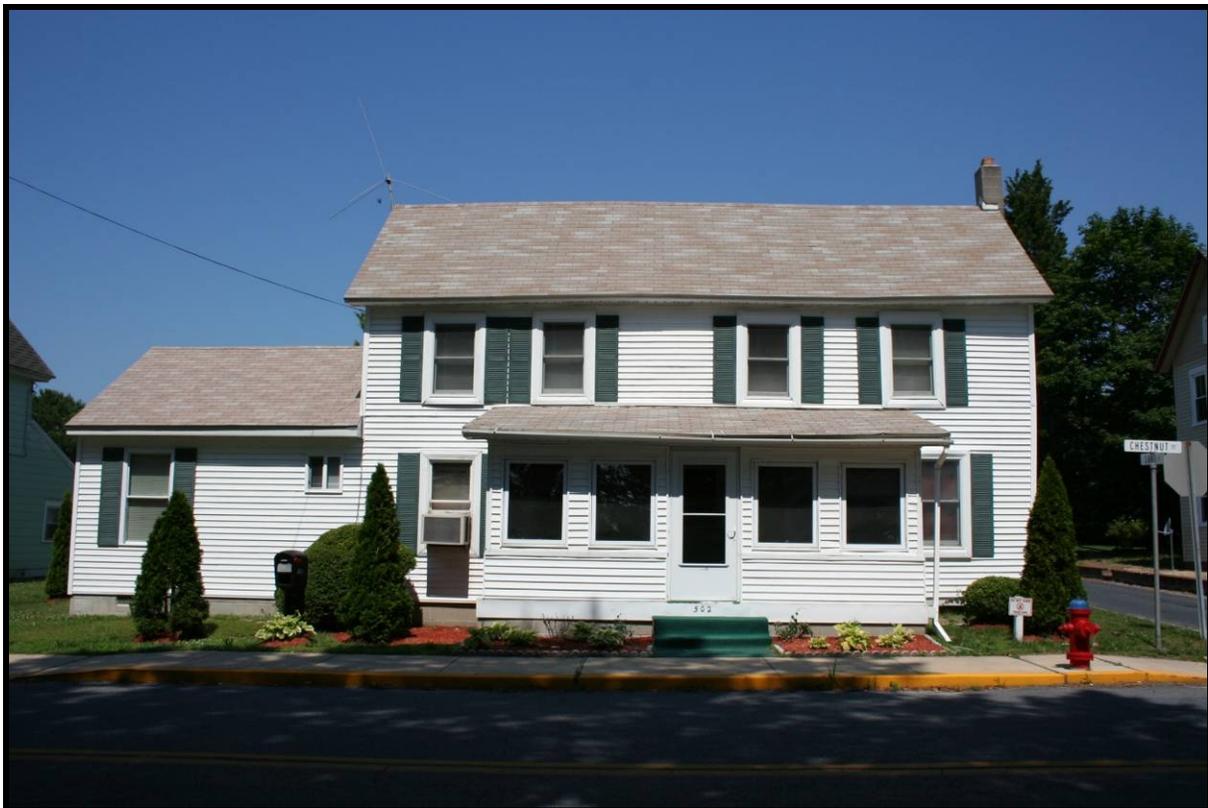
**502 Chestnut Street (W. Lindle House: 1868 Beers Map; Heirs of W. Lindle: 1887 Map of Milton)
Property Type: Single-Family Dwelling, Gable-Roofed Vernacular**

This nine-bay, two-and-a-half story, frame dwelling was built prior to 1868. Its main side-gabled block features a shed-roofed enclosed front porch on the east/southeast elevation, a one-story gable addition on the southwest gable end, and a rear one-story gable ell with a shed-roofed side addition on the northwest rear. A single door is centrally positioned in the façade in the enclosed front porch and a rear exit is located in the northwest side of the one-story rear gable ell. The majority of the windows are one-over-one sash with green louvered shutters, with the exception of six single-pane casement windows in the enclosed front porch addition (as well as one in the rear gable ell), four-pane casement windows in the upper-story of the northeast and southwest gable ends, two four-pane casement windows in the northwest side of the rear gable addition, and a single two-pane horizontal sliding window in the east/southeast side of the southwest gable addition. A cinderblock chimney is centered along the northeast gable end wall and another smaller cinderblock chimney is attached to the shed-roofed portion of the rear gable ell (northeast side). The exterior walls are covered in vinyl/aluminum siding and the roof exhibits multi-colored asphalt shingles. A man named W. Lindle owned the property in 1868, which was later left to his heirs in 1887. W. Lindle is most likely William W. Lindle, a fifty-two year old white male laborer and Delaware native. This dwelling is considered a non-contributing property for the expanded Milton Historic District due to loss of integrity of design.

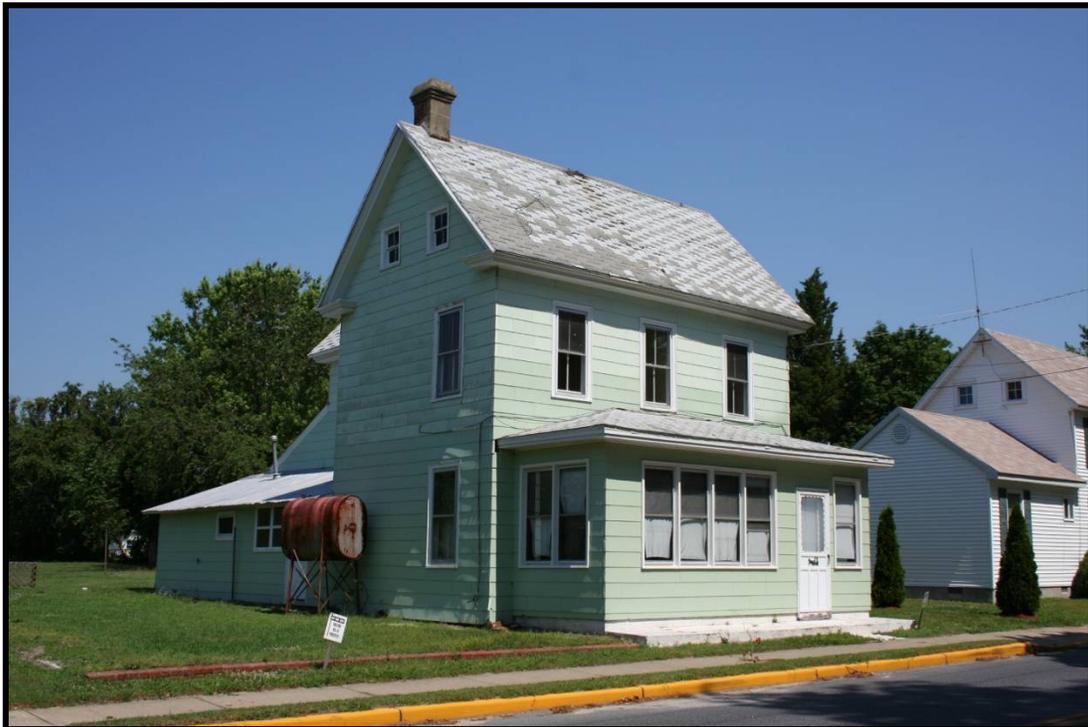
S-12113

504 Chestnut Street (1911 Sanborn Map)

Property Type: Single-Family Dwelling, Three-Bay Vernacular Italianate Style

This three-bay, two-and-a-half story house was built between 1887 and 1900 and exhibits elements of the Italianate style. The main side-gabled block with partially returning eaves has numerous additions, including an enclosed hipped-roof porch on the east/southeast façade, a two-story gable rear addition, a shed-roofed section which is fully integrated into the rear gable block, and another shed-roofed addition with a corrugated sheet metal roof, which is located on the southwest side of the rear gable addition. Doors are visible on every side of the house (possibly the rear as well) in the slightly off-center middle bay of the enclosed porch, the third bay on the southwest side of the shed-roof addition, and the second (potentially third) bay on the northeast side of the rear gable-roof addition. The windows in the main side-gable block are all two-over-two sash, with smaller two-over-two sash windows in the upper story and a decorative gothic-style two-over-two pointed arch window on the northeast side. The enclosed front porch has paired sets of one-over-one sash windows on either side and a set of four one-over-one sash ribbon windows on the east/southeast façade. The other additions all have one-over-one sash windows as well, with the exception of a small single-pane casement window located in the shed-roofed addition on the southwest side. A cement/plaster covered brick chimney with a decorative cap is located on the southwest interior ridge of the main side-gable block. The exterior walls are covered with asbestos shingle siding and the roof exhibits uniquely shaped asphalt shingles. The dwelling is an excellent example of the Three-Bay Vernacular Italianate style which was popular from the late 1860s to the early 1920s; it retains integrity of design, materials, workmanship, location, and setting, making it a contributing historic property for the expanded Milton Historic District.

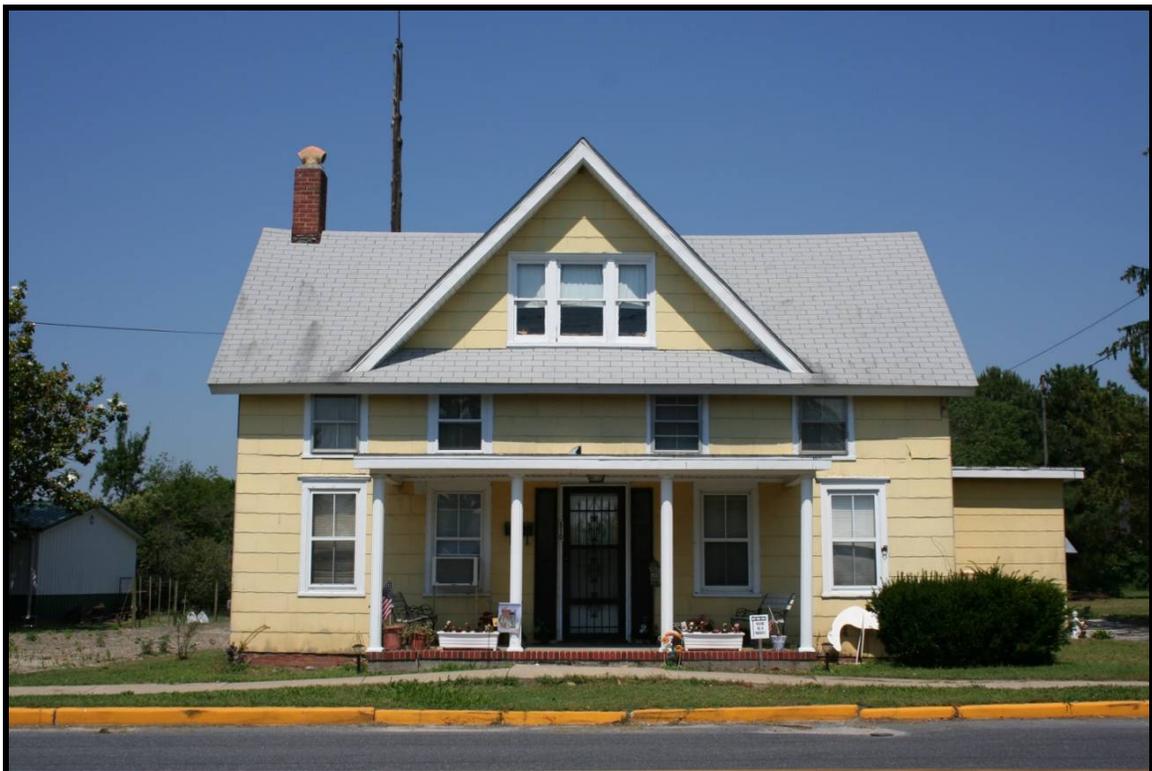
S-12112

510 Chestnut Street (J.M. Hall House: 1868 Beers Map)

Property Type: Single-Family Dwelling, Eclectic mixed style—Gothic Revival & Greek Revival Detailing

This five-bay, two-and-a-half story frame dwelling was built prior to 1868. The building appears to have experienced a major expansion, likely in the 19th century, which included installing a cross-gabled dormer on the southeast elevation, a shed-roofed porch with four fluted-column supports, and a two-and-a-half story cross-gabled addition ell on the northwest rear. There are three additions to the rear ell: a shed-roofed addition on the southwest side, a one-story gable-roofed addition on the northwest, and a flat-roofed addition on the northeast side. The windows on the first and second floor are all two-over-two sash, while the front dormer has a set of three one-over-one windows and the flat-roofed addition has a bay window on the northeast side. The front door is covered by an ornate wrought-iron storm door with full-length louvered shutters on either side. An interior chimney is located along the ridge near the southwest end of the main gable block as well as near the northwest gable end of the two-and-a-half story rear gable addition. The exterior walls are covered in asbestos shingles and the roof is a mix of asphalt shingles on the main blocks and standing-seam sheet metal on the rear one-story gable addition as well as the northwest shed-roofed addition. John M. Hall, a forty-seven year old white male house carpenter and Delaware native, owned the house in 1868. The dwelling's eclectic mixed style of Gothic Revival and Greek Revival detailing encompasses several periods of Milton's architectural history during the early 20th century; it retains integrity of design, materials, workmanship, location, and setting, making it a contributing historic property for the expanded Milton Historic District.

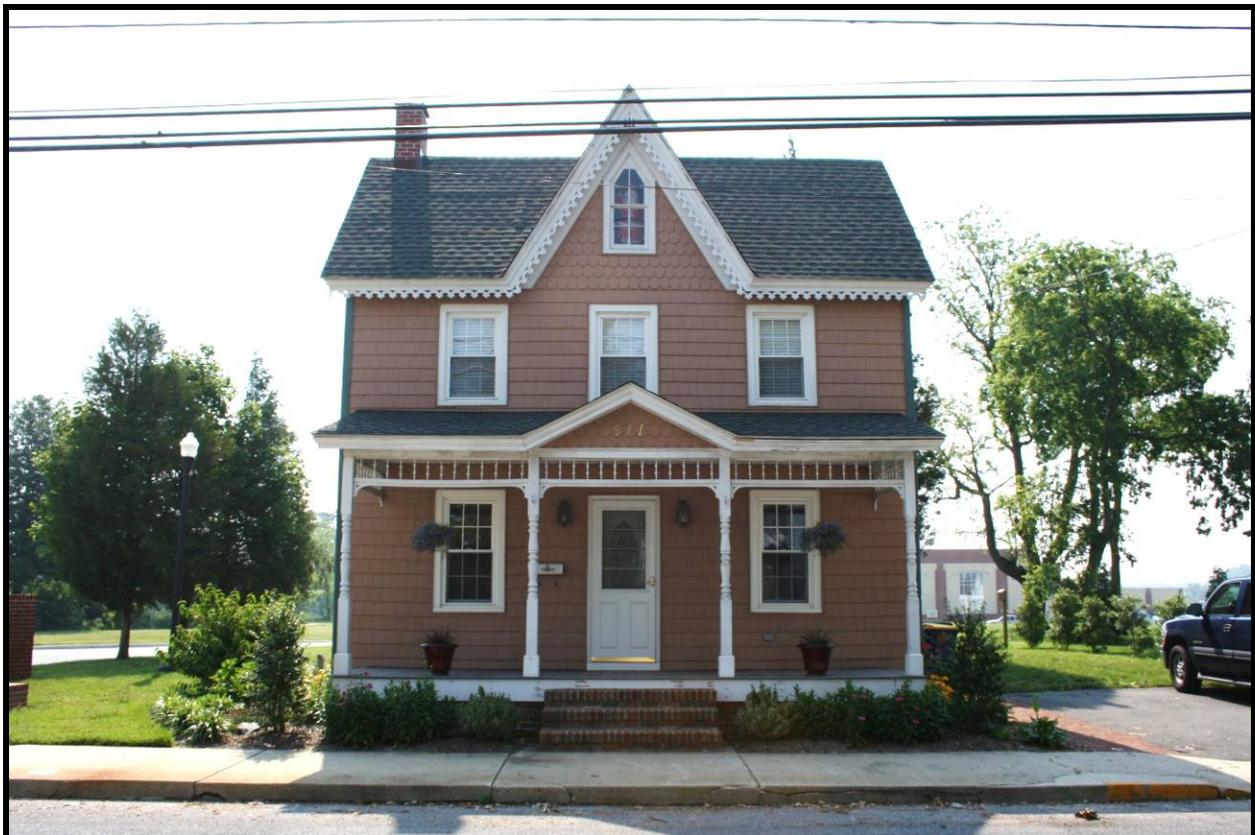
S-12139

511 Chestnut St (1887 Map of Milton)

Property Type: Single-Family Dwelling; Gothic Revival Style

This three-bay, two-and-a-half story, cross-gabled, frame Gothic Revival style dwelling was constructed between 1868 and 1887. It features a one-and-a-half story dropped gable rear addition and a southwest shed-roofed porch with decorative posts. The northwest elevation has a full-length shed-roofed wooden porch with a central cross-gable, decorative posts, and scroll work under the roof line. The front door has an oval light and is flanked by two windows. All of the windows on the northwest elevation are six-over-six sash, with exception to a decorative four-over-four peak head attic level window. The southwest side has two attic level windows; one is four-over-four sash and the second is covered by a louvered vent. The northeast side also has two four-over-four sash attic level windows as well as two six-over-six sash windows located on the rear addition. The rear southeast façade has a single four-over-four sash windows and double four-pane casement windows located on the rear addition. An interior chimney is located on the northeast ridge and the roof is covered with asphalt shingles. The exterior is clad with wooden clapboard and fish-scale shingles under the gable and shed-roofed ends. The cross-gabled roof and pointed-arch window of this dwelling are characteristic of the numerous Gothic Revival homes constructed throughout Milton during the late 19th and early 20th centuries. This dwelling retains integrity of location, setting, design, workmanship, materials, and feeling, making it a contributing historic property for the expanded Milton Historic District.
