APPENDIX A:
INVENTORY OF SURVEYED
PROPERTIES

MILTON • DELAWARE

APPENDIX A

This appendix begins with a chart of all the resources surveyed in Milton. The chart includes CRS numbers, address, function, style of architecture, the date the property first appears on a historic map, and whether or not the property should be considered contributing or non-contributing to a potential expanded National Register of Historic Places District in Milton or a local historic zone. Following the chart, descriptions of the surveyed resources provide more detailed information on the historic name of the property, function, a brief history, and a physical description of the property. The description also provides a short rationale for the property's recommendation for inclusion or exclusion to the National Register District. Photographs of each main building or resource appear with the descriptions.

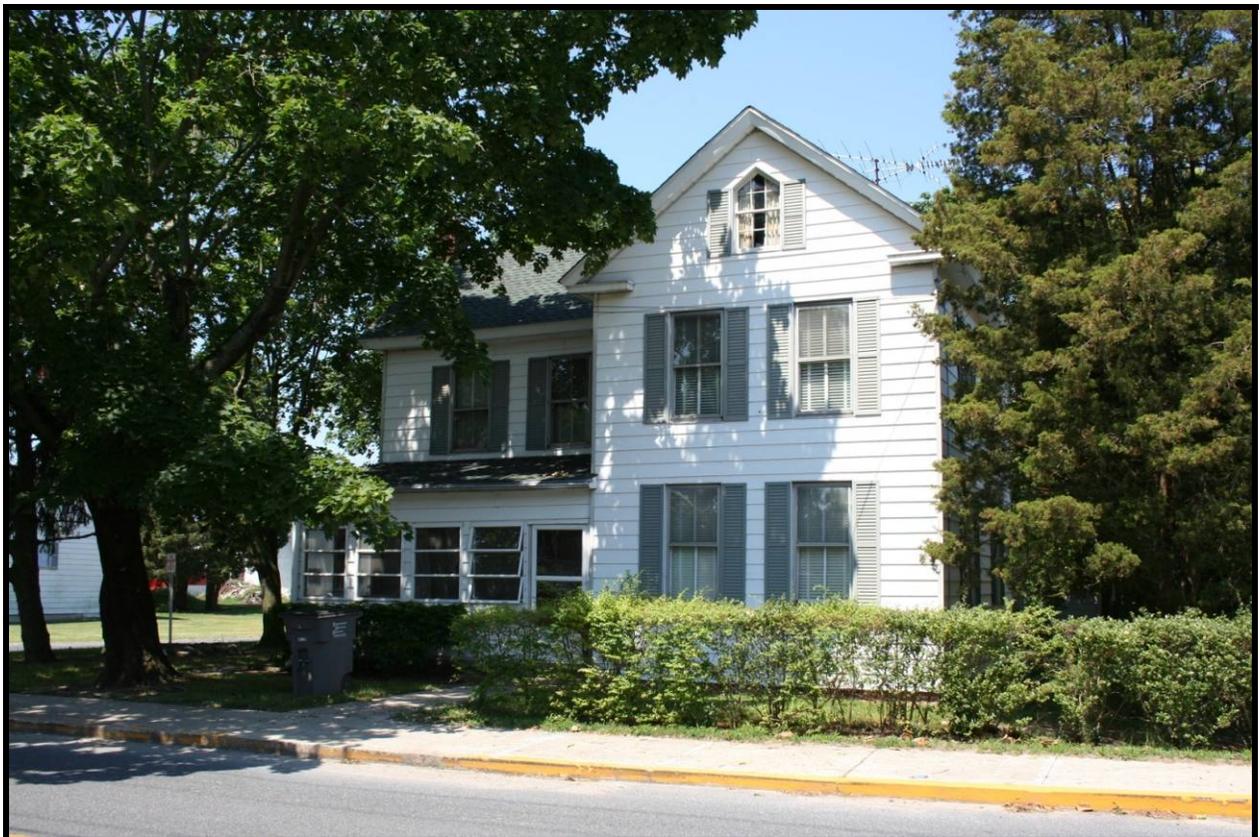
This two-and-a-half story, seven-bay dwelling was built between 1868 and 1887 exhibits characteristics of Queen Anne, Italianate, and Gothic Revival styles, specifically the L-shaped Queen Anne form, Gothic arched façade window, and two-over-two windows common in Italianate architecture. The main L-shaped block has multiple additions, including a shed-roofed enclosed front porch and a long, narrow gable-roofed rear (west/northwest) addition with an attached shed-roofed extension. The enclosed front porch consists of six tri-partite casement windows and a glass storm door (the original configuration of the windows and doors in the house is no longer visible due to the porch). The rest of windows are all two-over-two sash with louvered shutters, with the exception of a decorative six-over-six sash pointed-arch window on the east/southeast façade and two one-over-one sash windows on the south/southwest side of the rear gable addition. Two more doors are located along the south/southwest side of the building in the first and sixth bay from the west corner. A single brick chimney is located on the south/southwest end-wall of the main gable block. The walls are covered in wide vinyl/aluminum siding and the roof is clad in asphalt shingles. This dwelling exhibits characteristics of multiple styles popular throughout Milton in the late 19th and early 20th centuries; it retains integrity of design, materials, workmanship, location, and setting, making it a contributing historic property for the expanded Milton Historic District.

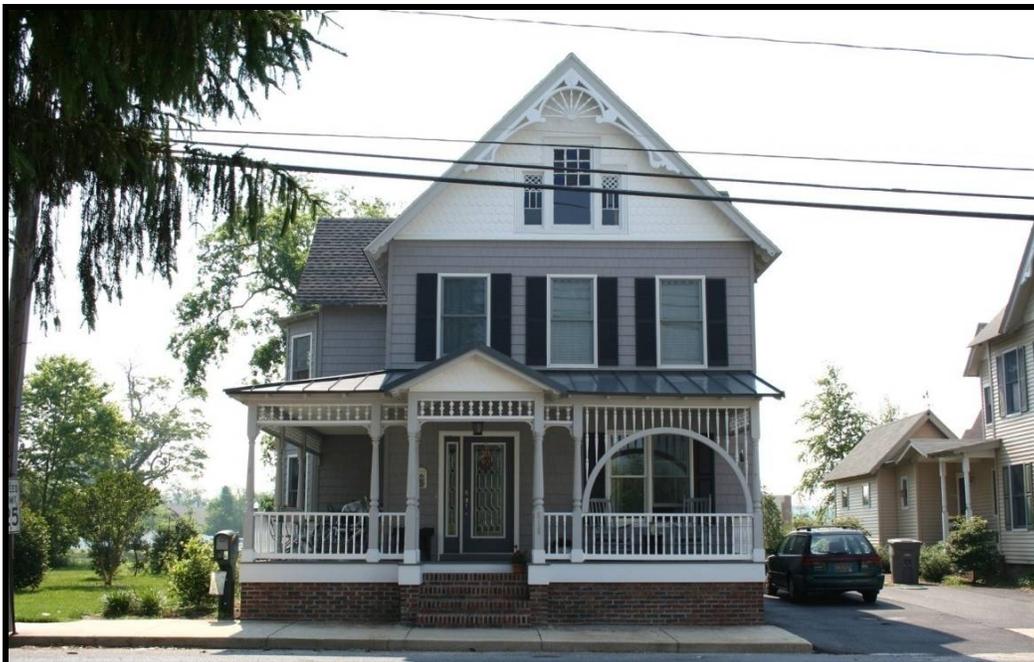
Property Type: Single-Family Dwelling, Queen Anne Style

This two-bay, two-and-a-half story Queen Anne style frame dwelling was built between 1887 and 1911. Its main front-gabled block features a selection of the ornate woodwork common on Milton's main thoroughfares: a decorative gable apron with ornate bargeboard trim, and a hipped-roof wrap-around porch with numerous carved wooden accents, ten turned-post supports, and a wooden railing which runs the full length of the porch. The south/southwest side of the house features a decorative cross-gable wall dormer with the same decorative elements which adorn the gable end of the façade. A shed-roofed addition with a cross-gabled accent over the door is also positioned near the south corner of this side. The house has two consecutive two-story gable sections of slightly different size which extend off the east/southeast rear of the structure. Along the north/northeast side of the building there is a one-story shed-roofed block near the rear, the continuation of the wrap-around front porch which culminates at the centrally-positioned cross-gabled extension, and a half-hexagonal tower centered below the decorative cross-gabled wing which exhibits the same gable apron and bargeboard accents as the front and south/southwest gable ends. The majority of the windows are one-over-one sash with louvered shutters, with the exception of an elaborate spider web oval window on the north/northeast side, a double casement window on the south/southwest side, and decorative upper-story Palladian style windows located in every gable end, which have a nine-over-one center window and two flanking windows composed of twelve diamond lights positioned over three vertical panes which are over one solid pane. The elaborate diamond-patterned lead-glass front door with matching sidelight (on left) is located in the far left bay of the north/northwest façade. A second, plain-panel door with a single light is located on the south/southwest side of the house in the fourth bay from the west/southwest corner. The exterior walls are covered with vinyl/wood shingle siding, with fish-scale shingles decorating the gable aprons. This dwelling, with its Queen Anne style ornamental details, exemplifies the master craftsmanship of the Victorian homes built in Milton from the late 1860s to the early 1920s; it retains integrity of design, materials, workmanship, location, and setting, making it a contributing historic property for the expanded Milton Historic District.

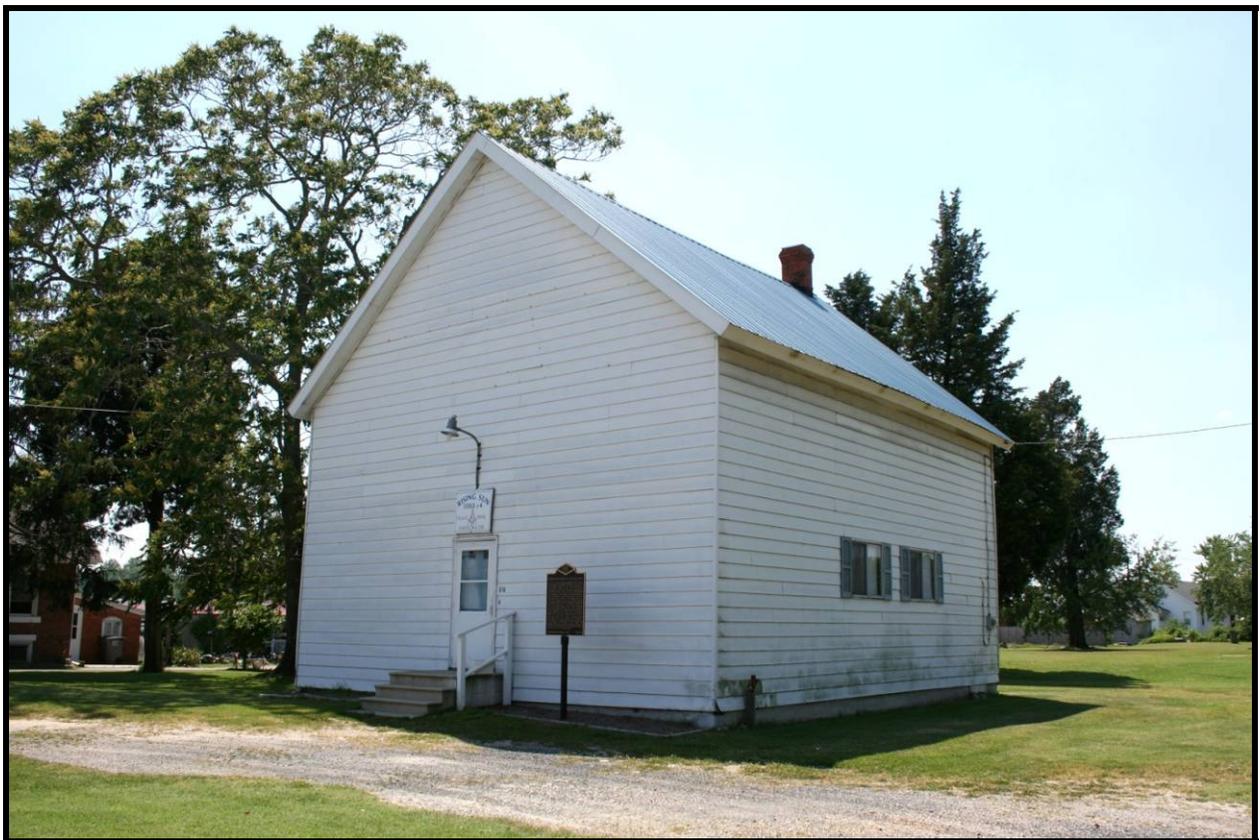
The Rising Sun Lodge is a plain, two-story, one-bay frame structure with a front-gable roof which was built prior to 1868. A single door with two top lights and a glazed aluminum storm door is centrally positioned on the southeast façade atop three concrete steps. The northeast side of the lodge has two sets of horizontal sliding windows with louvered inoperable shutters. The northwest rear contains no openings. An interior brick chimney is located along the ridge near the northwest end of the roof. The roof has a boxed cornice and is covered in standing seam sheet metal, while the exterior walls are clad in vinyl/aluminum siding. The building was used as a school in 1887 and is considered a non-contributing property for the expanded Milton Historic District due to loss of integrity in design and materials.

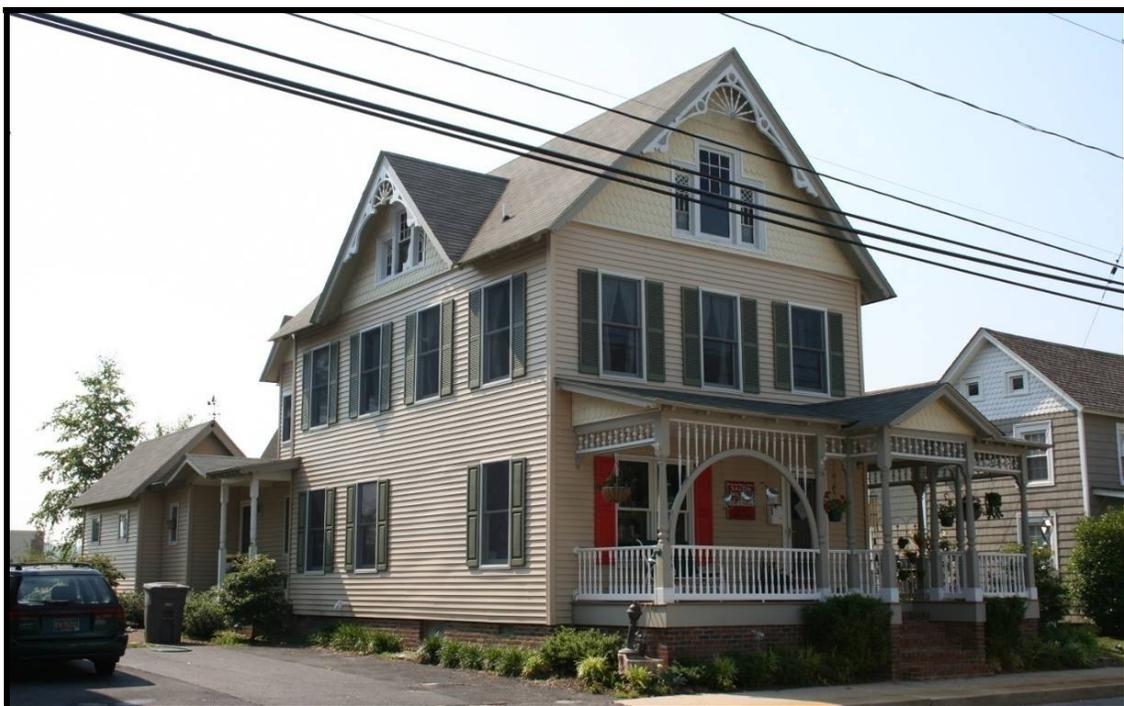
Property Type: Single-Family Dwelling; Queen Anne Style

This two-bay, two-and-a-half story Queen Anne style frame dwelling was built between 1887 and 1900. Its main front-gabled block features a selection of the ornate woodwork common on Milton's main thoroughfares: a decorative gable apron with ornate bargeboard trim, and a hipped-roof wrap-around porch with numerous carved wooden accents, ten turned-post supports, and a wooden railing which runs the full length of the porch. The north/northeast side of the house features a decorative cross-gabled wall dormer with the same decorative elements which adorn the gable end of the façade. A shed-roofed porch with two turned-post supports and a cross-gabled accent over the door is also positioned near the eastern end of this side. The southeast rear of the house has a two-story gable block with a cross-gabled extension which connects to the shed-roofed porch and a one-story front-gabled addition. The wrap-around front porch continues along the south/southwest side of the building where it culminates at the centrally-positioned cross-gabled extension. A half-hexagonal tower centered below the decorative cross-gabled wing which exhibits the same gable apron and bargeboard accents as the front and north/northeast gable ends is also located along this south/southwest side. The majority of the windows are one-over-one sash with louvered shutters, with the exception of several small casement windows on the northeast side of the one-story gable addition and decorative upper-story Palladian style windows located in every gable end which have a nine-over-one center window and two flanking windows composed of twelve diamond lights positioned over three vertical panes which are over one solid pane. The elaborate diamond-patterned leaded-glass front door is located in the far right bay of the northwest façade and a second door with an aluminum storm door cover is located on the north/northeast side of the house in the fourth bay from the eastern corner. The exterior walls are covered with vinyl/aluminum siding, with fish-scale shingles decorating the gable aprons. This dwelling, with its Queen Anne style ornamental details, exemplifies the master craftsmanship of the Victorian homes built in Milton from the late 1860s to the early 1920s; it retains integrity of design, materials, workmanship, location, and setting, making it a contributing historic property for the expanded Milton Historic District.

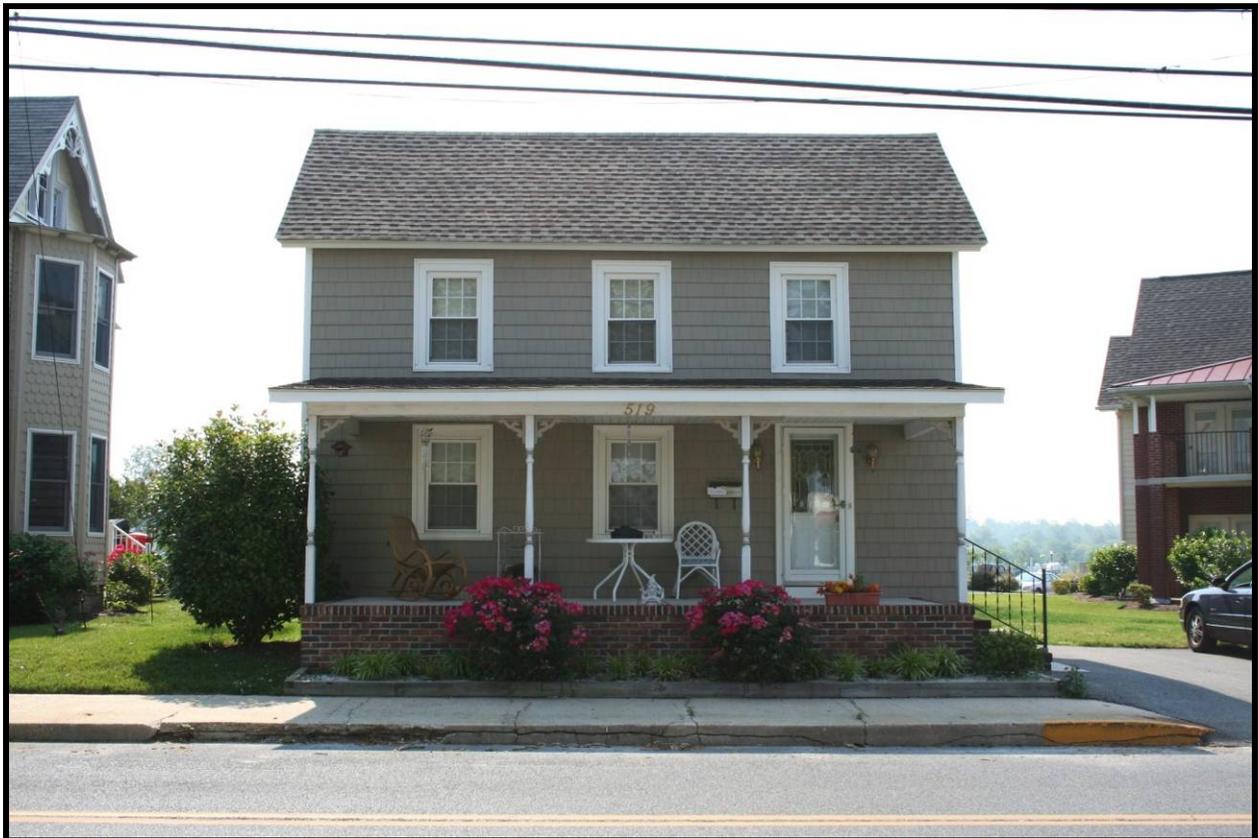
This three-bay, two-and-a-half story, frame, side-gabled dwelling with brick accents may have been built circa 1992, but definitely appears on aerial maps by 2002 (the building in the 1992 aerial resembles a warehouse, and the large complex behind the property supports this assessment). The shed-roofed front porch has four turned-post supports and decorative brackets. A two-story, cross-gabled wing with attached one-story gable block and an integrated hipped-roof wing are all connected to the east/southeast rear of the dwelling. The windows are all six-over-six sash in both the main block and rear wings, with the exception of two small, square upper-story single-pane casement windows on both the northeast and southwest gable ends of the main block. A top-light paneled door with decorative leaded-glass diamond patterning and a full-view aluminum storm door is located in the far right bay on the northwestern façade; a side entrance is located along the southwest side in the fifth bay from the western corner. The exterior walls are covered in vinyl/wooden shingles, with fish-scale shingles decorating the gable aprons on the main side-gable block. This dwelling is considered a non-contributing property for the expanded Milton Historic District due to its recent construction date.

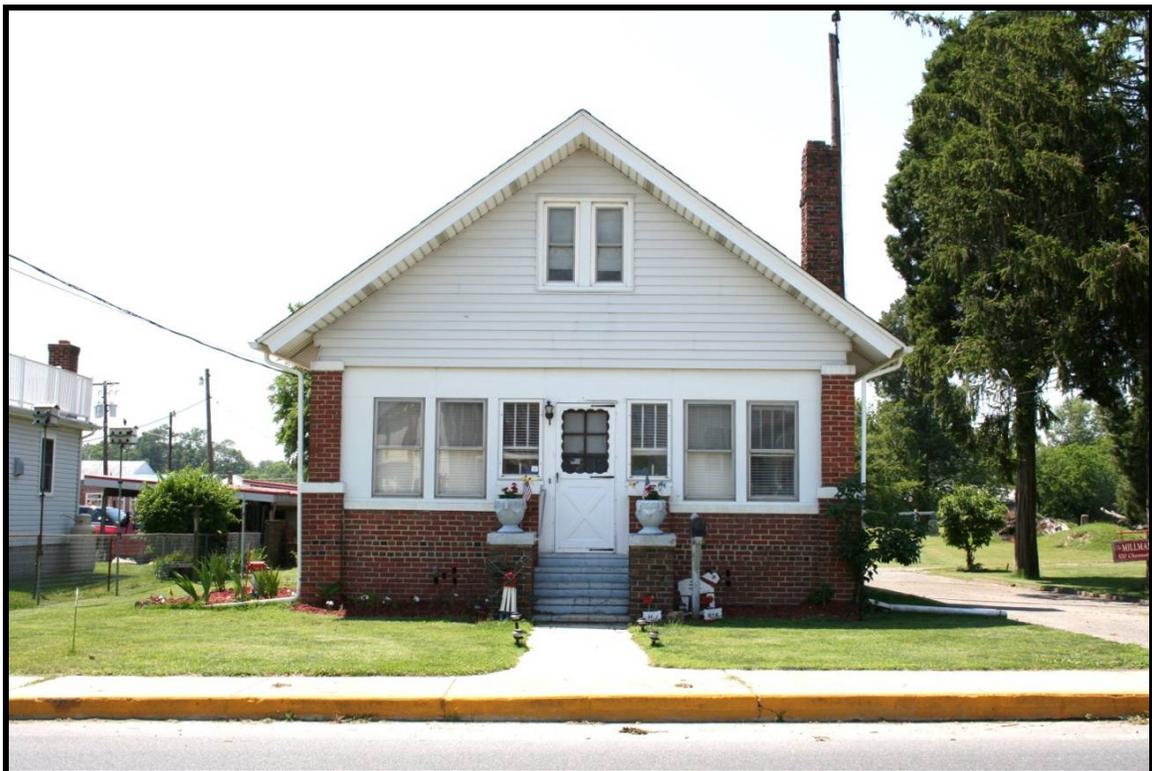
Property Type: Single-Family Dwelling, Vernacular Craftsman Style

This seven-bay, one-and-a-half story brick dwelling was built between 1923 and 1937 in the Vernacular Craftsman architectural style. The southeast gable front has a centrally-positioned door with a four-pane upper light and a set of concrete stairs with brick pillars leading to the entrance of the enclosed porch. Two four-over-one (narrow, vertical-panes) sash windows and a smaller three-over-one sash window are located on either side of the door, with the three-over-one windows closest to the door. The upper story of the southeast façade has a paired set of one-over-one sash windows centered in the gable end. The northeast side has a mix of one-over-one sash windows with a paired set of four-over-one sash windows near the eastern corner in the enclosed porch. The southwest side of the building has a cross-gable dormer with a bow window centered under the gable. The windows on the southwest side are one-over-one sash, with the exception of the paired four-over-one sash windows near the southern end in the enclosed porch. A side-entrance door with an attached deck is located on the southwest side in the far-left bay. Brick chimneys are located near the rear (west/northwest) interior ridge as well as on the exterior of the northeast side, where the chimney penetrates the extended eave. The exterior walls are primarily composed of red brick, with vinyl/aluminum siding covering the gable aprons and what appears to be painted wooden boards enclosing the front porch. The Vernacular Craftsman style of this dwelling became popular in the early 1920s and endured until the mid 1950s. The dwelling retains integrity of design, materials, workmanship, location, and setting, making it a contributing historic property for the expanded Milton Historic District.

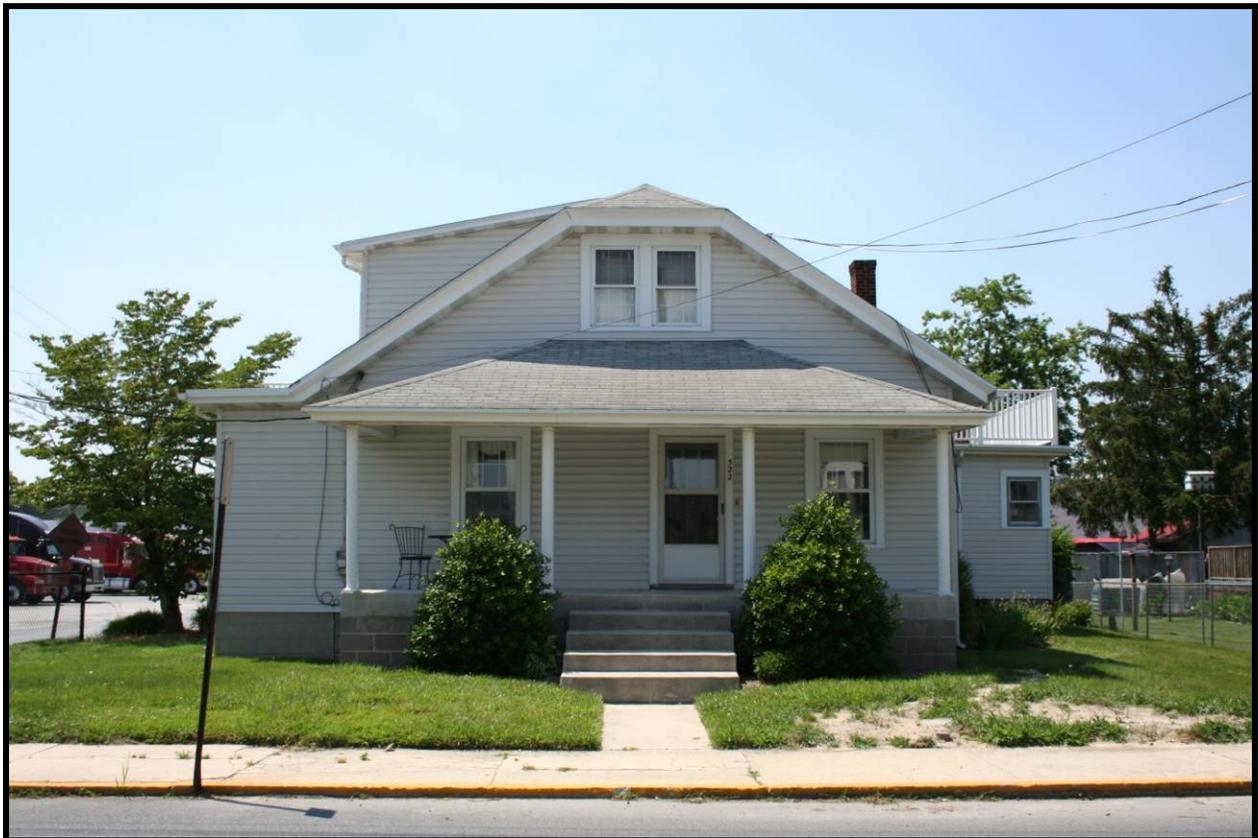
This four-bay, one-and-a-half story dwelling was built between 1923 and 1937 in the Vernacular Mission/Prairie style of architecture. The main clipped-gable block has an attached hipped-roof porch with four fluted-column supports and a large shed dormer on the south/southwest side of the roof. A flat-roofed addition with rooftop deck and railing surrounds the western end of the building and wraps around the rear to cover the northern corner as well. The majority of the windows are six-over-six sash, with the exception of several eight-over-eight sash windows in the flat roof addition and three narrow casement windows near the southern corner of the south/southwest side of the house. The main entrance door is located in the second bay from the left, while two side entrances and two rear entrances are located in the third and fourth bay from the western corner and the third and sixth bay from the northern corner, respectively. An interior brick chimney is located near the northern corner of the main block and a second interior chimney is positioned at the north corner of the flat-roofed addition. The walls are covered with vinyl/aluminum siding and the roof is clad in asphalt shingles. This property has been converted from a dwelling into commercial space for the Reed Trucking Company and is considered a non-contributing property for the expanded Milton Historic District due to loss of integrity in design and materials.

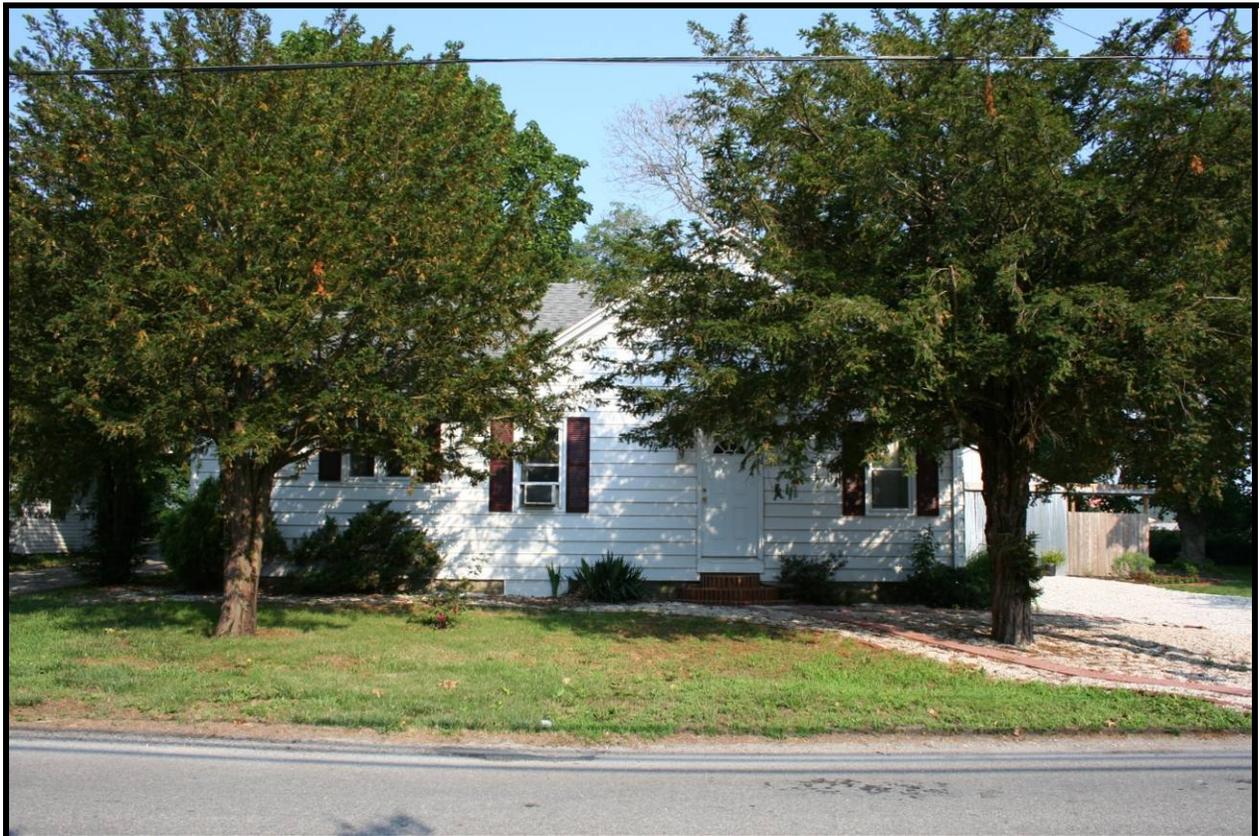
Property Type: Single-Family Dwelling, Double-Pile Cottage

This four-bay, one-and-a-half story dwelling was built between 1937 and 1954. The main block is side-gabled with a cross-gabled front wall dormer over the entry door. A gable-roofed addition is attached to the south/southwest side with a shed-roofed addition protruding off the north/northwest side of the gable addition. The paneled front door located in the second bay from the east/northeast corner of the house on the southeast façade has a small fanlight window and plain aluminum surrounds. While all of the windows are one-over-one double-hung sash, only the windows on the southeast façade have decorative louvered shutters. A brick end-wall chimney is located on the northeast gable end and the exterior walls are covered in wide vinyl/aluminum siding. Houses which exhibit the Cottage style, such as this dwelling, were predominantly built in Milton from the mid 1930s to the early 1960s, but some earlier examples do exist. The dwelling retains integrity of design, materials, workmanship, location, and setting, making it a contributing historic property for the expanded Milton Historic District.

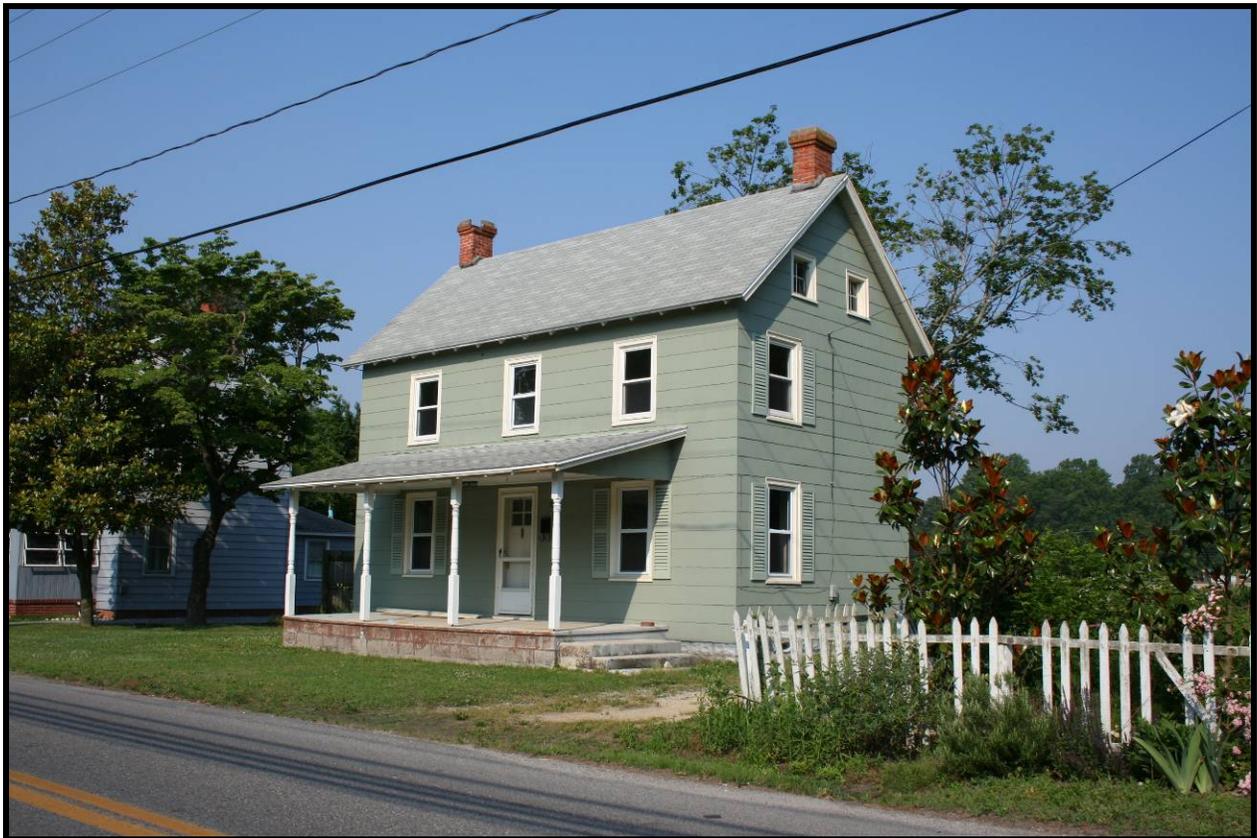
S-3473

713 Chestnut Street (1937 Aerial Map)

Property Type: Single-Family Dwelling, Eclectic Mixed Style

This three-bay, two-story dwelling was built prior to 1937 according to aerial maps in an Eclectic Mixed style; the original survey states that the house was built circa 1920. The front-gabled main block has a continuous pent-roof porch ring which wraps around three sides of the house and connects to the enclosed hipped-roof west/northwest front porch with a small, integrated shed-roofed extension. Two successive gable-roofed additions and a dropped one-story gable-roofed addition are connected on the east/northeast rear of the dwelling. A hipped-roof porch on the northern side of the house wraps around the second two-story addition and connects with the other two, integrating the one-story gable-roofed addition with the rest of the house. The windows on the west/northwest façade are predominantly single six-over-one sash, with the exception of a set of three windows in the central bay on the façade and two upper-story half-fanlights which flank the centrally-positioned exterior brick chimney. The rest of the house has sporadically positioned single and paired small one-over-one sash windows. Three entrances are located on the northern side of the house, with one positioned in the front porch, one in the main front-gabled block, and one in the rear one-story gable addition. The exterior walls of the additions as well as the second story of the main block are covered with vinyl/aluminum siding, while the first story of the main front-gabled block and enclosed front porch are covered in permastone. This dwelling is considered a non-contributing property for the expanded Milton Historic District due to loss of integrity in design and materials.

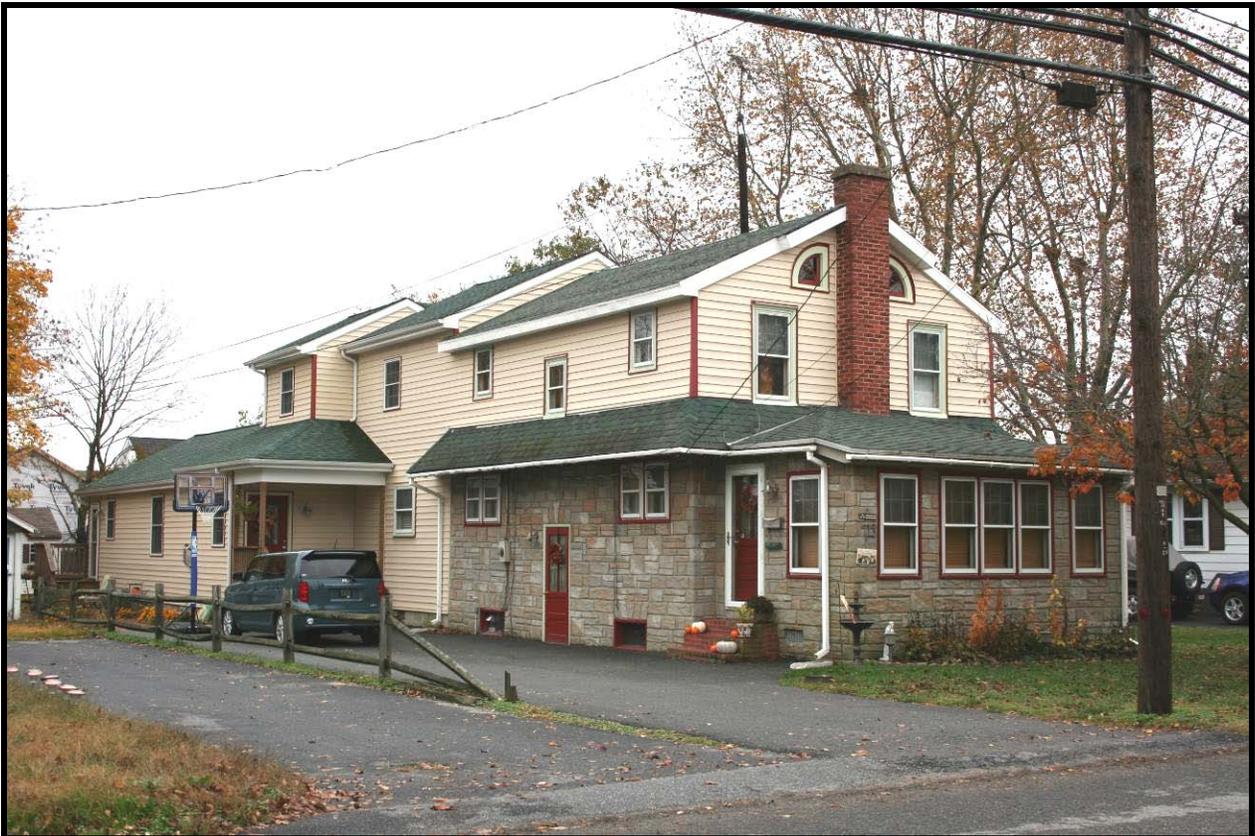
S-3474

714 Chestnut Street (1937 Aerial Map)

Property Type: Single-Family Dwelling, Three-Bay Vernacular Style

This three-bay, two-and-a-half story frame dwelling was built prior to 1937 according to aerial maps; the original survey states that the house was built circa 1900. The side-gabled main block has an enclosed shed-roofed front porch on the east/southeast façade and another one-story hipped-roof addition connected near the western corner of the west/northwest rear. The fenestration is predominantly regular, with evenly-spaced two-over-two sash windows in the upper story of the façade and along the other sides of the house. Two small four-pane casement windows are located in the upper story on the northeast and southwest gable ends. The enclosed front porch has a centrally-positioned aluminum storm door and paired sets of awning-style tripartite casement windows on all sides. Two small casement windows are located on the southwest side of the rear addition and a two-over-two sash window on the northeast side. Along the roof ridge of the main block, there are two interior brick chimneys with decorative corbelled caps located near the northeast and southwest ends of the house. The exterior of the house is composed of multiple materials; the walls are covered in wide clapboard siding, the porch base and house foundation is made of brick, and the porch is enclosed with vertical-board siding. This dwelling is representative of the classic Three-Bay Vernacular style which was prevalent in Milton from the mid 19th to the early 20th centuries; it retains integrity of design, materials, workmanship, location, and setting, making it a contributing historic property for the expanded Milton Historic District.

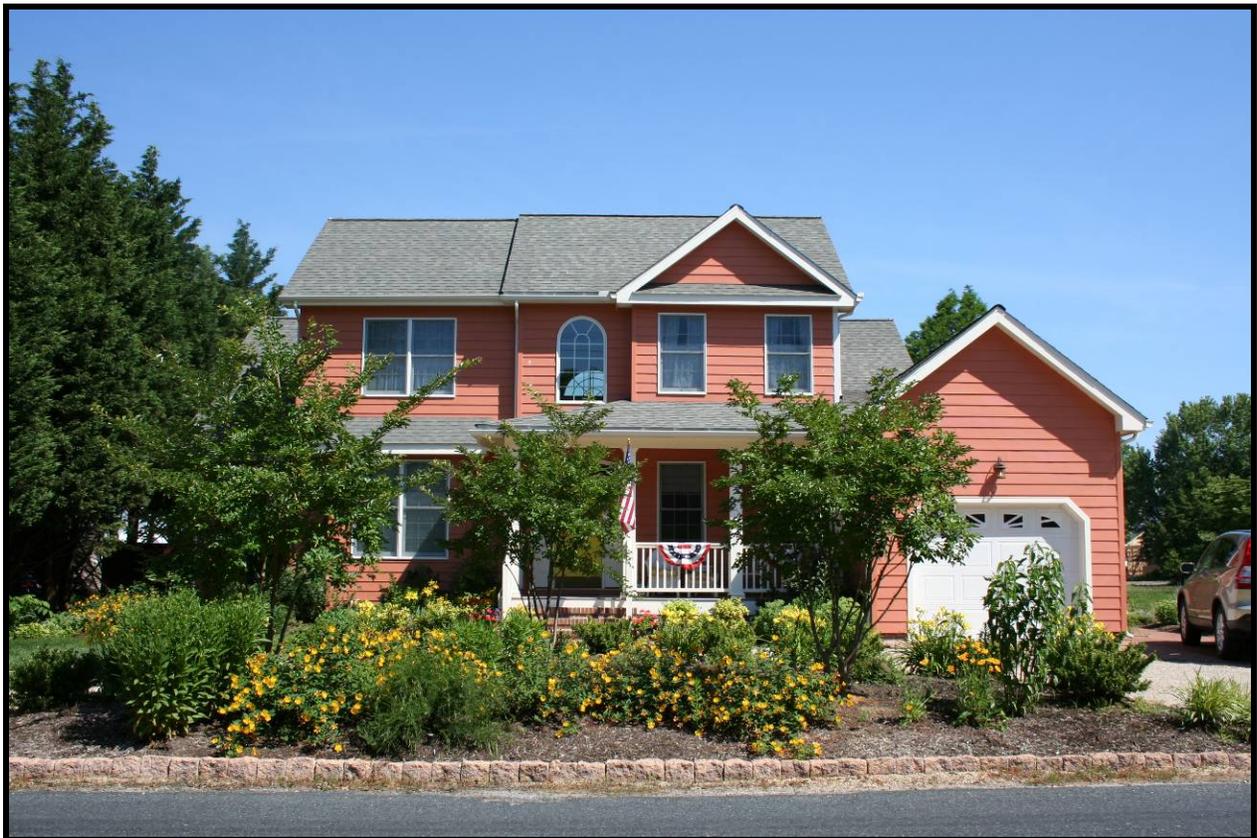
S-11999

Parcel #40.01 (121?) Clifton Street (1997 Aerial Map)

Property Type: Single-Family Dwelling, Style is Not Visible

This house was built between 1992 and 1997. Due to dense vegetation, it is difficult to determine the exact size and stylistic features of the home. From the aerial imagery, however, three front-gabled dormers are visible on the northeast side of the side-gabled roof as well as a shed-roofed porch. Based upon the roof design, it is possible that the house represents the Cape Cod style. The roof is covered in asphalt shingles and the exterior is sheathed in vinyl clapboard style siding. This dwelling is not considered a contributing historic property for the expanded Milton Historic District due to its recent construction date.

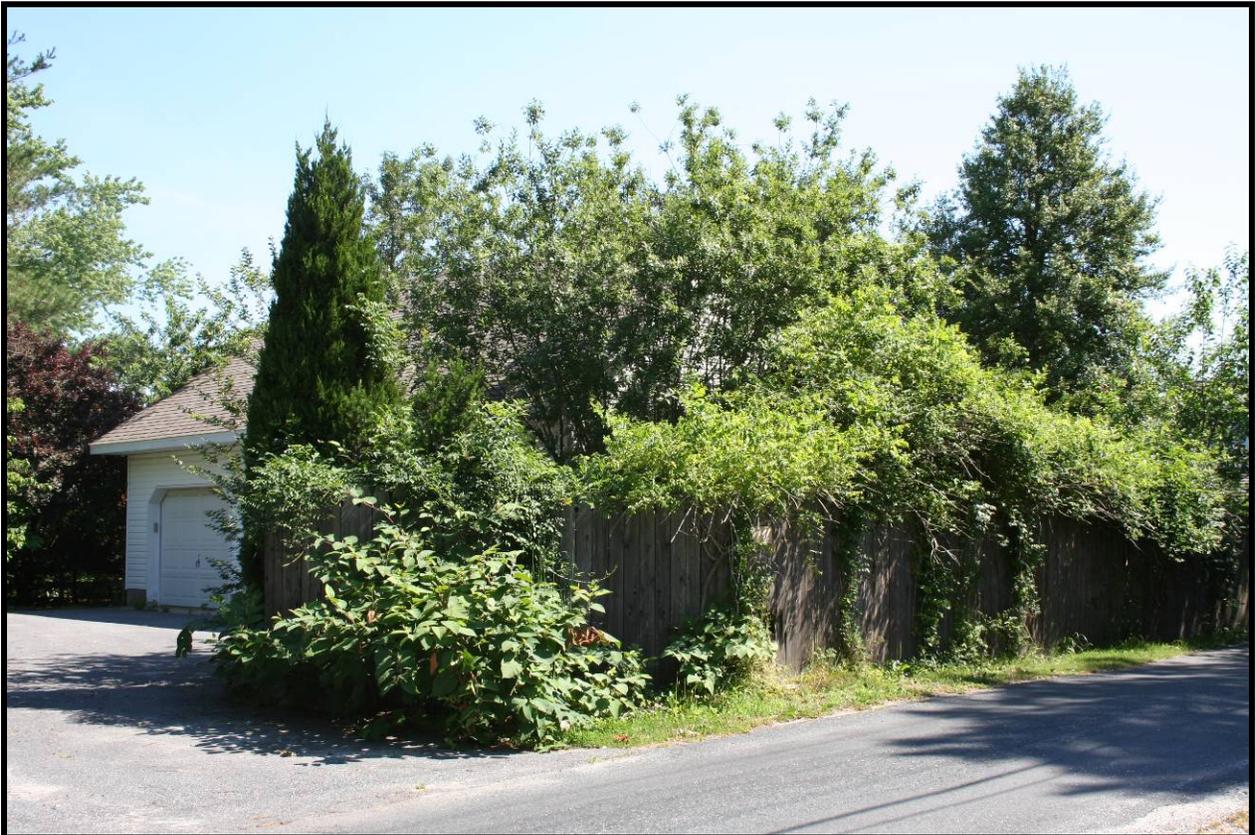
S-12065

108 Collins Street (1911 Sanborn Map)

Property Type: Single-Family Dwelling, Composite Ranch with Irregular Massing

This four-bay, one-story Ranch was potentially constructed circa 1911 and has been since been incorporated into the current structure, since a one-story, square dwelling which resembles the front-gabled block is present in the 1911 Sanborn map and on all of the remaining maps. The dwelling in its current form, however, isn't present until 1968 according to aerial maps. The dwelling consists of a central front-gabled block and two cross-gabled blocks of varying height and size on either side. The southeast façade has a mix of one-over-one sash windows and two-over-two double-hung sash windows. The main entrance door is positioned off-center in the cross-gabled end to the right of the two-over-two sash window. The northeast side also has a door with a small concrete porch and wrought-iron handrail. The southwest side has two one-over-one double-hung sash windows and an additional door. An exterior, concrete-block chimney is located on the southwest façade and an interior concrete-block chimney is located next to the northeast side-gabled block. The roof is covered in asphalt shingles and the exterior is sheathed in aluminum clapboard style siding. This dwelling is considered a non-contributing property for the expanded Milton Historic District due to loss of integrity in design and materials.

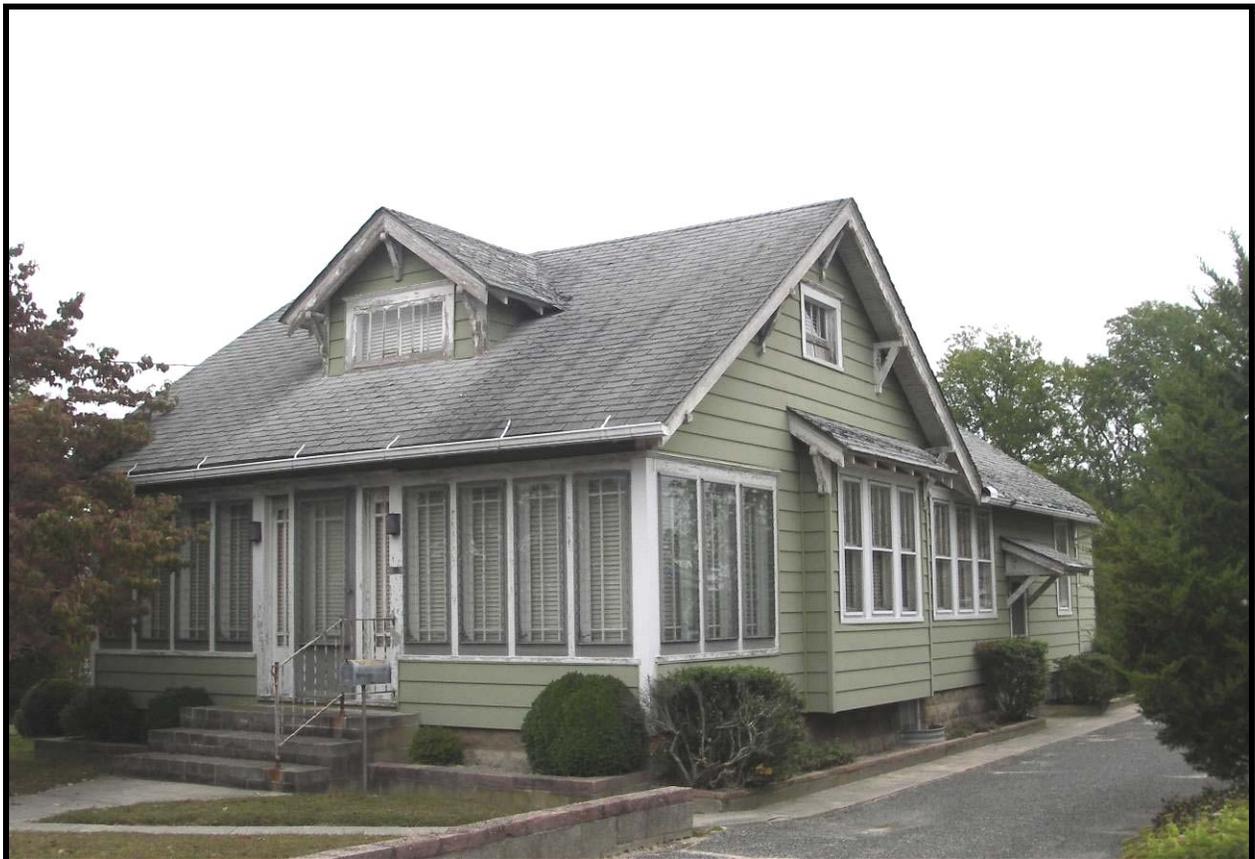
S-12085

This nine-bay, one-and-a-half story, cross-gabled dwelling was built in the Craftsman Bungalow style between 1923 and 1937. The northwest elevation has an original enclosed porch. A prominent one-bay, gable-roofed dormer extends over the central bay on the front (northwest) elevation. An interior chimney rises from the middle of the southeast cross gable. There is a small square one-story hipped-roofed addition on the rear (southeast) elevation. The main block of the dwelling is on a rusticated concrete block foundation and is covered in vinyl siding. Asphalt shingles cover the roof, which terminates in a wood boxed cornice with triangular knee braces. Fenestration throughout the dwelling is a combination of single-light fixed sashes, one-over-one sashes, and Prairie Style casement windows. The dwelling is an excellent example of the Craftsman Bungalow style which was popular in Milton during the mid 1930s; it retains integrity of materials, workmanship, design, location, and setting, making it a contributing historic property for the expanded Milton Historic District.

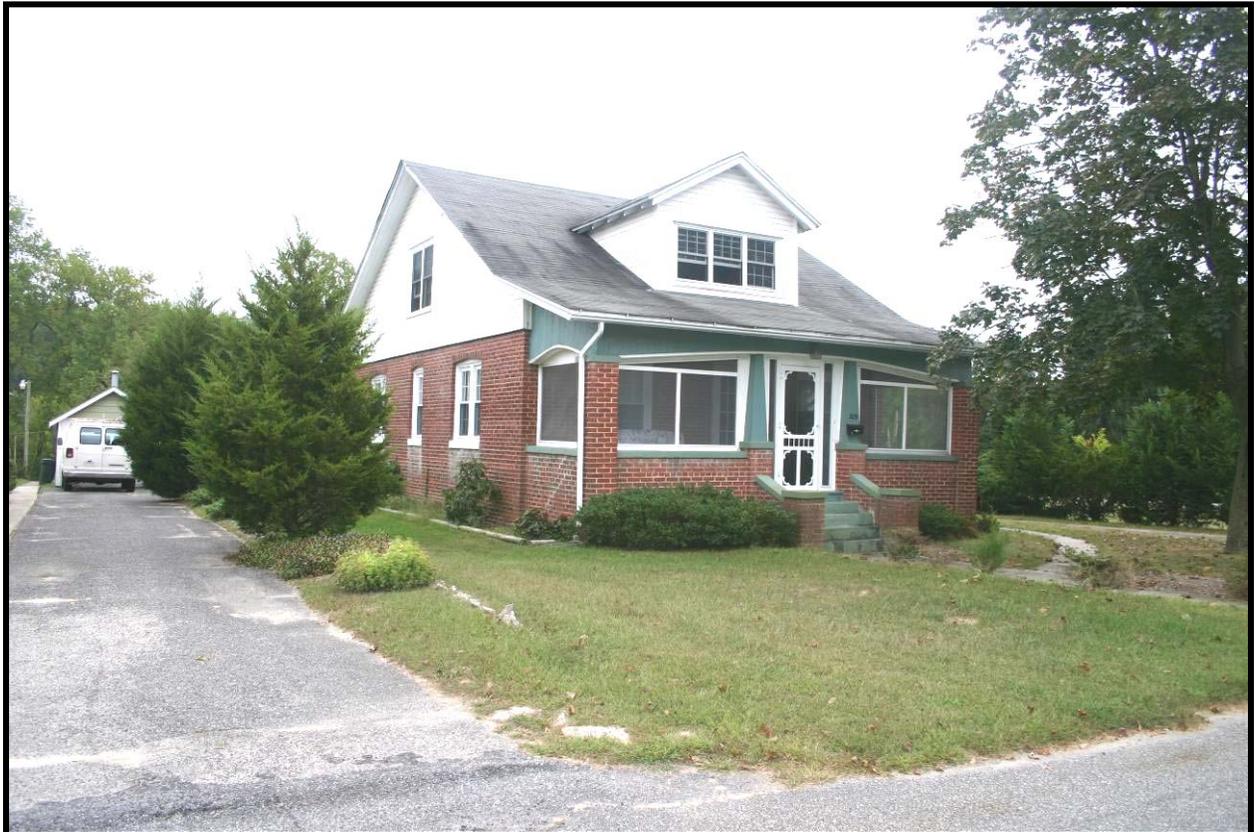
S-12082

309 Coulter Street (1937 Sanborn Map)

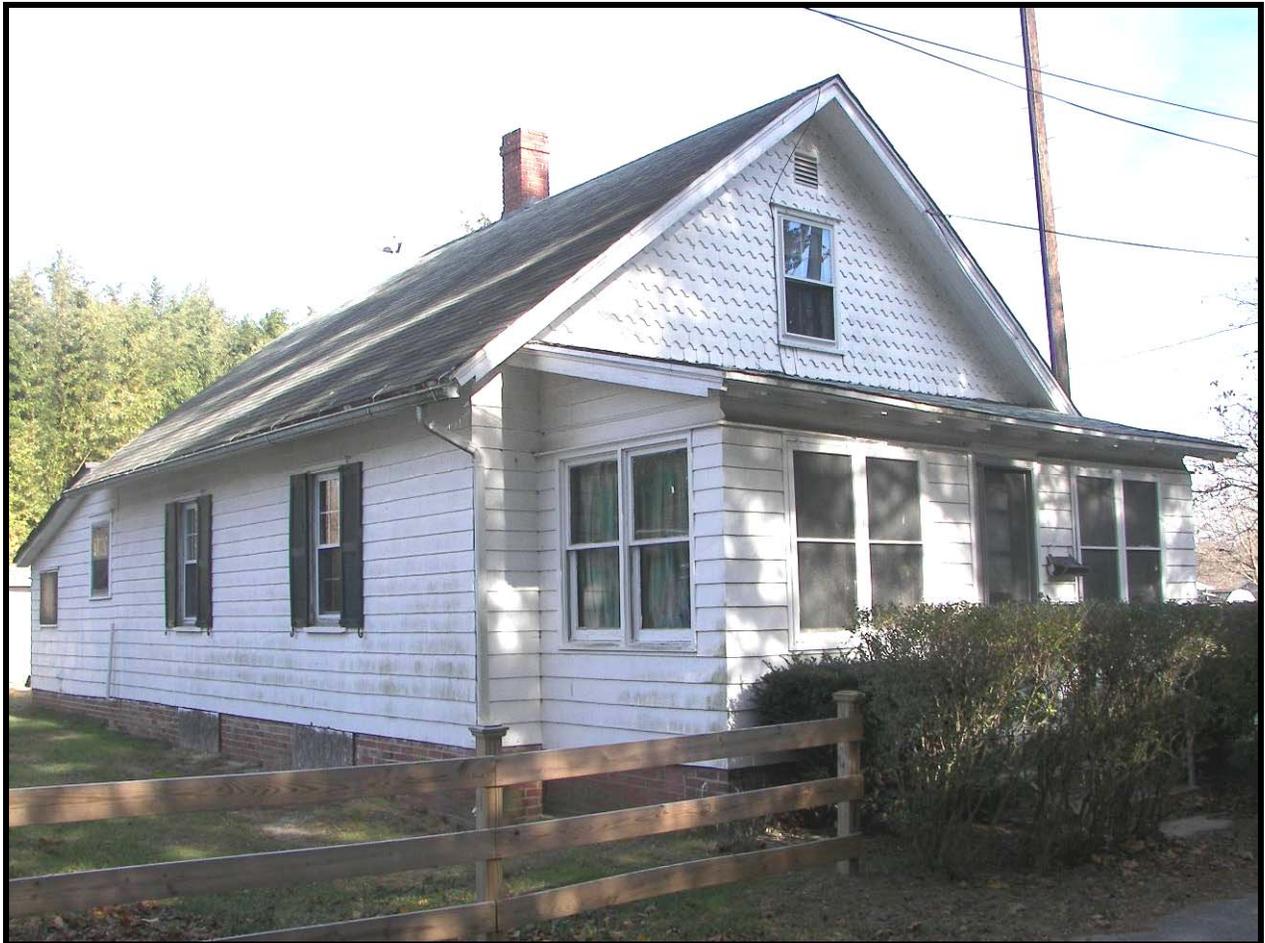
This three-bay, one-and-a-half-story, gable-front dwelling was constructed between 1923 and 1937 in a Vernacular Craftsman style. An enclosed, one-story porch spans the front (southwest) elevation covering all three bays. A series of one-story, shed-roofed additions extend off the rear (northeast) elevation of the dwelling, each being one bay deep. One interior brick chimney rises through the middle of the gable ridge. Fenestration on the front (southwest) elevation consists of one door in the central bay of the enclosed porch, paired one-over-one light sashes on the enclosed porch, and a single two-over-two sash window in the gable end. Fenestration throughout the remaining original block consists of paired and single six-over-six-light replacement sashes with operable louvered shutters. Sitting on a brick foundation, the majority of the dwelling is covered with vinyl siding while decorative shingles sheath the gable ends. The roof is asphalt shingled and terminates with exposed rafters. The dwelling is a good example of the Craftsman style which was popular in Milton from the early 1920s to the late 1930s; it retains integrity of materials, workmanship, design, location, and setting, making it a contributing historic property for the expanded Milton Historic District.

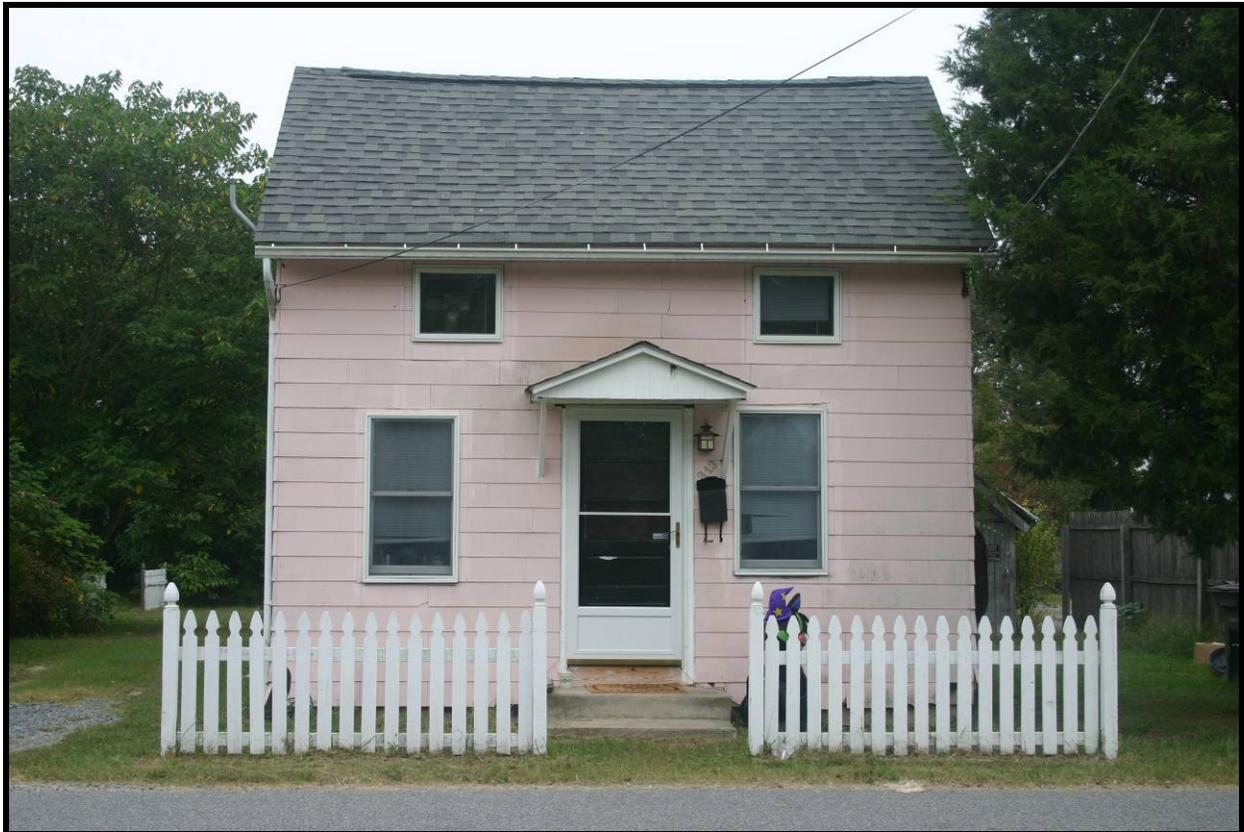
S-12083

This three-bay, two-story, side-gabled vernacular dwelling was built between 1887 and 1911 with a single-cell plan. A one-story, single-pile, shed-roofed addition extends from the rear (northeast) elevation. Fenestration on the front (southwest) elevation consists of a door in the central bay covered by a pedimented portico, flanked by two one-over-one-light replacement sashes. The second story has two bays that do not align with the first story bays; openings in these two bays are single fixed-light replacement windows. The rear addition is accessed via an exterior door on the southeast elevation. The asphalt-shingled roof terminates in a boxed cornice. The dwelling is sheathed with asbestos shingles. The dwelling is an excellent example of a modest Three-Bay Vernacular dwelling common in Milton at the turn of the century; it retains integrity of materials, workmanship, design, location, and setting, making it a contributing historic property for the expanded Milton Historic District.
