APPENDIX A:
INVENTORY OF SURVEYED
PROPERTIES

MILTON • DELAWARE

APPENDIX A

This appendix begins with a chart of all the resources surveyed in Milton. The chart includes CRS numbers, address, function, style of architecture, the date the property first appears on a historic map, and whether or not the property should be considered contributing or non-contributing to a potential expanded National Register of Historic Places District in Milton or a local historic zone. Following the chart, descriptions of the surveyed resources provide more detailed information on the historic name of the property, function, a brief history, and a physical description of the property. The description also provides a short rationale for the property's recommendation for inclusion or exclusion to the National Register District. Photographs of each main building or resource appear with the descriptions.

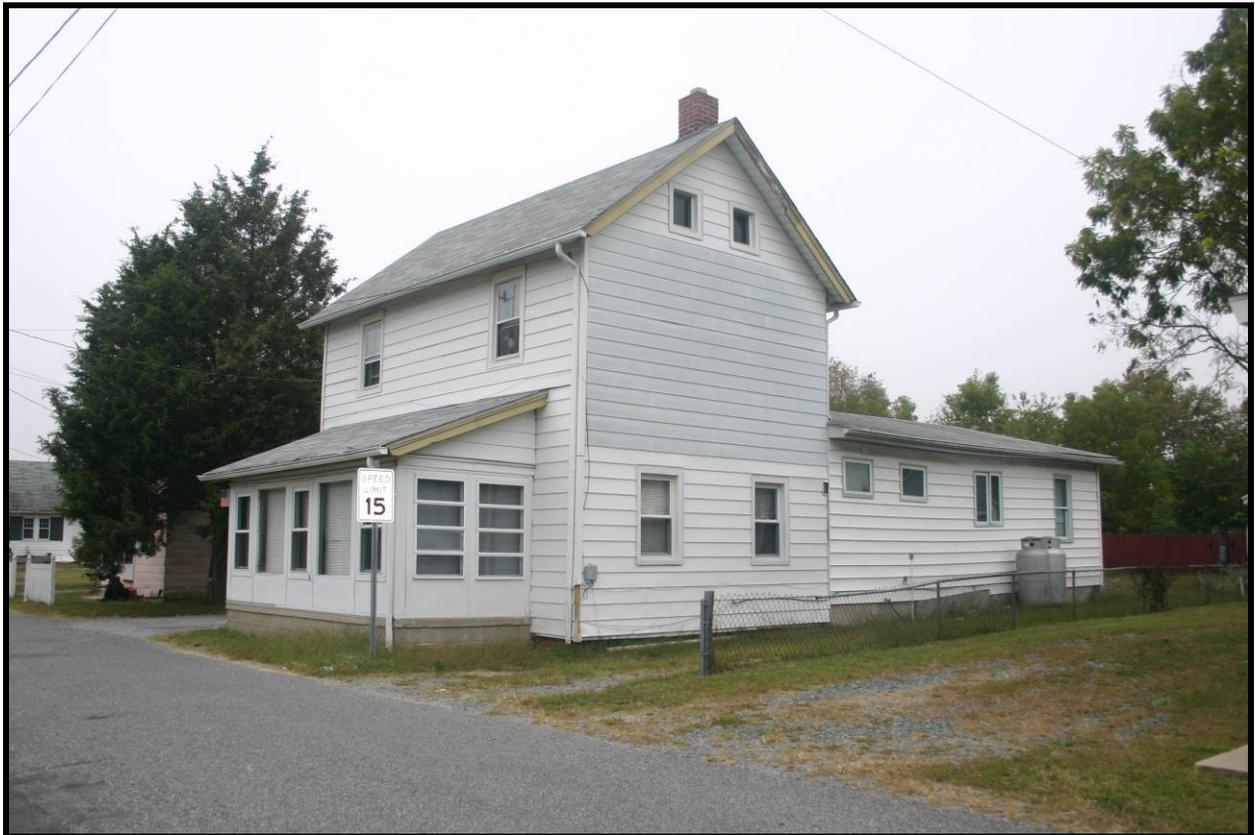
S-12084

This three-bay, two-and-a-half story, side-gabled dwelling was built between 1887 and 1911. A one-story, half-hipped addition extends three bays off the rear (northeast) elevation, nearly doubling the footprint of the dwelling. A one-story enclosed porch covers the entire front (southwest) elevation and is accessed via a door on the northwest side. Fenestration on the front elevation consists of one-over-one light sash windows alternating with large single-light windows in the enclosed porch. The second floor has only two bays filled with one-over-one light replacement sash windows. One interior brick chimney rises in the southeast gable end. The dwelling is sheathed in vinyl siding; its roof is covered with asphalt shingles and terminates in a boxed cornice. A pair of small single-light fixed windows occupy the upper story of each gable end. The dwelling is representative of the classic Three-Bay Vernacular style which was prevalent in Milton from the mid 19th to the early 20th centuries; it retains integrity of materials, workmanship, location, and setting, making it a contributing historic property for the expanded Milton Historic District.

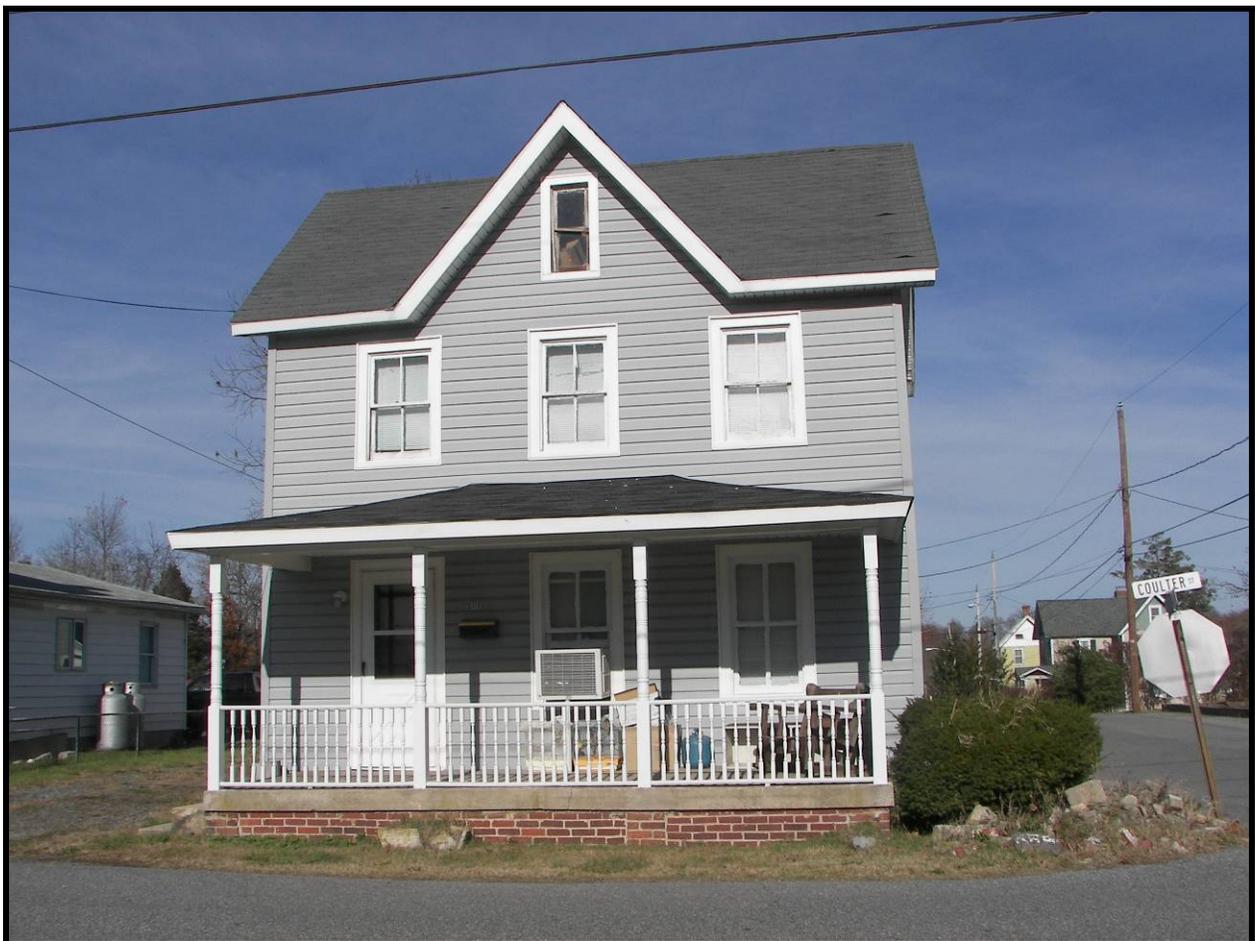
S-9026

This three-bay, two-and-a-half story, gable-roofed dwelling was constructed between 1911 and 1923 in a Vernacular Gothic Revival style, with a central cross gable on the front (southwest) elevation. The original dwelling forms an L-shape, with a shed-roofed one-story addition in the corner of the L on the southeast elevation. A one-story, half-hipped porch covers all three bays on the front elevation. A one-story, gable-roofed ell extends from the northernmost bay of the of the northeast gable end. The main roof is covered with asphalt shingles and terminates in a boxed cornice. Vinyl siding covers all sections of the dwelling. Windows throughout the dwelling are the original two-over-two light sash. A single one-over-one light sash fills the cross gable, while a pair of small four-light fixed windows fill the gable ends of the front side-gabled section. An interior capped brick chimney rises in the middle of the rear cross-gable section of the L. The dwelling is an excellent example of the Vernacular Gothic Revival style in Milton which became popular in during the late 19th and early 20th centuries; it retains integrity of design, materials, workmanship, location, and setting, making it a contributing historic property for the expanded Milton Historic District.

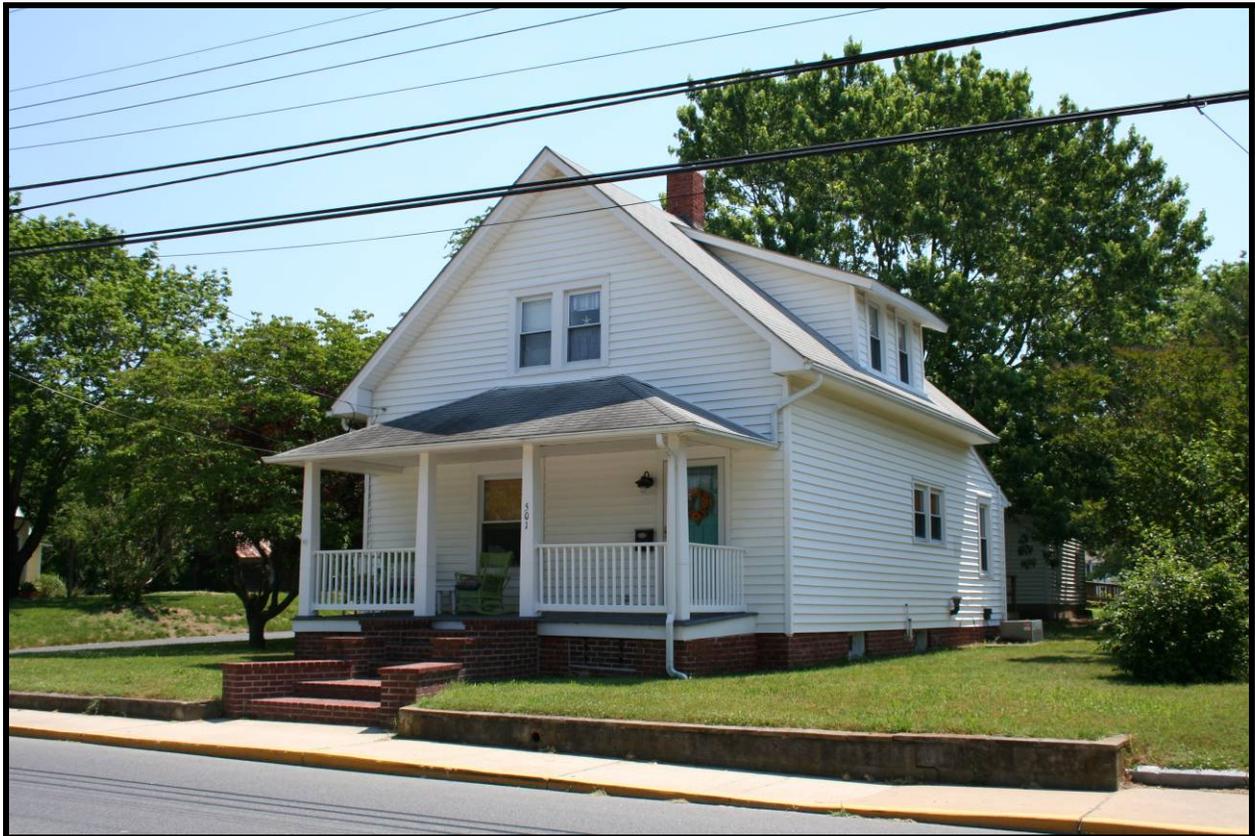
S-12106

503 Federal Street (1937 Sanborn Map)

Property Type: Single-Family Dwelling, Craftsman Bungalow Style

This one-and-a-half story, side-gabled, Craftsman Bungalow was constructed between 1923 and 1937. The overall shape of the structure remains unaltered, but the once open porch has been enclosed with jalousie windows. The porch also has large decorative posts at the corners and a slightly arched cornice. The northwest façade has a front-gabled dormer with three one-over-one sash windows. The southwest elevation has six windows which are a mix of jalousie and one-over-one sash. The northeast side has twelve windows which are a mix of jalousie and one-over-one sash. The exterior walls of the first floor are red brick with two yellow brick bands at the basement level; yellow bricks are also used as keystones above the windows. The upper story has vinyl clapboard-style siding. Bungalows became a popular housing style in Milton during the mid 1930s, but significantly declined in construction rates during the following years. The characteristics of Milton's bungalows vary considerably, from small, simple dwellings to large, elaborate homes made from high-quality materials, such as this property. The dwelling retains integrity of design, materials, workmanship, location, and setting, making it a contributing historic property for the expanded Milton Historic District.

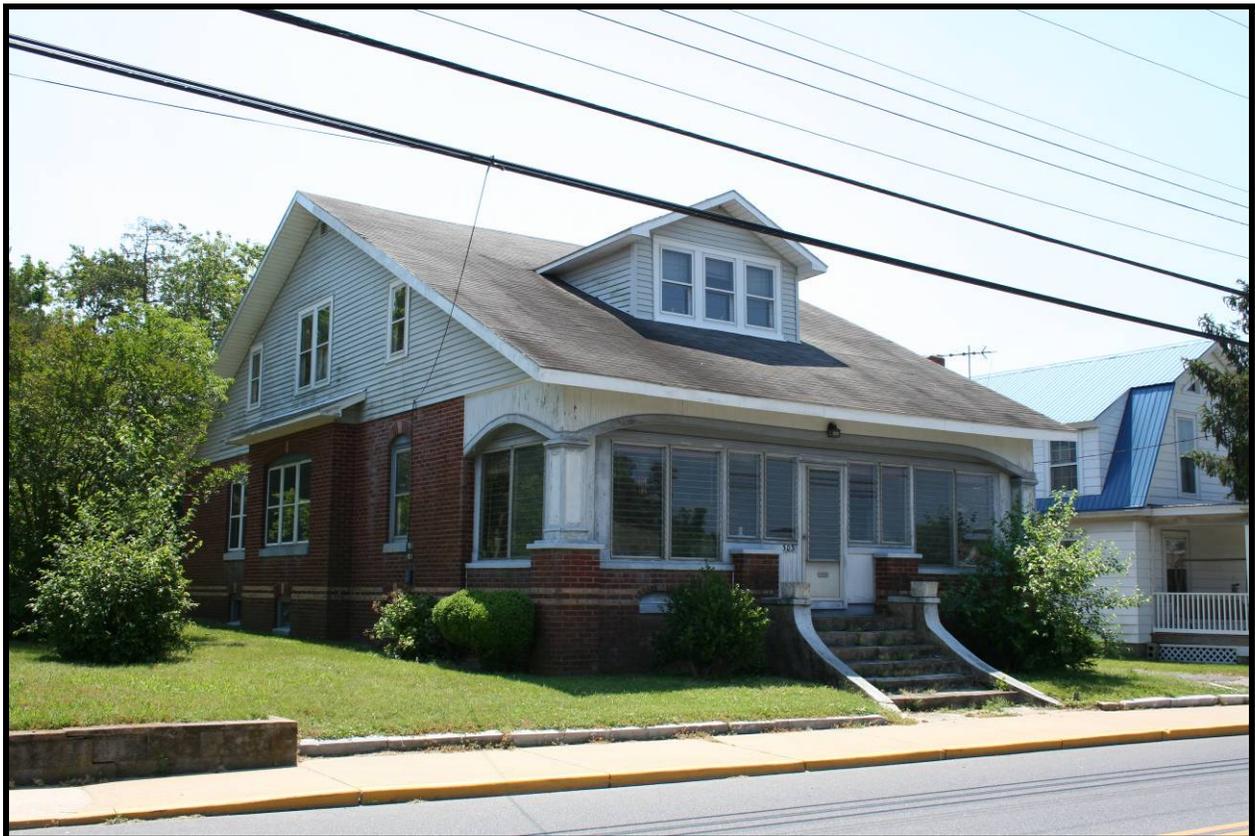
S-12103

504 Federal Street (1937 Aerial Map)

Property Type: Single-Family Dwelling, Prairie Style

This one-and-a-half story, hip-roofed, Prairie-Style dwelling was constructed prior to 1937. The number of bays on the southeast façade of the main block is not visible due to the enclosed porch. A hip-roofed dormer with two paired one-over-one sash windows is centrally positioned on the southeast façade. The northeast elevation has four one-over-one sash windows flanked by inoperable louvered shutters. The southwest side has five one-over-one sash windows flanked by inoperable louvered shutters. An interior cement block chimney is located toward the northeast corner. The roof is covered in asphalt shingles and the exterior of the structure is sheathed in aluminum clapboard style siding. This prairie style dwelling is one of only two surveyed and represents one of the more rare housing styles in Milton; it retains integrity of design, materials, workmanship, location, and setting, making it a contributing historic property for the expanded Milton Historic District.

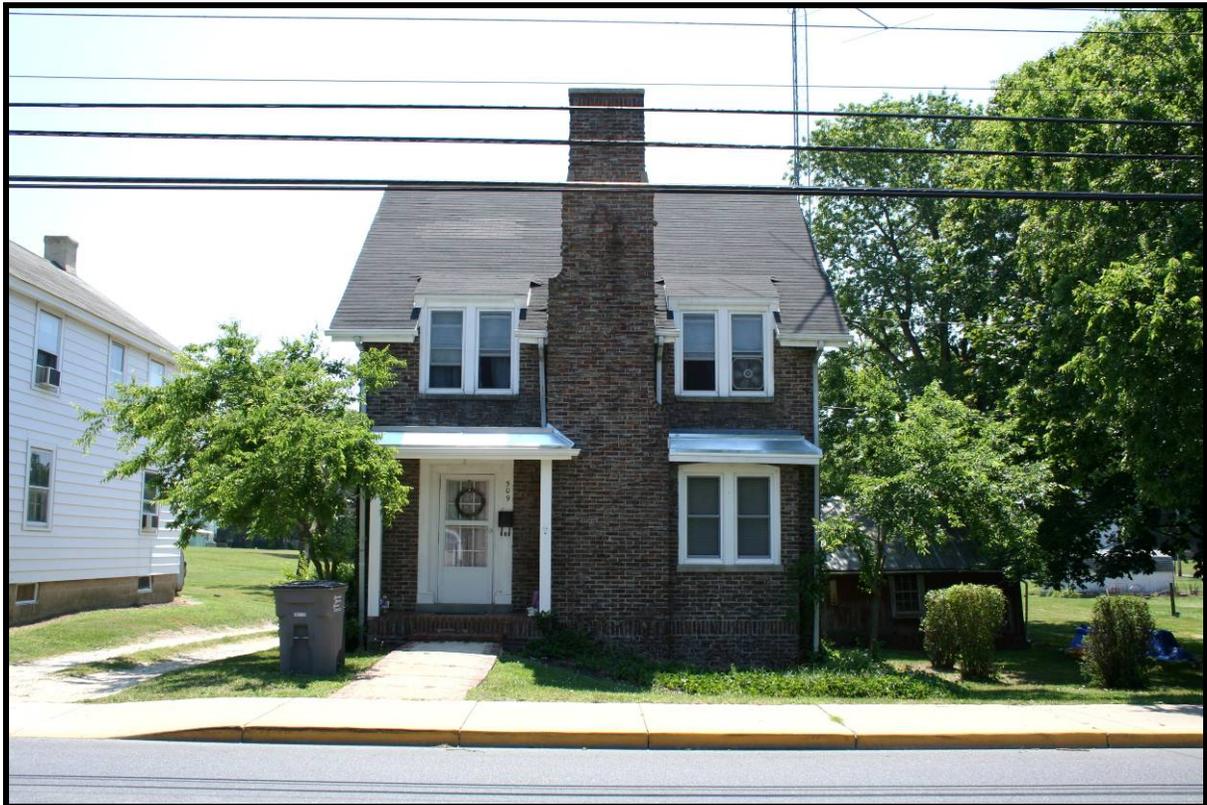
S-12110**513 Federal Street (1923 Sanborn Map)****Property Type: Single-Family Dwelling, Queen Anne Style**

This two-and-a-half story, two-bay, frame Queen Anne style dwelling was constructed between 1911 to 1923. The wraparound screened-in porch on the northwest side of the main front-gabled block is supported by simple square post and square baluster railing. The hipped-roof porch on the southeast rear has been enclosed. A pair of one-over-one double-hung-sash windows is next to the entrance door on the ground level of the northwest façade and is flanked by inoperable louvered shutters. The second floor has two one-over-one double-hung sash windows which are flanked by inoperable louvered shutters. The attic level has three one-over-one double-hung sash windows with no shutters. The southwest elevation has three paired one-over-one double-hung sash windows, one triple arrangement of one-over-one windows on the ground level, and a paired set of one-over-one sash windows in the dormer; all windows except those located in the cross-gabled dormers and gable ends of the main block are flanked by inoperable louvered shutters. The northeast elevation has four paired one-over-one double-hung sash windows. The southeast rear elevation has a tripled set of one-over-one double-hung sash windows at the attic level and a paired set on the ground floor to the left of entrance door in the enclosed hipped-roof porch. The second level has three single one-over-one double-hung sash windows with inoperable louvered shutters. A brick interior chimney is located near the southeast rear on the northeast side of the center ridge. The roof surfaces on the main block and wraparound porch are covered in asphalt shingles while the rear addition is covered in sheet metal. The exterior of the dwelling is sheathed in vinyl clapboard style siding. This dwelling, with its Queen Anne style ornamental details, exemplifies the master craftsmanship of the Victorian homes built in Milton from the late 1860s to the early 1920s. It retains integrity of design, materials, workmanship, location, and setting, making it a contributing historic property for the expanded Milton Historic District.

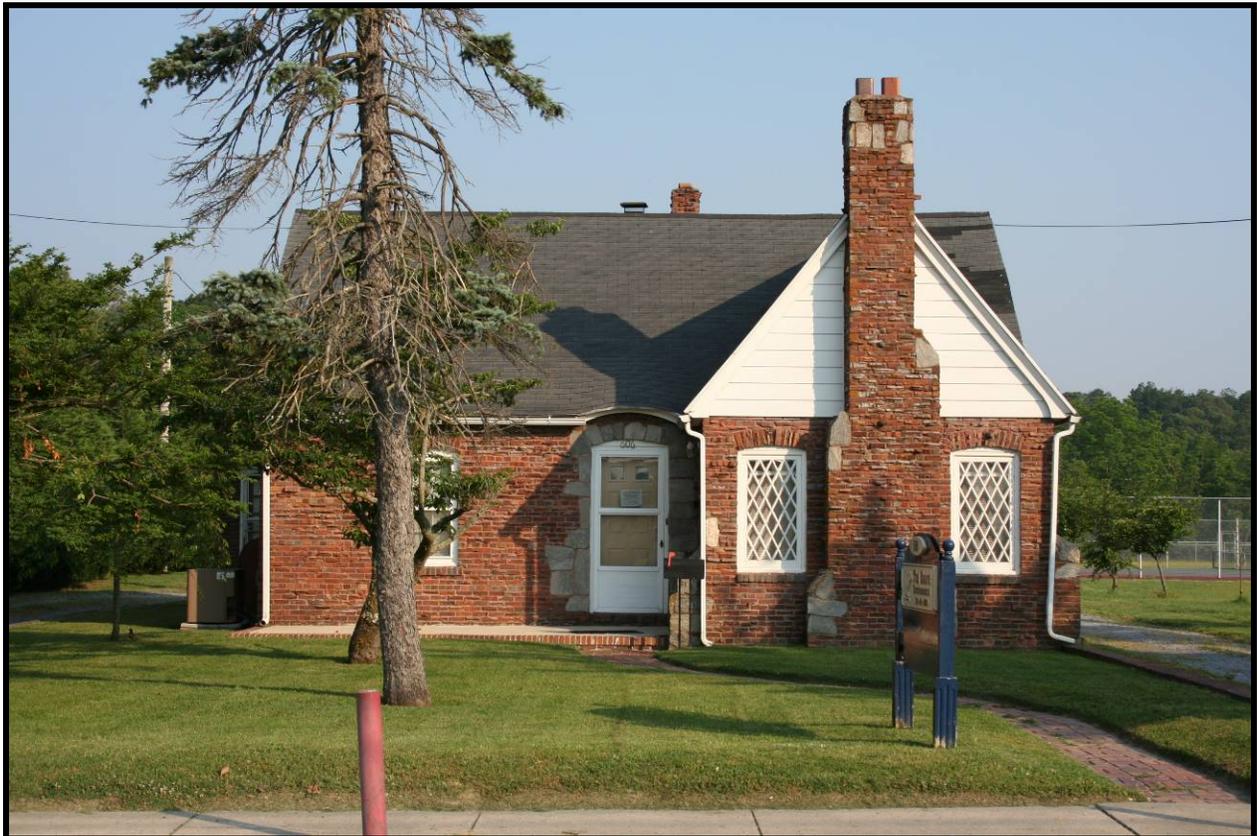
S-12133

610 Federal Street (1954 Aerial Map)

Property Type: Single-Family Dwelling, Minimal Ranch

This three-bay, one-and-a-half story, brick FHA style Minimal Ranch dwelling has an overall T-shape plan and was constructed between 1937 and 1954. On the southeast elevation, four single-hung sash windows surround the front entrance door which is covered by a metal awning. Two windows are visible on the northeast elevation and the southwest side has three single-hung sash windows and a horizontal sliding window surrounding the side entrance which also has a metal awning. The cross-gabled roof is covered in asphalt shingles. An exterior brick chimney is located on the gable end of the northeast elevation. Due to its early 1950s construction date, this home is one of the earliest examples of a Ranch-style FHA dwelling constructed in Milton and therefore part of a select few to be considered a contributing property for the Milton expanded historic District. This dwelling also retains integrity of design, location, and setting, further supporting the recommendation.

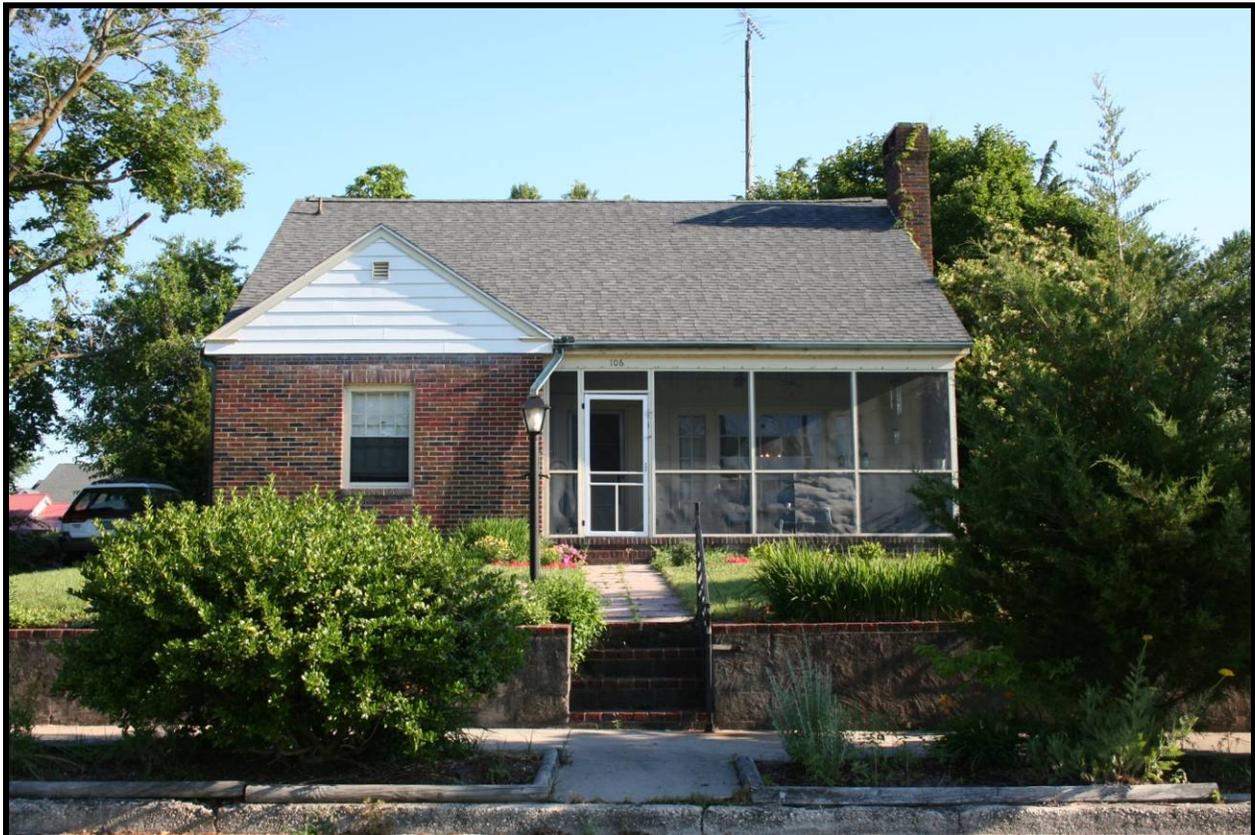
S-12040

108 Lake Drive (1937 Aerial Map)

Property Type: Single-Family Dwelling, Bungalow with Craftsman Detailing

This four-bay, two-story, frame dwelling was built prior to 1937 in the Bungalow style with Craftsman details. The steeply pitched side-gabled roof has a shed-roofed dormer on the south/southeast eave and a new cross-gable, two-story addition on the north/northwest rear. The front porch is incorporated underneath the main roof, which is supported by four Doric columns. The raised-panel front door with two-upper lights is located on the front porch in the first bay from the south/southwest corner and an additional side entrance is positioned in the third bay from the northwest corner on the west/southwest elevation. The windows are a mixture of six-over-one double-hung sash and one-over-one double-hung sash on all sides, except for several windows in the new rear addition, which are grouped sets of three windows with an upper transom light. A large brick end-wall chimney is located on the east/northeast gable end and the exterior walls are covered in cedar shake shingles as well as wood clapboard. Bungalows became a popular housing style in Milton during the mid 1930s, but significantly declined in construction rates during the following years. The characteristics of Milton's bungalows vary considerably, from small, simple dwellings to large, elaborate homes made from high-quality materials, such as this property. The dwelling retains integrity of materials, workmanship, location, and setting, making it a contributing historic property for the expanded Milton Historic District.

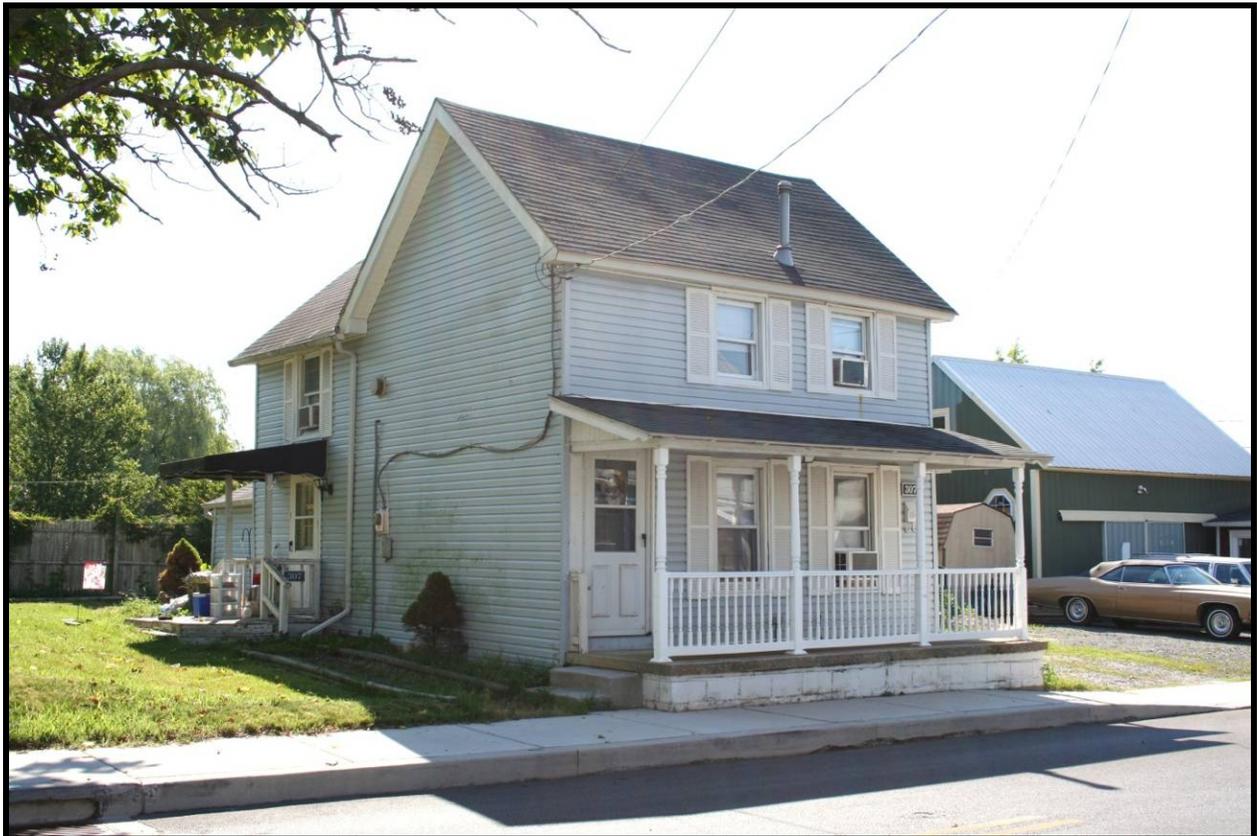
S-12033

308 Mulberry Street (P.B. Jackson's Property: 1887 Map of Milton)

Property Type: Single-Family Dwelling, Three-Bay Vernacular with Italianate Detailing

This three-bay, two-and-a-half story, frame, Vernacular dwelling with Italianate detailing was constructed between 1868 and 1887. Off the southwest elevation of the main side-gabled block is a two-story, cross-gabled addition. Each side of the addition has an enclosed, one-story, shed-roofed addition. On the northeast façade, an open porch with turned wooden posts and a wooden railing runs the length of the elevation. The northeast elevation has regular fenestration with five double-hung sash windows. The northwest elevation has at least four double-hung sash windows and two four-pane casement windows. The southeast elevation has five double-hung sash windows, two four-pane casement windows, and a pair of double-hung sash windows. The southwest elevation has two double-hung sash windows, two four-pane casement windows, and a pair of double-hung sash windows. An interior, brick chimney is located on the main block toward the southeast gable end and another brick chimney is centrally-located in the rear addition. The exterior is sheathed in vinyl or aluminum siding and the roof is cover with asphalt shingles. Peter B. Jackson, a native of Delaware, owned the house in 1887. He was a farmer and his wife Elizabeth Jackson kept the house. The dwelling is an excellent example of the Three-Bay Vernacular Italianate style which was popular from the late 1860s to the early 1920s; it retains integrity of materials, workmanship, location, design, feeling, and setting, making it a contributing historic property for the expanded Milton Historic District.

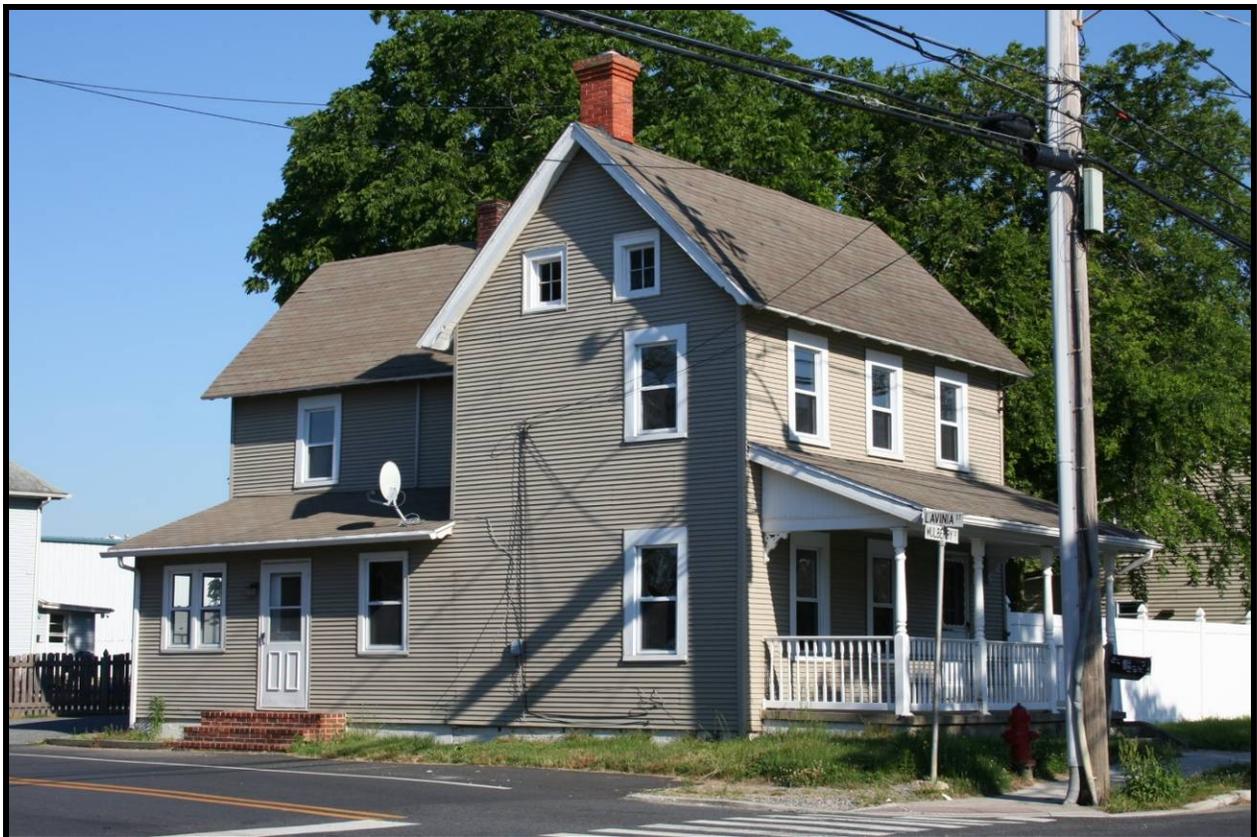
S-12022

311 Mulberry Street (1887 Map of Milton)

Property Type: Single-Family Dwelling, Three-Bay Vernacular with Italianate Detailing

This three-bay, two-and-a-half story, frame, Vernacular dwelling with Italianate detailing was constructed between 1868 and 1887. A two-story, cross-gabled addition and a single-story, shed-roofed addition have been added to the northeast rear elevation of the main side-gabled block. A hipped-roof, one-story, open porch with wooden posts is attached to the southwest façade and runs the entire length of the elevation. The southwest façade has a regular fenestration, with two two-over-two double-hung sash windows and three one-over-one double-hung sash windows. The southeast elevation has staggered fenestration with five one-over-one double-hung sash windows. The northwest elevation has three one-over-one double-hung sash windows. The northeast rear elevation has a one-over-one double-hung sash window. An interior brick chimney is centrally located on the main block near the southeast gable end and a second interior brick chimney is located in the cross gabled addition toward the northeast elevation. The exterior is sheathed in aluminum or vinyl siding and the roof material is grey asphalt shingles. The dwelling is an excellent example of the Three-Bay Vernacular Italianate style which was popular from the late 1860s to the early 1920s; it retains integrity of materials, workmanship, location, design, feeling, and setting, making it a contributing historic property for the expanded Milton Historic District.

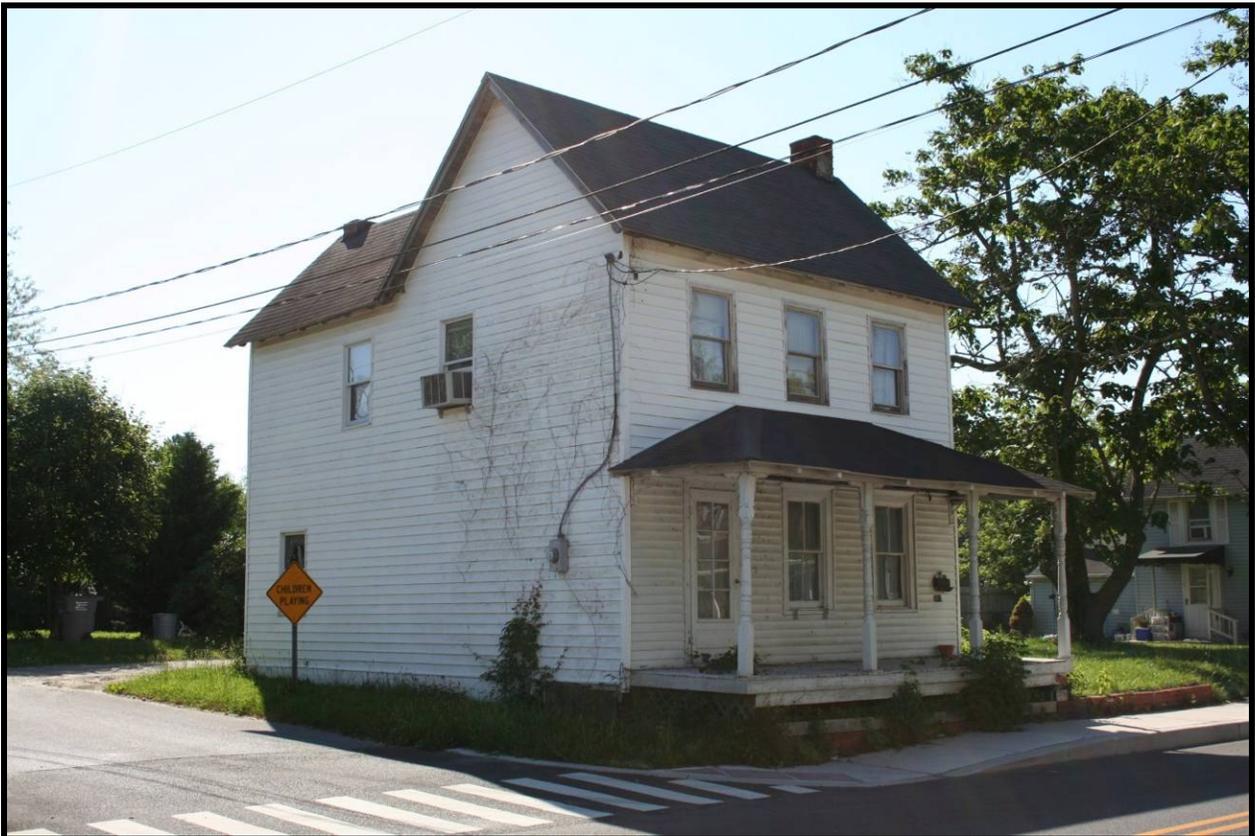
S-12032

312 Mulberry Street (P.B. Jackson House: 1868 Beers Map)

Property Type: Single-Family Dwelling, Three-Bay Vernacular with a Two-Bay Addition

This three-bay, two-and-a-half story, side-gabled, frame dwelling with an integrated two-bay addition was constructed prior to 1868. Later additions extend from the southwest elevation: the western-most shed-roofed addition is two stories high and has an attached single-story shed-roofed porch, while the eastern-most addition is one story and has a shed roof. The northeast elevation has regular fenestration with eight six-over-six double-hung sash windows and a horizontal sliding window on the second story, directly above the centrally-located door. A porch with wooden posts and a wooden railing runs the length of three bays on the northeast facade. The northwest elevation has a door as well as four three-over-three double-hung sash windows and two sliding windows. The southeast elevation has a door as well as four windows, two of which are horizontal sliding windows. A brick chimney is located on the main block toward the northwest elevation. The roof is covered in standing-seam sheet metal and the exterior of the dwelling is sheathed in aluminum or vinyl siding. Peter B. Jackson was a native of Delaware and owned the house in 1868. He was a farmer and his wife Elizabeth Jackson kept the house. Despite the major addition, this dwelling is a good example of the classic Three-Bay Vernacular style which was prevalent in Milton from the mid 19th to the early 20th centuries; it retains integrity of materials, workmanship, location, design, feeling, and setting, making it a contributing historic property for the expanded Milton Historic District.

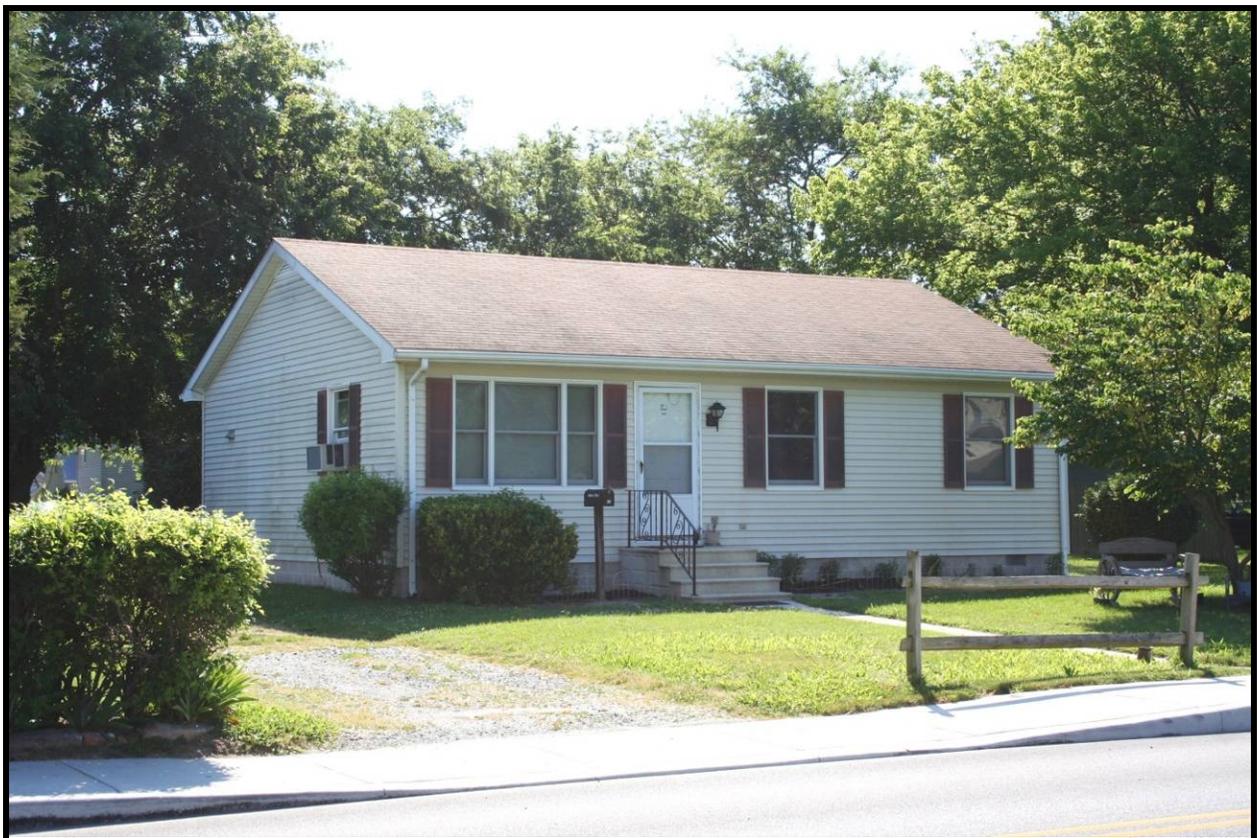
S-12002

401 Mulberry Street (1954 Aerial Map)

Property Type: Single-Family Dwelling, Minimal Ranch Style

This three-bay, one-and-a-half story, frame, Vernacular dwelling was constructed between 1937 and 1954. The southwest façade has a front-gabled, pent-roofed cover sheltering the off-center entrance door and three one-over-one double-hung sash windows, two of which are paired. The southeast elevation has a centrally-located door and three one-over-one double-hung sash windows while the northwest façade has three one-over-one double-hung sash windows. The northeast rear elevation has three one-over-one double-hung sash windows. A slightly off-center interior brick chimney is located along the ridge of the roof. The roof is covered in asphalt shingles and the exterior of the dwelling is sheathed in aluminum or vinyl siding. Due to its early 1950s construction date, this home is one of the earliest examples of a Ranch-style dwelling constructed in Milton and therefore part of a select few to be considered a contributing property for the Milton expanded historic District. This dwelling also retains integrity of design, materials, workmanship, location, and setting, further supporting the recommendation.

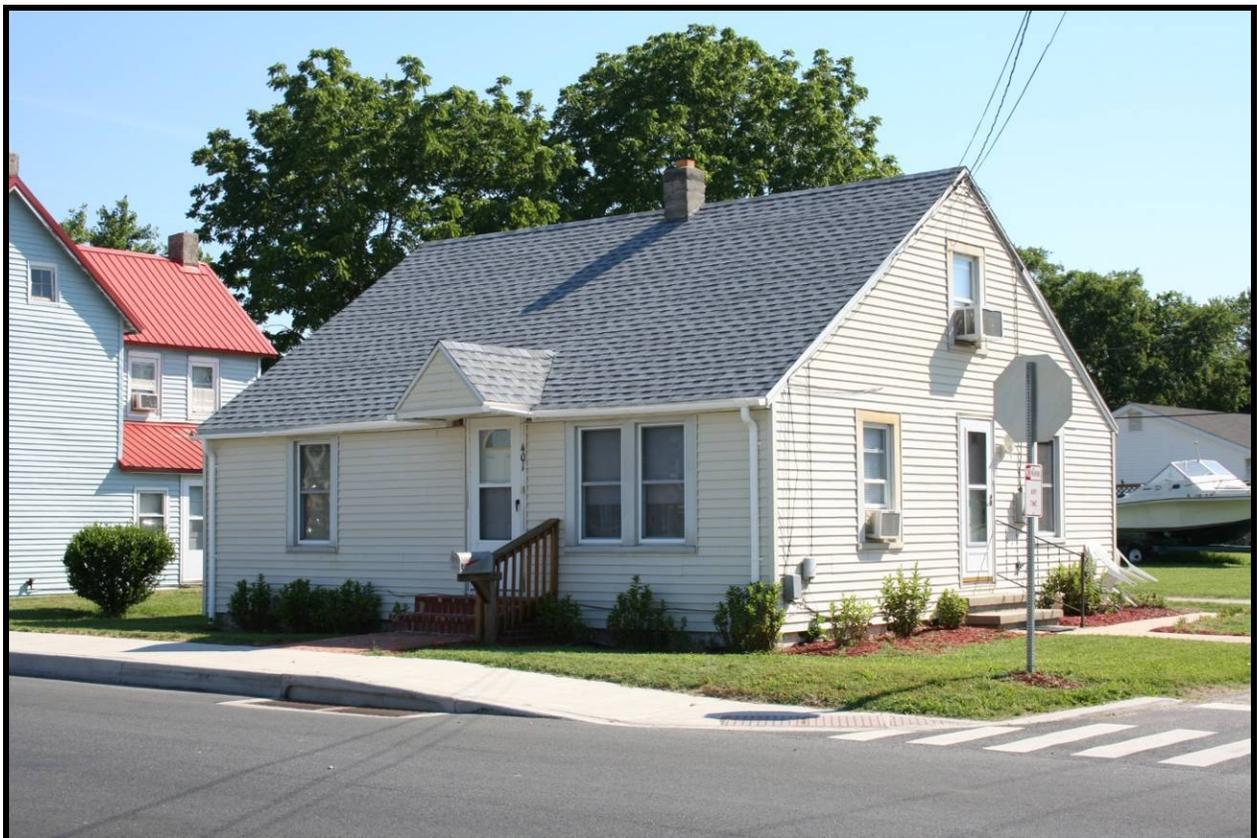
S-12003

403 Mulberry Street (George Prettyman House: 1887 Map of Milton)

Property Type: Single-Family Dwelling, Three-Bay Vernacular Style

This three-bay, two-and-a-half story, frame dwelling was constructed circa 1887. A two-story, cross-gabled addition has been added to the northeast elevation of the main side-gabled block, while a one-story shed-roofed addition is attached to the southeast elevation. A shed-roofed addition on the northwest elevation contains a door of unknown purpose. The southwest elevation has five one-over-one double-hung sash windows and the southeast elevation has four one-over-one double-hung sash windows and two four-pane casement windows. There is a door centrally-located on the southeast elevation of the shed-roofed addition. On the northwest elevation, the staggered fenestration is composed of six one-over-one double-hung sash windows and two four-pane casement windows. The one-over-one windows on the main block all have plain wood surrounds and inoperable louvered shutters, while the windows on the additions all have plain wood surrounds and no shutters. An interior brick chimney is located near the southeast gable end of the main block. Another interior brick chimney is located near the northeast elevation of the two-story cross-gabled addition. The roof is covered in standing-seam sheet metal and the exterior of the dwelling is sheathed in aluminum or vinyl siding. In 1887 George Prettyman owned the property; he was a brick mason and a native of Delaware. This dwelling is representative of the classic Three-Bay Vernacular style which was prevalent in Milton from the mid 19th to the early 20th centuries; it retains integrity of location, setting, design, workmanship, materials, and feeling, making it a contributing historic property for the expanded Milton Historic District.

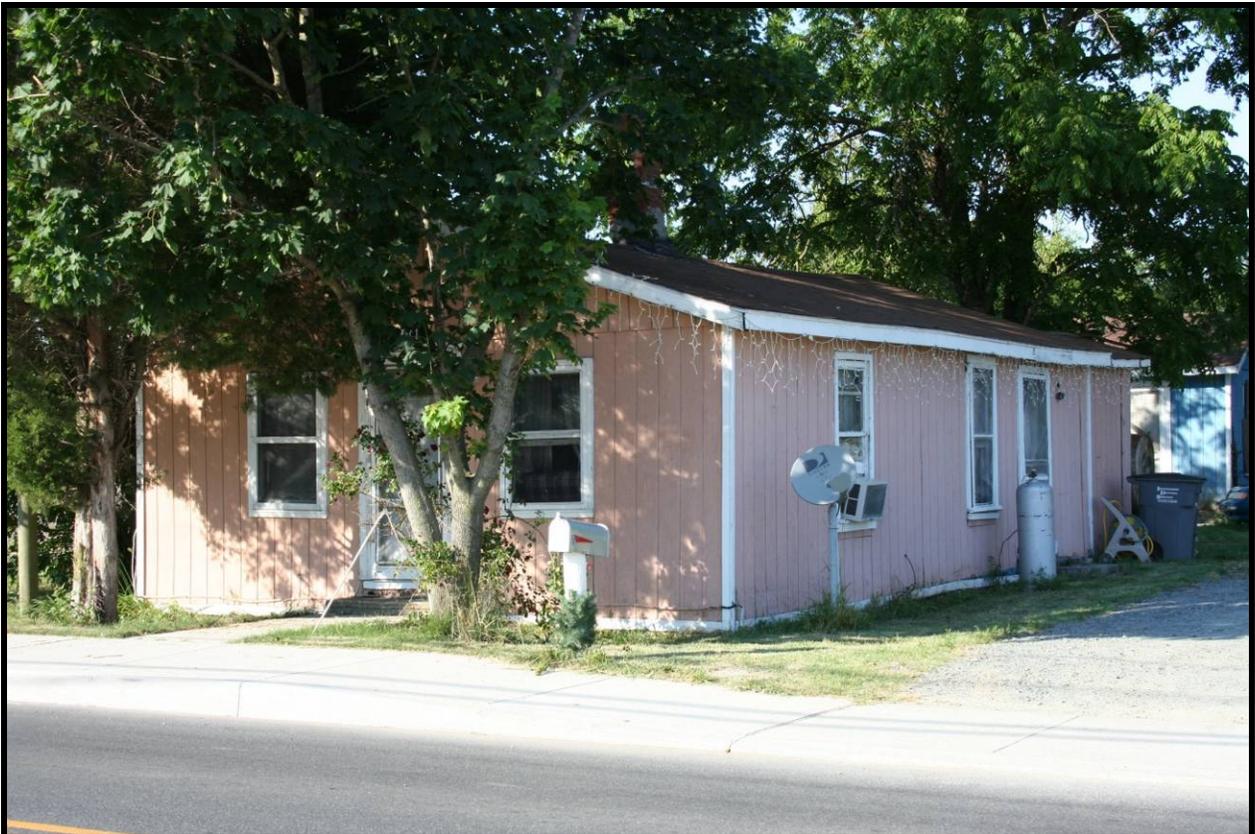
S-12005**423 Mulberry Street (J.H. Carey House (Belonged to his heirs: 1868 Beers Map))****Property Type: Single-Family Dwelling, Queen Anne Style**

This three-bay, two-and-a-half story, cross-gabled, frame Queen Anne dwelling was constructed prior to 1868. A one-story, shed-roofed addition is connected to the northeast rear elevation. A single-story, shed-roofed porch is supported by wooden spindle posts and wraps around the southwest and northwest elevations. The southwest façade has two doors, two small casement windows, and two double-hung sash windows. The southeast elevation has three casement windows and three one-over-one double-hung sash windows. The northwest elevation has four one-over-one double-hung sash windows and two casement windows. The northeast elevation has three one-over-one double-hung sash windows, one small casement window, and a door in the central bay. A brick interior chimney is located along the ridge of the main front-gabled block and another is located along the ridge of the side-gabled wing. The roof is covered in standing-seam sheet metal and the exterior of the dwelling is sheathed in aluminum or vinyl siding. According to historic maps, this property belonged to the heirs of J.H. Carey in 1868. This dwelling is a less elaborate version of the Queen Anne style homes which were popular in Milton from the late 1860s to the early 1920s; it retains integrity of design, materials, workmanship, feeling, location, and setting, making it a contributing historic property for the expanded Milton Historic District.

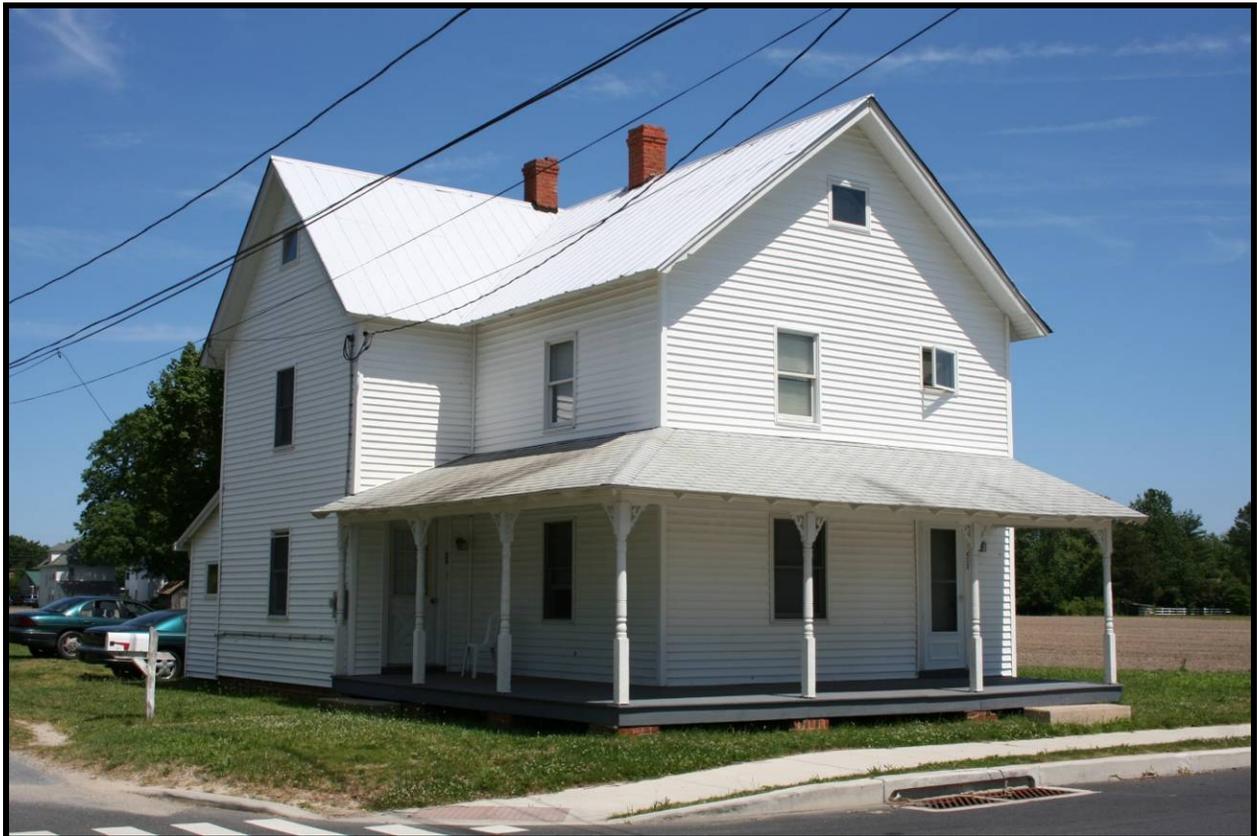
S-11965

501 Mulberry Street (2007 Aerial Map)

Property Type: Single-Family Dwelling, Composite House with Irregular Massing

This two-and-a-half story, cross-gabled, frame dwelling was constructed between 2001 and 2007. The southwest façade has two large shed-roofed porches flanking each side of the two-story cross-gabled front wing. Two shed-roofed wall dormers are located on both the southwest and northeast side of the roof. A rear one-car garage with a second-story living space is attached to the main dwelling by a two-story enclosed hallway. The dwelling is sheathed in vinyl siding and the roof is covered in asphalt shingles. This dwelling is considered a non-contributing property for the expanded Milton Historic District due to its recent construction date.

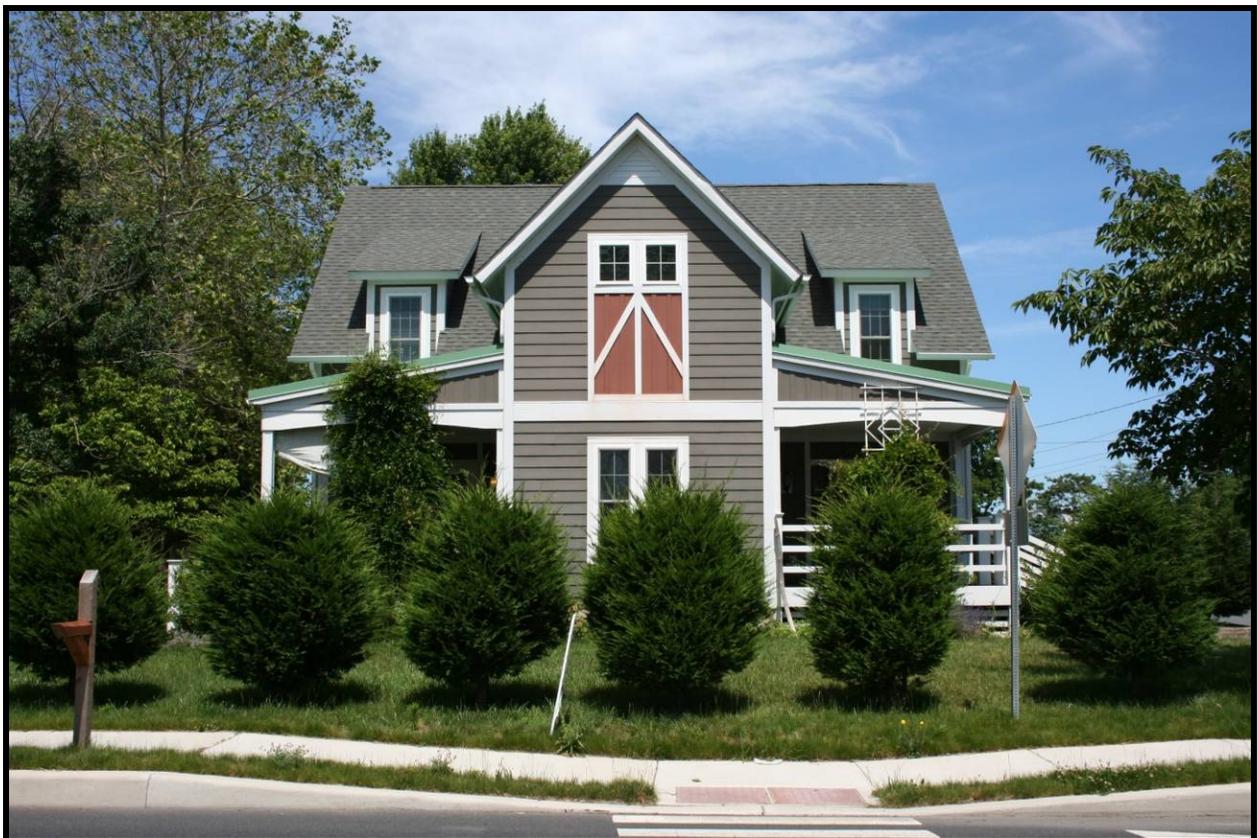
S-11964

503 Mulberry Street (1937 Aerial Map)

Property Type: Single-Family Dwelling, Two-Bay Front-Gabled Vernacular (Carpenter Gothic Details)

This two-bay, two-and-a-half story, frame, front-gabled Vernacular dwelling with Carpenter Gothic detailing was not featured on any of the Sanborn maps, but was constructed prior to 1937 according to aerial maps. Two additions were added to the northeast elevation: one with a shed roof and the other a hipped roof. The southwest façade has two small casement windows flanking a two-over-two double-hung sash window with an upper wooden triangular arch and four six-over-six double-hung sash windows, two of which are paired. An entrance door is located in the western bay on the front façade as well as an open hipped-roof porch with lattice work. The southeast elevation has at least three windows, while the northwest elevation has four six-over-six double-hung sash windows. A brick chimney is located near the eastern corner of the main block. The roof is covered in asphalt shingles, the front-gabled end has decorative verge board trim, and the rest of the building is sheathed in aluminum or vinyl siding. This dwelling's carpenter gothic details are rare in Milton; it retains integrity of location, setting, design, workmanship, materials, and feeling, making it a contributing historic property for the expanded Milton Historic District.
