APPENDIX A:
INVENTORY OF SURVEYED
PROPERTIES

MILTON • DELAWARE

APPENDIX A

This appendix begins with a chart of all the resources surveyed in Milton. The chart includes CRS numbers, address, function, style of architecture, the date the property first appears on a historic map, and whether or not the property should be considered contributing or non-contributing to a potential expanded National Register of Historic Places District in Milton or a local historic zone. Following the chart, descriptions of the surveyed resources provide more detailed information on the historic name of the property, function, a brief history, and a physical description of the property. The description also provides a short rationale for the property's recommendation for inclusion or exclusion to the National Register District. Photographs of each main building or resource appear with the descriptions.

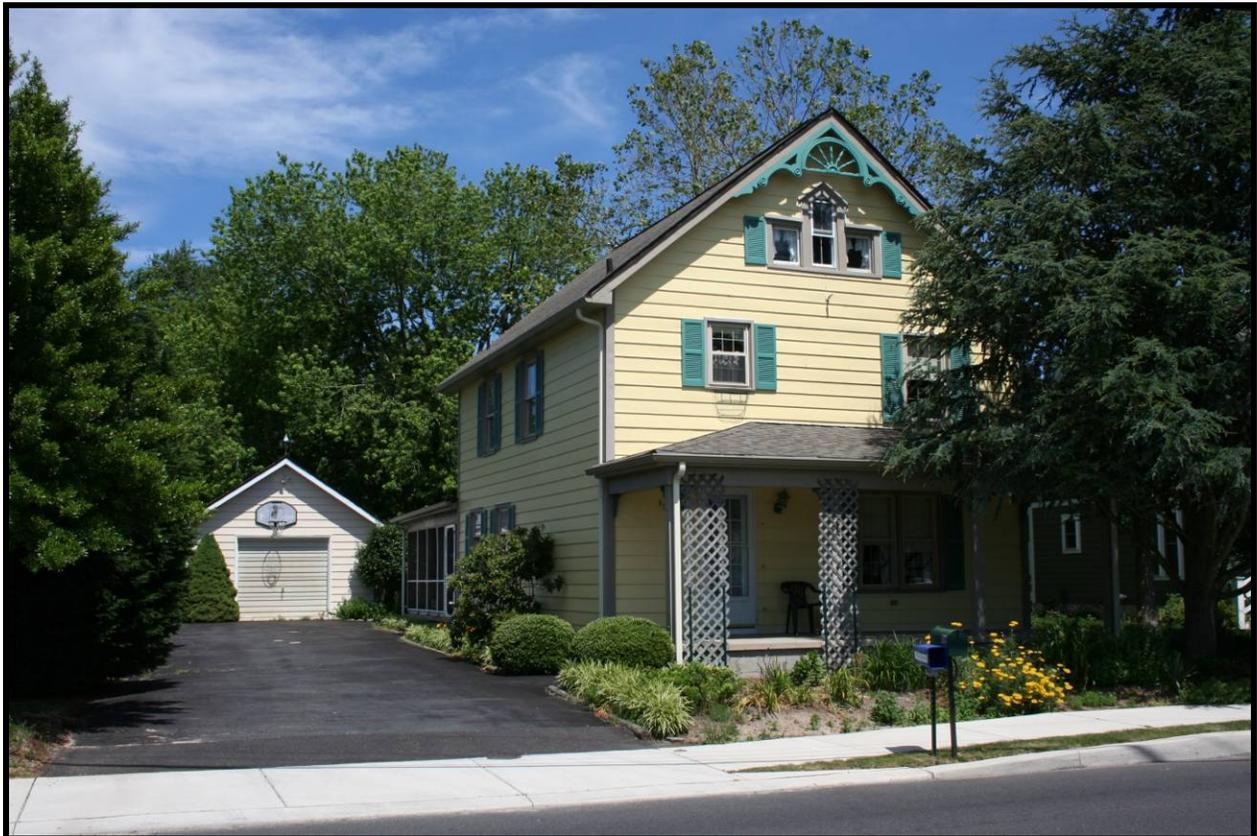
S-11958

515 Mulberry Street (1961 Aerial Map)

Property Type: Single-Family Dwelling, Three-Bay Front-Gabled Vernacular Style

This three-bay, two-story, side-hall plan, vernacular frame dwelling was constructed between 1954 and 1961. A single-story gable addition and a shed-roofed addition were added to the northeast elevation of the main front-gabled block. An open shed-roofed porch runs the length of the southwest façade and is supported by three square columns. A door is located in the far western bay on the southwest façade as well as four one-over-one double-hung sash windows. The southeast elevation has six one-over-one double sash windows with a door located in the far northern bay. The southwest façade has four one-over-one double sash windows. All of the windows have inoperable solid shutters. A brick interior chimney is located near the rear of the dwelling on the ridge of the main block. The roof is covered in asphalt shingles and the exterior of the dwelling is sheathed in aluminum or vinyl siding. This dwelling's unique, front-gabled, three-bay style is not common in Milton; it retains integrity of location, setting, design, workmanship, materials, and feeling, making it a contributing historic property for the expanded Milton Historic District.

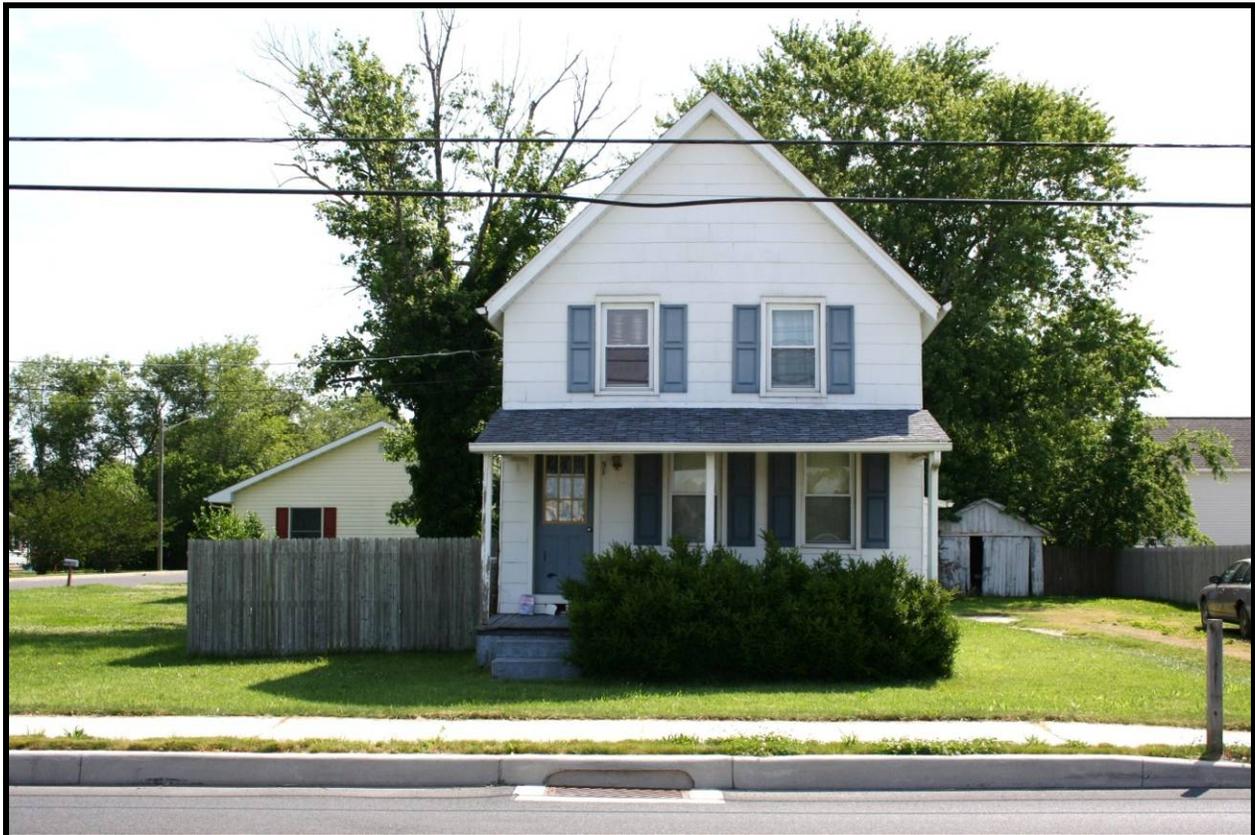
S-11946

517 Mulberry Street (1954 Aerial Map)

Property Type: Single-Family Dwelling, Craftsman Style

This three-bay, one-and-a-half story, front-gabled, Craftsman style frame dwelling was constructed between 1937 and 1954. The southwest façade has a hipped-roof porch supported by square wooden posts and a small shed-roofed porch addition is connected to the northeast elevation. Three sets of paired one-over-one double-hung sash windows can be found on the southwest elevation. On the three remaining elevations the windows are all single one-over-one double-hung sash. An interior brick chimney is located on the eastern slope of the ridge toward the center of the dwelling. Asphalt shingles cover the roof and the exterior of the dwelling is sheathed in aluminum or vinyl siding. The dwelling is a good example of the Craftsman style which was popular in Milton from the early 1920s to the late 1930s; it retains integrity of materials, workmanship, design, location, and setting, making it a contributing historic property for the expanded Milton Historic District.

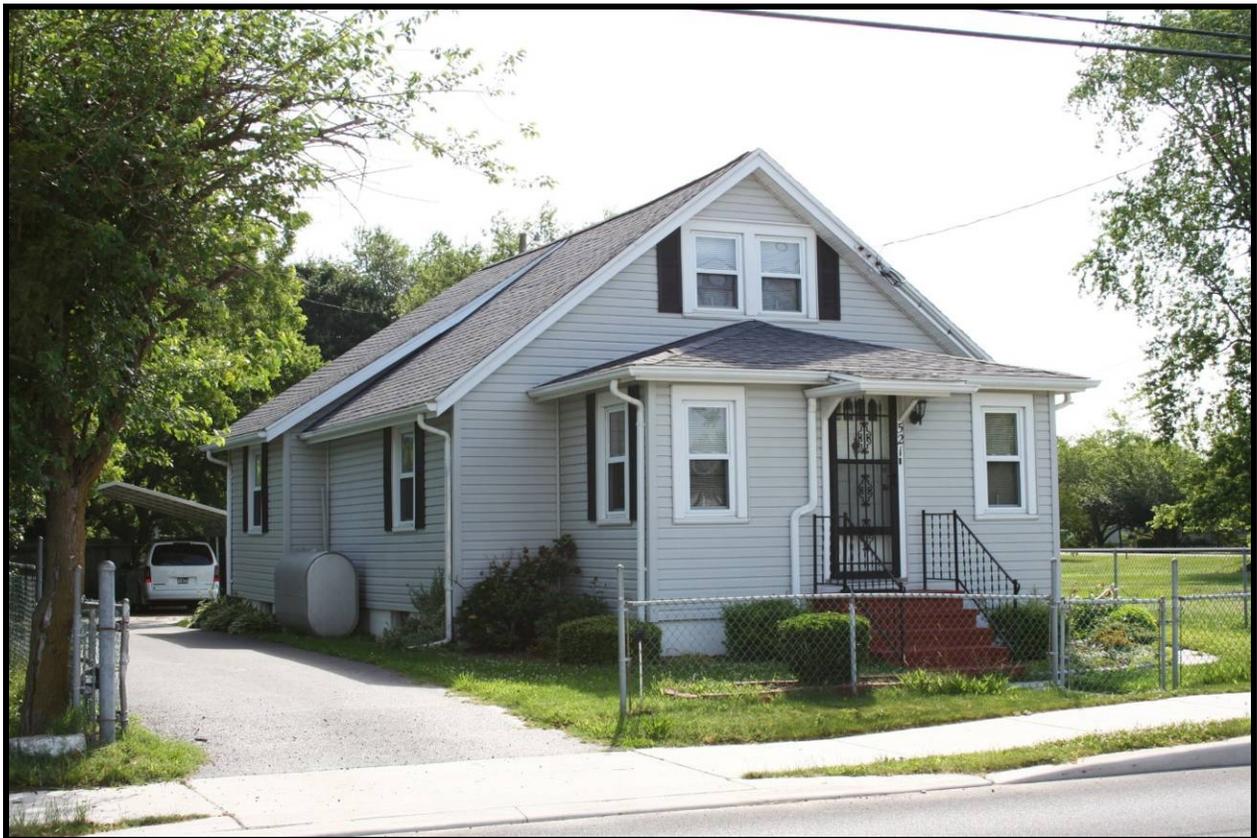
S-11944

523 Mulberry Street (1937 Aerial Map)

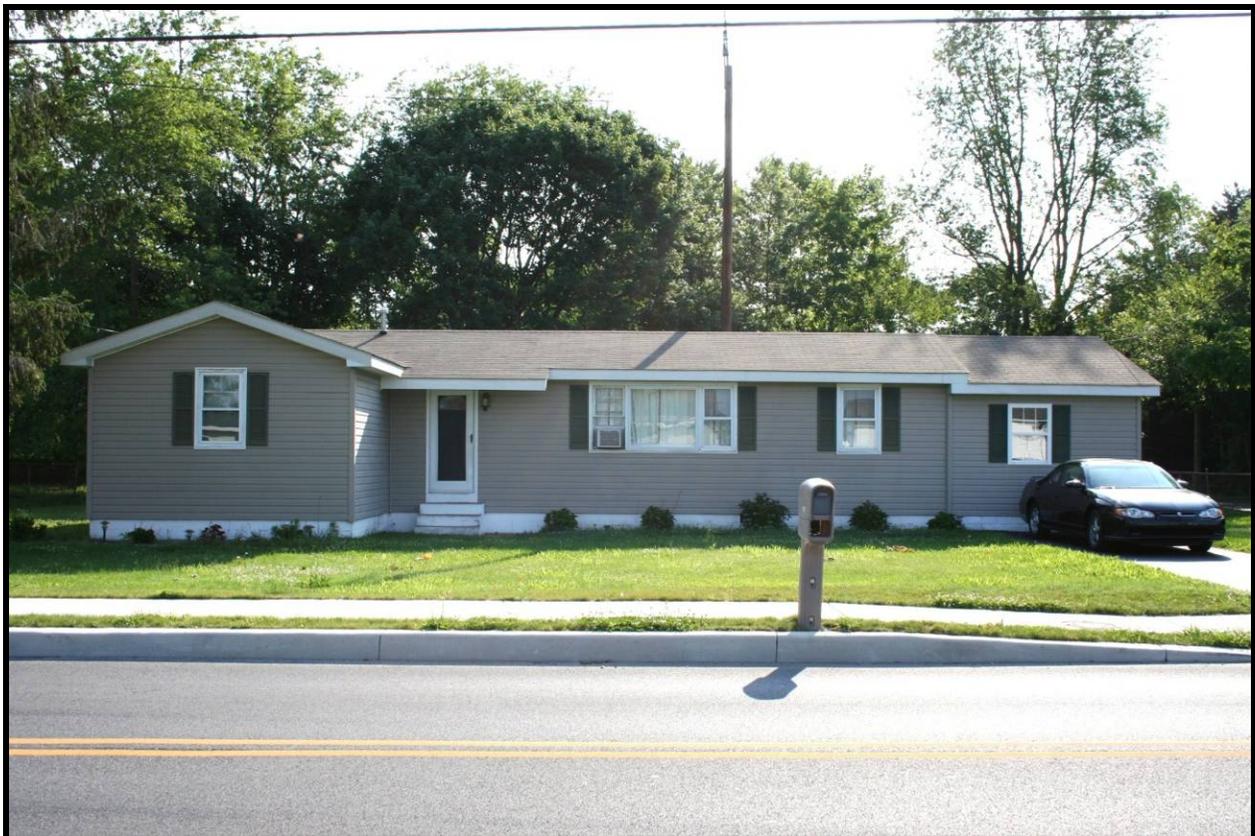
S-11929

603 Mulberry Street (1968 Aerial Map)

Property Type: Single-Family Dwelling, Ranch Style

This single-story, five-bay Ranch was constructed between 1961 and 1968. On the southwest façade, the centrally-located entrance is flanked on each side by two horizontal sliding windows which have inoperable louvered shutters. The southeast elevation has two horizontal sliding windows as well which are flanked by inoperable louvered shutters. Located south of the ridge toward the northwest elevation is an interior brick chimney. The front façade is stone while the three remaining façades are finished with board and batten siding. The roof is covered with asphalt shingles. This dwelling is considered a non-contributing property for the expanded Milton Historic District.

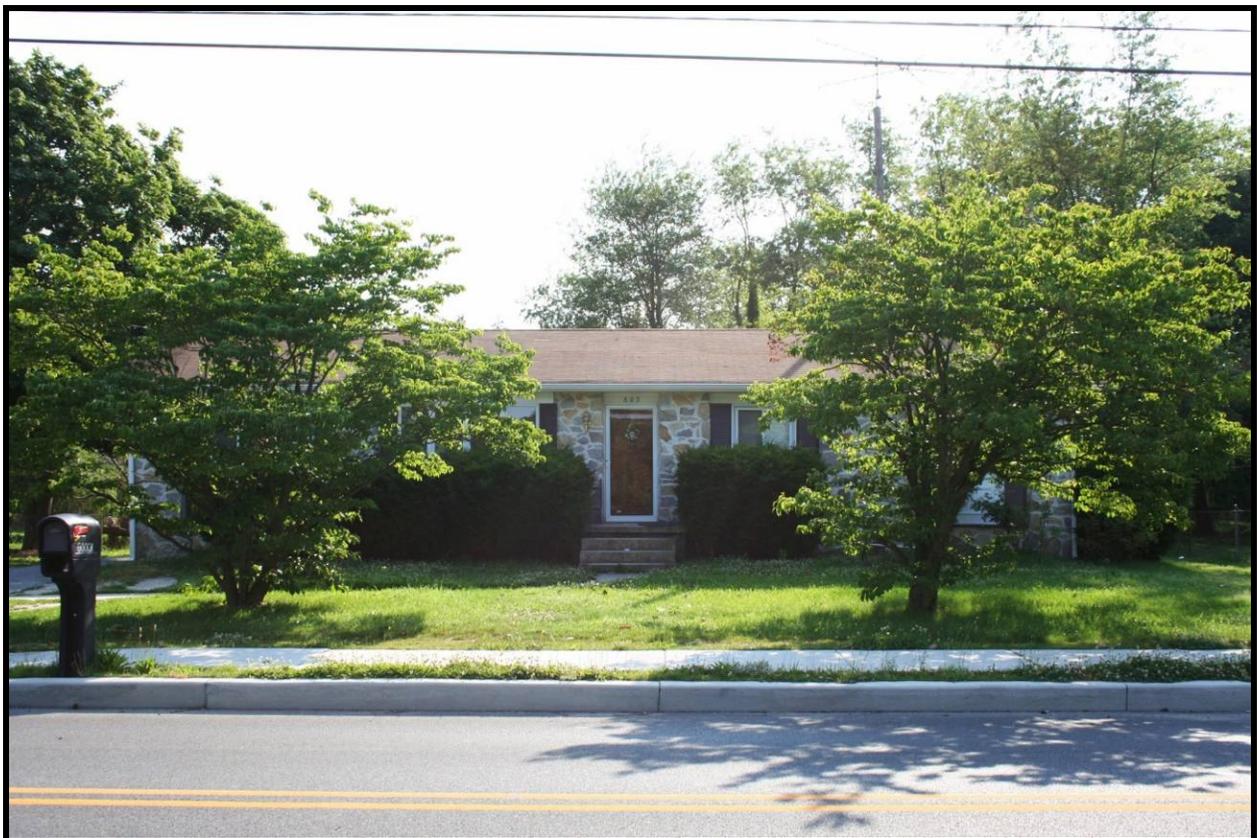
S-11928

605 Mulberry Street (1968 Aerial Map)

Property Type: Single-Family Dwelling, Ranch Style

This one-story, six-bay, side-gabled Ranch was constructed between 1961 and 1968. Four single six-over-six, double-hung sash windows and a pair of six-over-six double-hung sash windows are located on the southwest façade; each window has inoperable paneled shutters. The southeast and northwest gable ends have no openings. Asphalt shingles cover the roof and the exterior of the dwelling is sheathed in aluminum or vinyl siding. This dwelling is considered a non-contributing property for the expanded Milton Historic District due to its construction date.

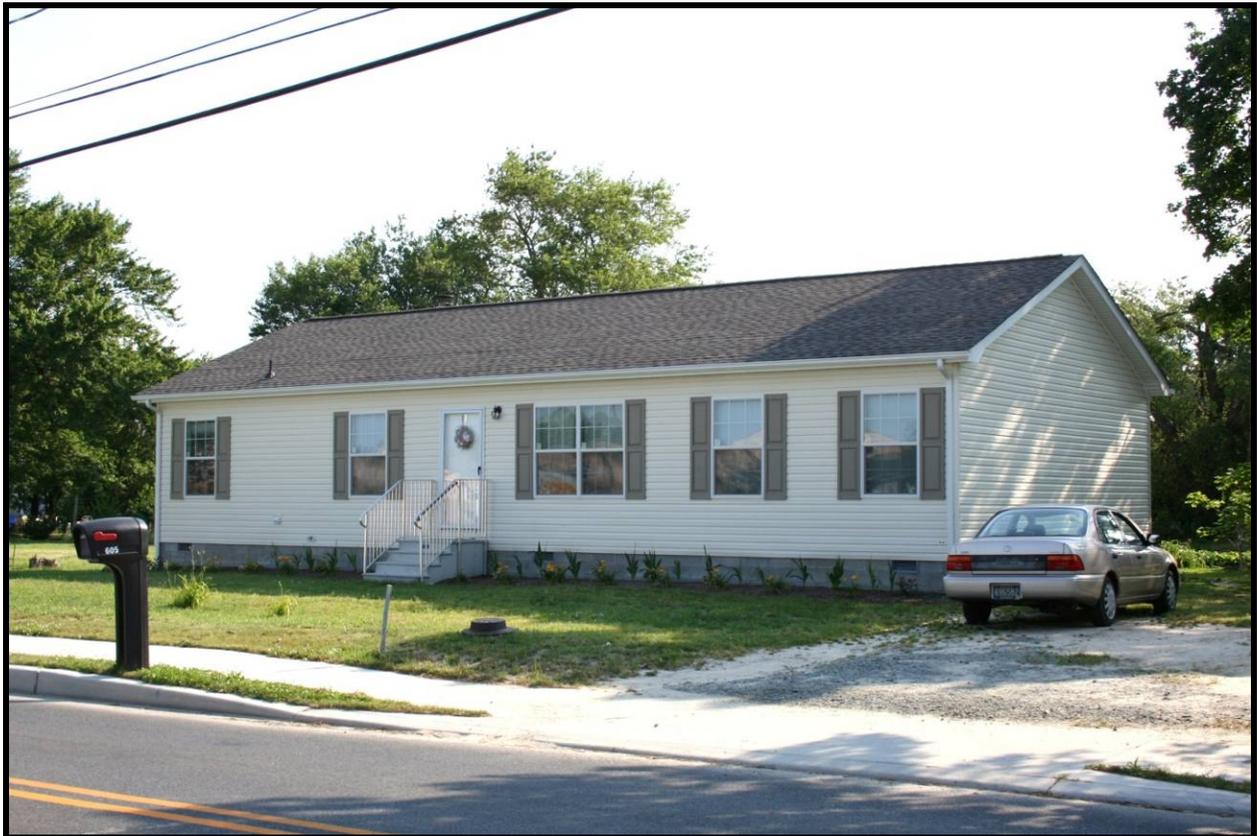
S-11927

607 or 609 Mulberry Street (1954 Aerial Map)

Property Type: Single-Family Dwelling, Minimal Ranch Style

This one-and-a-half story, four-bay, side-gabled, Minimal Ranch style frame dwelling was constructed between 1937 and 1954. The original structure was a three bay, center-hall plan until a side-gabled addition was attached to the southeast elevation, converting the three-bay into current four-bay configuration. On the southwest façade of the main block are two sets of paired one-over-one double-hung sash windows on either side of the door, as well as a single one-over-one double-hung sash window on the addition. All windows on the southwest elevation are flanked by inoperable louvered shutters, while all other windows on the three remaining elevations are one-over-one double-hung sash without shutters. A brick interior chimney is located on the original block on the southeast gable end. The roof is covered in standing-seam sheet metal and the exterior was constructed with concrete block. Due to its early 1950s construction date, this home is one of the earliest examples of a Ranch-style dwelling constructed in Milton and therefore part of a select few to be considered a contributing property for the Milton expanded historic District. This dwelling also retains integrity of design, materials, workmanship, location, felling, and setting, further supporting the recommendation.

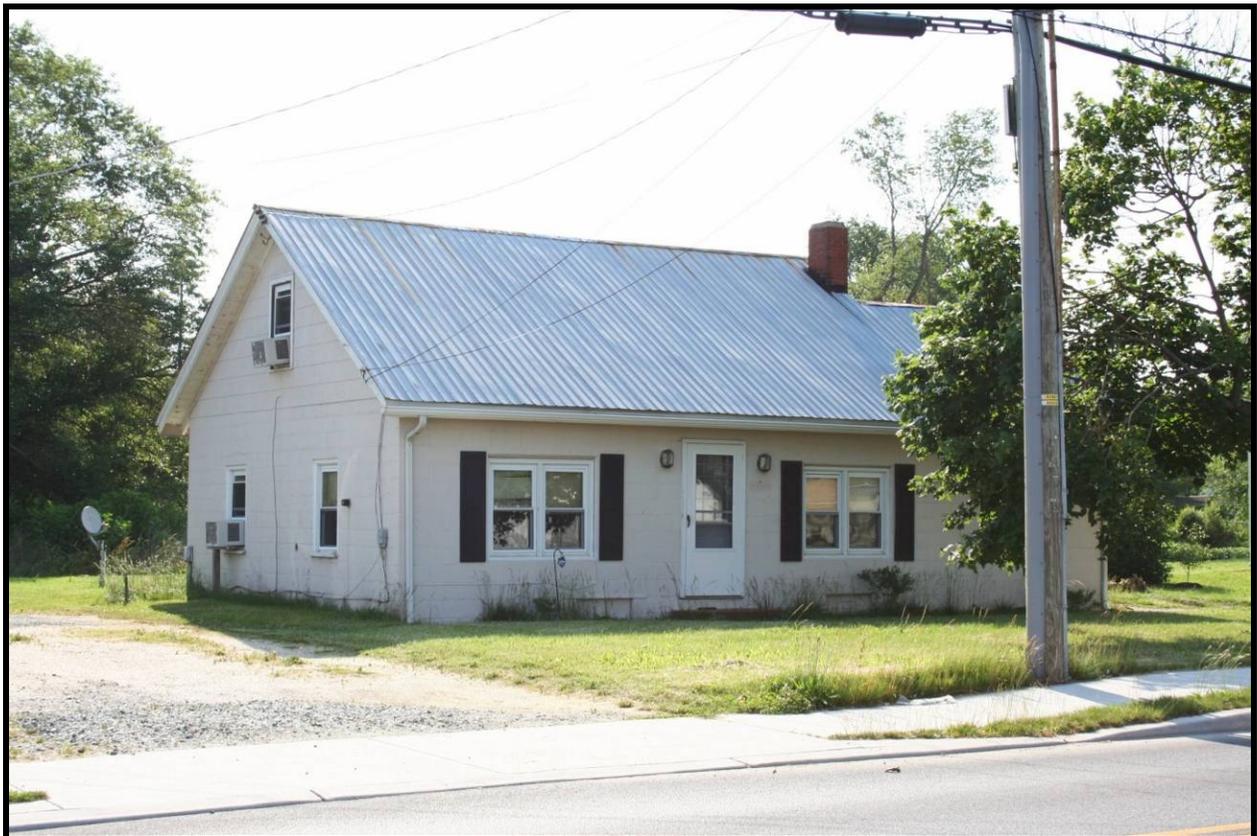
S-11926

611 Mulberry Street (1954 Aerial Map)

Property Type: Single-Family Dwelling, Three-bay Vernacular with Greek Revival Detailing

This one-and-a-half story, four-bay, side-gabled, frame dwelling was constructed between 1937 and 1954. A large, single-story, shed-roofed addition has been added on the northeast rear elevation. On the southwest façade, the shed-roofed porch which runs the full length of the façade has been enclosed and five nine-over-nine double-hung sash windows are positioned around the entrance door. On the upper floor of the southwest elevation are three one-over-one double-hung sash windows. The southeast elevation has a bay window on the main block as well as a one-over-one double-hung sash window at the upper level (flanked by inoperable louvered shutters). The northwest elevation has three one-over-one double-hung sash windows flanked by inoperable louvered shutters and a brick chimney which is located toward the rear of the main block. Asphalt shingles cover the roof and the exterior of the dwelling is sheathed in aluminum or vinyl siding. This dwelling is representative of the classic Three-Bay Vernacular style which was prevalent in Milton from the mid 19th to the early 20th centuries; the Greek Revival details are only found on few other Three-Bay Vernacular home throughout the town. It retains integrity of location, setting, design, workmanship, materials, and feeling, making it a contributing historic property for the expanded Milton Historic District.

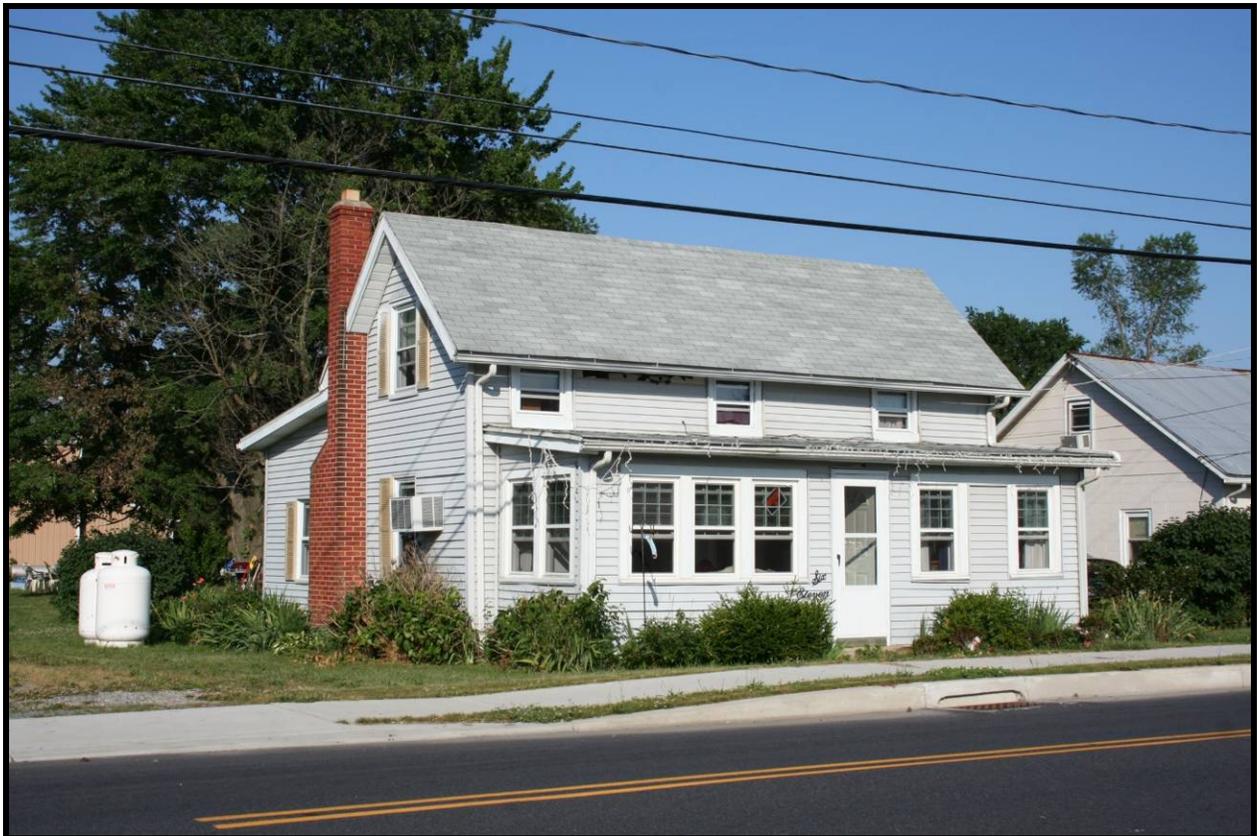
S-11925

615 Mulberry Street (1961 Aerial Map)

Property Type: Single-Family Dwelling, Cape Cod Style Cottage

This one-and-a-half story, two-bay, frame, Cape Cod style dwelling was constructed between 1954 and 1961. It appears that no major changes have been made on the original side-gabled structure. The southwest façade has a small pent roof over the entrance door and stoop along with a pair of six-over-six double-hung sash windows. The southeast elevation has a four six-over-six double-hung sash windows surrounding a door. An interior brick chimney is located on the northeast slope of the green asphalt-shingled roof and the exterior of this dwelling is sheathed in asbestos shingles. Simple Cape Cod style dwellings began to appear in Milton during the early 1920s and continued in popularity until about 1960. This dwelling retains integrity of location, setting, design, workmanship, materials, and feeling, making it a contributing historic property for the expanded Milton Historic District.

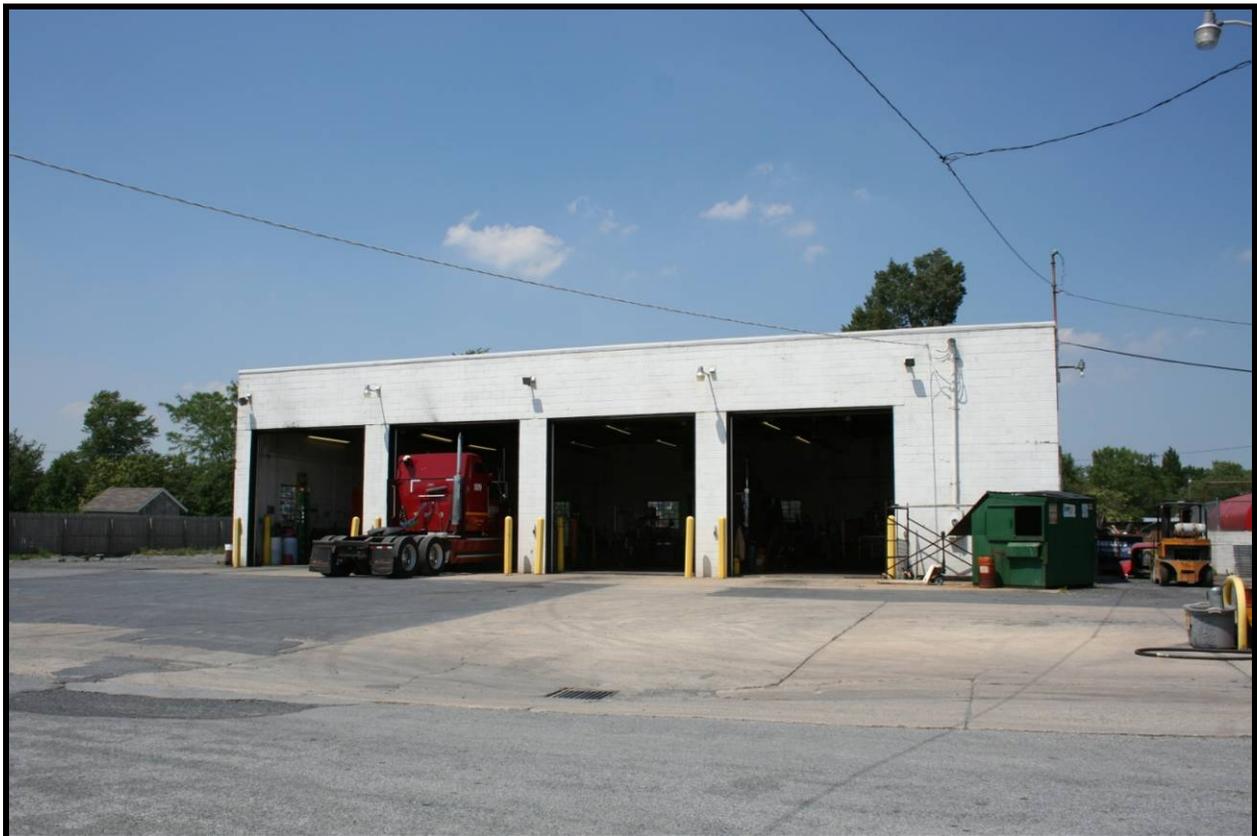
S-11916

Reed's Garage: Parcel #29.00 New Street (1992 Aerial Map)

Property Type: Commercial space, "Reed's Garage" (Service Station)

This four-bay, single-story, concrete block structure was built between 1968 and 1992 and currently functions as Reed's Garage. The southwest façade has four large roll-up garage doors. The southeast elevation has two doors located towards the southern corner as well as a four-pane window, a nine-pane window, and a double-hung sash window. The northwest elevation has four nine-pane windows which are evenly spaced. This dwelling is considered a non-contributing property for the expanded Milton Historic District due to its construction date.

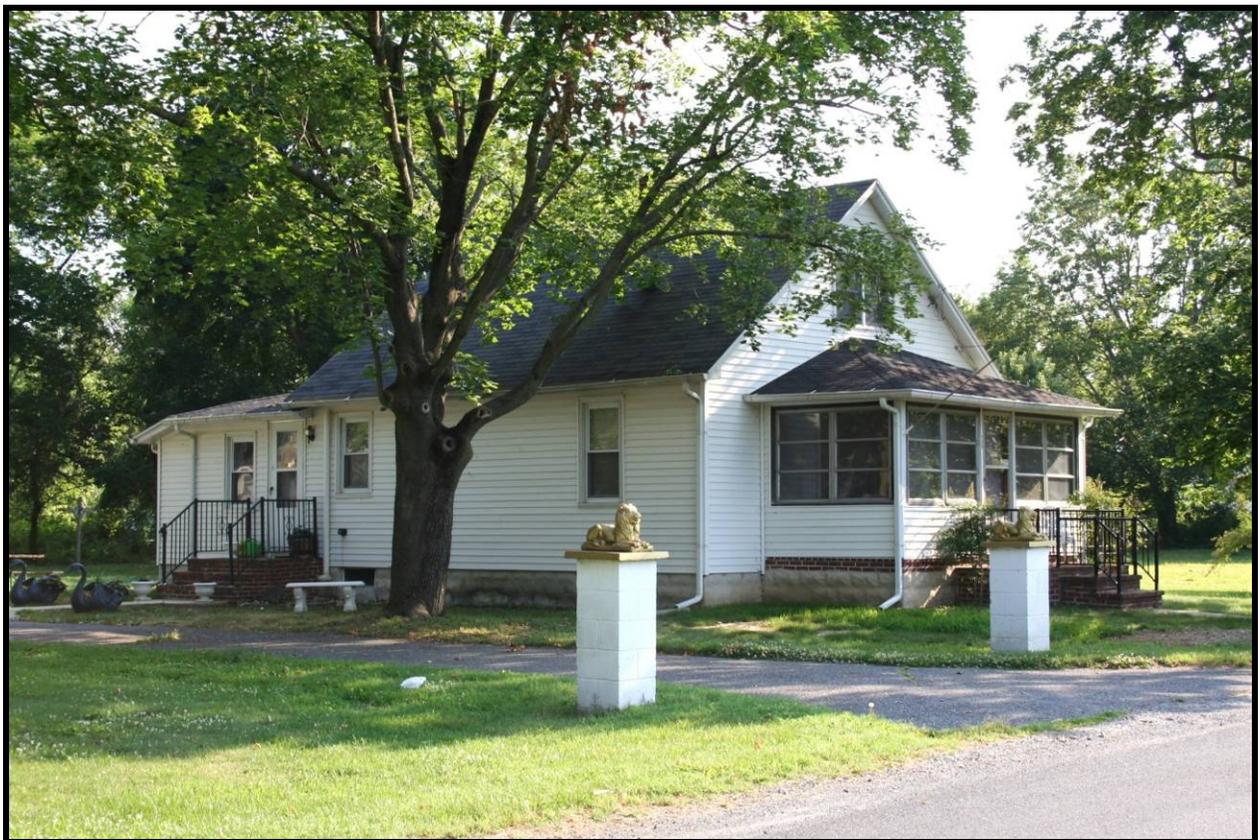
S-11933

108 Orchard Street (1954 Aerial Map)

Property Type: Single-Family Dwelling, Craftsman Style

This three-bay, frame, front-gabled, one-and-a-half story Craftsman style dwelling was built between 1937 and 1954. The original rectangular dwelling has two, one-story telescoping additions. The northwest addition has a hipped roof and is attached to the main block, while the second addition has a shed roof and is integrated into the rear of the first addition. The enclosed front porch on the southeast facade has a hipped roof, paired tripartite windows, and a centrally-located door. An interior brick chimney is located on the main block toward the center of the dwelling. Windows on the main block are double-hung sash with aluminum surrounds. The roof is covered in asphalt shingles and the exterior of the dwelling is sheathed in vinyl siding. Located to the northwest of the building are two detached front-gabled outbuildings. The dwelling is a good example of the Craftsman style which was popular in Milton from the early 1920s to the late 1930s; it retains integrity of materials, workmanship, design, setting, location, and setting, making it a contributing historic property for the expanded Milton Historic District.

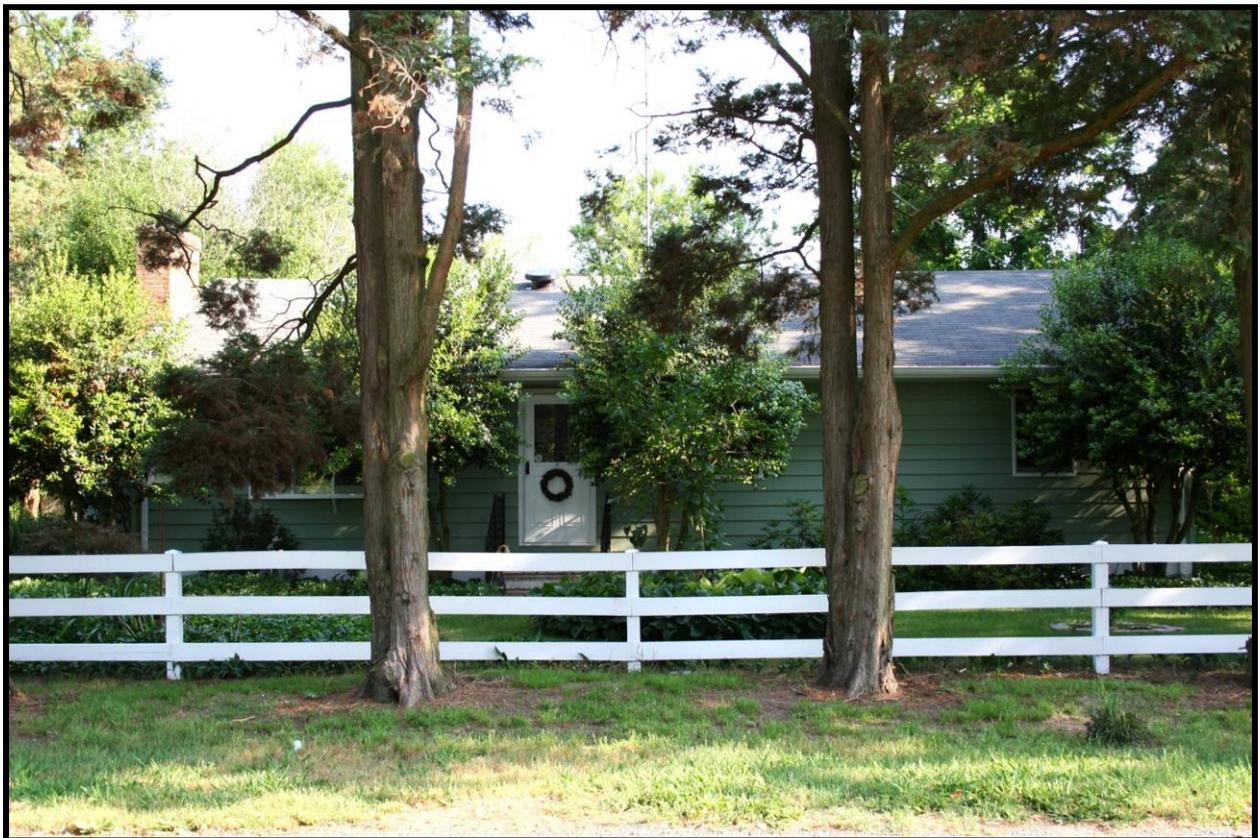
S-11932

110 Orchard Street (1992 Aerial Map)

Property Type: Single-Family Dwelling, Ranch Style

This four-bay, frame, single-story, side-gabled Ranch was built between 1968 and 1992. A central rear addition with a gable roof is attached to the northwest side of the main block. A second addition is connected to the earlier addition at the northwest side and runs parallel to the main block. A third lean-to addition was added on the southwest side of the main block and has a shed roof. The fenestration is irregular, with one-over-one double-hung sash windows and a tripartite modern bay window on the southeast façade. The house is sheathed with vinyl or aluminum siding and has an asphalt-shingled roof. An exterior brick chimney is located on the southwest gable end. This dwelling is considered a non-contributing property for the expanded Milton Historic District due to its construction date.

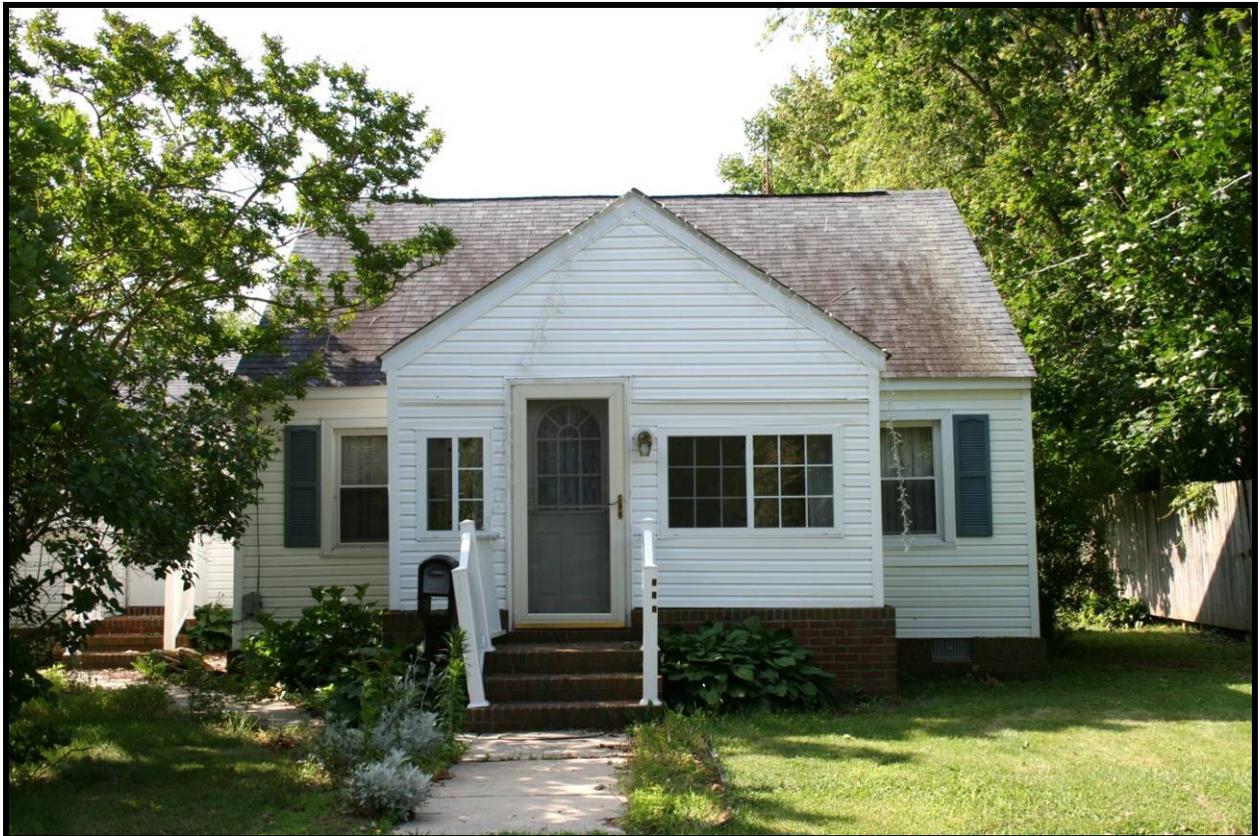
S-11940

111 Orchard Street (1954 Aerial Map)

Property Type: Single-Family Dwelling, Cross-Plan Cape Cod Style

This one-and-a-half story, frame, eight-bay, Cape Cod style dwelling was built between 1937 and 1954. The main side-gabled block has a cross-gabled entrance projecting from the northwest façade. A one-story rectangular addition located on the east corner of the main block has a salt box roof which is parallel to the roof of the main structure. On the southeast side of the first addition is a one-story shed-roofed addition. Fenestration is irregular with a mix of one-over-one double-hung sash windows, three-over-three horizontal sliding sash windows, nine-over-nine horizontal sliding sash windows, and a bay window which is comprised of a stationary pane flanked by one-over-one hung sash windows. On the main block, two vinyl shutters can be found on the northwest façade, with one on each of the windows closest to the corners. The roof is covered in asphalt shingles and the exterior is sheathed in vinyl siding. This dwelling is considered a non-contributing property for the expanded Milton Historic District due to loss of integrity in design and materials.

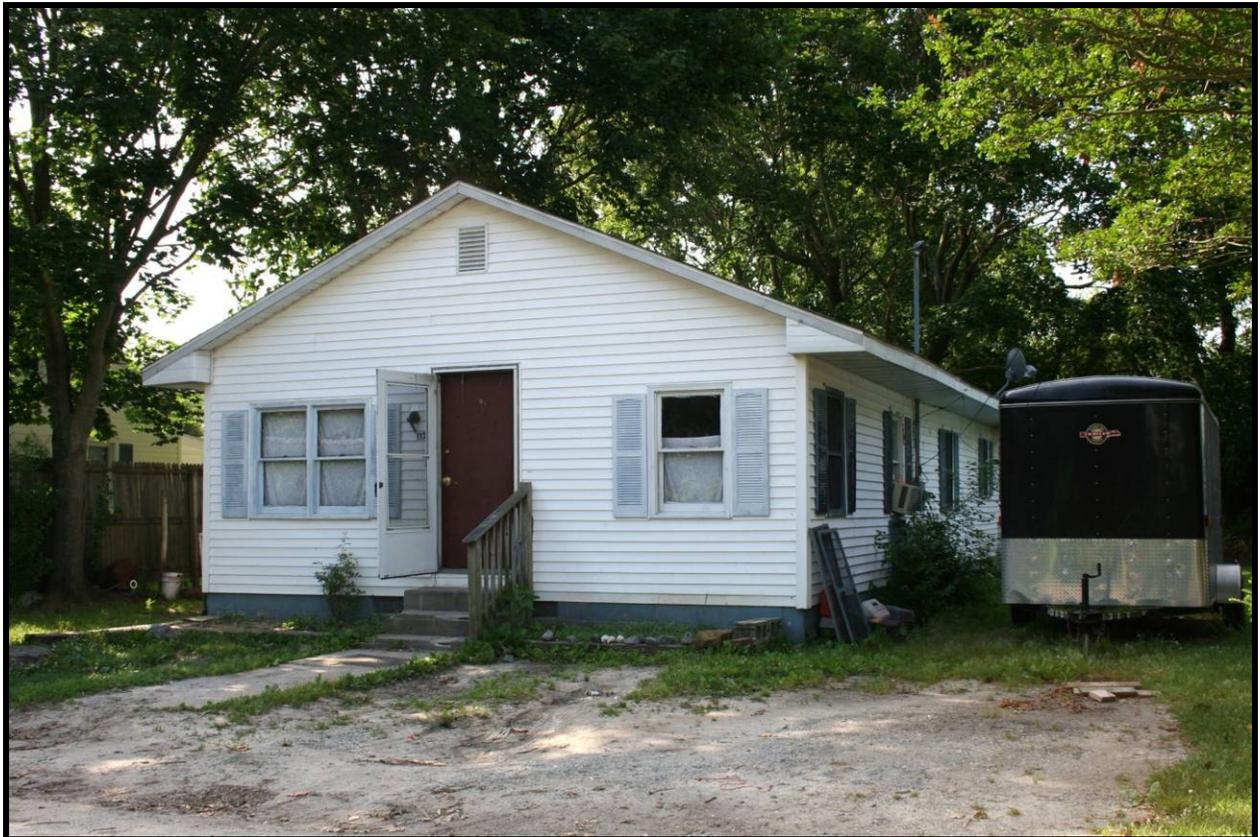
S-11941

113 Orchard Street (1954 Aerial Map)

Property Type: Single-Family Dwelling, Ranch Style

This single-story, frame, three-bay, front-gabled Ranch was built between 1937 and 1954. All the windows are one-over-one double-hung sash with plain aluminum surrounds and a pair of inoperable vinyl louvered shutters. A brick chimney is located on the exterior of the northeast façade and the exterior walls are covered in vinyl or aluminum siding. Due to its early 1950s construction date, this home is one of the earliest examples of a Ranch-style dwelling constructed in Milton and therefore part of a select few to be considered a contributing property for the Milton expanded historic District. This dwelling also retains integrity of design, location, and setting, further supporting the recommendation.

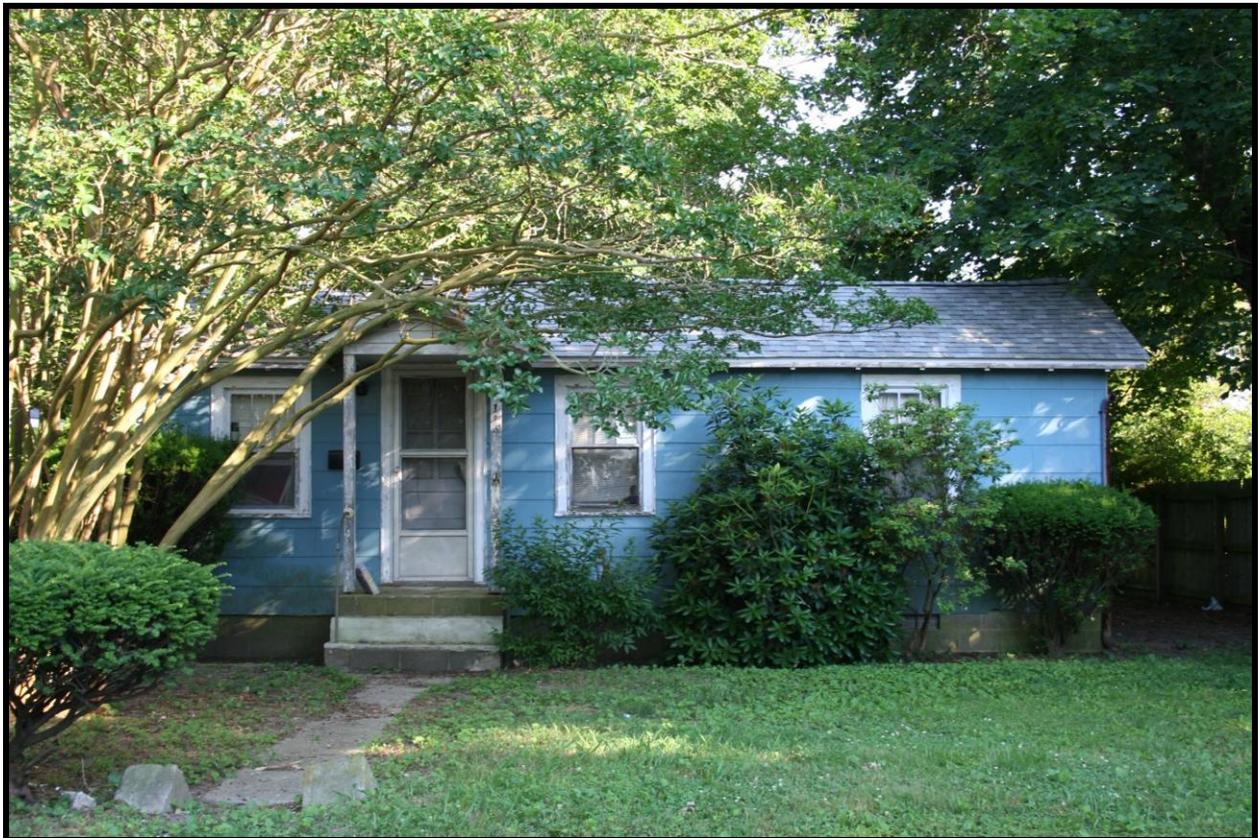
S-11942

115 Orchard Street (1954 Aerial Map)

Property Type: Single-Family Dwelling, Ranch Style

This single-story, frame, four-bay, side-gabled Ranch was built between 1937 and 1954. The southeast elevation has a shed-roofed addition which runs the length of the façade and the northwest façade has a small cross-gabled roof with two square posts which covers the front stoop. The windows on the northwest façade of the main block are three-over-one double-hung sash with wood trim surrounds. The addition has a four-pane window which is visible on the northeast side of the structure. The roof is covered in asphalt shingles and has exposed rafters and open eaves. Asbestos shingles sheath the entire dwelling. Due to its early 1950s construction date, this home is one of the earliest examples of a Ranch-style dwelling constructed in Milton and therefore part of a select few to be considered a contributing property for the Milton expanded historic District. This dwelling also retains integrity of design, feeling, materials, workmanship, location, and setting, further supporting the recommendation.

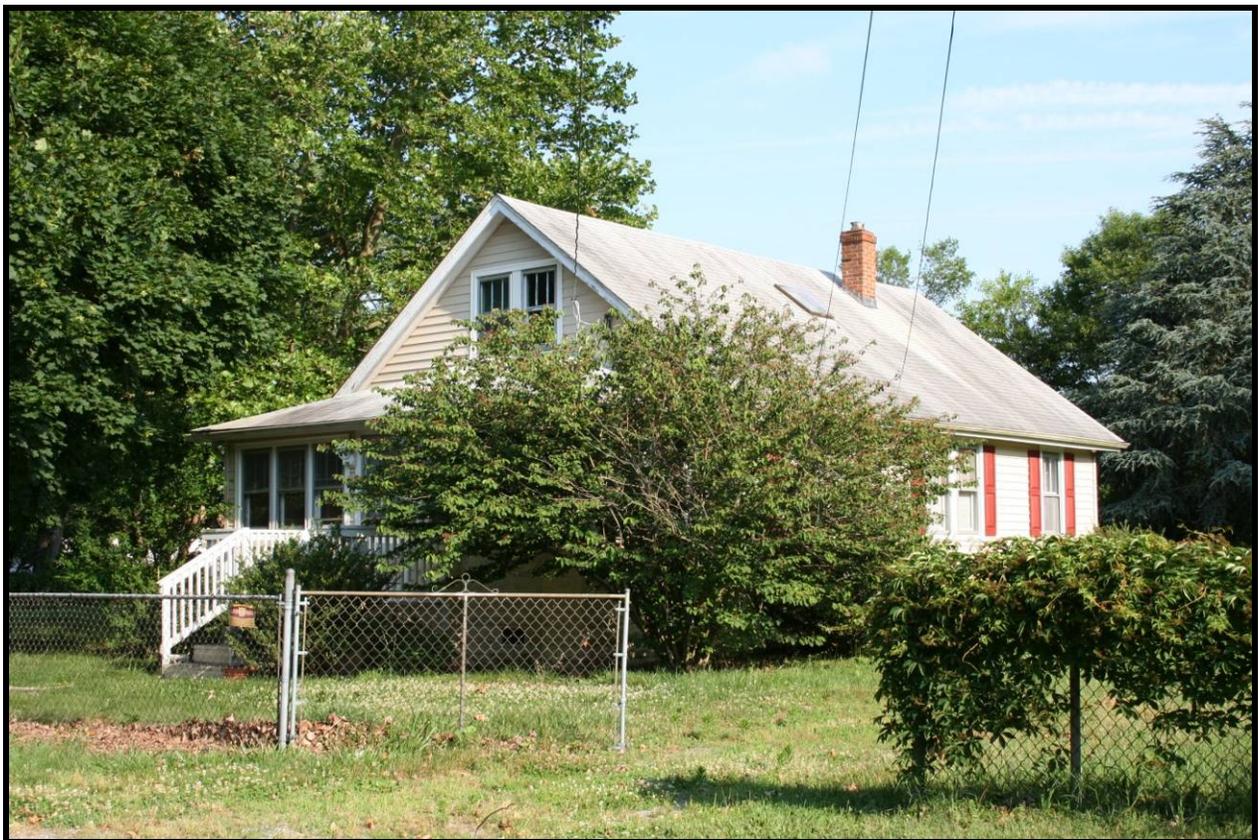
S-11931

118 Orchard Street (1954 Aerial Map)

Property Type: Single-Family Dwelling, Craftsman Style

This one-and-a-half story, frame, three-bay, front-gabled, Craftsman style dwelling was built between 1937 and 1954. The hipped-roof porch on the southeast façade has been enclosed and has a wood deck-style landing with wooden railings. The brick interior chimney is located on the northeast side of the roof, east of the ridge, near a modern skylight. Boxed eaves run the entire perimeter of the structure. Windows on the structure are three-over-one double-hung sash with plain aluminum surrounds and each window is surrounded by inoperable panel style shutters. The enclosed porch has an arrangement of adjacent tripartite windows with no shutters. The exterior of the building is sheathed in vinyl siding with rusticated concrete blocks rising to the windows on the front (southeast) elevation. The roof is covered in asphalt shingles. The dwelling is a good example of the Craftsman style which was popular in Milton from the early 1920s to the late 1930s; it retains integrity of materials, workmanship, design, feeling, location, and setting, making it a contributing historic property for the expanded Milton Historic District.

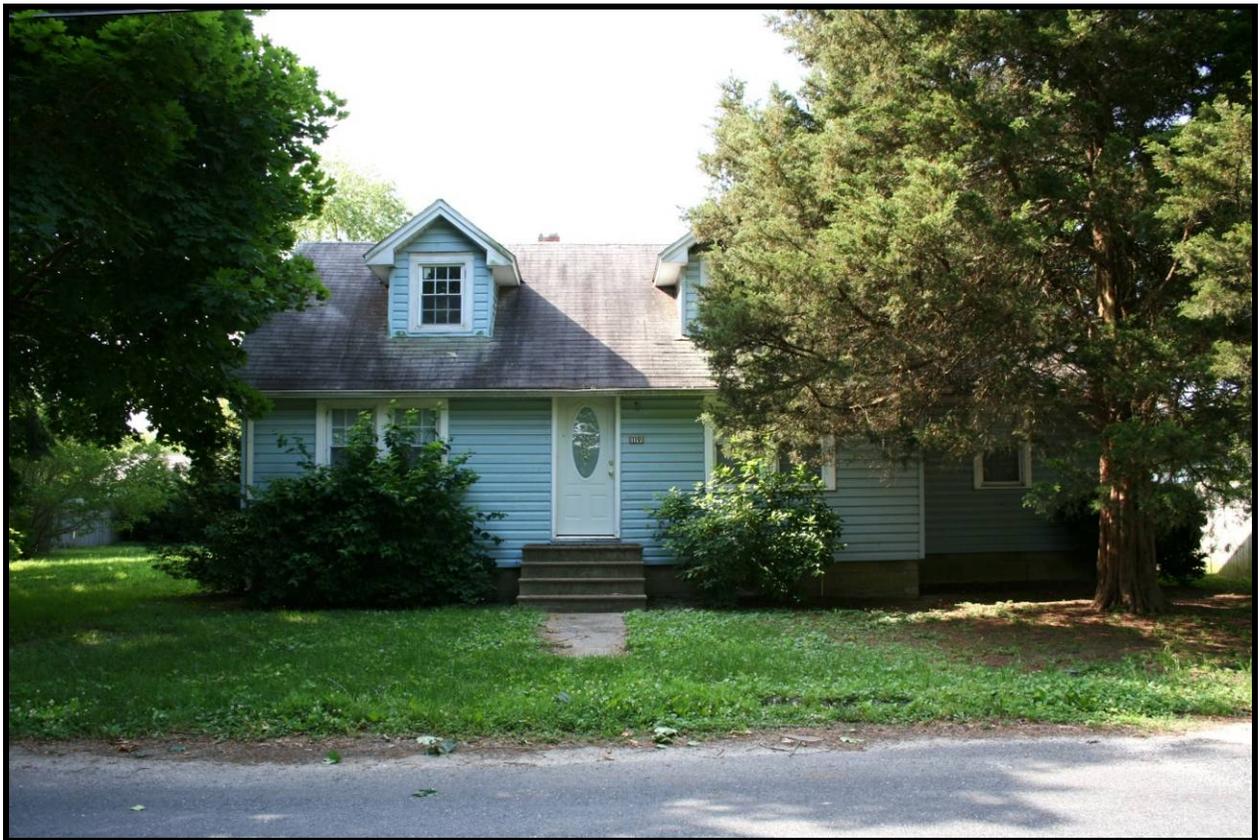
S-11943

119 Orchard Street (1954 Aerial Map)

Property Type: Single-Family Dwelling, Cape Cod Style

This four-bay, frame, one-and-a-half story, Cape Cod style dwelling was built between 1937 and 1954. A one-story, side-gabled, telescoping wing is connected to the main block on the southwest side. Two traditional gable-roofed dormers with six-over-six double-hung sash windows are located on the northwest elevation of the original side-gabled block. The interior brick chimney is set slightly off-center and toward the northeast side of the asphalt-shingled roof. A cement stoop is located on the northwest façade, while a wooden deck is connected to the southeast elevation. On the northeast elevation of the main block, six-over-six double-hung sash windows are paired with plain aluminum surrounds; the windows on the wing and other three facades are all single six-over-six double-hung sash. Cape Cod style dwellings began to appear in Milton in the early 1920s and continued in popularity until about 1960. This dwelling retains integrity of location, setting, design, workmanship, materials, and feeling, making it a contributing historic property for the expanded Milton Historic District.

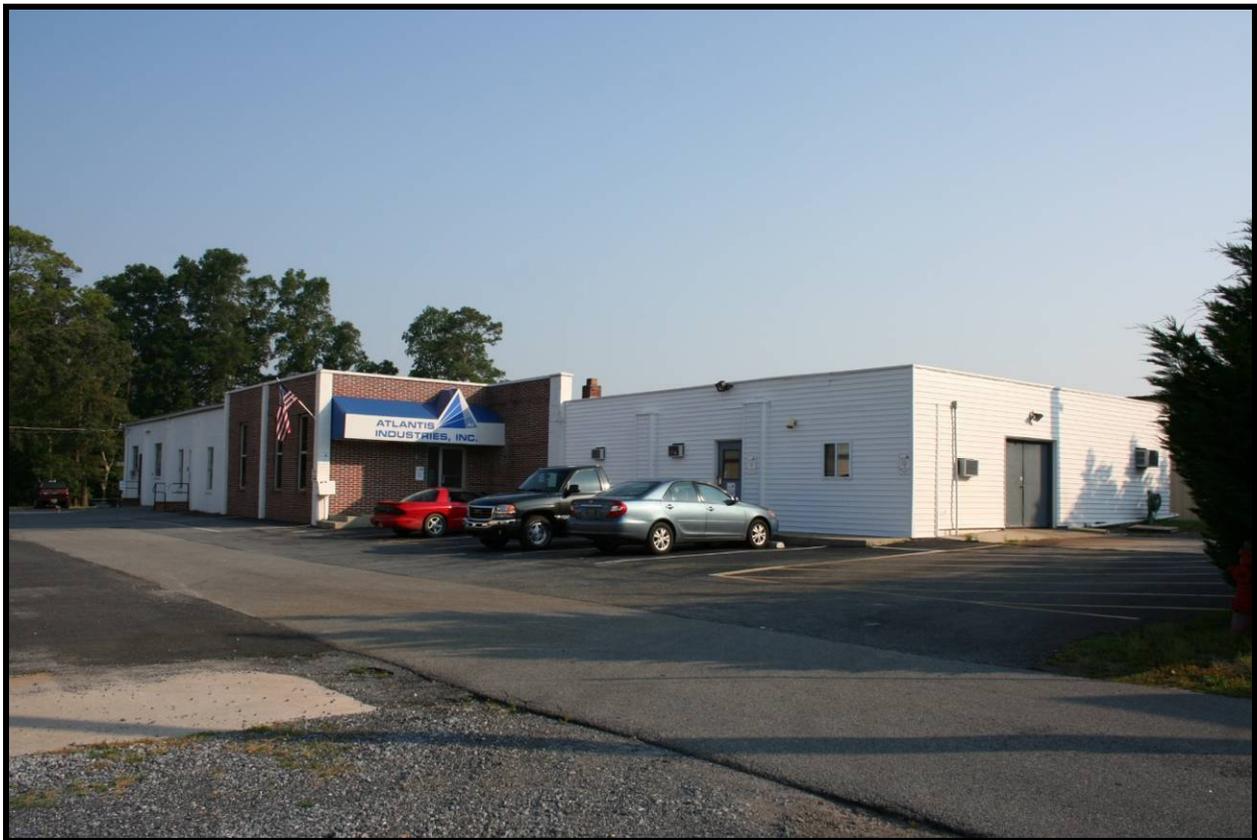
S-11917

Atlantis Industries: Parcel #6.00 Park Street (1961 Aerial Map)

Property Type: Commercial Property

This commercial property consists of multiple buildings. The larger, single-story, flat-roofed industrial building was constructed between 1954 and 1961. This building is composed of brick, cement block, and frame sections, which are covered in vinyl/aluminum siding. Another smaller, single-story building on the property has a gable roof, vertical siding, two entrances, and two large rollup garage doors. The second storage building was constructed between 1968 and 1992. These structures are considered non-contributing properties for the expanded Milton Historic District due to loss of integrity in design and materials.
