APPENDIX A:
INVENTORY OF SURVEYED
PROPERTIES

MILTON • DELAWARE

APPENDIX A

This appendix begins with a chart of all the resources surveyed in Milton. The chart includes CRS numbers, address, function, style of architecture, the date the property first appears on a historic map, and whether or not the property should be considered contributing or non-contributing to a potential expanded National Register of Historic Places District in Milton or a local historic zone. Following the chart, descriptions of the surveyed resources provide more detailed information on the historic name of the property, function, a brief history, and a physical description of the property. The description also provides a short rationale for the property's recommendation for inclusion or exclusion to the National Register District. Photographs of each main building or resource appear with the descriptions.

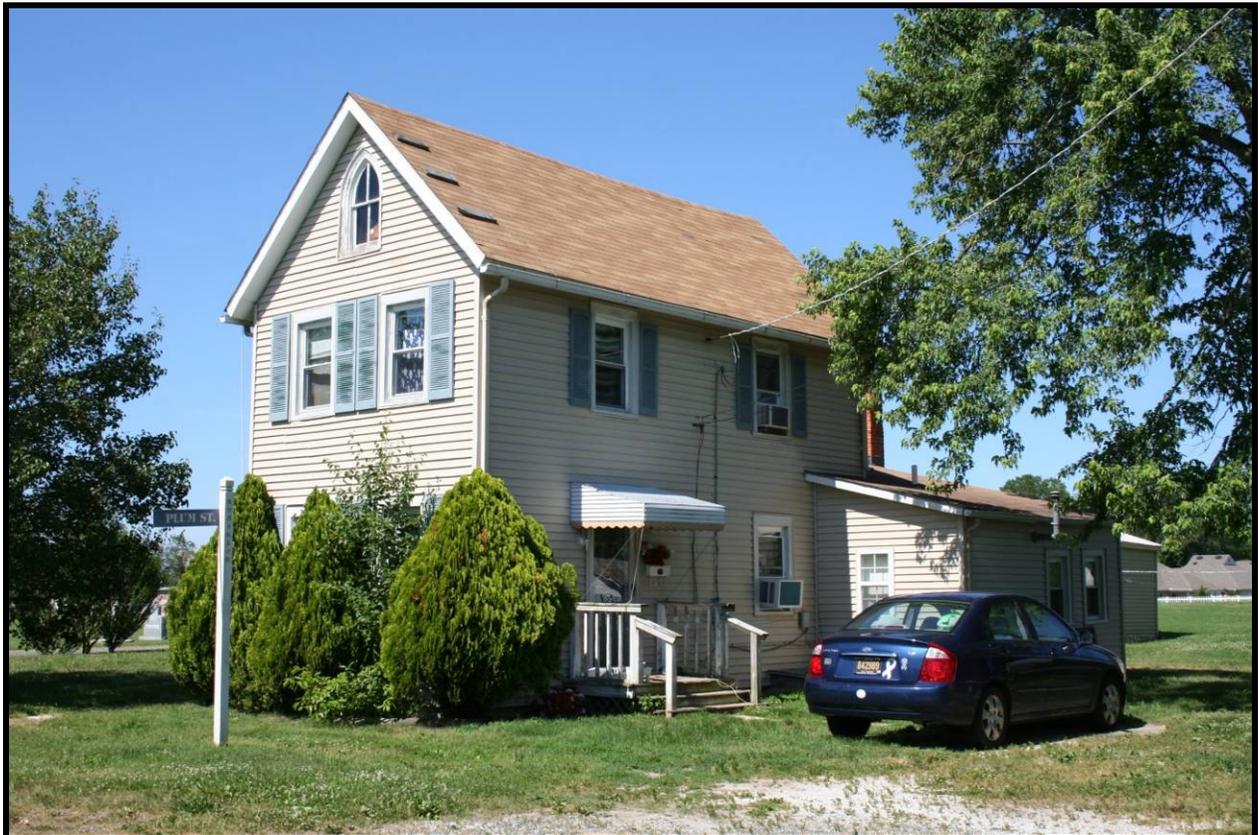
S-11982

511 Plum Street (1911 Sanborn Map)

Property Type: Single-Family Dwelling, Two-Bay Vernacular with Gothic Revival Detailing

This four-bay, two-and-a-half story, frame, side-gabled dwelling with Gothic Revival detailing was constructed between 1887 and 1911. A gable-roofed, single-story addition wraps around the northeast corner of the main block. Three one-over-one double-hung sash windows are located on the southeast façade and the two windows on the second floor have inoperable louvered shutters. The entrance door is covered by an aluminum awning. The southwest elevation has four one-over-one double-hung sash windows with inoperable louvered shutters and a two-over-two Gothic arch top window at the attic level. An exterior brick chimney is centered along the ridge on the rear addition. The roof is covered in asphalt shingles and the exterior of the dwelling is sheathed in clapboard style vinyl or aluminum siding. The pointed-arch attic window is perhaps the only remaining Gothic Revival detail from this early 20th century dwelling; it retains integrity of location, setting, design, workmanship, materials, and feeling, making it a contributing historic property for the expanded Milton Historic District.

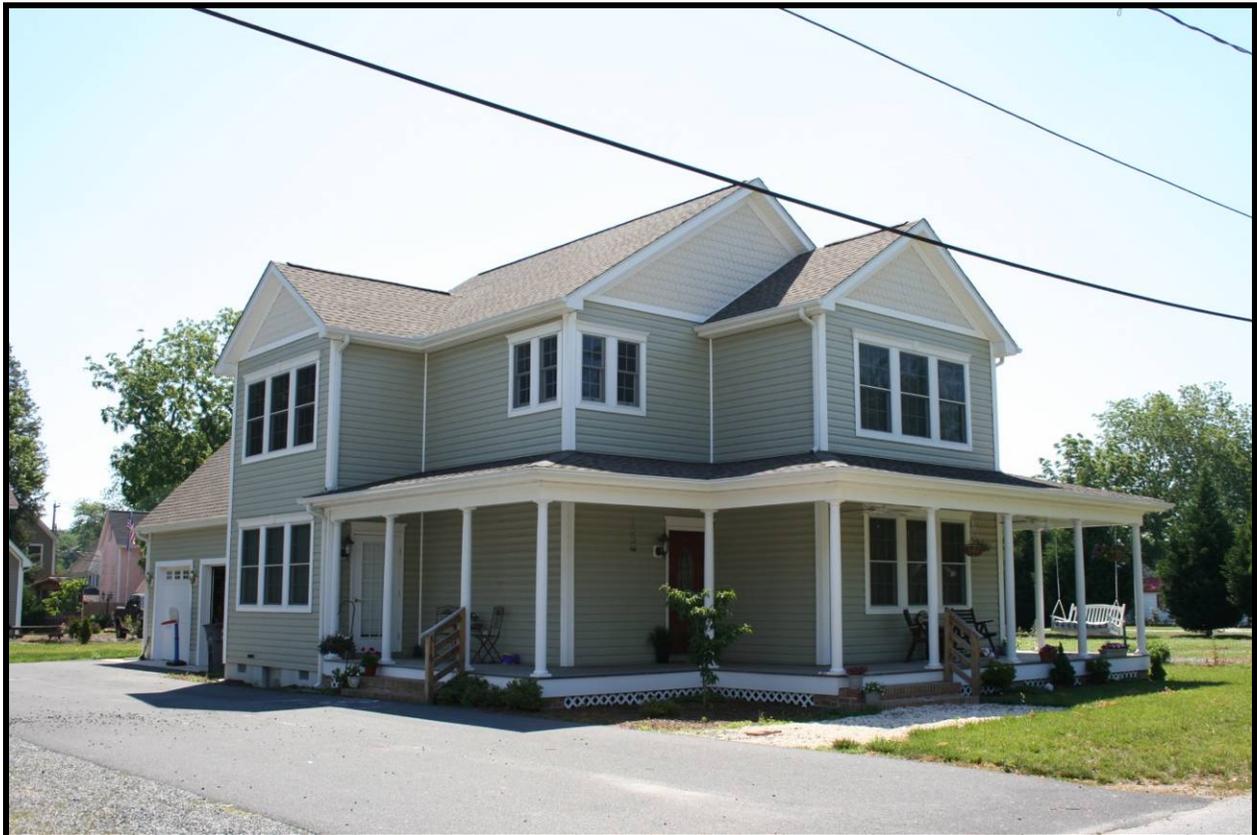
S-12018

316 Reed Street (2007 Aerial Map)

Property Type: Single-Family Dwelling, Queen Anne Revival Style

This two-story, front-gabled, Queen Anne Revival dwelling was constructed between 2002 and 2007. A hipped-roof porch supported by simple Doric columns wraps around the southwest, northwest, and southeast elevations. Staggered parallel front gables located on the southwest façade and side-gabled roofs intersect the main block on the northwest and northeast sides. The windows on the northwest elevation are a mix of tripled six-over-six double-hung sash windows and doubled four-over-four double-hung sash windows. The southeast elevation has tripled six-over-six double-hung sash windows with a three-light transom window above each one. The southwest façade has a mix of six-over-six double-hung sash windows and four-over-four double-hung sash windows. All windows have decorative molding with lintel detail and a keystone. Dutch lap vinyl or composite siding sheaths most of the exterior of the dwelling while fish-scale siding covers the remainder. The roof is covered with asphalt shingles. This dwelling is considered a non-contributing property for the expanded Milton Historic District due to its recent construction date.

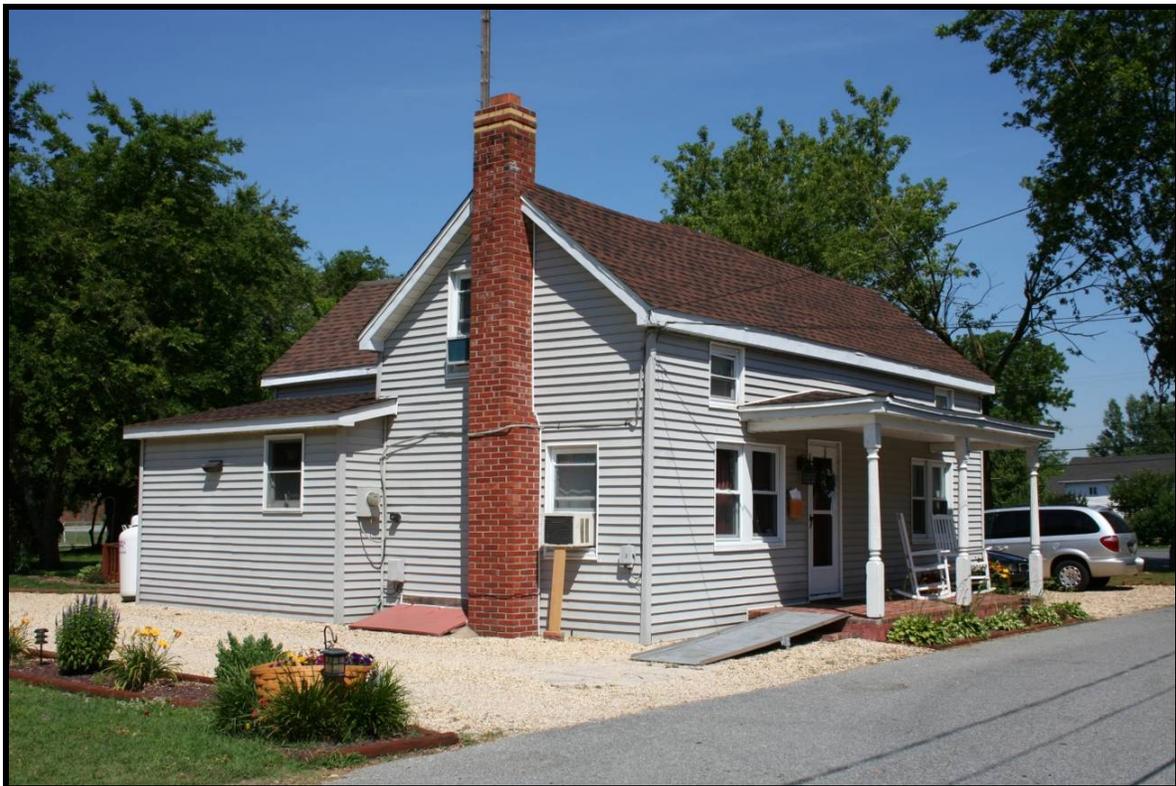
S-12009**317 Reed Street (C. Reed House: 1868 Beers Map; W. Robinson House: 1887 Map of Milton)****Property Type: Single-Family Dwelling, Three-Bay Vernacular with Greek Revival Detailing**

This three-bay, one-and-a-half story, frame dwelling was constructed prior to 1868. A cross-gabled wing was added to the southwest rear elevation of the main side-gabled block and additional shed-roofed lean-to wings were connected to the cross-gabled wing on the southeast, northwest, and southwest elevations. A hipped-roof porch supported by turned posts is centered above the entrance door on the northeast façade, along with contemporary paired one-over-one double-hung sash windows which flank the entrance door and two single one-over-one double-hung windows are located at attic level. The northwest elevation has a one-over-one double-hung sash window visible, while the southeast elevation has three one-over-one double-hung windows. An exterior brick chimney is located on the southeast gable end of the main block. The exterior of this dwelling is sheathed in clapboard style vinyl siding and the roof is covered in asphalt shingles. A man named Curtis C. Reed owned this property in 1868; he was a thirty-seven year old house carpenter and a native of Delaware. In 1887, the property was owned by W. Robinson; this individual is most likely William Robinson, a forty-nine year old coachman and Delaware native. This dwelling is representative of the classic Three-Bay Vernacular style which was prevalent in Milton from the mid 19th to the early 20th centuries; the Greek Revival details are only found on few other Three-Bay Vernacular homes throughout the town. It retains integrity of location, setting, design, workmanship, materials, and feeling, making it a contributing historic property for the expanded Milton Historic District.

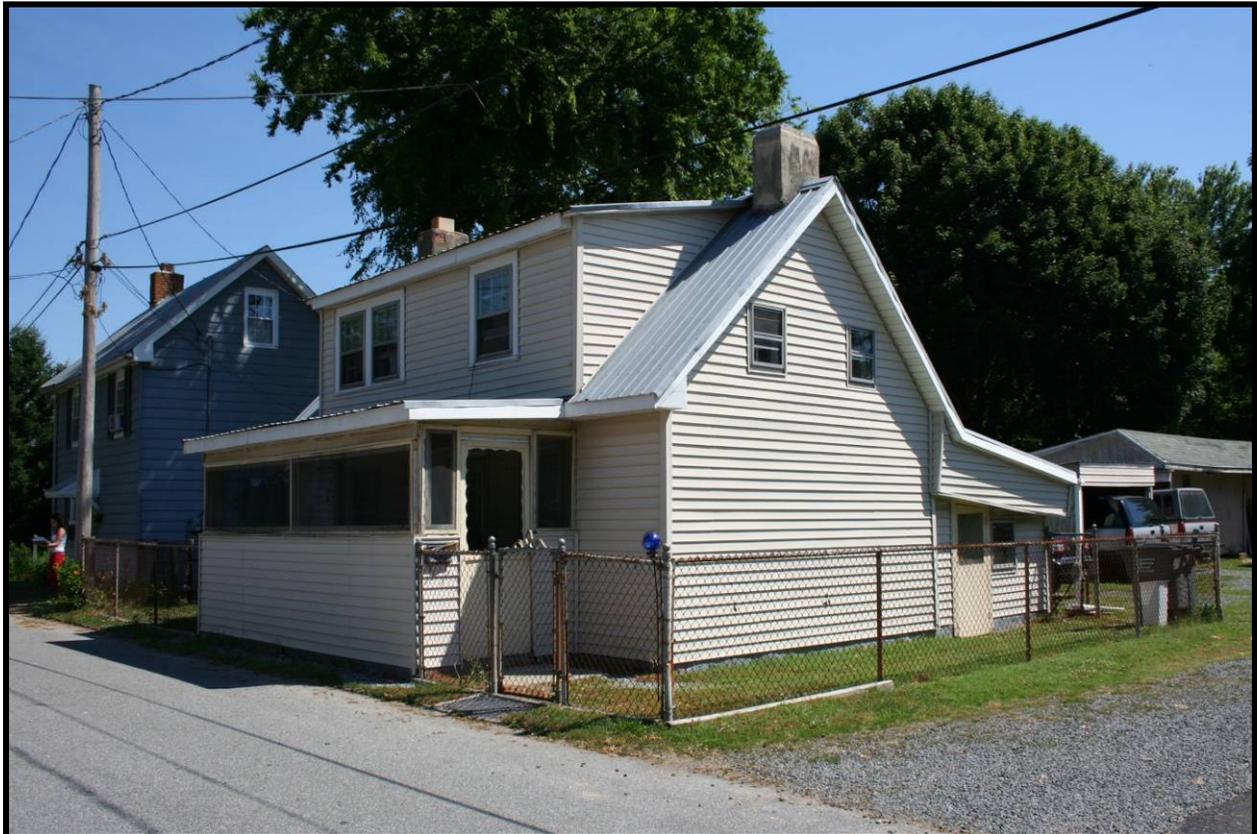
S-12017

318 Reed Street (William Palmore House: 1887 Map of Milton)

Property Type: Single-Family Dwelling, Hall and Parlor Plan Dwelling

This three-bay, one-and-a-half story, side-gabled, frame dwelling was constructed between 1868 and 1887. A large shed-roofed dormer is centered on the southwest side of the roof and the shed-roofed porch on the southwest façade has been enclosed. A shed-roofed rear addition is connected to the northeast façade. The southwest elevation appears to have five six-over-six double-hung sash windows, two of which are paired. The southeast and northwest elevations have modern one-over-one double-hung sash windows. Two interior brick chimneys are located along the ridge toward the southeast and northwest gable ends. The exterior of the dwelling is sheathed in aluminum clapboard style siding and the roof is covered in corrugated sheet metal. According to historic maps, William Palmore owned this property in 1887. This dwelling is considered a non-contributing property for the expanded Milton Historic District due to loss of integrity in design and materials.

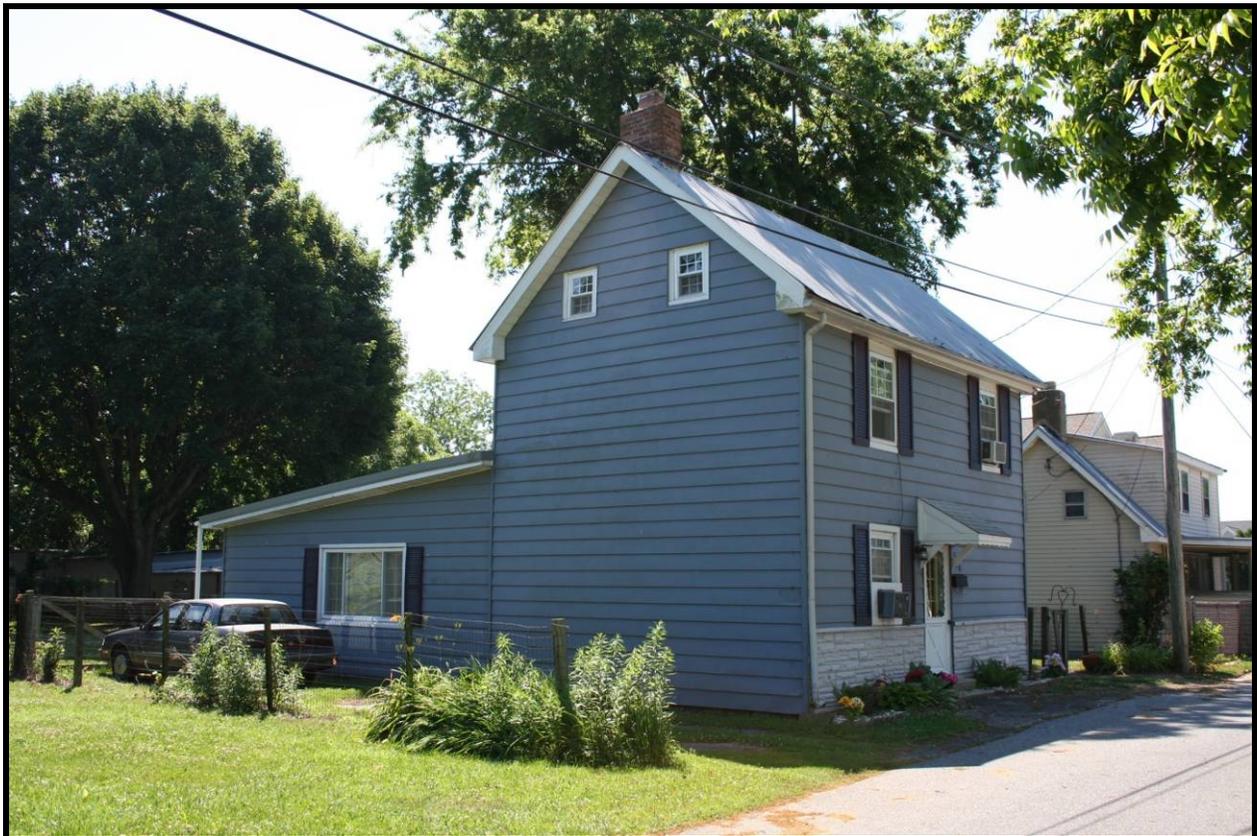
S-12016

320 Reed Street (J.H. Stevenson House: 1887 Map of Milton)

Property Type: Single-Family Dwelling, Two-Bay Vernacular Style

This two-bay, two-and-a-half story, side-gabled, frame vernacular dwelling was constructed between 1868 and 1887. A single-story, shed-roofed addition has been added to the northeast (rear) elevation. All three modern six-over-six double-hung sash windows on the southwest facade have inoperable louvered shutters and the front entrance door is covered by a pent roof. The southeast elevation has a mix of six-over-six double-hung sash windows and four-over-four horizontal sliding windows. The northwest elevation has two six-over-six casement windows at the attic level and one tripartite window with a fixed center pane surrounded by eight pane casement windows on the first floor. An interior brick chimney is located on the ridge of the main block toward the northwest gable end. Wide clapboard-style aluminum siding sheaths the dwelling, except for a small section of permastone which runs a few feet high along the southwest façade. The roof on the main block is covered in corrugated sheet metal. A J.H. Stevenson owned this property in 1887; it is probable that J.H. Stevenson is Joseph Stevenson who is listed on the 1880 census. He was a native of Delaware and worked as a ship carpenter. This Two-Bay Vernacular dwelling is a variation of the classic Three-Bay Vernacular style which was prevalent in Milton from the mid 19th to the early 20th centuries. It retains integrity of design, materials, feeling, workmanship, location, and setting, making it a contributing historic property for the expanded Milton Historic District.

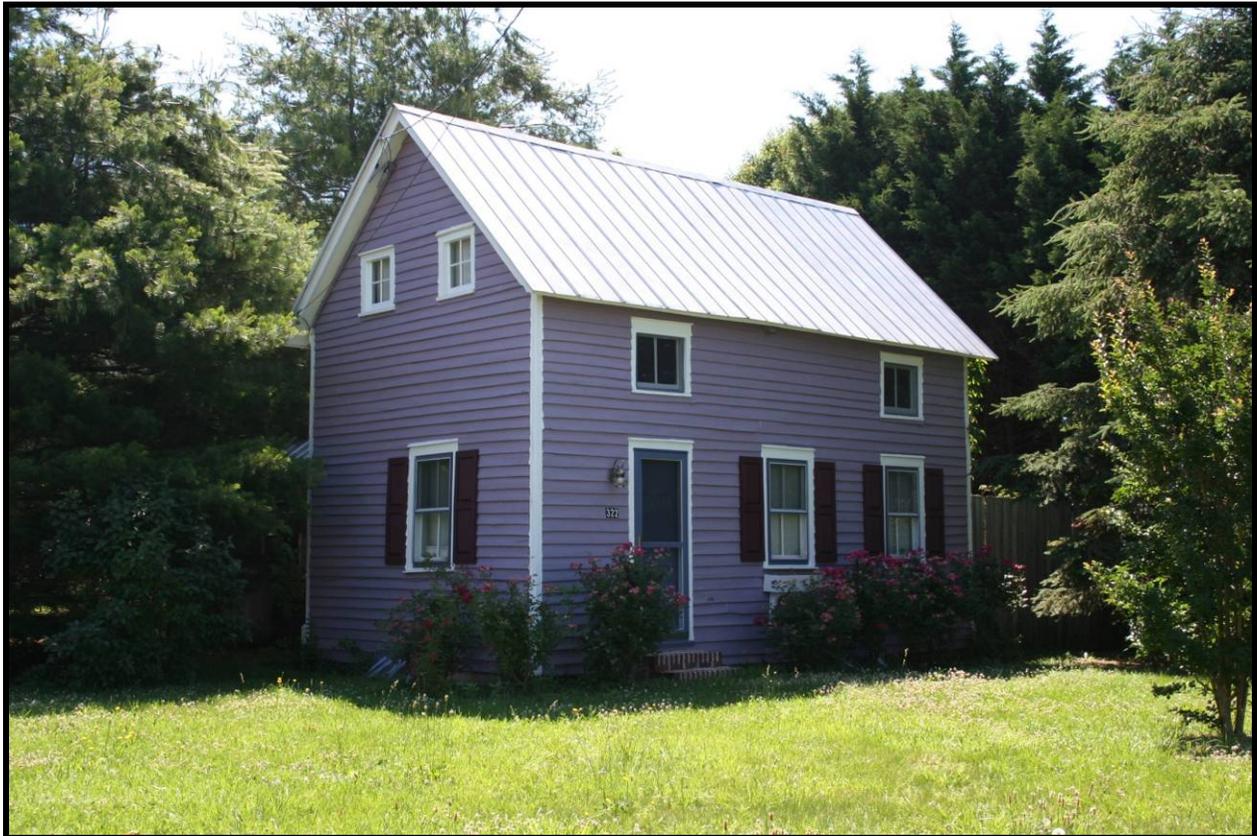
Property Type: Single-Family Dwelling, Three-Bay Vernacular Style

This three-bay, one-and-a-half story, frame, side-gabled, Vernacular dwelling was constructed between 1911 and 1923. A small, single-story, cross-gabled wing located at the southeast corner has a shed-roofed addition which extends from the southeast eave. The southwest façade has two two-over-two double-hung sash windows which are flanked by inoperable paneled shutters, while the second floor has two horizontal sliding windows. The northwest elevation has a two-over-two, double-hung sash window flanked by inoperable paneled shutters and two four-pane casement windows are located at attic level. The exterior of the dwelling is sheathed in painted wood clapboard siding and the roof is covered in standing-seam sheet metal. This dwelling is representative of the classic Three-Bay Vernacular style which was prevalent in Milton from the mid 19th to the early 20th centuries; it retains integrity of location, setting, design, workmanship, materials, and feeling, making it a contributing historic property for the expanded Milton Historic District.

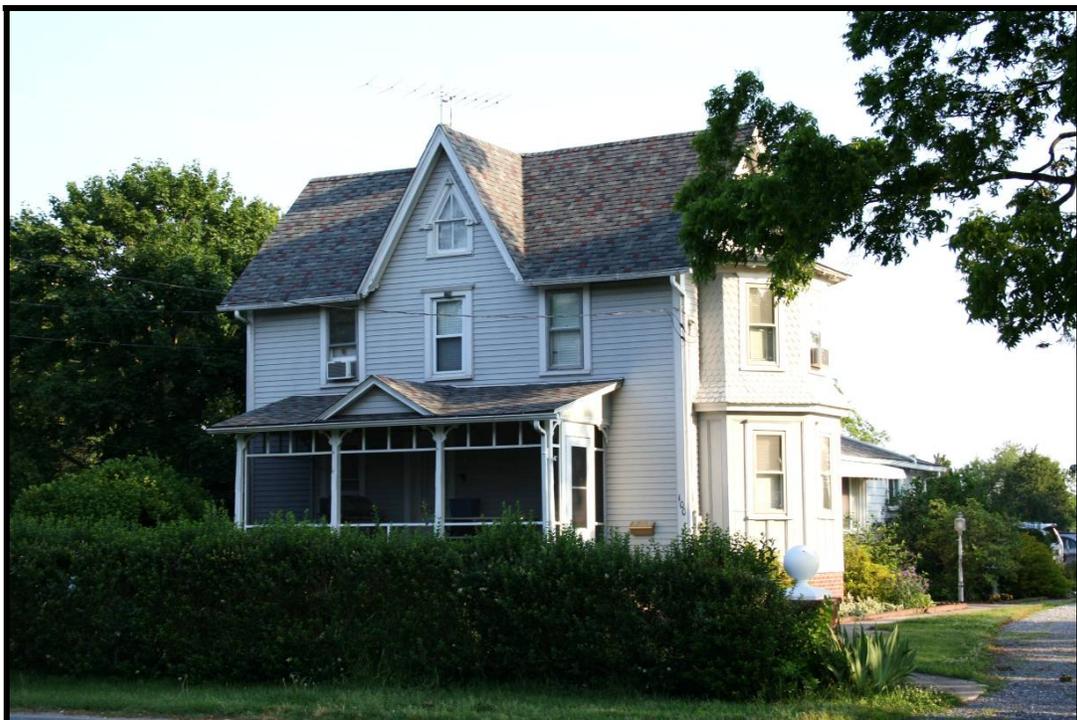
S-3420**100 Beach Highway (Rt. 16) (1911 Sanborn Map)****Property Type: Single-Family Dwelling, Gothic Revival Style**

This three-bay, two-and-a-half-story, frame Gothic Revival dwelling was built between 1887 and 1911. It has an eastern two-story bay window addition, eastern enclosed porch addition, and northern rear addition. The dwelling has two interior chimneys: one located west of center on the main block roof ridge and the second centered on the ridge of the cross gable. The south façade has regular fenestration consisting of seven windows with plain wood surrounds. A decorative two-over-two peak-head window is located in the cross gable of the upper story. The other windows are one-over-one sash windows and the central window of the second story has decorative molding. On the first story there is a wood door flanked by two windows in a screen-enclosed porch which has decorative cutwork brackets, a wood railing, and a small cross-gabled roof. The east elevation has at least eleven windows and two doors, with the door for the screened front porch located in the southern-most bay. The enclosed porch of the east elevation has two paired sets of four-pane windows flanking a matching wood and glass door. The second story has three one-over-one sash windows. The added two-story bay has six one-over-one sash windows and exposed eaves. The first floor of the bay is covered with board and batten siding and the second floor is corbelled and covered in fish scale shingles. The north rear elevation has at least three windows and one door with a covered entryway. The exterior of the dwelling is covered in vinyl siding and the roof is covered with poly-chromatic asphalt shingles. The cross-gable roof and pointed arch window of this dwelling are characteristics of the numerous gothic Revival style homes constructed throughout Milton during the late 19th and early 20th century. It retains integrity of location, setting, design, workmanship, materials, and feeling, making it a contributing historic property for the expanded Milton Historic District.

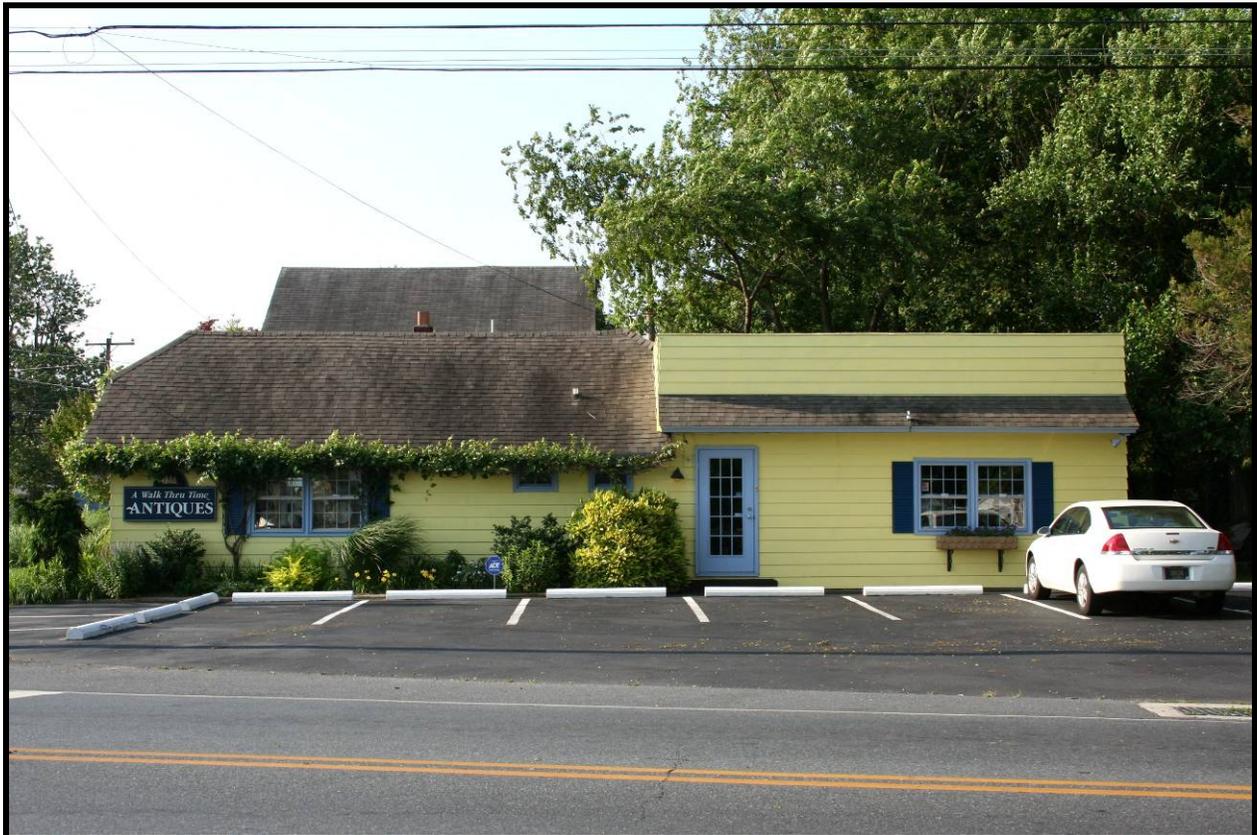
S-11918

Property Type: Commercial Property (Antique Store), Mixed Style

This two-bay, one-story, clipped front-gable commercial building currently houses an antique store and was built between 1937 and 1954. The building has a shed-roofed addition connected to the southeast elevation of the main block, a rear flat-roofed addition, and a shed-roofed addition on the rear block of the northwest elevation, giving this building an overall “L” shape. The northeast elevation has one window and a fifteen-light set of French wooden doors with plain wood surrounds. The northwest façade has two paired sets of eight-over-eight sash windows and two single four-pane casement windows with plain wood surrounds. A fifteen-light wooden door with plain wood surrounds is located in the second bay from the west corner. The building has a chimney located on the southern slope of the main block and a second is located on the southern end of the flat-roofed addition. The exterior of the building is covered with aluminum/vinyl siding and the roof is covered with coursed asphalt shingles. This store retains integrity of location, setting, design, workmanship, materials, and feeling, making it a contributing historic property for the expanded Milton Historic District.

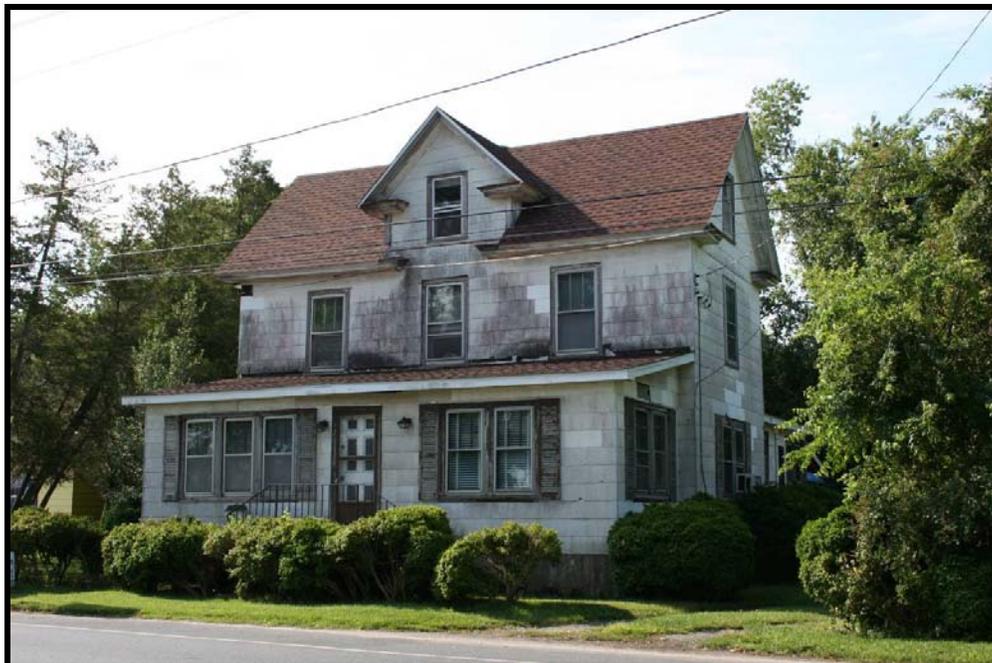
S-11919

Property Type: Single-Family Dwelling, Three-Bay Gothic Revival Style

This three-bay, side-gabled, Gothic Revival style frame dwelling was built between 1923 and 1937. It is two-and-a-half stories tall, has a rear cross-gabled addition, and two rear shed-roofed additions. The northwest façade has an enclosed shed-roofed porch with a nine-panel wooden door and an aluminum and glass storm door located in the central bay. The fenestration is regular and features nine windows with plain wood surrounds. The windows on the enclosed porch have inoperable louvered shutters and consist of a triple three-over-one sash window in the northern-most bay and a double three-over-one sash window in the western-most bay. The second story has three single one-over-one sash windows and a single one-over-one sash window is located in the cross gable of the upper story. The southwest elevation has six windows consisting of two paired three-over-one sash windows with inoperable louvered shutters, a single three-over-one sash window, and a one-over-one sash window in the upper story. One single window, one double window, and a door are located on the southern addition, but the view of these features is partially obstructed. The northeast elevation has at least ten windows consisting of three paired three-over-one windows, three single three-over-one windows, and a single one-over-one window located in the cross gable of the upper story. The windows have a regular fenestration and plain wood surrounds. A door is located in the second bay from the south corner of the rear cross-gabled addition. The exterior walls are covered with aluminum/vinyl siding and the roof is covered with coarsed asphalt shingles. The roof has a boxed cornice and the northwest, southwest, and northeast gables feature partially returning eaves. This dwelling is an excellent example of the numerous gothic Revival style homes constructed throughout Milton during the late 19th and early 20th century. It retains integrity of location, setting, design, workmanship, materials, and feeling, making it a contributing historic property for the expanded Milton Historic District.

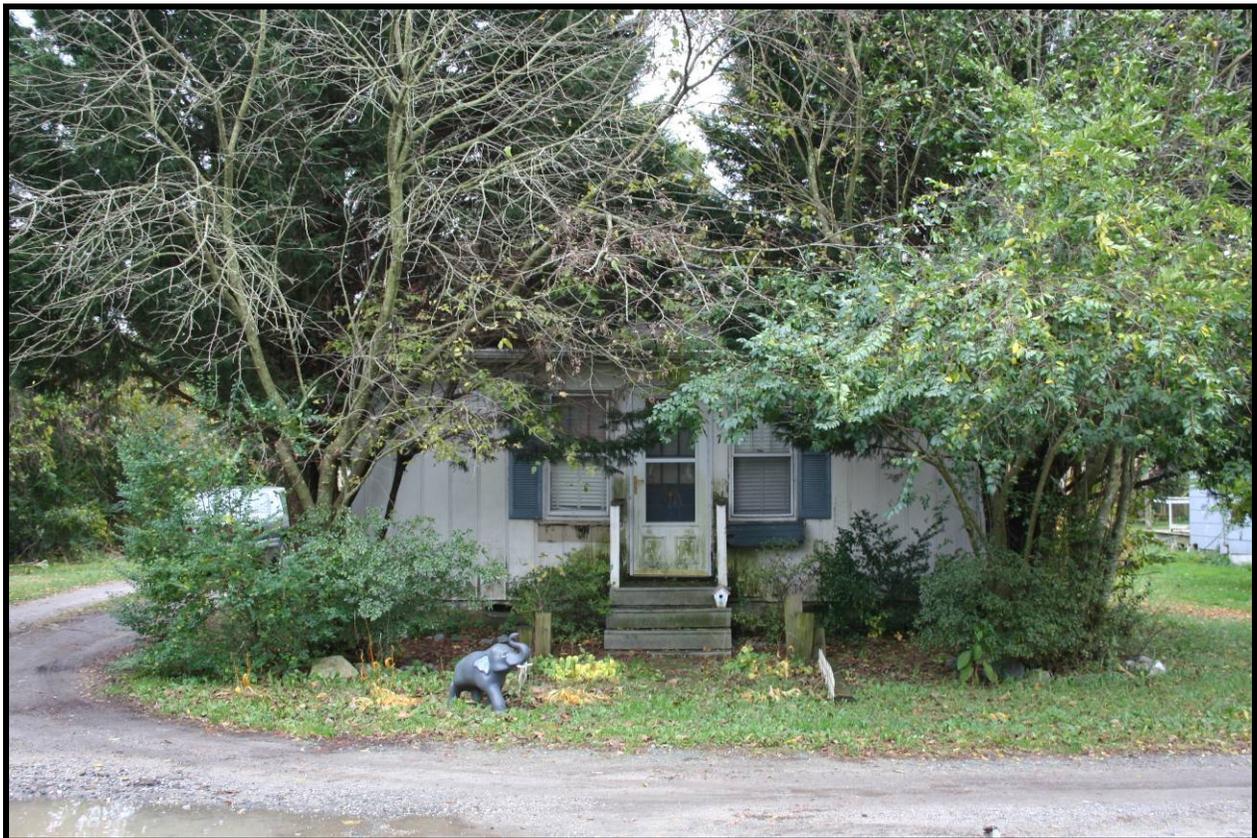
S-11920.01

Property Type: Single-Family Dwelling, Craftsman Shotgun Style

This three-bay, one-and-a-half story, Craftsman Shotgun style dwelling was built between 1937 and 1954. The main front-gabled block has a rear shed-roofed addition. All of the windows are three-over-one sash with plain wood surrounds. The northwest façade has two single windows flanking a nine light, two-paneled wooden door with an aluminum and glass storm door. The main entry is located in the central bay over a small three-step stoop with a wooden railing. The southwest elevation has three paired windows with regular fenestration and the southwest façade has three paired windows as well as one single window. An exterior chimney is located in the third bay from the northern corner and is flanked by windows. The exterior of the dwelling is covered in vertical-board siding and the roof is covered with coursed asphalt shingles. With the exception of a few modern structures, the shotgun-style dwellings in Milton all range in age from the early 1920s to the mid 1950s and often exhibit Craftsman characteristics, such as this home. This dwelling retains integrity of location, setting, design, workmanship, materials, and feeling, making it a contributing historic property for the expanded Milton Historic District.

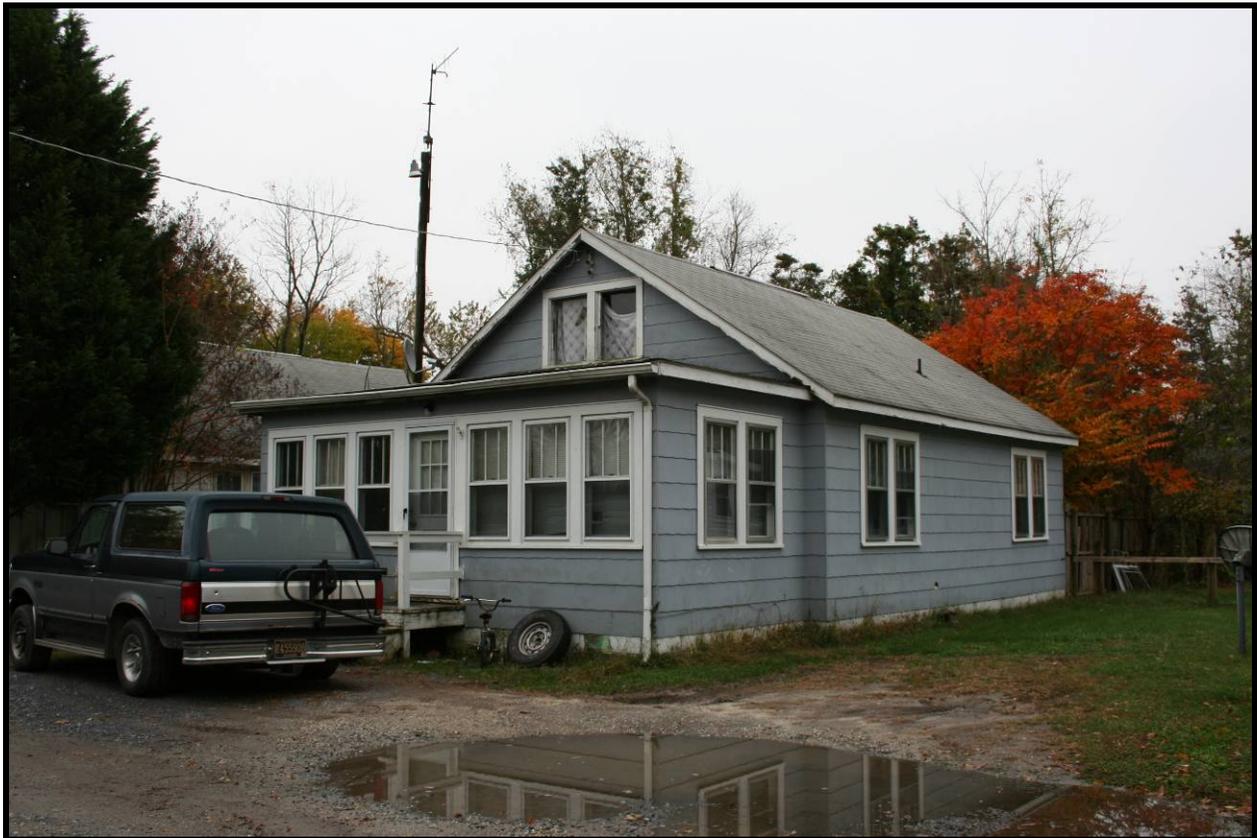
S-11920.02

Property Type: Single-Family Dwelling, Craftsman Shotgun Style

This three-bay, one-and-a-half story vernacular Craftsman Shotgun style frame dwelling was constructed between 1937 and 1954. It has a rear shed-roofed addition and an enclosed front porch. The northwest façade has two tripled sets of three-over-one windows flanking a nine-pane, two-paneled wooden door with an aluminum and glass storm door. A two-step wooden stoop with railing is flush with the door and one paired fixed window is located in the upper story. The doors and windows on the northwest façade have plain wood surrounds and extend almost the entire length of the porch. The southwest elevation has three paired, three-over-one windows with a regular fenestration. A small brick chimney is located along the interior roof slope on the northeast side. The northeast elevation likely has three-paired, three-over-one windows as well, but only two of the pairs are visible. The exterior walls are covered with aluminum/vinyl siding and the roof is covered with coursed asphalt shingles and displays open eaves. With the exception of a few modern structures, the shotgun-style dwellings in Milton all range in age from the early 1920s to the mid 1950s and often exhibit Craftsman characteristics, such as this home. This dwelling retains integrity of location, setting, design, workmanship, materials, and feeling, making it a contributing historic property for the expanded Milton Historic District.

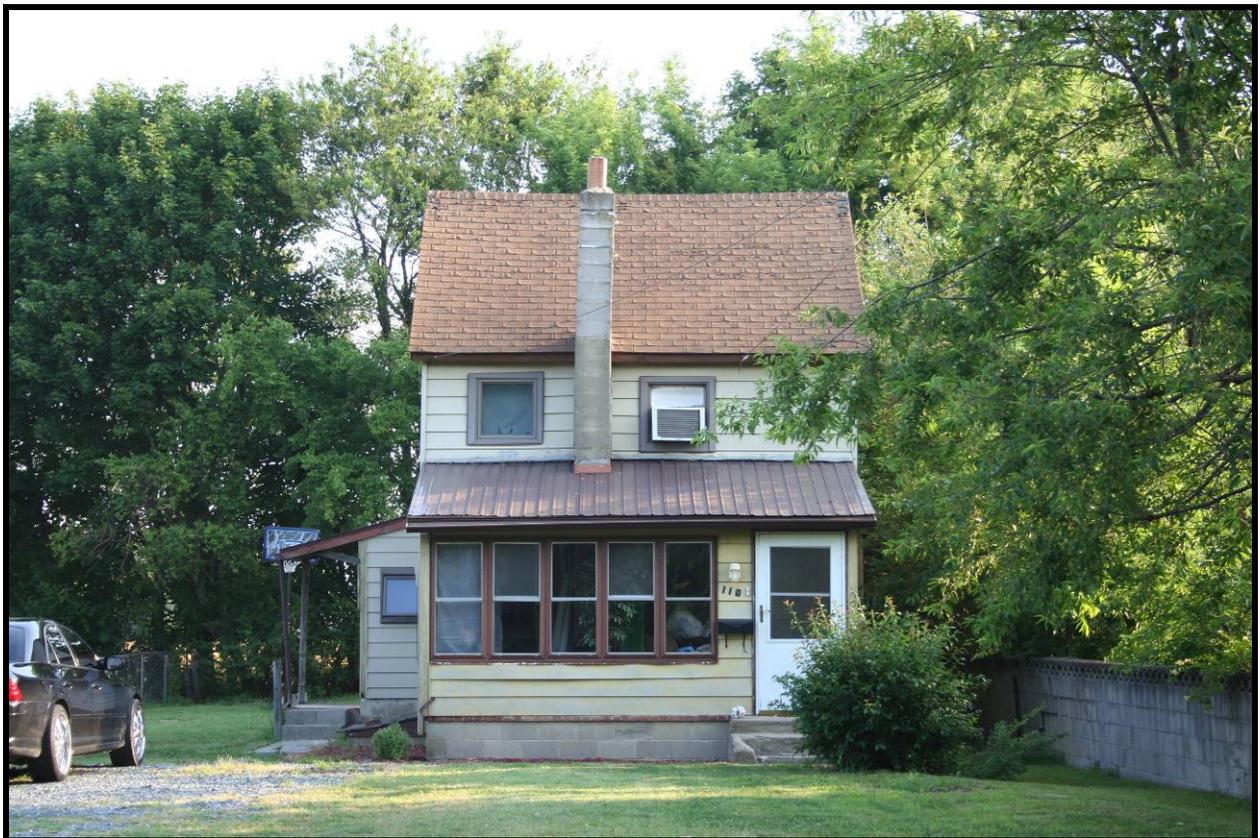
S-3421**110 Beach Highway (Rt. 16) (1937 Aerial Map)****Property Type: Single-Family Dwelling, Three-Bay Vernacular**

This four-bay, two-and-a-half story, Vernacular frame dwelling was built prior to 1937 according to aerial maps; the original survey forms provide a more specific date of circa 1800. It has a shed-roofed rear addition and a shed-roofed enclosed front porch. The southern front porch features five consecutive one-over-one sash windows and an aluminum and glass storm door in the far-east bay. A shallow three-step stone stoop is flush with the door. Two upper-story awning windows flank a concrete chimney that cuts through the porch roof and one awning window is located on the south façade of the west entryway. The west elevation features two upper-story awning windows, at least one one-over-one sash window, and a small casement window in the southern-most bay. An aluminum storm door is located in the second bay in an enclosed entryway. The exterior siding is aluminum/vinyl and the roof is covered in coursed asphalt shingles and corrugated sheet metal. This dwelling is a unique variation of the common Three-Bay Vernacular form which became prevalent in Milton during the late 19th and early 20th centuries. It retains integrity of location, setting, design, workmanship, materials, and feeling, making it a contributing historic property for the expanded Milton Historic District.

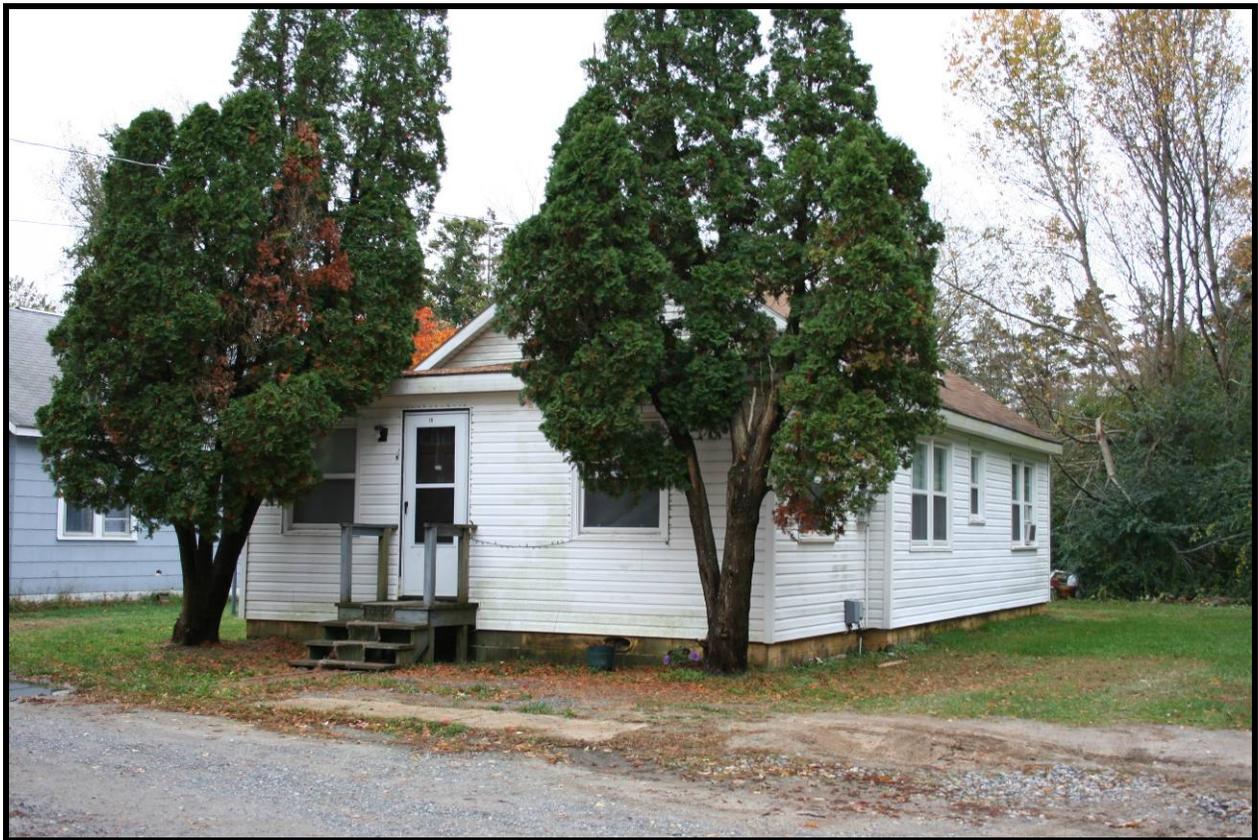
S-11920.03

Property Type: Single-Family Dwelling, Craftsman Shotgun Style

This three-bay, front-gabled, Craftsman Shotgun style dwelling was built between 1937 and 1954. It stands one-and-a-half stories tall with a rear shed-roofed addition. All of the windows are one-over-one double-hung sash with vinyl surrounds. The northwest façade has an enclosed porch with irregular fenestration. Two single windows flank a nine-panel wood door with a glass and aluminum storm door. The southwest elevation has two single and two paired sets of windows, while the northeast elevation has three single and two paired sets of windows. Aluminum or vinyl siding covers the exterior walls and the roof is covered with coursed asphalt shingles. With the exception of a few modern structures, the shotgun-style dwellings in Milton all range in age from the early 1920s to the mid 1950s and often exhibit Craftsman characteristics, such as this home. This dwelling retains integrity of location, setting, design, workmanship, materials, and feeling, making it a contributing historic property for the expanded Milton Historic District.

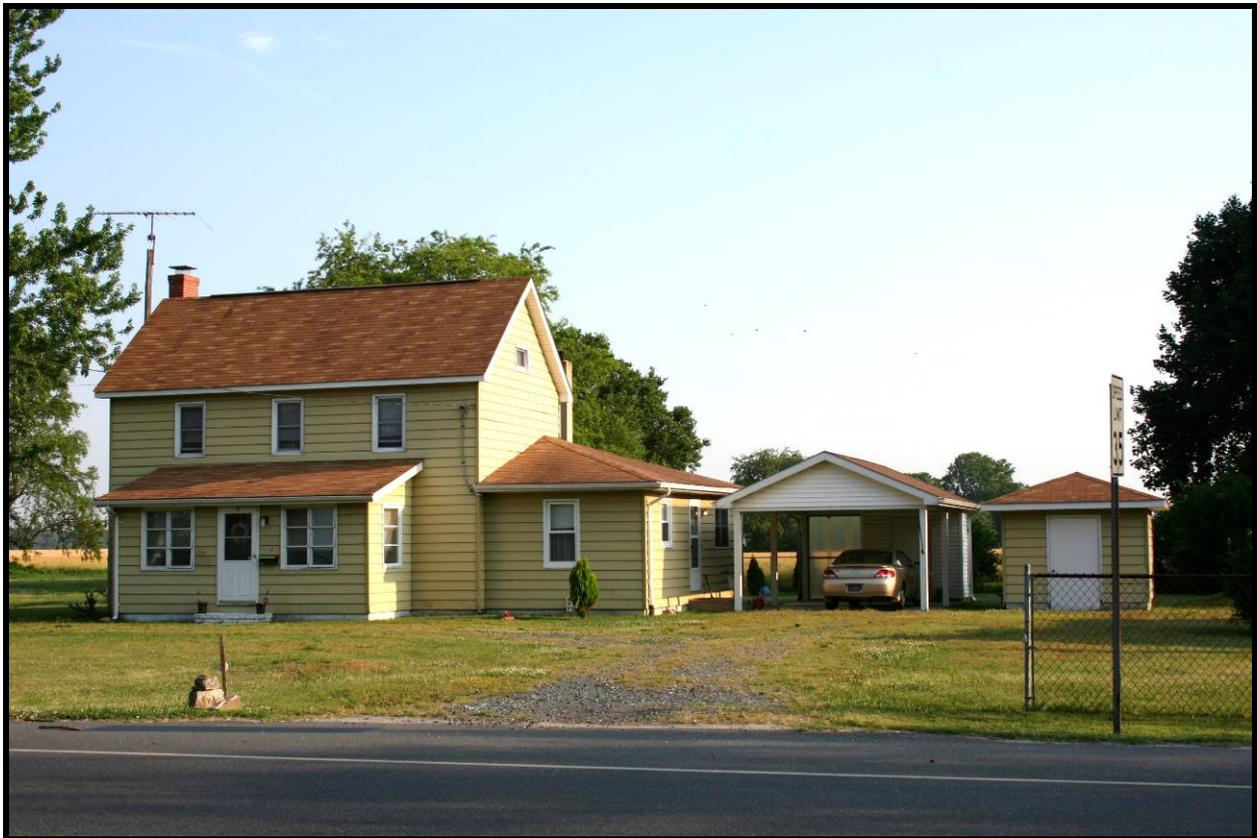
S-3422**112 Beach Highway (Rt. 16) (1937 Aerial Map)****Property Type: Single-Family Dwelling, Three-Bay Vernacular**

This three-bay, two-and-a-half story Vernacular dwelling was constructed prior to 1937 according to aerial maps; the original survey forms provide a more specific date of circa 1890 to 1910. The shed-roofed porch on the south façade has been enclosed and a wrap-around, hipped-roof addition stretches around the east elevation and runs the entire length of the rear (north) elevation. The enclosed porch has a central door which is flanked on either side by paired sets of tripartite casement windows. The rest of the windows in the main block are one-over-one sash with plain wood surrounds, with the exception of small casement windows located at the attic level. The hipped-roof addition has one visible door on the east elevation which is centered between a single one-over-one sash window and a paired set of one-over-one sash windows. Both the main side-gabled block and the hipped-roof addition have boxed cornices and are covered in asphalt shingles. A brick end-wall chimney is located on the west gable end and a concrete block chimney is positioned toward the eastern corner of the northern (rear) elevation. This dwelling is representative of the classic Three-Bay Vernacular style which was prevalent in Milton from the mid 19th to the early 20th centuries; it retains integrity of location, setting, design, workmanship, materials, and feeling, making it a contributing historic property for the expanded Milton Historic District.

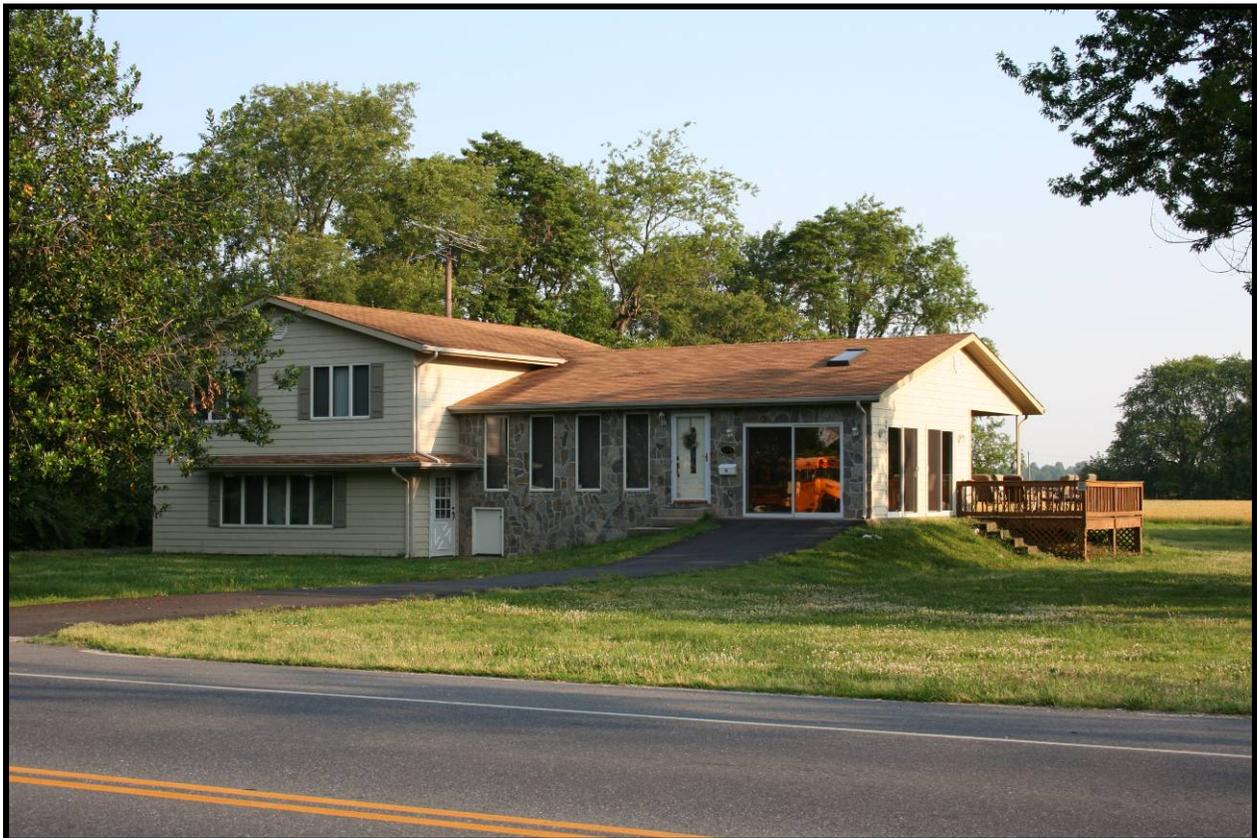
S-11915

Property Type: Single-Family Dwelling, Split-Level Style

This Split-level dwelling was built between 1968 and 1992. It is comprised of a one-story side-gabled main block attached to a two-story front-gabled block on the west gable end. A rear shed-roofed addition gives this dwelling an overall “T” shape. The southeast façade has seven windows with plain wood surrounds. The western block has a set of five single-pane windows on the first story and two tripled sets of single-paned windows on the second floor, all with inoperable louvered shutters. The eastern block has four fixed windows and two doors on the two eastern-most bays. The central wooden door with a vertical glass plane and plain aluminum surrounds is covered with a glass storm door. A sliding glass door is located in the far eastern bay, indicating that the garage was altered to form a habitable living space. The northeast façade has a twelve-pane aluminum/vinyl door and two sliding-glass doors. There is an open wooden deck off to the east with lower lattice work. The southwest elevation has at least one fixed window and a brick exterior chimney. The exterior walls are covered in aluminum/vinyl siding and to roof is covered with coursed asphalt shingles. This dwelling is considered a non-contributing property due to its construction date.
