APPENDIX A:
INVENTORY OF SURVEYED
PROPERTIES

MILTON • DELAWARE

APPENDIX A

This appendix begins with a chart of all the resources surveyed in Milton. The chart includes CRS numbers, address, function, style of architecture, the date the property first appears on a historic map, and whether or not the property should be considered contributing or non-contributing to a potential expanded National Register of Historic Places District in Milton or a local historic zone. Following the chart, descriptions of the surveyed resources provide more detailed information on the historic name of the property, function, a brief history, and a physical description of the property. The description also provides a short rationale for the property's recommendation for inclusion or exclusion to the National Register District. Photographs of each main building or resource appear with the descriptions.

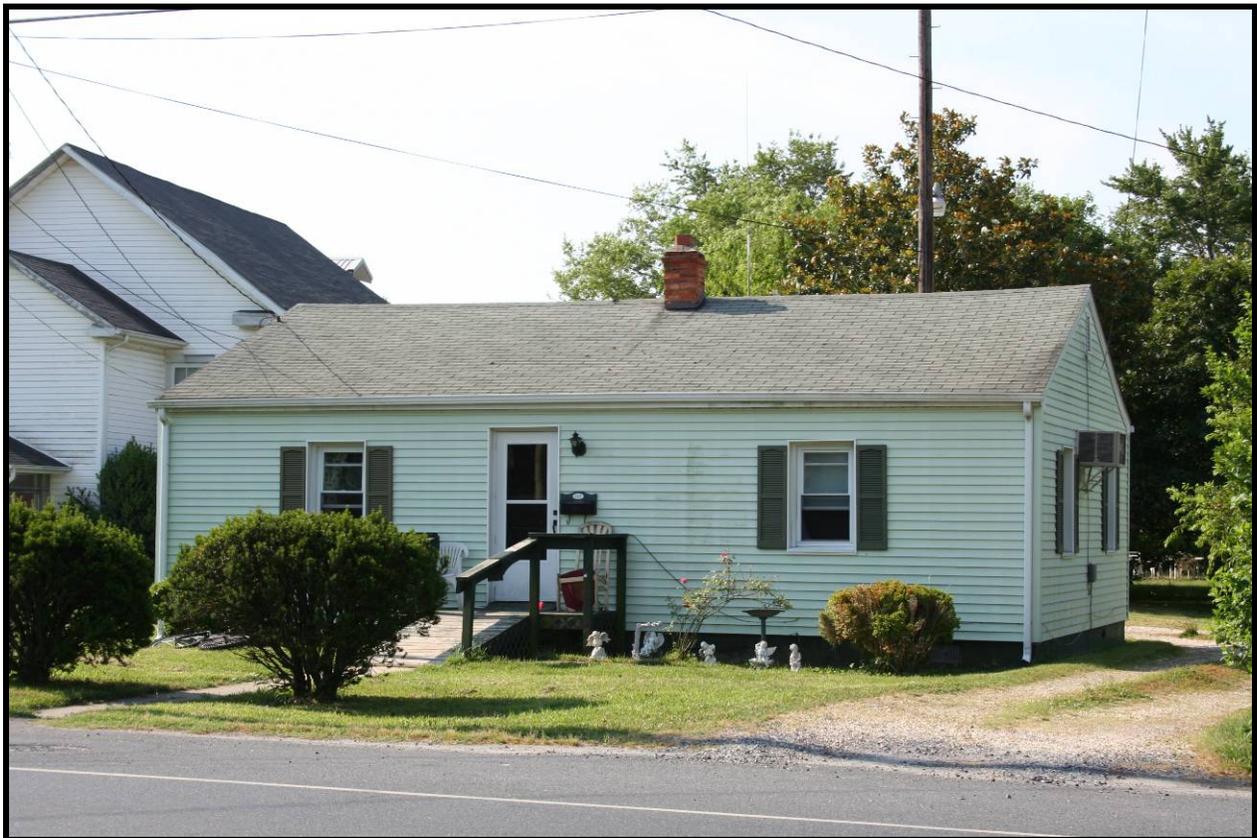
S-11923

Property Type: Single-Family Dwelling, Ranch Style

This three-bay, one-and-a-half story, side-gabled Ranch was built between 1961 and 1968. All of the windows are one-over-one double-hung sash with plain wood surrounds and inoperable wooden louvered shutters. The northwest façade has two windows, one in each outer bay, and a door in the central bay. The door is covered with a plain aluminum and glass storm door and is set over a small wood porch with a ramp. The southwest elevation has two windows and a small attic vent centered under the gable peak. The northeast elevation has three bays with a window in each outer bay and a door in the center bay. A two-step stoop is located under the door and a small attic vent is under the gable peak. The dwelling has a brick interior chimney which is centrally located along the roof ridge. The house is covered with aluminum/vinyl siding and the roof is covered with coursed asphalt shingles. This dwelling is considered a non-contributing property for the expanded Milton Historic District due to its construction date.

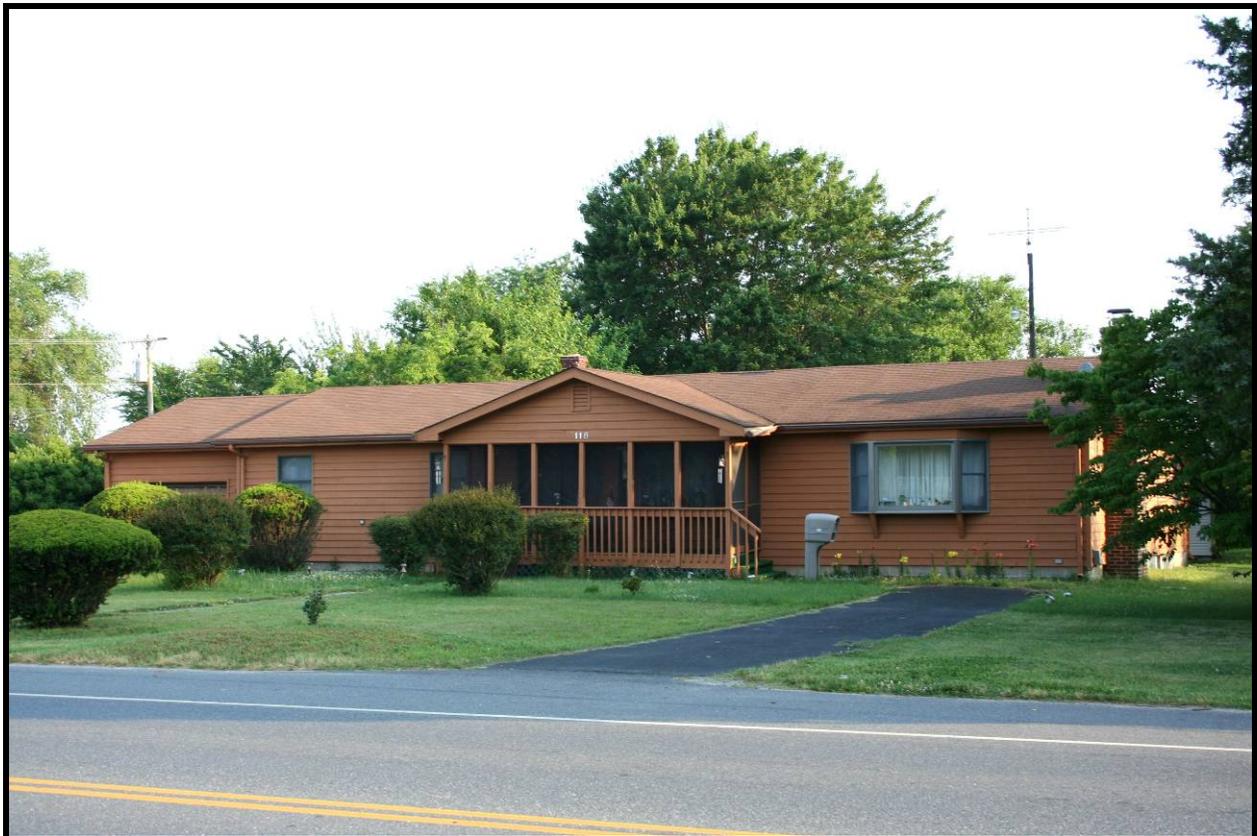
S-11914**118 Beach Highway (Rt. 16) (1992 Aerial Map)****Property Type: Single-Family Dwelling, Ranch Style**

This Ranch first appears on the 1992 Aerial Map of Milton, but it is believed that construction occurred circa 1975 (the dwelling was built between 1968 and 1992). The frame dwelling has a screen-enclosed front porch and a rear cross-gabled addition. The south façade has six bays with eight windows in a regular fenestration. The windows are comprised of two single one-over-one sash windows, one triple-pane casement bay, and a central casement window with two flanking one-over-one sash panes. A residential garage door is located in the southwestern bay and a nine-panel wooden door with a wrought iron and glass storm door is located in the fourth bay from the western corner. The door is enclosed within the screened porch, which is one room deep and supported by plain wood posts and railing. The opening under the porch is covered with lattice work. The view of the east elevation is partially obstructed, but exhibits at least one one-over-one sash window. The west elevation has two one-over-one sash windows and a screen door with wood surrounds located on the porch bay. The dwelling has two chimneys; one is located on the rear northwest slope and the other on the eastern exterior. The exterior walls are covered with vinyl siding and the roof is covered with coursed asphalt shingles. This dwelling is considered a non-contributing property for the expanded Milton Historic District due to its construction date.

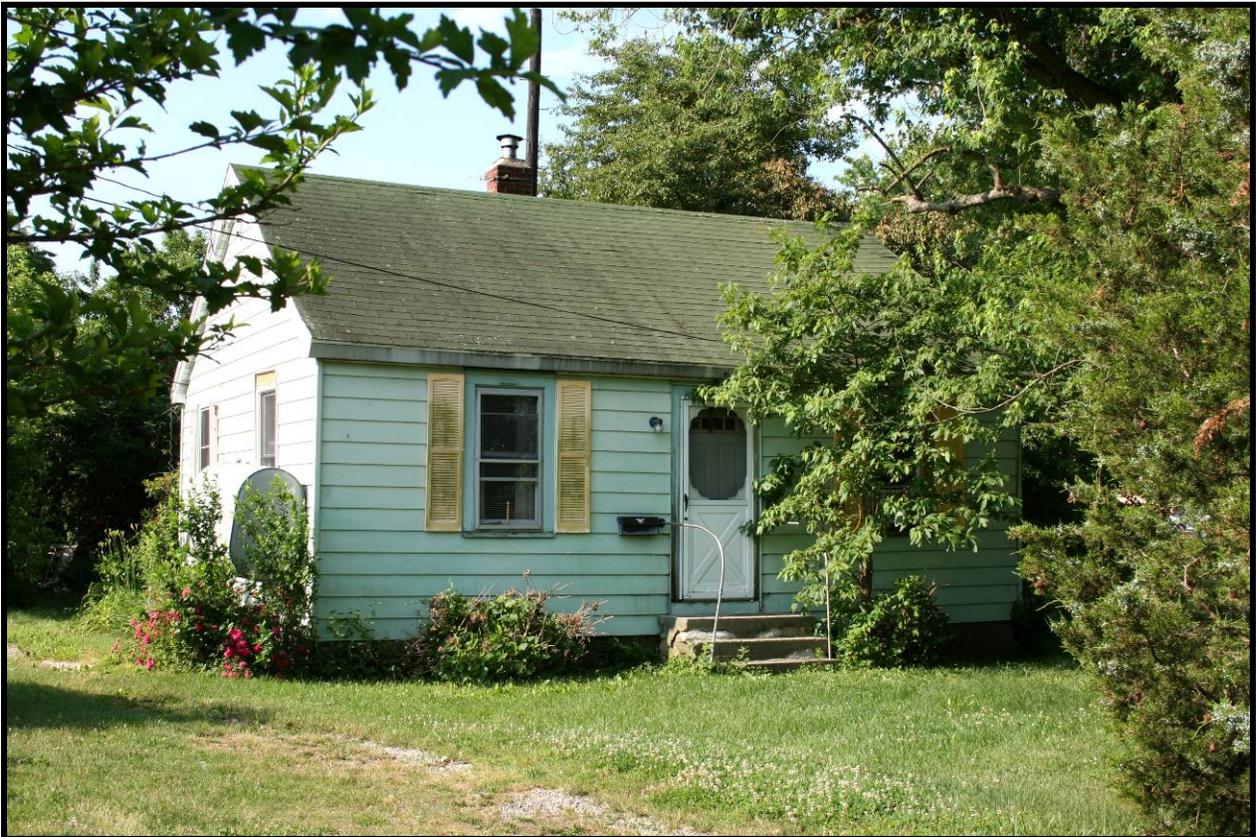
S-11924

Property Type: Single-Family Dwelling, Minimal Ranch

This three-bay, one-story, side-gabled frame dwelling was built between 1937 and 1954. All of the windows are one-over-one sash with plain wood surrounds. The northwest façade has regular fenestration that features two one-over-one sash windows with inoperable wooden louvered shutters flanking the four-light, two-paneled wooden door located in the central bay. The door is covered by an aluminum storm door and has a three-step stoop with a metal railing. The southwest and northeast elevations both have two one-over-one sash windows with decorative wood screens and inoperable wooden louvered shutters. The dwelling has a brick chimney on the rear slope towards the eastern side of the house. The exterior is covered with aluminum vinyl siding and the roof is covered with coursed asphalt shingles. Due to its early 1950s construction date, this home is one of the earliest examples of a Ranch-style dwelling constructed in Milton and therefore part of a select few to be considered a contributing property for the Milton expanded historic District. This dwelling also retains integrity of design, materials, workmanship, location, felling, and setting, further supporting the recommendation.

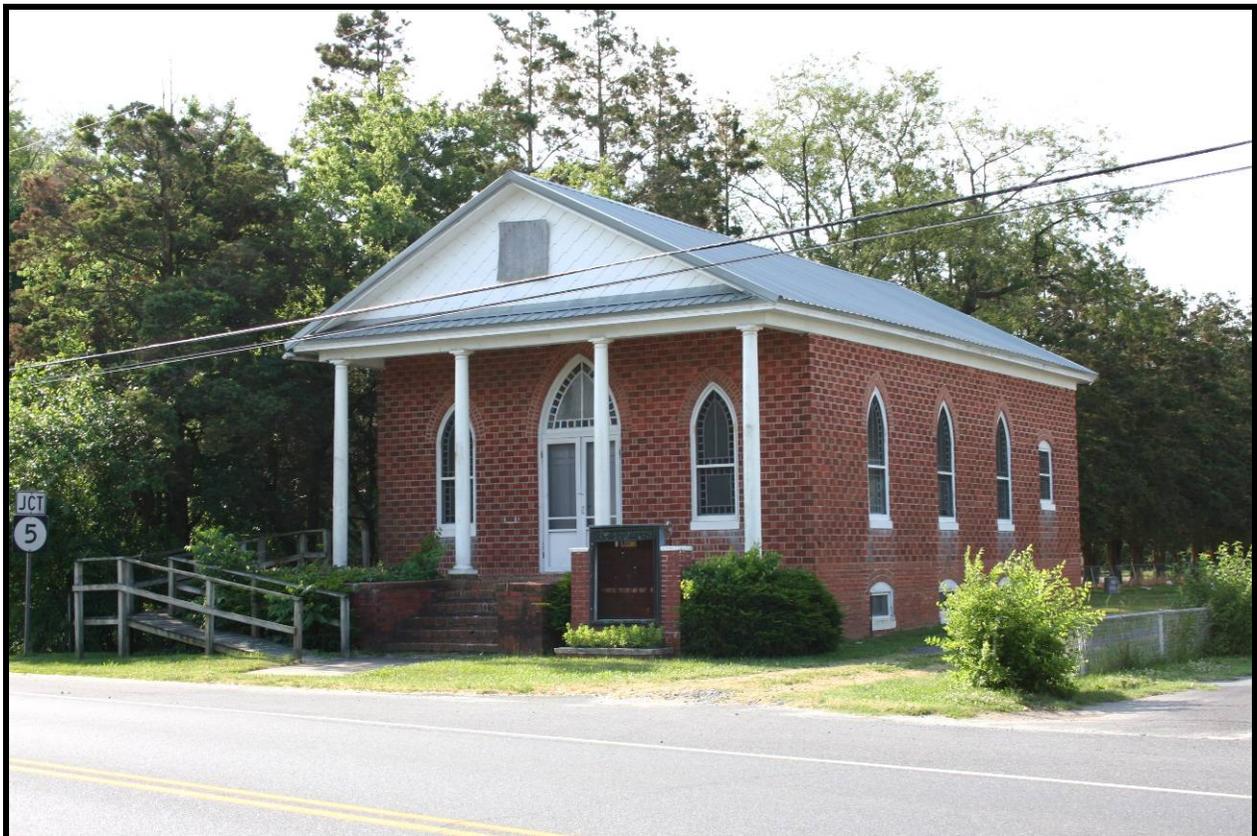
The First Congregational United Church of Christ building is a three-bay, front-gabled, one-story structure with Gothic and Greek Revival elements was built prior to 1937 (most likely between 1923 and 1937). The front (northwest) elevation has regular fenestration with two pointed-arch stained glass windows and panel double wooden doors in the central bay with a pointed-arch stained glass fanlight and plained wood surrounds. The church's Greek Revival influence can be seen in the open shed-roofed porch supported by four Doric columns. The southwest elevation has regular fenestration with seven windows consisting of three pointed-arch stained glass windows with lower casements, three triple paned casement windows, and one stained glass casement on the southeastern most bay. The northeast elevation has at least two pointed-arch stained glass windows with lower casements and two triple-pane casement windows with plain wood surrounds. The southeast elevation has one pair of pointed-arch stained glass windows with lower casements and three doors. There is a door in each of the three bays, two of which are visible (a baton door in the first bay and a six-panel wooden door in an enclosed brick vestibule). The church has one chimney located on the eastern slope of the northeast elevation. The exterior of the building is brick and the roof is lined with standing seam metal and box eaves. The combination of both Gothic and Greek Revival architectural elements in this church is unique in the town of Milton, where most of the Churches are either Gothic revival or Contemporary; it retains integrity of location, setting, design, workmanship, materials, and feeling, making it a contributing historic property for the expanded Milton Historic District.

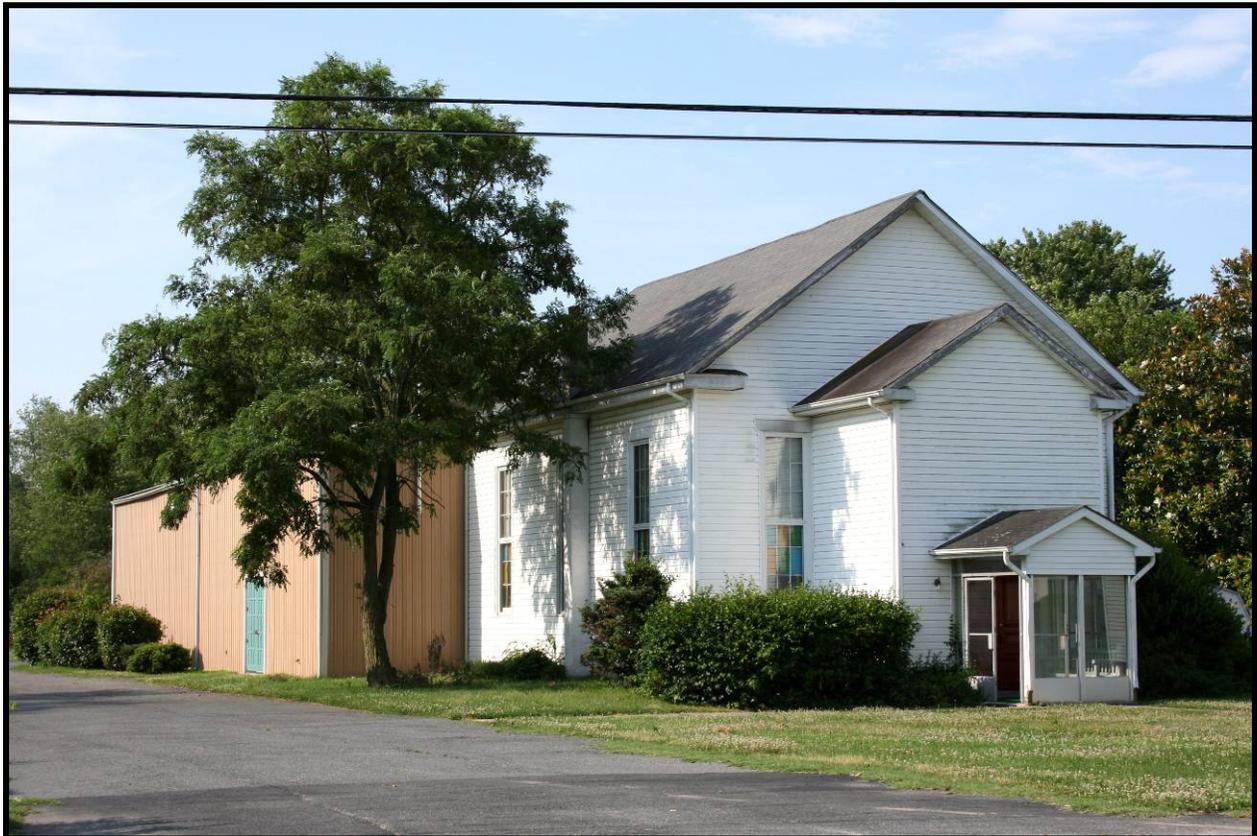
S-11922

Property Type: Church

The Landmark Baptist Church is a front-gabled vernacular structure which was built between 1961 and 1968. The church has several additions that include a large gable-roofed addition to the southeast side of the main block, a small front-gabled rear addition, a shed-roofed rear entrance vestibule, and a front-gabled front entrance vestibule. The northwest façade has a stepping front-gabled roof with returning cornices on all but the roof of the vestibule. There are two windows and one door enclosed in the glass-paned vestibule. All of the visible windows of the church are eighteen-pane with colored glass in the lower nine panes. The southwest elevation has a regular fenestration with at least three of these tall windows. The northeast elevation also has three windows located on the main block with an exterior chimney on the main block of the church. A door is located on the northeastern bay of the addition and a second double glass and aluminum door is located in the entrance of the vestibule. The exterior walls of the main block are covered with horizontal vinyl/aluminum siding while the addition is covered with vertical siding. The roof is covered with asphalt shingles and has boxed eaves. This church is considered a non-contributing property for the expanded Milton Historic District due to loss of integrity in design and materials.

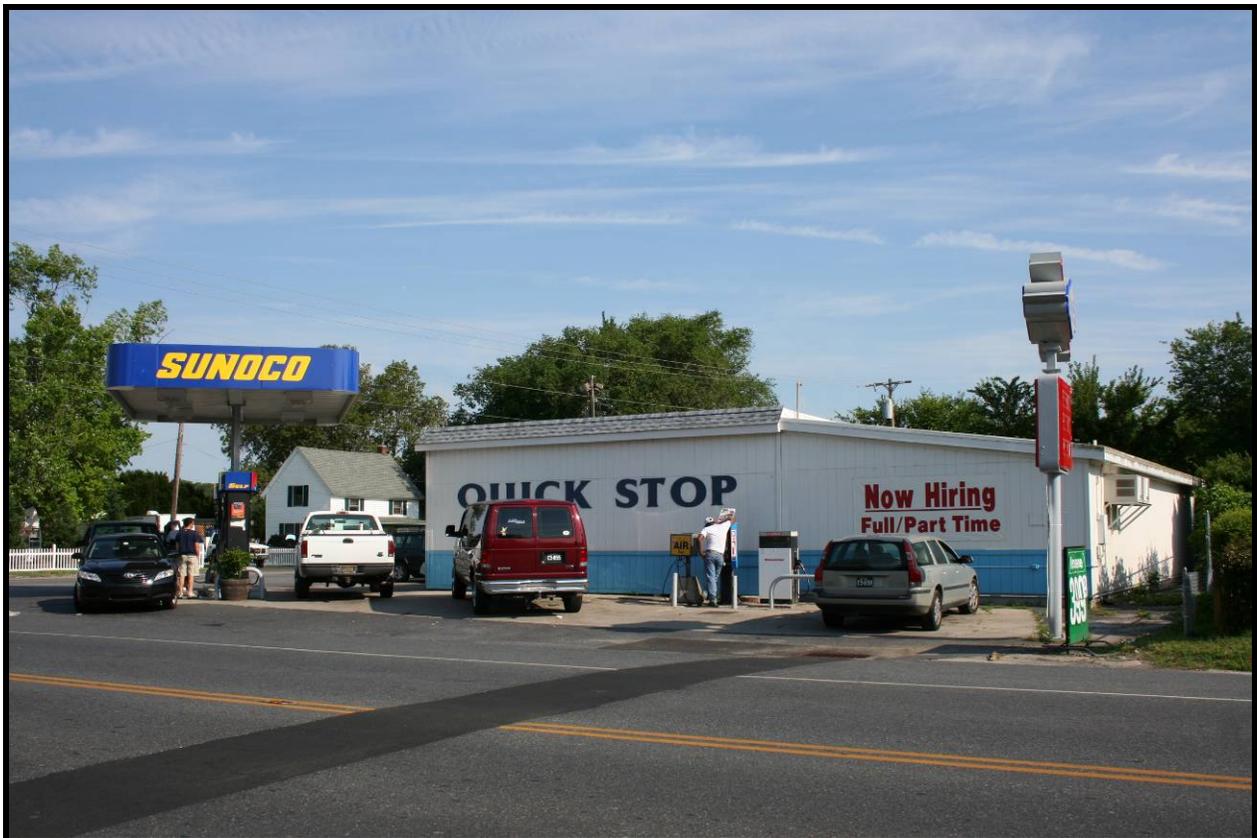
S-11913

Property Type: Commercial Property

This rectangular, one-story commercial frame building, built between 1937 and 1954, currently houses Quick Stop Sunoco Gas Station. The building has a rear shed-roofed addition that spans the width of the building and a shed-roofed addition on the northern elevation. The west façade has a large casement window and a commercial glass and metal door with plain wood surrounds. The exterior walls are covered with vertical aluminum/vinyl siding. The roof is flat with mansard sides and is covered with coursed asphalt shingles. The construction of this building reflects the growing population of Milton during the 1930s and the need for more gas station to accommodate the rising number of automobiles within the town. This building retains integrity of design, location, and setting, making it a contributing historic property for the expanded Milton Historic District.

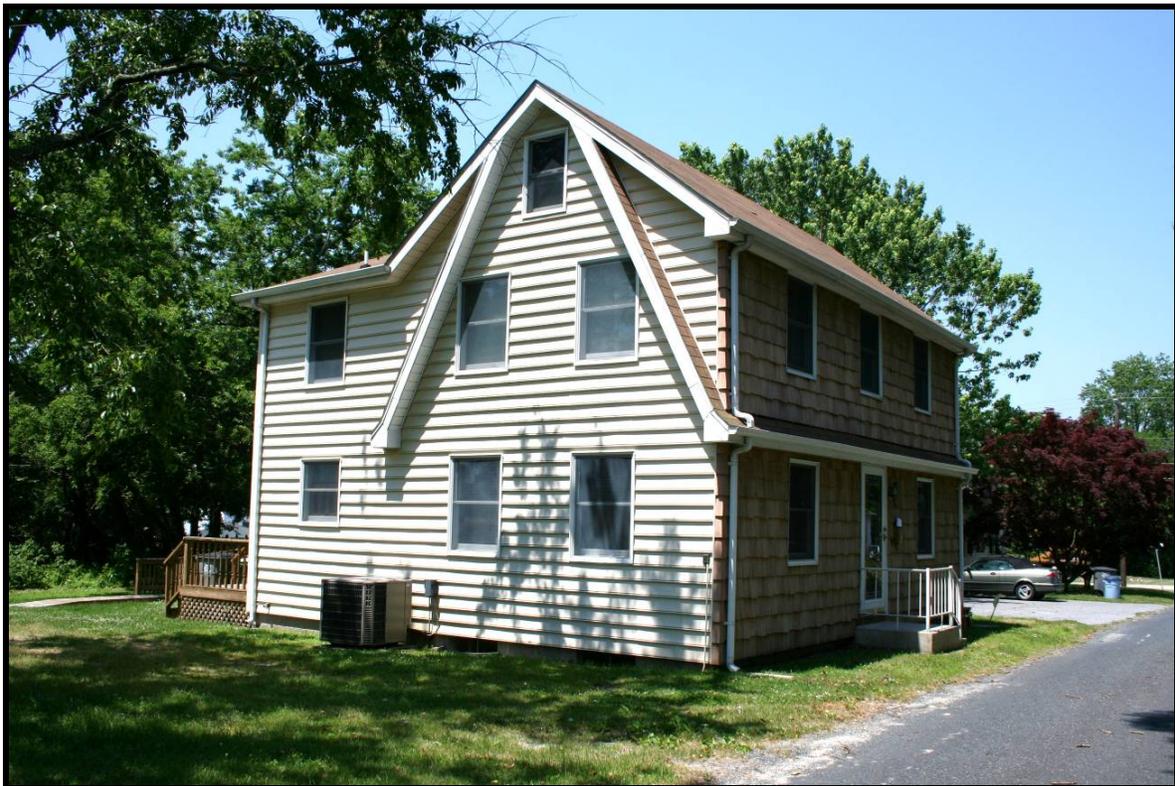
S-12115

Property Type: Single-Family Dwelling, Dutch Colonial Revival Style

This three-bay, two-and-a-half story Dutch Colonial Revival style, frame dwelling was built between 1937 and 1954. Several additions have changed the shape of both the structure and roofline. A cross-gabled two-story wing was added to the rear south/southwest façade and a smaller single-story dropped cross-gabled wing on the west/southwest façade have altered the shape of the structure from rectangular to square. A full-width shed dormer on the front north/northeast façade and the rear south/southwest forms a side-gabled roof over the integrated gambrel roof. There is evidence of a steeply-pitched Dutch colonial gambrel roof at both gable ends. The front door, located on the central bay of the north/northeast façade, displays a decorative fanlight over a four-paneled door behind a full-view storm door. Below, a small concrete stoop with metal railing connects two steps to the ground. All of the windows are regularly fenestrated, one-over-one sash windows with plain aluminum surrounds. The exception is one tripartite, focal bay window with a single-pane center located on the northern most bay of the west/northwest elevation. The front north/northeast elevation is covered with vinyl irregular cedar shake shingles while the sides of the building are covered with vinyl clapboard-style siding with bead detailing. The roof is covered with asphalt shingles. The dwelling features an open wooden deck that protrudes from the rear south/southwest side. The dwelling is one of only a few Dutch Colonial style homes constructed in Milton between the mid 1930s to the mid 1950s; it retains integrity of design, materials, workmanship, location, feeling, and setting, making it a contributing historic property for the expanded Milton Historic District.

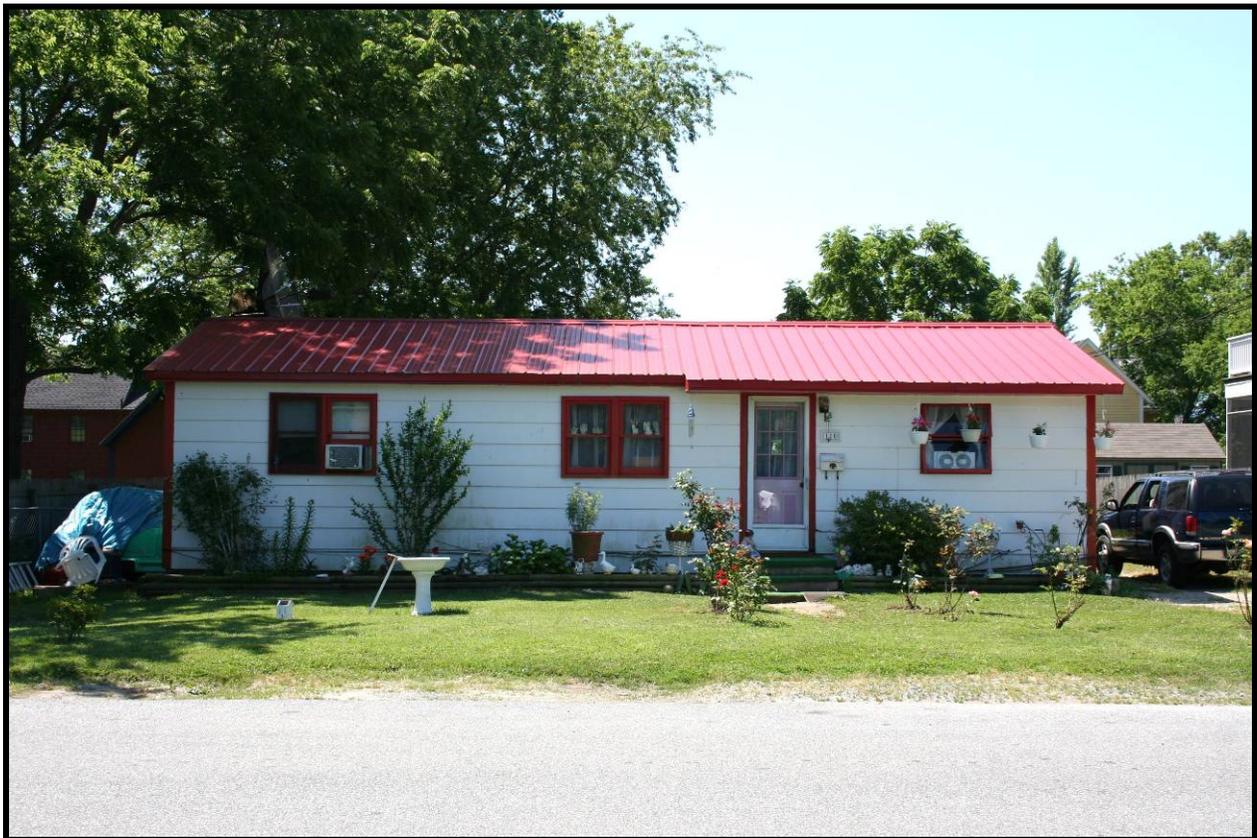
S-12019

Property Type: Single-Family Dwelling, Ranch Style

This four-bay, side-gabled Ranch was built between 1961 and 1968. It has one cross-gabled rear addition which is flush with the northeast elevation, forming an overall "L" shape. The dwelling has a standing-seam sheet metal roof, boxed eaves, and a reinforced concrete basement. All of the windows are one-over-one sash with plain wood surrounds. The northwest façade has five staggered windows with one single window on the western-most bay and two sets of paired windows on the third and fourth bays from the west corner. A nine-light, double-paneled wooden door featuring plain wood surrounds and an aluminum and glass storm door are located in the second bay to the west. The southwest elevation exhibits a single window on the first bay from the north corner and a door covered by a storm door in the second bay. The northeast elevation has four single windows with regular fenestration. The exterior walls are covered in aluminum/vinyl siding. This dwelling is considered a non-contributing property for the expanded Milton Historic District due to its construction date.

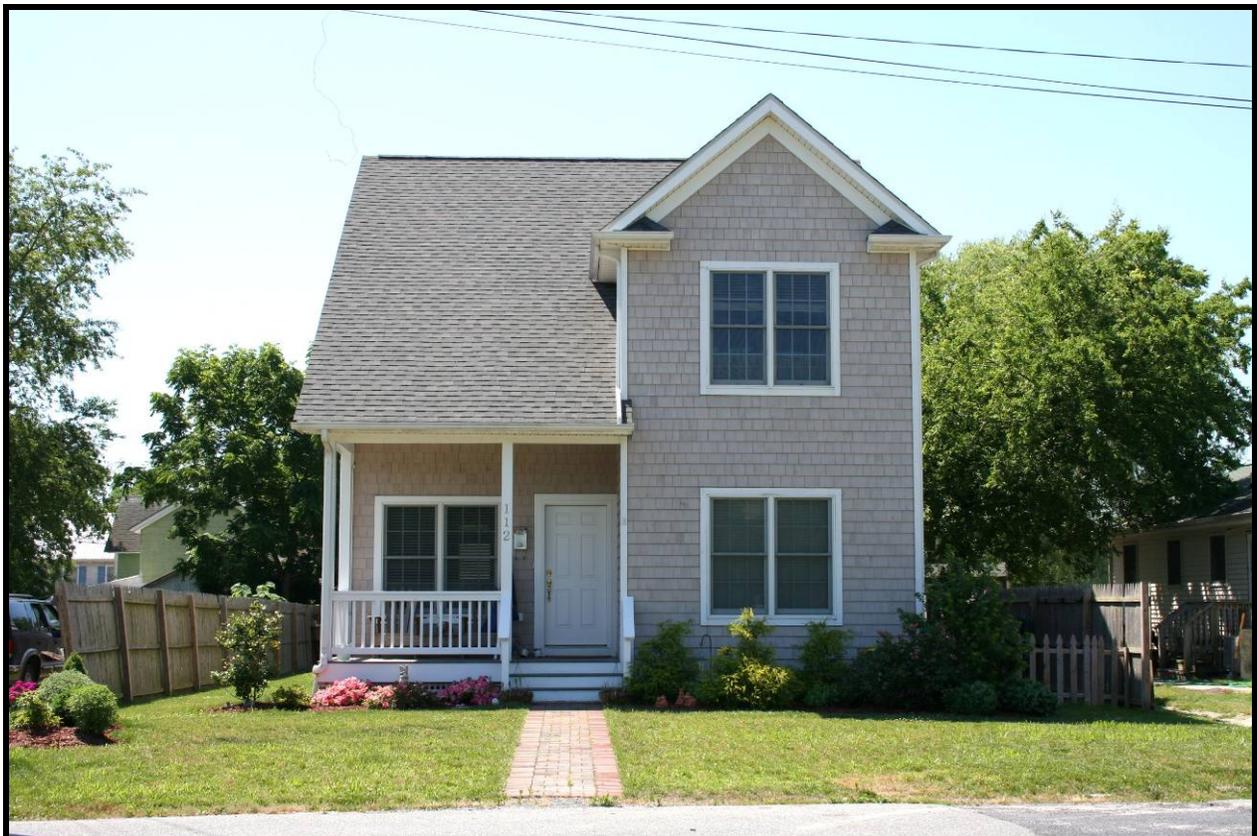
S-12020

Property Type: Single-Family Dwelling, Queen Anne Revival Style

This four-bay, two-story, frame Queen Anne Revival style dwelling, built between 2002 and 2007, has a side-gabled roof with a cross gable. All of the windows are six-over-six sash with plain wood surrounds. The northwest façade has regular fenestration, with three paired windows and a nine-panel door with wood surrounds located in the second bay from the eastern corner. The southwest elevation has three windows in a staggered fenestration and the northeast has three windows with regular fenestration. The rear southeast elevation has a screened-in porch under an open balcony that is enclosed with a wood railing. The exterior walls are covered in wooden shingles and the roof is lined with coursed asphalt shingles and boxed eaves. This dwelling is considered a non-contributing property for the expanded Milton Historic District due to its recent construction date.

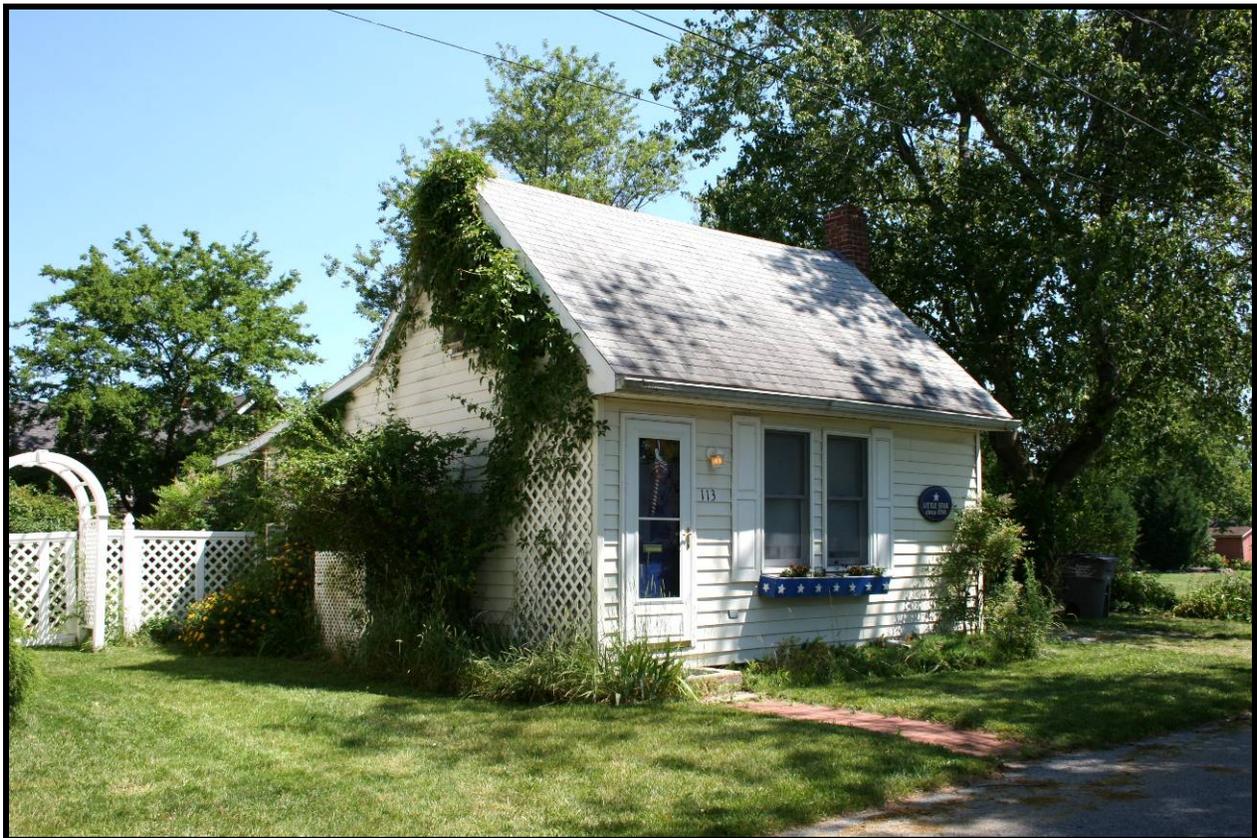
S-12015

Property Type: Button Shop, Cottage (Cape Cod Style)

This two-bay, one-and-a-half story side-gabled frame button shop was built between 1868 and 1887. Two shed-roofed additions project off the northwest (rear) elevation and a brick end-wall chimney is centered on the northeast gable end. All of the windows are one-over-one sash with plain wood surrounds, except for two casement windows on either side of the chimney. The southeast façade features paired windows with inoperable paneled shutters in the far eastern bay and a nine-panel wooden door behind a glass and aluminum storm door. The door features plain wood surrounds and is located in the western bay. The northeast and southwest elevations each have at least one sash window flanked by inoperable paneled shutters. The exterior walls are covered in aluminum/vinyl siding and the roof is lined with coursed asphalt shingles and boxed eaves. This is one of the earliest cottage-style dwellings built in Milton; it retains integrity of design, feeling, location, and setting, making it a contributing historic property for the expanded Milton Historic District.

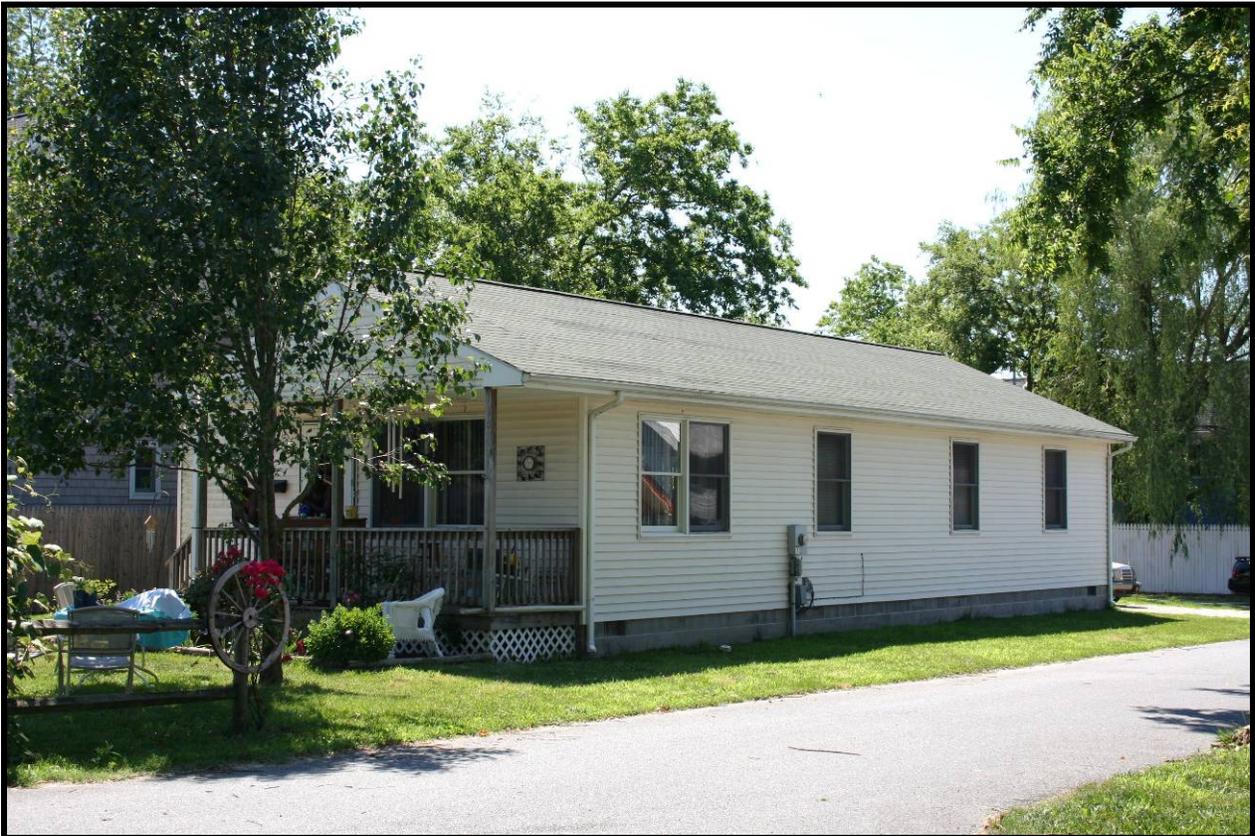
S-12021

Property Type: Single-Family Dwelling, Shotgun Style

This two-bay, one-story front-gabled frame Shotgun style dwelling was built between 1997 and 2002. All of the windows are one-over-one sash windows with plain surrounds. The northwest façade has paired windows with a regular fenestration and a front door with plain surrounds in the far eastern bay. There is an open porch toward the western corner of the northwest façade with a front-gabled offset roof and three support posts with a plain wooden railing. The southwest elevation has two paired windows in the northern-most bay and three single windows with regular fenestration. The northeast elevation has a staggered fenestration with five windows and a wooden door with nine lights and an aluminum and glass storm door in the central bay. The exterior walls are covered with aluminum/vinyl siding and the front-gabled roof has boxed eaves and is covered with coursed asphalt shingles. This dwelling is considered a non-contributing property for the expanded Milton Historic District due to its recent construction date.

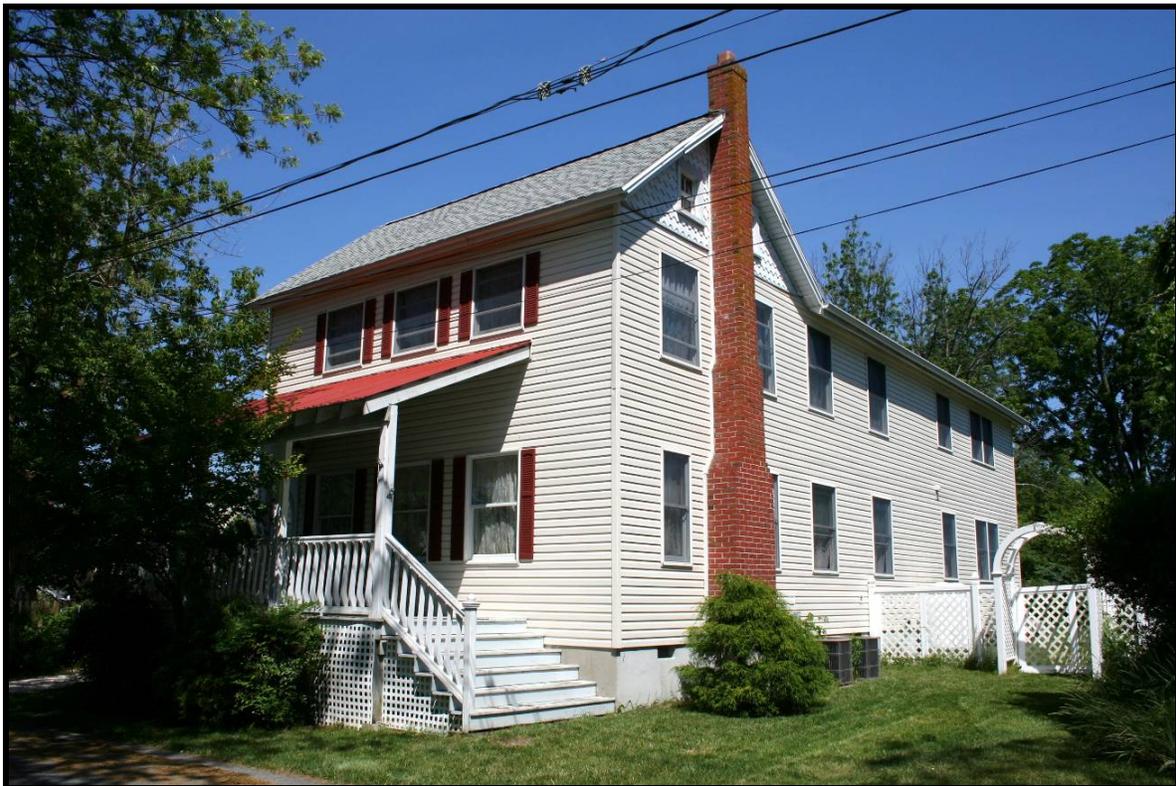
S-12014**115 Tilney Street (1887 Map of Milton)****Property Type: Single-Family Dwelling, Four-Bay Vernacular**

This four-bay, two-and-a-half story, side-gabled frame dwelling, which was built between 1868 and 1887, includes a cross-gabled rear addition and an attached shed-roofed rear addition. The dwelling features two porches: the southeast façade porch has an open shed roof with standing-seam sheet metal and is supported by four wooden posts with a plain wood railing and lattice work; on the southwest elevation, a two-story, shed-roofed porch supported by six plain-wood posts is enclosed with screen on the first floor and the second story is bordered with lattice work. The southeast façade has six one-over-one sash windows with inoperable louvered shutters and a regular fenestration. A wooden door with a decorative glass oval and plain wood surrounds is located on the far left bay, south of the windows. The northeast elevation features sixteen windows with regular fenestration that include two paired one-over-one sash, ten single one-over-one sash, and two, two-over-two sash upper story windows flanking the exterior chimney. The southwest elevation has eleven staggered windows consisting of two, two-over-two sash upper-story windows and six one-over-one sash windows, all with plain wood surrounds. Two doors, one on each level, are enclosed within the porch. The exterior of the dwelling is covered with aluminum/vinyl siding and the roof is covered with coursed asphalt shingles and lined with boxed eaves. This Four-Bay Vernacular dwelling is a variation of the classic Three-Bay Vernacular style which was prevalent in Milton from the mid 19th to the early 20th centuries; it retains integrity of location, setting, design, workmanship, materials, and feeling, making it a contributing historic property for the expanded Milton Historic District.

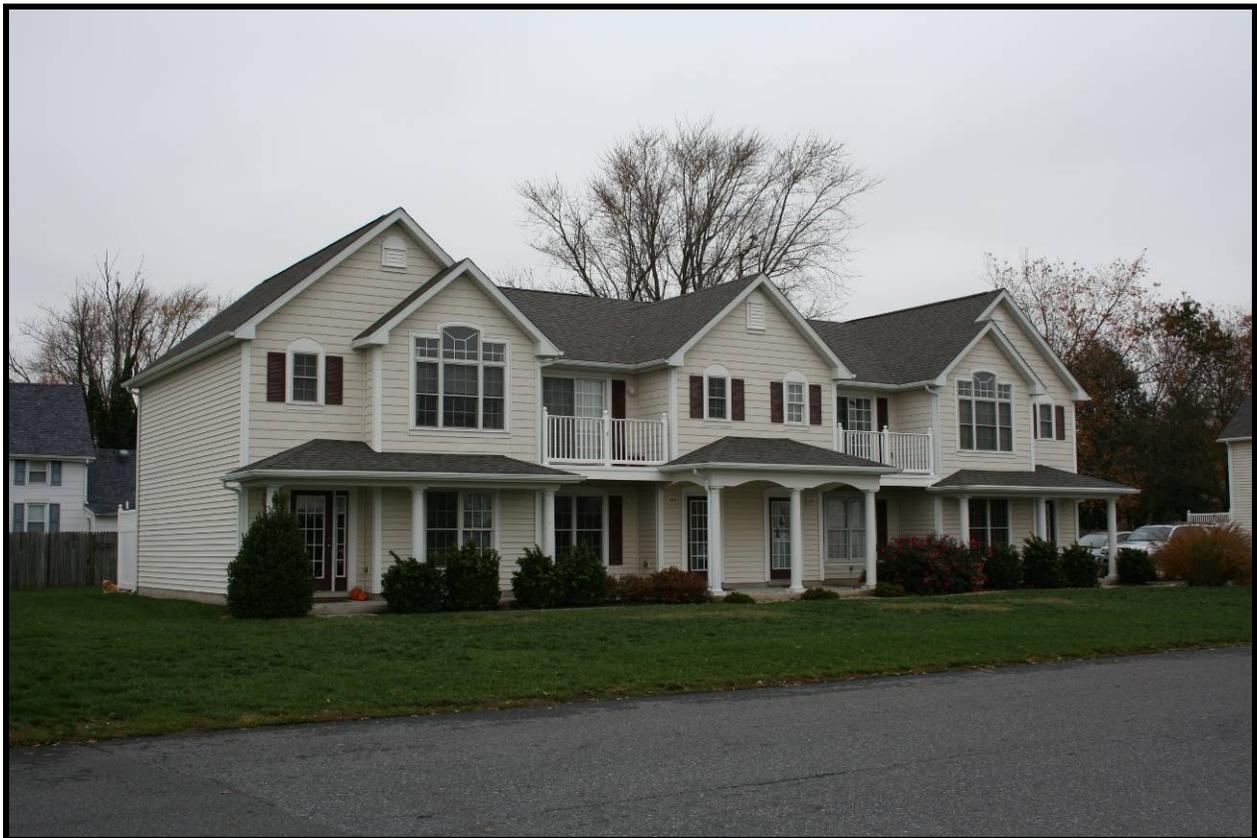
S-11963.01 → 11963.06

Property Type: Apartment Complexes, Townhouse Style

These eight-bay, two-story, frame, cross-gabled townhouses were constructed between 2002 and 2007. Each structure houses four townhouse units. Two multi-gables flank a central single gable connected by cross gables. Hipped-roof porches cover each of the four entrance doors and are supported by Doric columns. Two second-floor decks are located between the three front gables and accessed by sliding doors. The southeast façade has four doors at ground level and four sets of paired six-over-six double-hung sash windows. The second level has four four-over-four, double-hung sash windows which are flanked by inoperable shutters; two tripartite windows are also on the second level. All second-floor windows have arched wood tops. The northeast and southwest elevations have no windows or doors. The roof is covered in asphalt shingles and the exterior is sheathed in vinyl or aluminum siding. These structures are considered non-contributing properties for the expanded Milton Historic District due to their recent construction date.

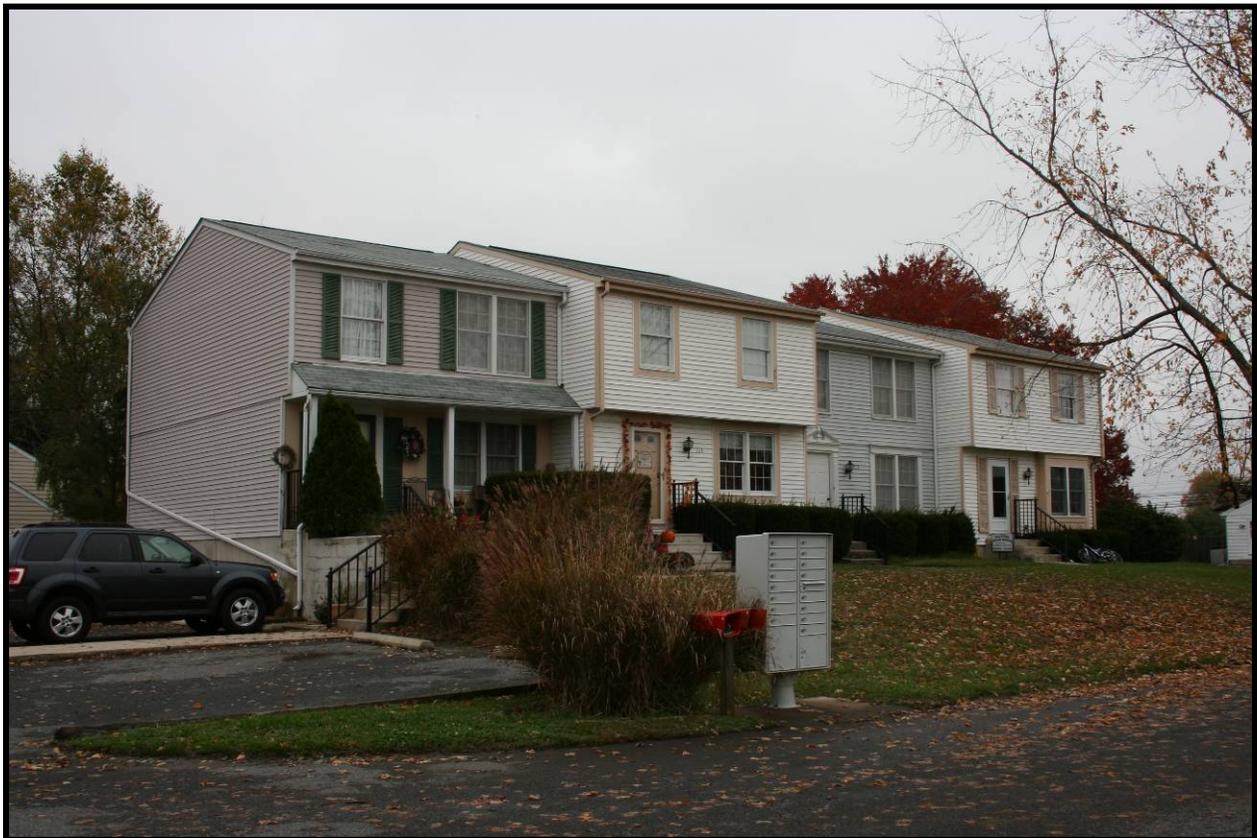
S-11960.02

Property Type: Apartment Complex, Colonial Revival Townhouses

This structure is comprised of four two-story, side-gabled Colonial Revival townhouse units and was constructed between 1968 and 1992. The units are staggered so the roof plains are uneven and the front façades are offset from each other. The western-most unit has a shed-roofed porch which is supported by simple wooden posts. The southeast façade of each unit has an entrance door in the western-most bay with a paired six-over-six double-hung sash windows to the east of the door. The second level of each unit has either two six-over-six double-hung sash windows or a single and a paired set of six-over-six double-hung sash windows. The two end units have louvered shutters flanking both the door and the windows. The northeast and southwest elevations have no windows or doors. The roof is covered in asphalt shingles and the exterior is sheathed in vinyl or aluminum siding. This structure is considered a non-contributing property for the expanded Milton Historic District due to its recent construction date.

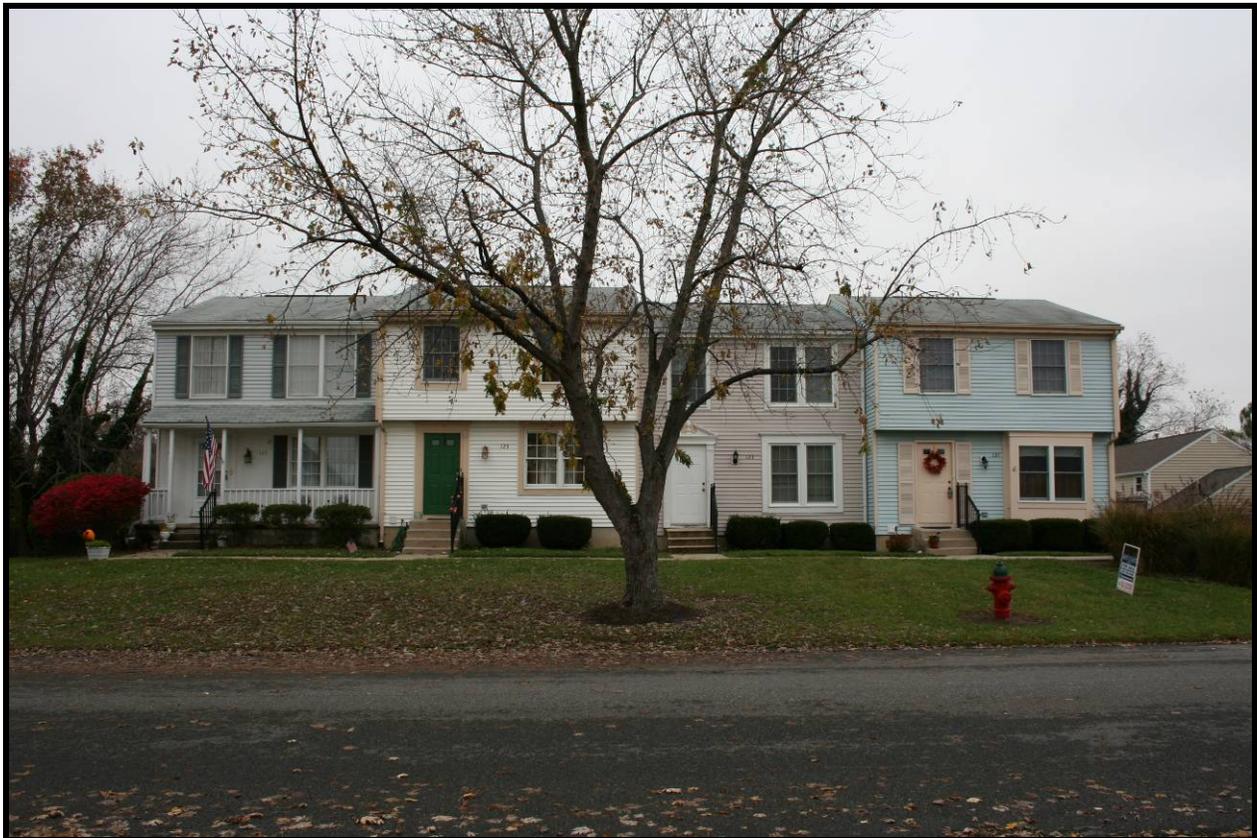
S-11960.01

Property Type: Apartment Complex, Colonial Revival Townhouses

This structure is comprised of four two-story, side-gabled Colonial Revival townhouse units and was constructed between 1968 and 1992. The units are staggered so the roof plains are uneven and the front façades are offset from each other. The western-most unit has a shed-roofed porch supported by simple wooden posts. The southeast façade of each unit has an entrance door in the western-most bay with a paired six-over-six double-hung sash windows to the east of the door. The second level of each unit has either two six-over-six double-hung sash windows or a single and a paired set of six-over-six double-hung sash windows. The two end units have louvered shutters flanking both the door and the windows. The northeast and southwest elevations have no windows or doors. The roof is covered in asphalt shingles and the exterior is sheathed in vinyl or aluminum siding. This structure is considered a non-contributing property for the expanded Milton Historic District due to its recent construction date.

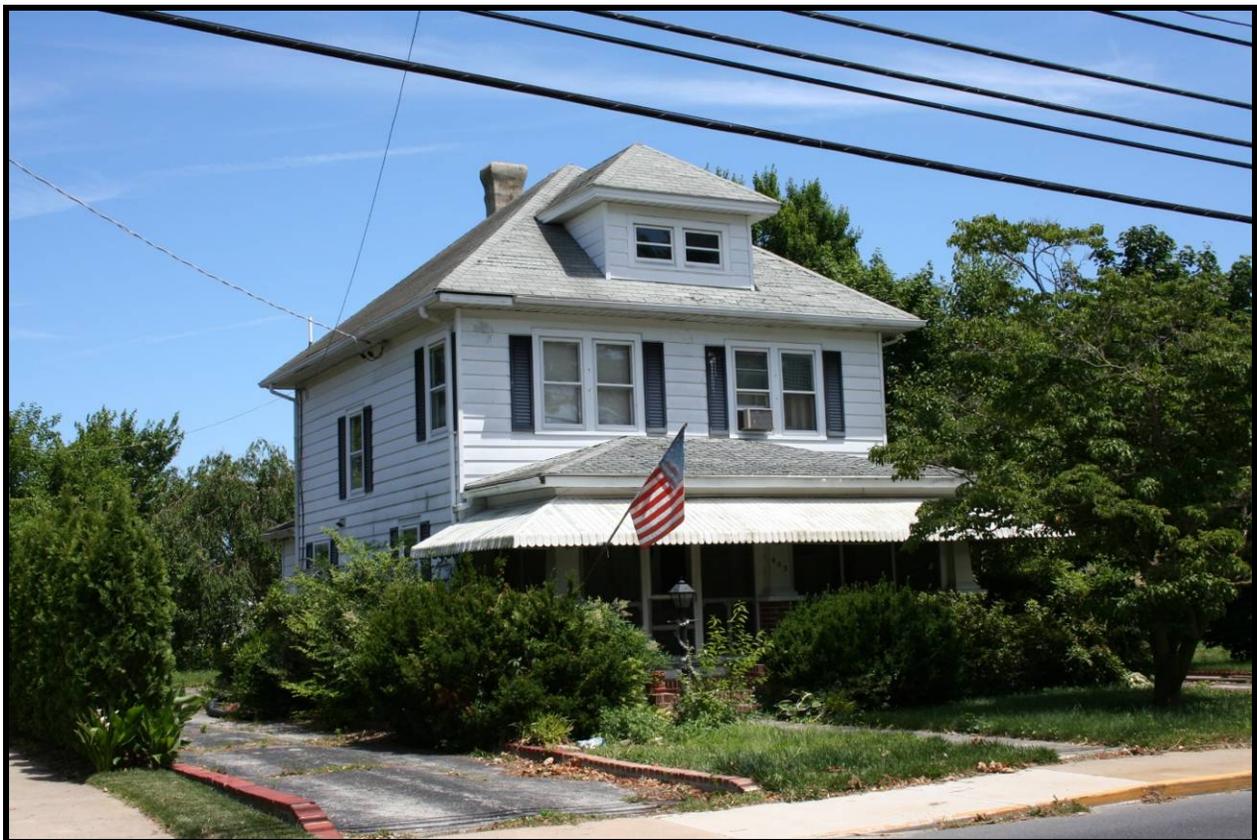
S-1622

405 Union Street (1937 Sanborn Map)

Property Type: Single-Family Dwelling, Four Square Style

This two-bay, two-and-a-half story, Four Square style, hipped-roof, frame dwelling was constructed between 1923 and 1937. A hipped-roof dormer is located in the center of the roof on the southwest elevation. A hipped-roof porch runs the length of the southwest elevation. A hipped-roof addition runs the full length of the northeast (rear) elevation and a square, hipped-roof addition is connected to the northeast corner of the rear porch. Three sets of paired double-hung sash windows are located on the southwest elevation along with a tripartite one-over-one double-hung sash window. The first and second floor windows have inoperable louvered shutters. A brick chimney is located on the northeastern side of the ridge of the hipped-roof. Asphalt shingles cover the roof and the exterior of the dwelling is sheathed in aluminum clapboard style siding. This dwelling is an excellent example of the Four Square style which was popular in Milton during the early 20th century; it retains integrity of design, materials, workmanship, location, feeling, and setting, making it a contributing historic property for the expanded Milton Historic District.
