APPENDIX A:
INVENTORY OF SURVEYED
PROPERTIES

MILTON • DELAWARE

APPENDIX A

This appendix begins with a chart of all the resources surveyed in Milton. The chart includes CRS numbers, address, function, style of architecture, the date the property first appears on a historic map, and whether or not the property should be considered contributing or non-contributing to a potential expanded National Register of Historic Places District in Milton or a local historic zone. Following the chart, descriptions of the surveyed resources provide more detailed information on the historic name of the property, function, a brief history, and a physical description of the property. The description also provides a short rationale for the property's recommendation for inclusion or exclusion to the National Register District. Photographs of each main building or resource appear with the descriptions.

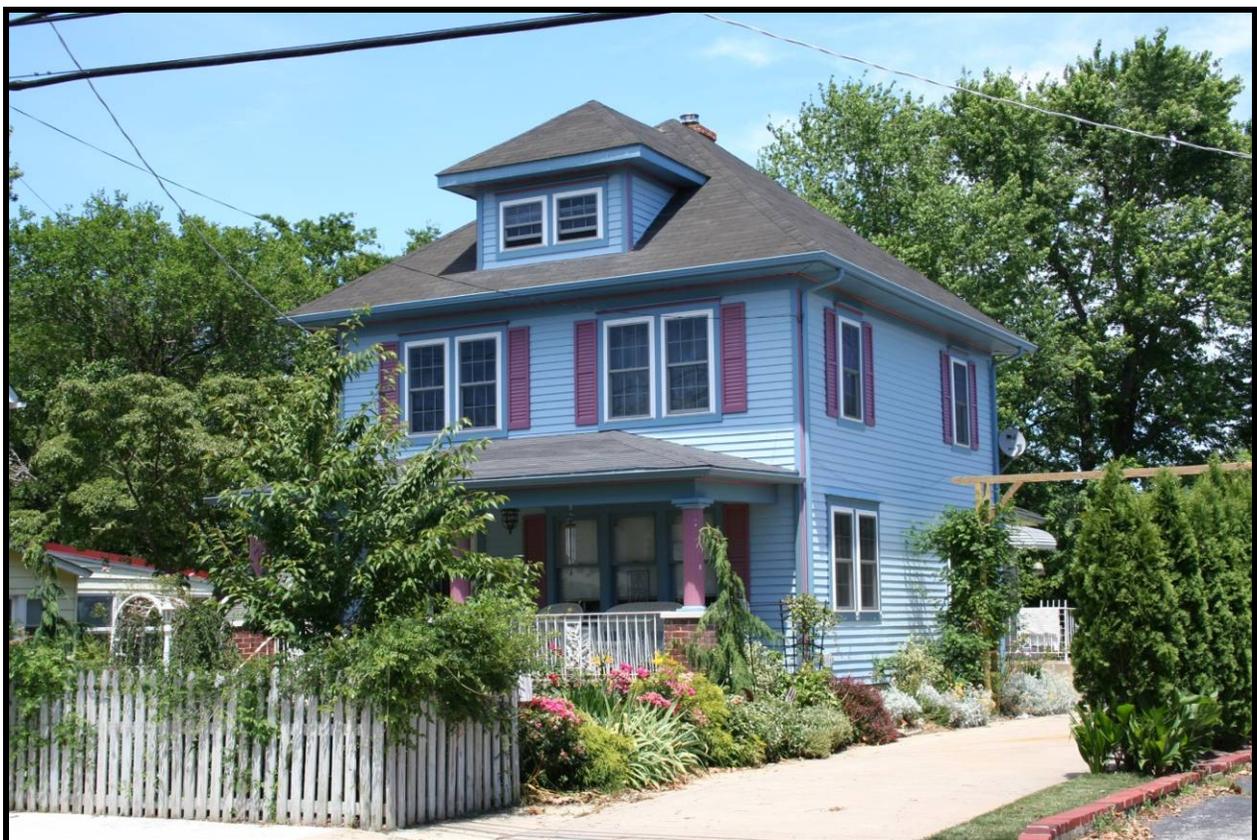
S-1623

407 Union Street (1911 Sanborn Map)

Property Type: Single-Family Dwelling, Gothic Revival Style

This two-and-a-half story, three-bay, frame, front-gabled Gothic Revival style dwelling with an asymmetrical cross gable was constructed between 1887 and 1911. A small bay window addition was added near the southwest corner. An enclosed, shed-roofed, single-story addition runs the length of the northeast elevation. Each gable end has an attic window with a gothic arched top and decorative scrollwork at the eaves. A gable-roofed stoop with decorative support posts covers the entrance door and five two-over-two double-hung sash windows are located on the southwest elevation; the windows are flanked by inoperable louver shutters. An interior brick chimney is located along the ridge of the main block toward the front elevation. The roof is covered in asphalt shingles and the exterior is sheathed in clapboard-style aluminum siding on all sides, except for the southwest street level elevation and bay window addition which have board and batten siding. The dwelling is an excellent example of the Vernacular Gothic Revival style in Milton which became popular in during the late 19th and early 20th centuries; it retains integrity of design, materials, feeling, workmanship, location, and setting, making it a contributing historic property for the expanded Milton Historic District.

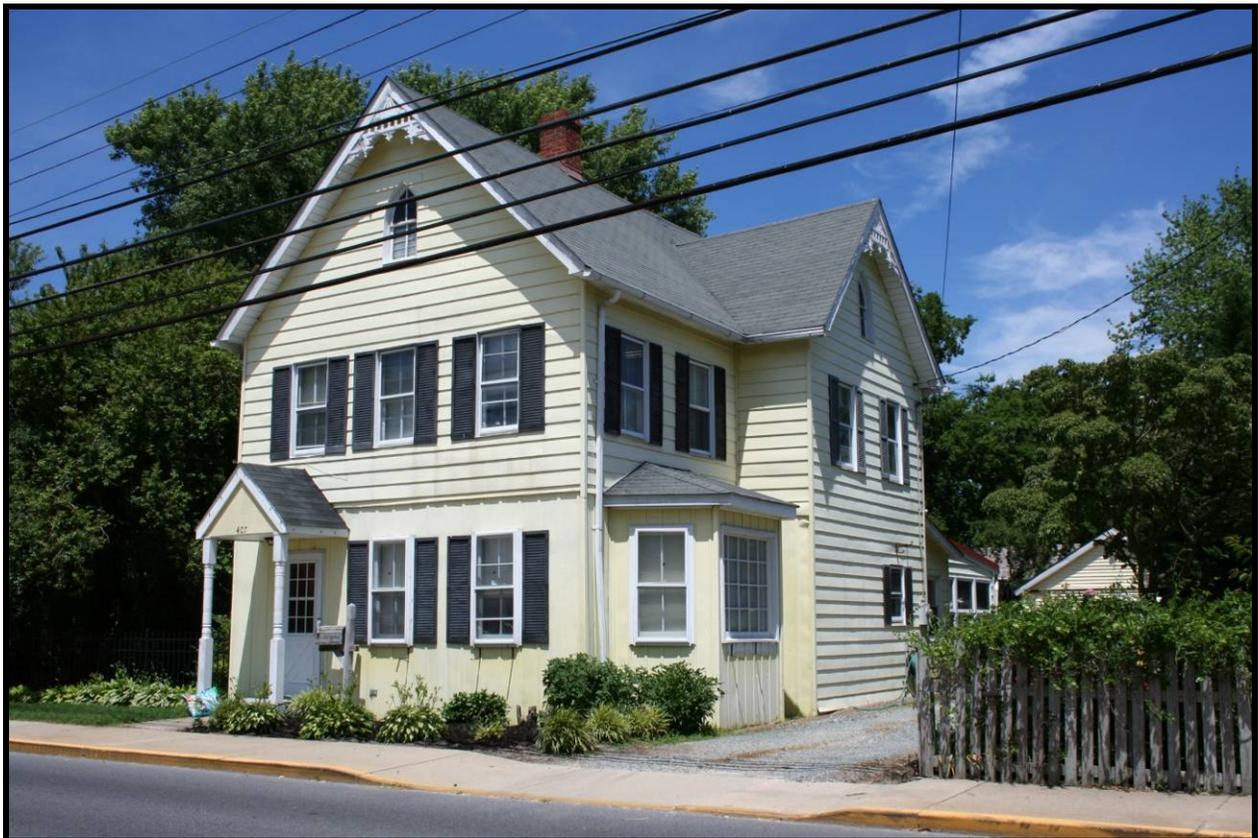
S-1625

411 Union Street (1992 Aerial Map)

Property Type: Single-Family Dwelling, Colonial Revival Style

This four-bay, two-story, frame, side-gabled Colonial Revival style dwelling was built in 1977 according to the original survey forms (current structure first appears on aerial maps in 1992). A flat-roofed addition is connected to the northeast corner of the dwelling, as well as a large wooden second-floor deck. The southwest façade has a mix of six eight-over-twelve and eight-over-eight double-hung sash windows with inoperable louver shutters. The entrance door is located in the second bay from the northwest corner and is flanked by inoperable louvered shutters. The northwest elevation has a mix of three eight-over-twelve and eight-over-eight double-hung sash windows with inoperable louvered shutters. The door, positioned in the far left bay, also has inoperable louvered shutters on either side. Asphalt shingles cover the roof and the exterior of the dwelling has vinyl clapboard-style siding. This dwelling is considered a non-contributing property for the expanded Milton Historic District due to its date of construction.

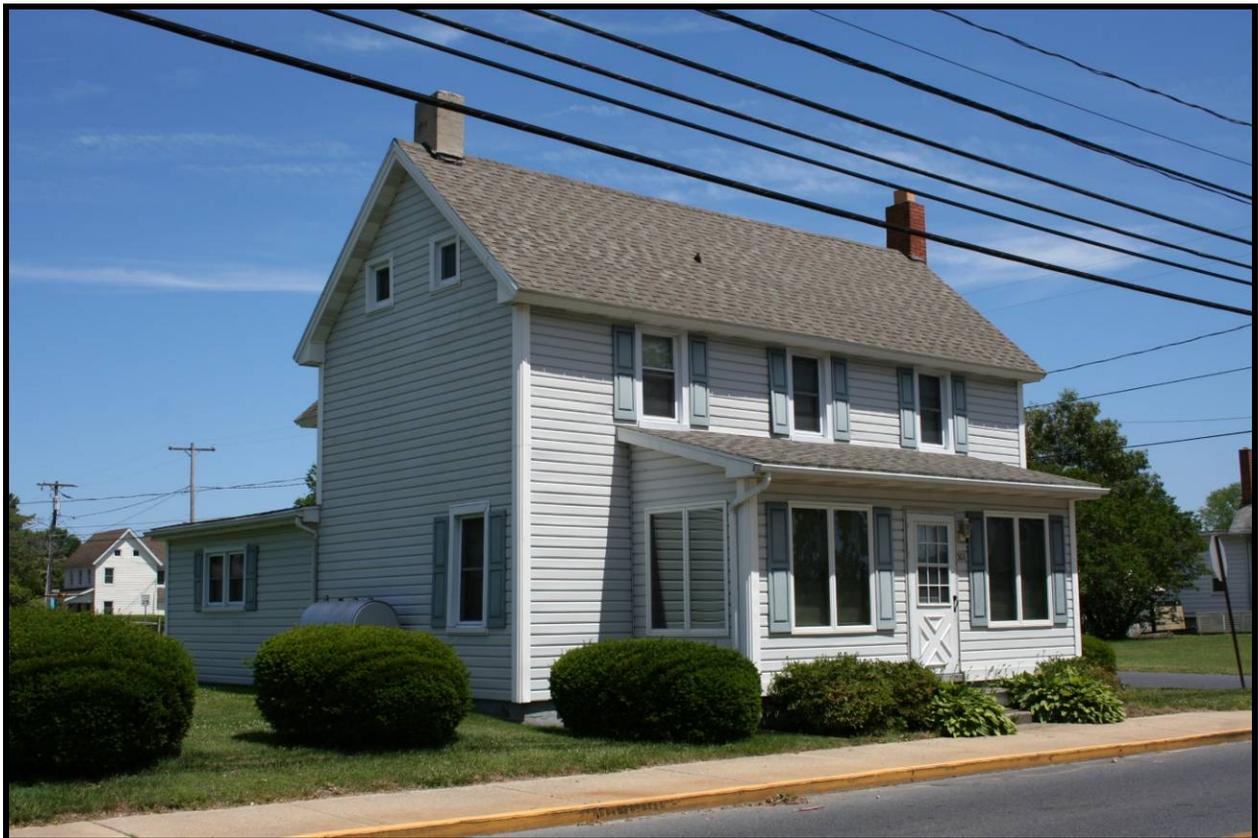
S-11967

502 Union Street (William F. Manship House: 1868 Beers Map)

Property Type: Single-Family Dwelling, Three-Bay Vernacular Italianate Style

This three-bay, side-gabled, two-and-a-half story, Vernacular Italianate style frame dwelling with a T-shaped plan was built prior to 1868. Connected to the two-and-a-half story cross-gabled rear wing of the house are three single-story additions: a gable-roofed and shed-roofed addition on the northwest elevation, as well as a shed-roofed addition with a central cross-gable on the southeast elevation. Five two-over-two, double-hung sash windows are located on the northeast façade along with a nine-light wooden door with a decorative lower panel; only the first floor windows on the northeast side have inoperable panel shutters. On the other visible elevations are a mix of two-over-two, six-over-six, and one-over-one double-hung sash windows. Three chimneys can be found on the house: an interior brick chimney is located toward the southeast gable end on the ridge, an interior brick chimney is located in the center of the cross-gable wing, and an exterior brick chimney is located off the southwestern elevation of the rear one-story gable-roofed addition. The roofing material is asphalt shingles, except for the standing-seam sheet-metal roof on the northeast entrance porch. Asbestos shingle siding is on the main block and vinyl, narrow clapboard-style siding covers the additions. Several period outbuildings are located to the rear of the property. William F. Manship owned the property according to the 1868 census record; he was a retail merchant and a native of Delaware. The two-over-two sash windows of this dwelling are characteristic of the Three-Bay Vernacular Italianate style homes which were popular in Milton from the late 1860s to the early 1920s; it retains integrity of materials, workmanship, location, feeling, and setting, making it a contributing historic property for the expanded Milton Historic District.

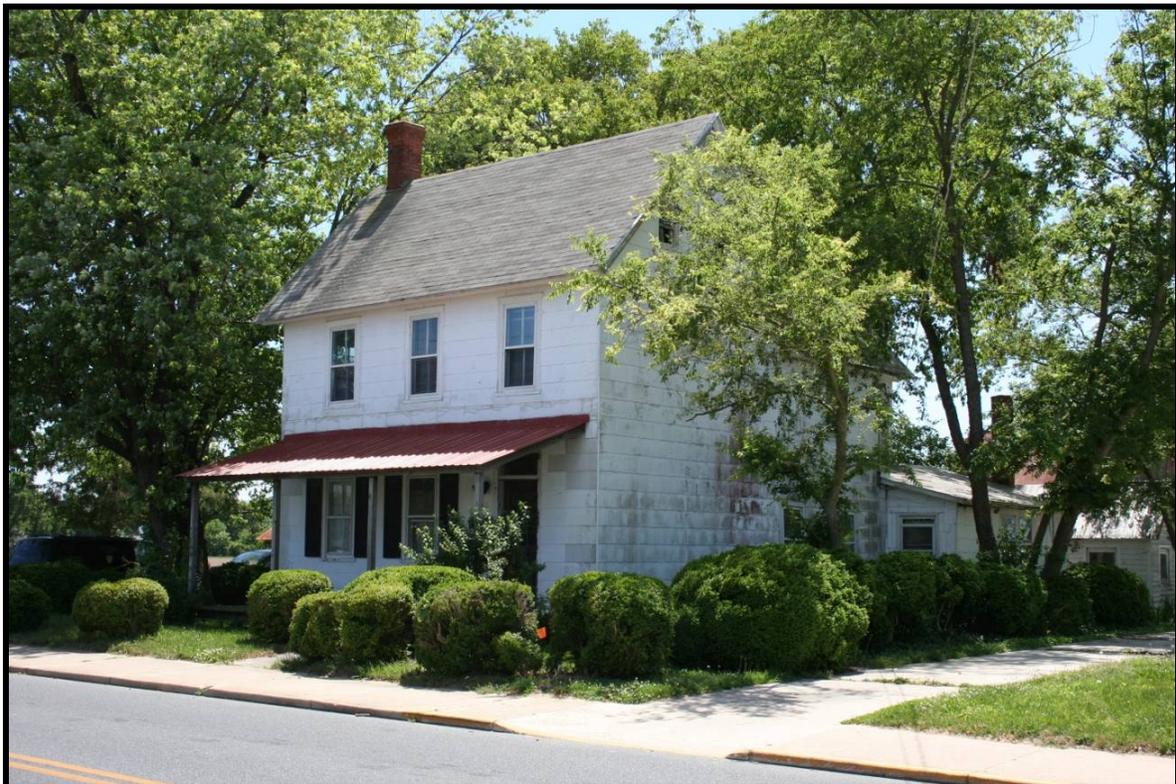
S-11968

Parcel#16.00 Union Street (506 or 508 Union) (1923 Sanborn)

Property Type: Single-Family Dwelling, Cape Cod Style

This three-bay, two-story Cape Cod was built between 1911 and 1923. The side-gabled main block has two twin dormers on the east/northeast front elevation, an enclosed shed-roofed porch on the façade, and a shed-roofed lean-to addition at the west/southwest end of the building. The enclosed front porch has ornate cutwork brackets decorating the exterior and the walls are composed entirely of sliding glass doors. The windows are all one-over-one sash with raised-panel inoperable shutters, except for the dormers which are left undecorated. The exterior walls are predominantly covered with vinyl/aluminum clapboard style siding, with the exception of vertical siding which is used to cover the dormers. Simple Cape Cod style dwellings began to appear in Milton during the early 1920s and continued in popularity until about 1960. This dwelling retains integrity of location, setting, design, workmanship, materials, and feeling, making it a contributing historic property for the expanded Milton Historic District.

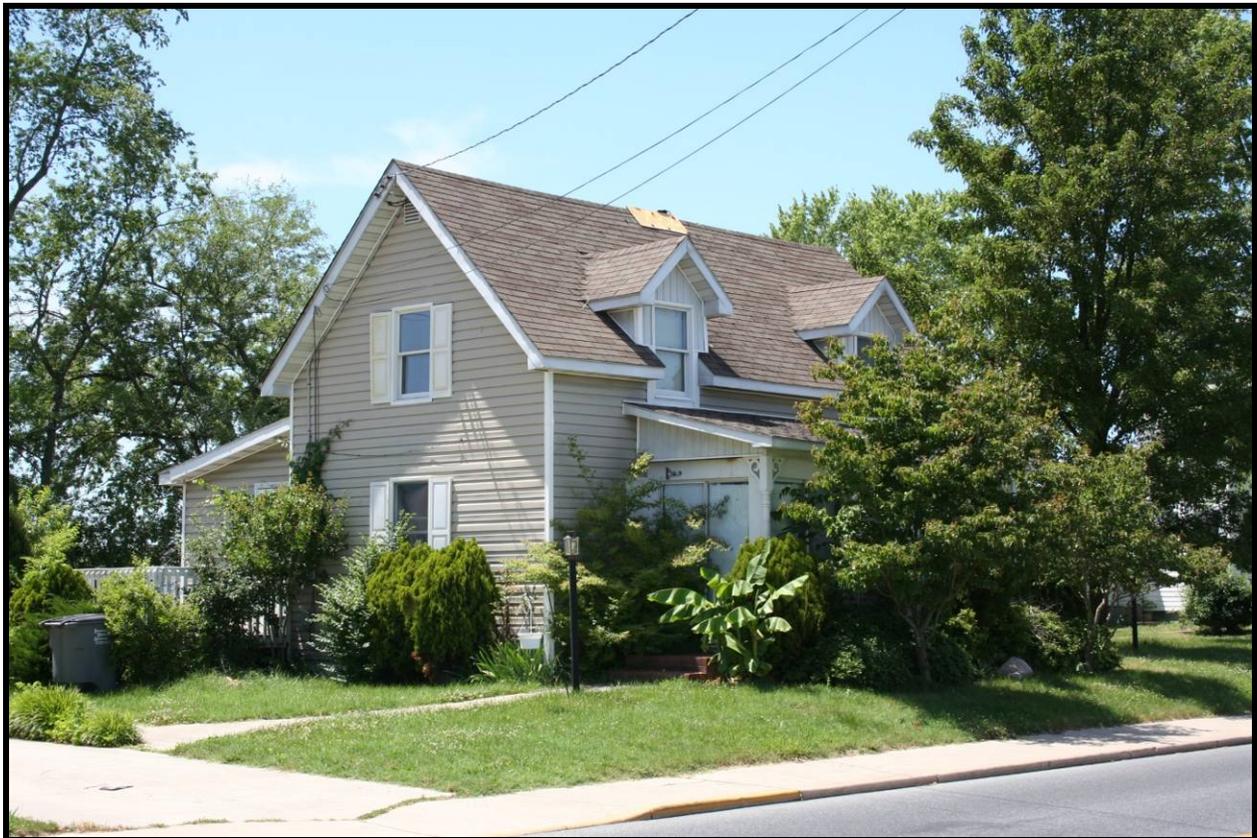
S-11976

509 Union Street (1923 Sanborn)

Property Type: Single-Family Dwelling, Gothic Revival Style

This three-bay, two-and-a-half story, cross-gabled, frame, Gothic Revival style dwelling was constructed between 1911 and 1923. Along the southwest elevation is a single-story, screened-in, hipped-roof porch with a central cross-gable, decorative posts and scroll work, and brick pier supports under the porch. A single-story, shed-roofed addition is connected to the northeast elevation. At the northwest corner there is a wraparound porch which has been screened. The southwest elevation has five one-over-one double-hung sash windows around the centrally-located door. A single-pane casement window on the third story has false shaping window trim that creates an arch. The second floor windows have inoperable shutters, while the first and third floor windows are undecorated. The other visible elevations have a mix of single and paired one-over-one double-hung sash windows with inoperable louvered shutters. An interior brick chimney is located on the ridge to the southeast side of the main gable block. The roof is covered in asphalt shingles and vinyl clapboard-style siding sheaths the first and second floors, while vinyl fish scale shingles cover the third floor. The cross-gabled roof and pointed-arch attic window of this dwelling are characteristic of the numerous Gothic Revival homes constructed throughout Milton during the late 19th and early 20th centuries. This dwelling retains integrity of location, setting, design, workmanship, materials, and feeling, making it a contributing historic property for the expanded Milton Historic District.

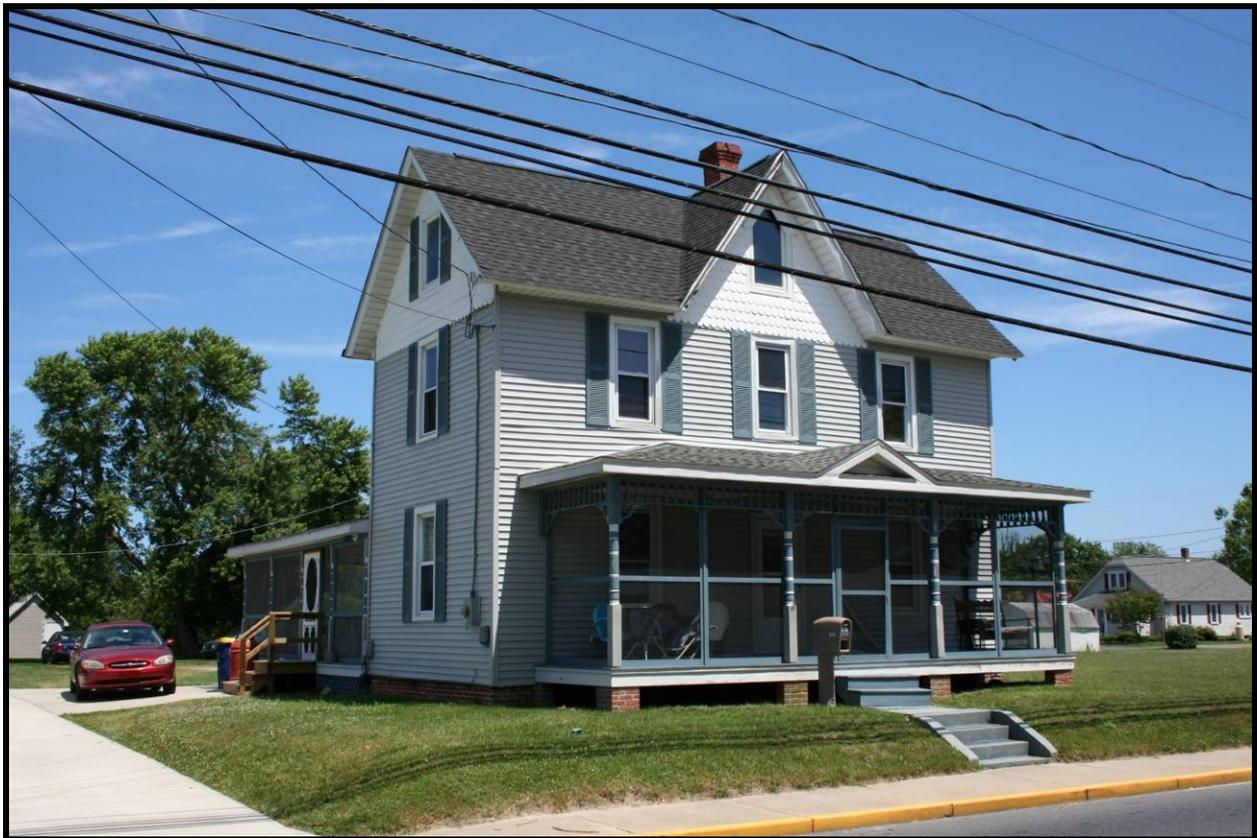
S-11969.01

510 Union Street (1937 Aerial Map)

Property Type: Single-Family Dwelling, Four Square Style

This two-and-a-half story, two-bay, hipped-roof, frame, Vernacular Four Square style dwelling was constructed prior to 1937 according to aerial maps (no Sanborn maps exist for this property between 1911 to 1937). A hipped-roof porch runs the length of the northeast façade and is supported by simple square posts. The hipped-roof has a front-facing gable dormer located on the northeast façade, a hipped-roof dormer on the northwest elevation, and cross gable on the southeast elevation. Two shed-roofed additions were constructed of the southwest elevation. Three one-over-one double-hung sash windows and a fixed casement window are located on the northeast elevation; all other visible windows are one-over-one double-hung sash windows on all floor levels. The first and second floors have vinyl Dutch lap style siding, while the third floor has vinyl fish-scale siding. All roof surfaces are covered with asphalt shingles. This dwelling is an excellent example of the Four Square style which was popular in Milton during the early 20th century; it retains integrity of design, materials, workmanship, location, feeling, and setting, making it a contributing historic property for the expanded Milton Historic District.

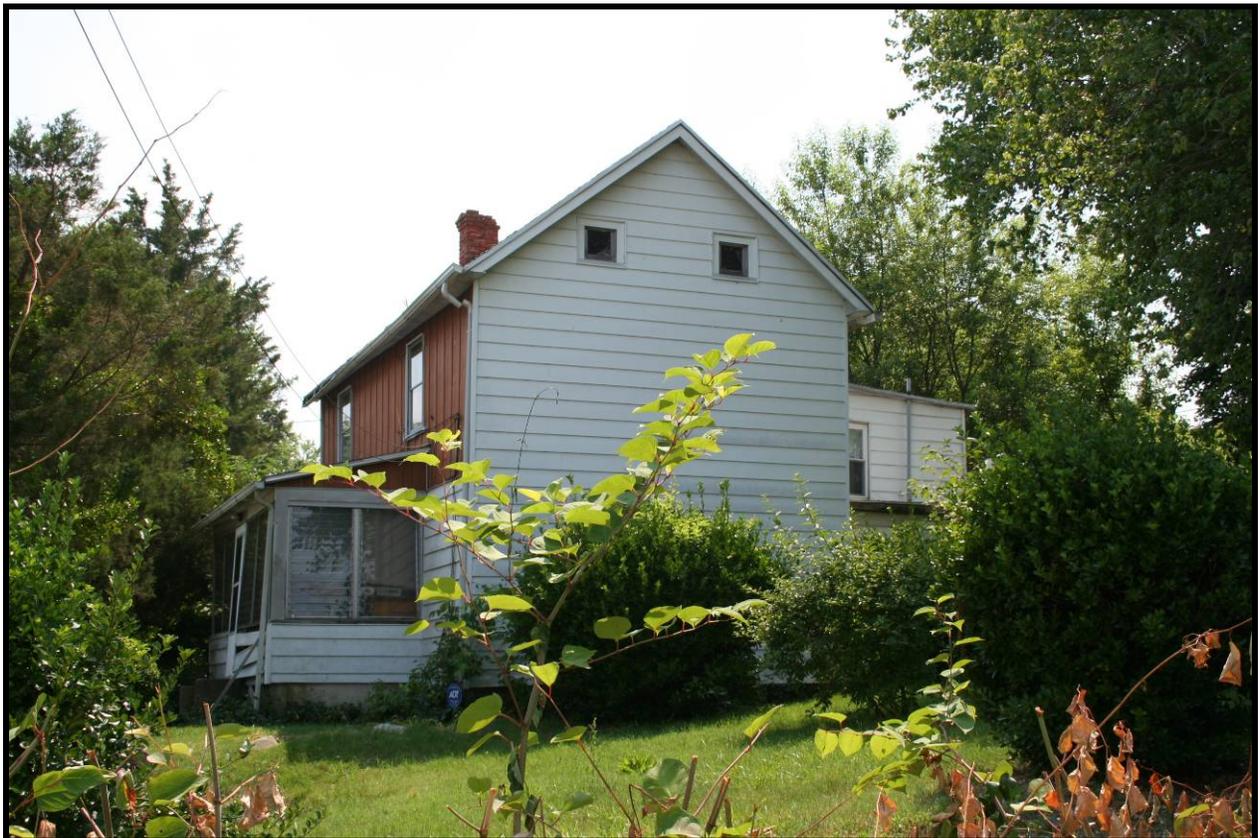
S-12059

112 Walnut Street (1911 Sanborn Map)

Property Type: Single-Family Dwelling, Three-Bay Vernacular

This three-bay, two-and-a-half story, side-gabled, frame dwelling was constructed between 1887 and 1911. An open hipped-roof porch runs the length of the southeast façade and is supported by plain wood posts with a plain wood railing. A two-story cross-gabled addition is connected to the northwest (rear) elevation and a single-story shed-roofed addition was constructed off the northeast elevation. The southeast façade has four two-over-two double-hung sash windows and an entrance door. The northeast elevation has two four-pane casement windows and four two-over-two double-hung sash windows, while the southwest elevation has two four-pane casement windows and five two-over-two double-hung sash windows. An interior brick chimney is located on the ridge of the main block toward the northeast gable end. The roof is covered in standing-seam sheet metal and the exterior walls are sheathed in wooden shingles. This dwelling is representative of the classic Three-Bay Vernacular style which was prevalent in Milton from the mid 19th to the early 20th centuries; it retains integrity of location, setting, design, workmanship, materials, and feeling, making it a contributing historic property for the expanded Milton Historic District.

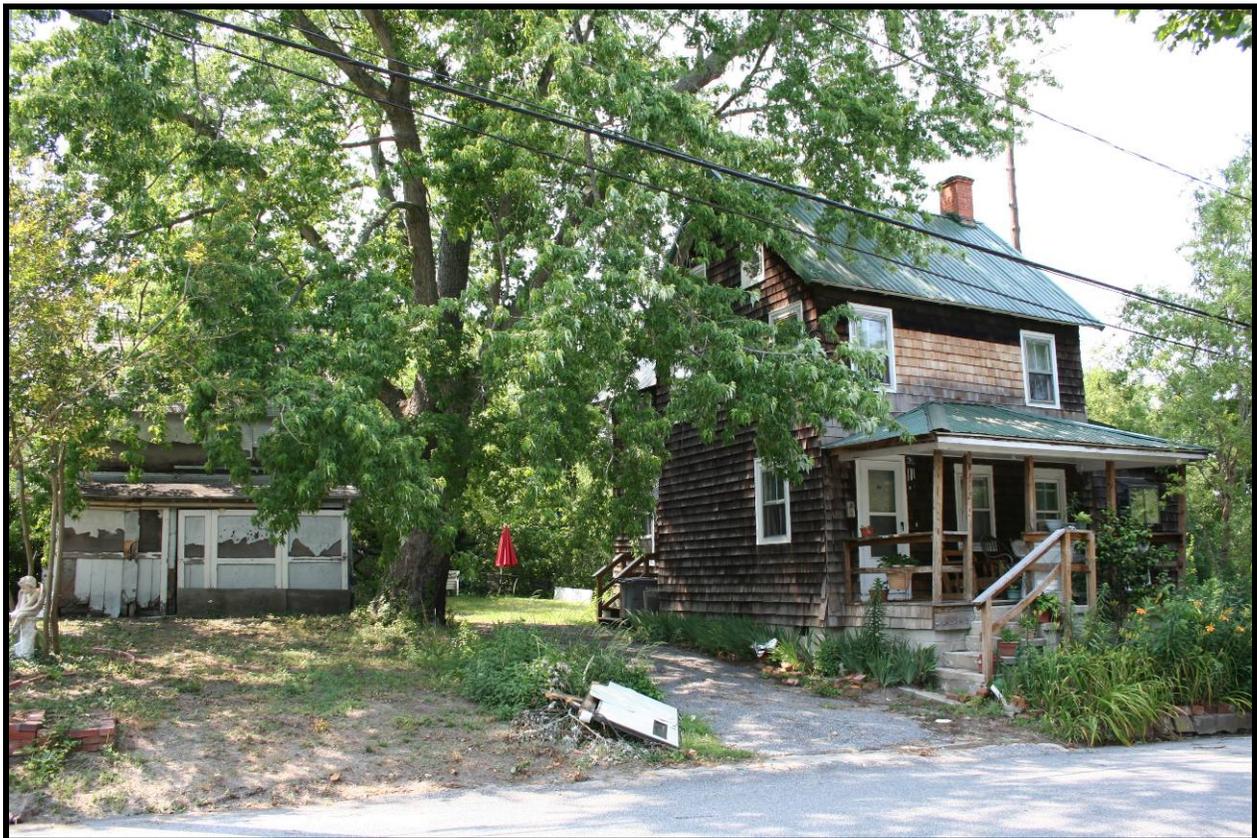
S-12062

115 Walnut Street (2002 Aerial Map)

Property Type: Single-Family Dwelling, Victorian Revival Style

This three-bay, two-and-a-half story, frame, front-gabled, vernacular Victorian Revival style dwelling was constructed between 1997 and 2002. No visible exterior alterations have occurred. A shed-roofed porch runs the full width of the front elevation and is supported by spindlework posts with a spindlework railing. The wooden porch wraps around to the northeast elevation. A small front-gabled roof projection sits on top of the shed-roofed porch above the entrance door. The northwest façade has six six-over-six double-hung sash windows which are flanked by inoperable paneled shutters. The northeast elevation has five windows which are a mix of single and paired six-over-six double-hung sash which are flanked by inoperable paneled shutters. Two gable dormers on the northeast slope of the roof each have a four-over-four double-hung sash window. A sliding-glass door opens to the uncovered wooden deck. The front gable has decorative verge board detailing and partially returning eaves. The roof is covered by asphalt shingles and the exterior of the two lower floors and the dormers are sheathed in aluminum or vinyl siding, the attic level on the gable end is sheathed in fish scale shingles. This dwelling is considered a non-contributing property for the expanded Milton Historic District due to its recent construction date.

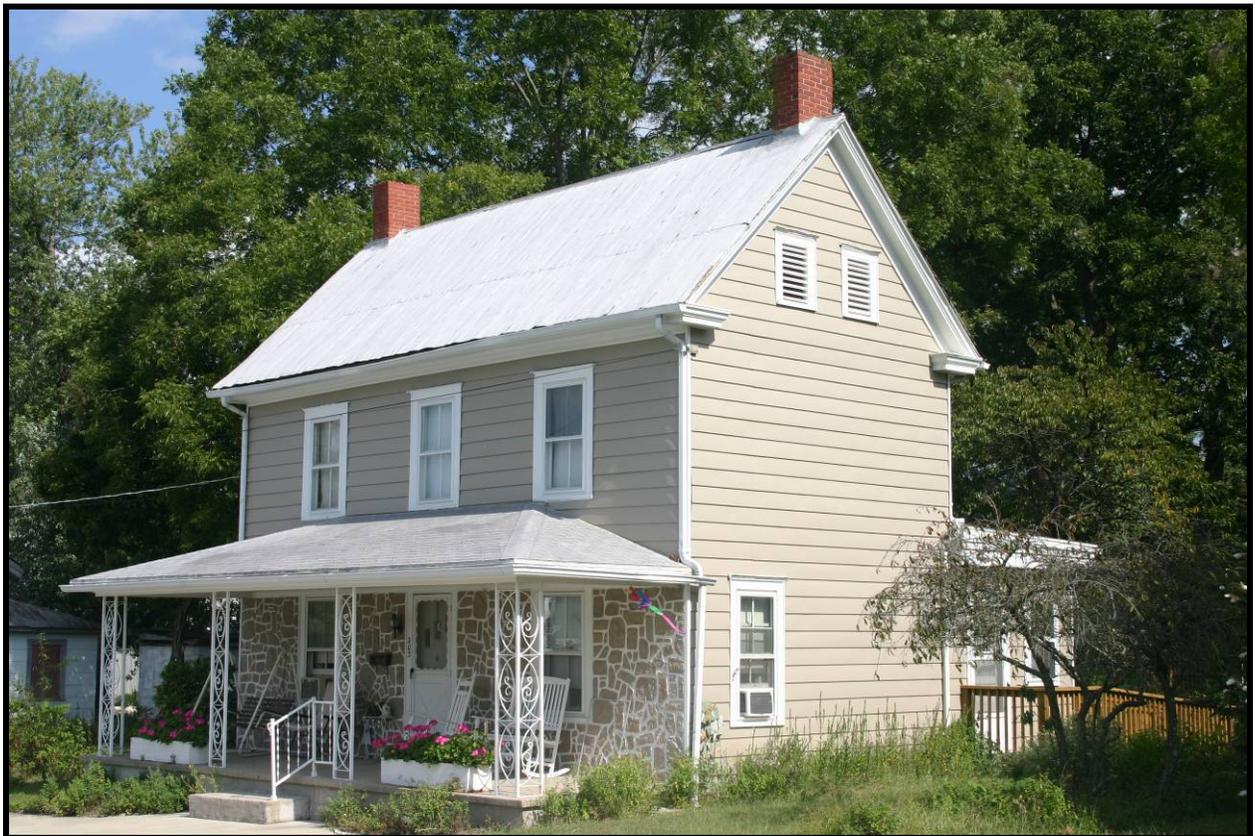
S-12073

**209 Walnut Street (M.C. Darby House: 1868 Beers Map; J.M. Darby House: 1887 Map of Milton)
Property Type: Single-Family Dwelling, Three-bay Vernacular**

This three-bay, two-and-a-half story, L-shaped, gable-roofed dwelling was built prior to 1868; a one-story, shed-roofed porch with turned posts and simple brackets extends along the front (northwest) elevation and a one-story, shed-roofed addition covers the northeast elevation of the rear ell. The asphalt-shingled roof on the L-shaped section terminates in a boxed cornice. The house is sheathed with vinyl siding. Interior brick chimneys rise in two locations: one in the northeast gable of the front block and the other in the southeast gable of the rear ell. A door is located in the northernmost bay of the front block, suggesting a side-hall passage plan; six-over-six sash windows fill the remaining openings on the dwelling. Myers C. Darby, a sixty-two year old white male sailor, owned the house in 1868 which he then passed on to James M. Darby (presumably his son), a fifty year old white male steam boat captain in 1887. An excellent example of the classic Three-Bay Vernacular style, this dwelling retains integrity of location, setting, design, workmanship, materials, and feeling, and is considered a contributing historic property for the expanded Milton Historic District.

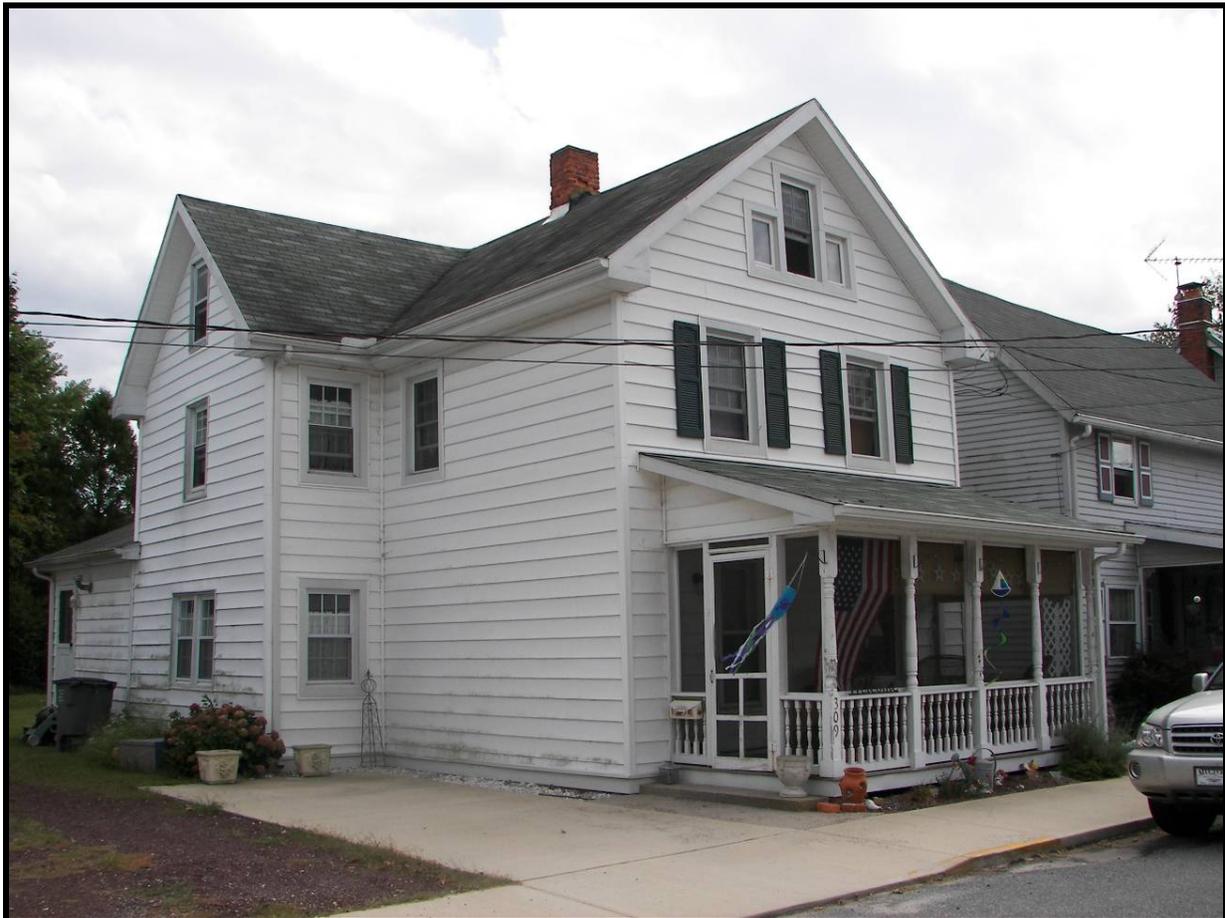
S-12077

311 Walnut Street (1887 Map of Milton)

Property Type: Single-Family Dwelling, Three-Bay Vernacular

This three-bay, two-story vernacular house was built between 1868 and 1887, and it exhibits a side-gabled roof; changes in the first-floor fenestration suggest the possibility of an original duplex. The house has an enclosed one-story porch with a shed roof in the middle of the northwest side, and there are paneled shutters on the first and second floor windows on the northwest side. There is also a flat-roof addition on the southeast side. This dwelling is representative of the classic Three-Bay Vernacular style which was prevalent in Milton from the mid 19th to the early 20th centuries; it retains integrity of location, setting, design, workmanship, and materials, making it a contributing historic property for the expanded Milton Historic District.

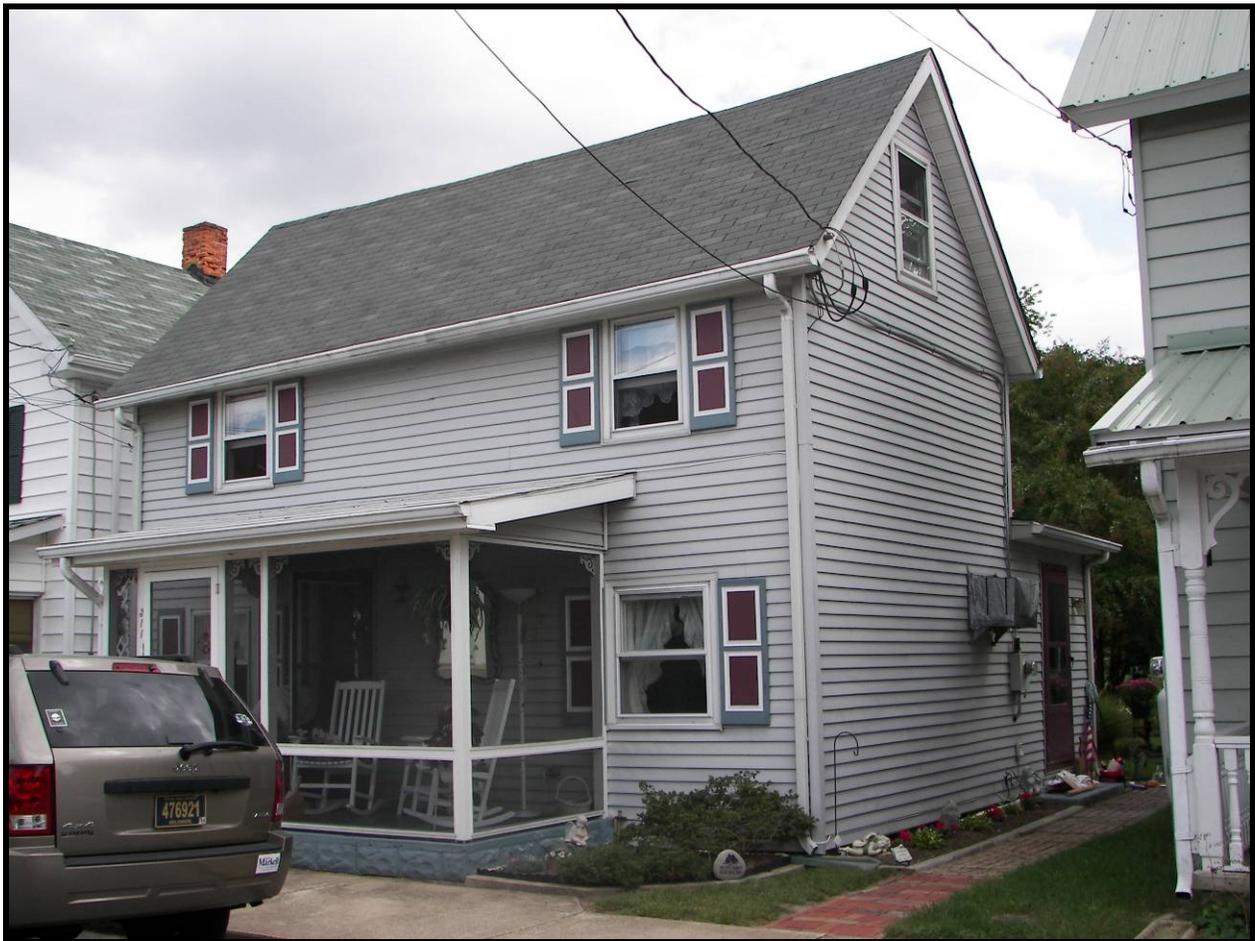
S-12080

312 Walnut Street (1937 Sanborn Map)

Property Type: Single-Family Dwelling, Cape Cod Style

Originally the front (southwest) elevation of this three-bay, one-and-a-half story, gable-roofed dwelling faced Parker Street. Built between 1923 and 1937 in the Cape Cod style with Colonial revival details, the dwelling featured a central front door covered by a gable-roofed portico and flanked by tripartite bay windows. The dwelling has been expanded twice: first with a hipped-roof, one-story addition on the southeast gable end, and then with a shed-roofed extension of the rear (northeast) elevation. A brick chimney rises through the center of the original gable roof. Sheathed in vinyl siding, the dwelling features six-over-six sash windows in most openings. Due to the major changes in the form and massing of the building, the dwelling is considered a non-contributing property for the expanded Milton Historic District.

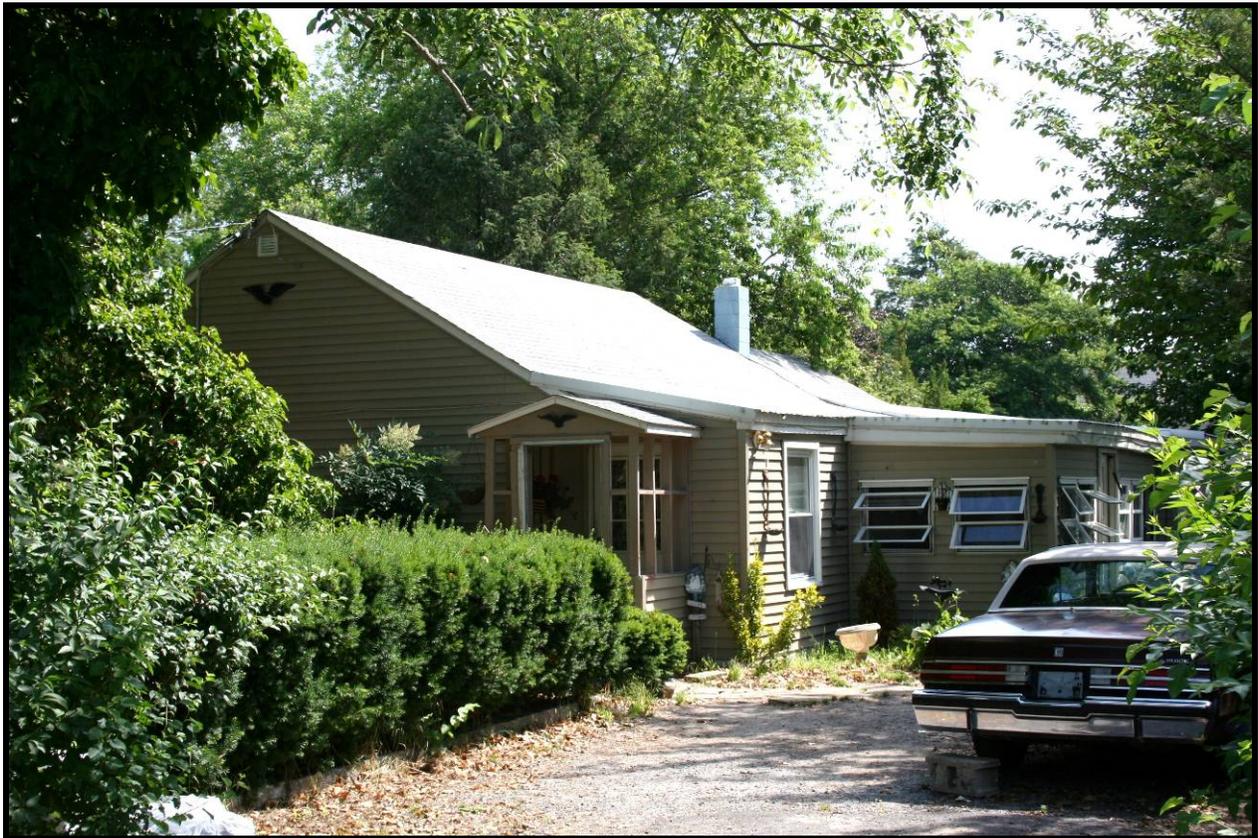
S-11966

119 Willow Street (1937 Aerial Map)

Property Type: Single-Family Dwelling, Craftsman Shotgun style

This three-bay, one-and-a-half story, Craftsman Shotgun style frame dwelling was built prior to 1937 according to aerial maps (no Sanborn maps exist for this property between 1911 to 1937). The property has two additions that augment the rectilinear shape: an enclosed front porch on the south/southeast façade and a rear north/northwest addition. The northwest addition has an open wooden deck with four steps to street level. The main block has a cross-gabled roof covered by corrugated sheet metal and the additions have dropped half-hipped roofs covered with asphalt shingles. The front south/southeast façade has three one-over-one single-hung sash windows with plain aluminum surrounds— two at street level and one at attic level. A door with plain aluminum surrounds and a cross-buck storm door is located in the center bay with a small stoop with three stairs to the ground. The east/northeast elevation has one-over-one single and paired windows with regular fenestration. Windows on the main block are double-hung with wood trim while the additions to either side have single-hung windows with plain aluminum surrounds. The last bay from the southeast corner has a door covered by a cross-buck storm door with plain aluminum surrounds. The west/southwest elevation has four single one-over-one sash windows with wood trim. A cement parged brick chimney is located in the interior of the northeast eave. The exterior of the main block is covered with wood clapboard, while the additions are covered with vinyl clapboard style siding. With the exception of a few modern structures, the shotgun-style dwellings in Milton all range in age from the early 1920s to the mid 1950s and often exhibit Craftsman characteristics, such as this home. This dwelling retains integrity of location, setting, design, workmanship, materials, and feeling, making it a contributing historic property for the expanded Milton Historic District.
