THE HISTORIC LANDSCAPE AT GIBRALTAR--

A PROPOSAL FOR ITS PRESERVATION

A thesis submitted to the Faculty of the University of Delaware in partial
fulfillment of the requirements for the degree of Master of Science
in Public Horticulture Administration

Summer 1997

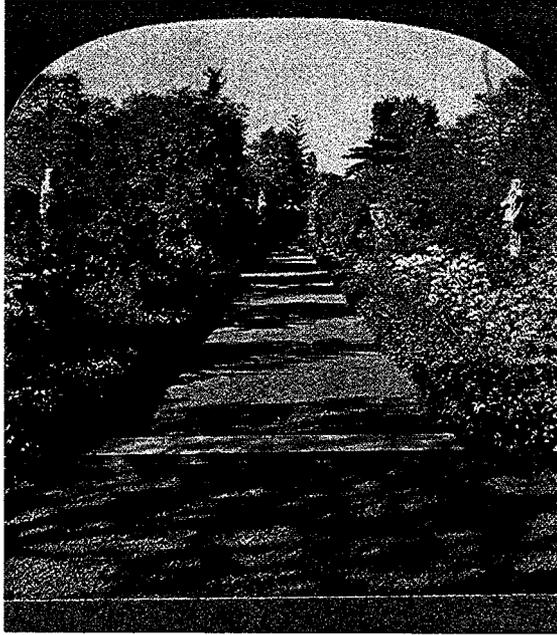
Figure 34: South-north view of Bald Cypress Allée. Late 1920s-1930s. Courtesy of the Sharp family.

After completion of the Tea House and planting of the Allée, four female, nearly life-size, cast stone statues were placed along the walkway, representing the four seasons (O-23). "Winter" and "Summer" stood, facing each other, at the south end of the Allée, "Spring" and "Autumn" at the north end; each set in a niche-like planting of clipped *Buxus sempervirens* 'Arborescens.' Figure 34 views the Allée from the Tea House

towards the Flower Garden, revealing two of the "seasons" amidst flowering *Rosa rugosa*. Two *Pinus strobus* flanked the large iron gate, forming a triangle with the *Pinus strobus* at the opposite end of the Flower Garden. The original lead cupids atop the gate pillars were already replaced with stone ornaments (O-18) when the picture was taken. Clipped *Hedera helix* formed a low hedge along the meticulously kept grass walk. The walk widened in the center of the Allée into two rectangular "breaks," each adorned with a cast stone vase (O-24). Figure 35 shows the "break" on the east side with the vase on a pedestal.

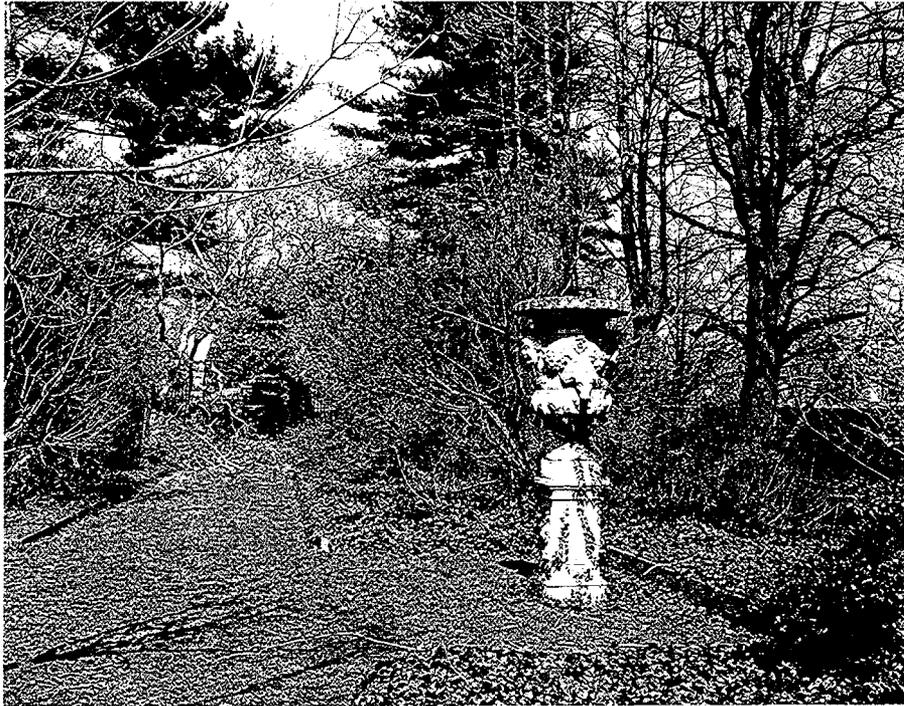
Figure 35: Center “break” of Bald Cypress Allée with cast stone vase. 1997. Photograph by David Ames.

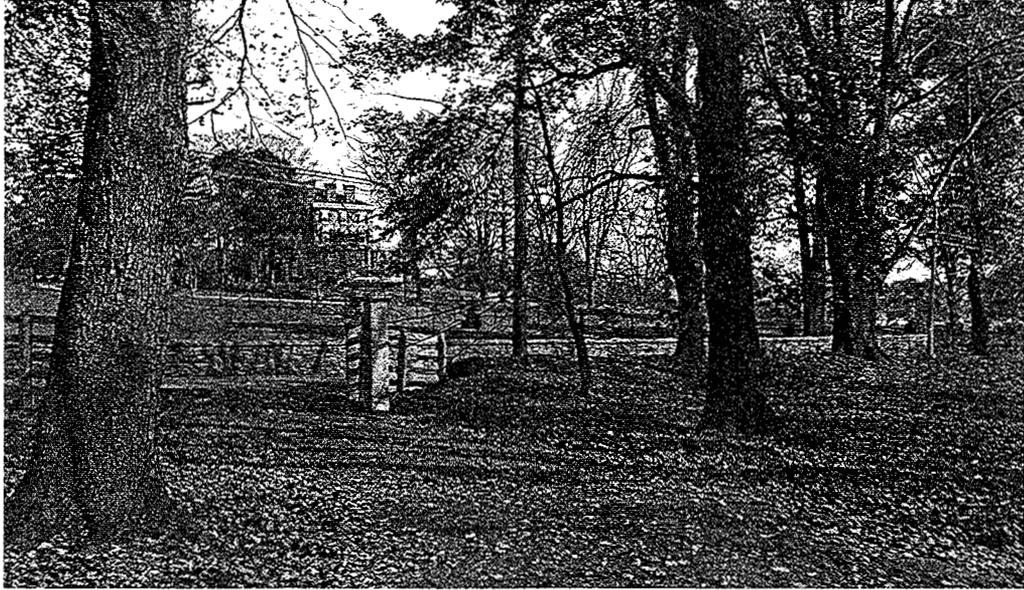
Figure 36: Southwest portion of Gibraltar property and house. Late 1910s-early 1920s. Courtesy of the Sharp family.

of the Mansion from Pennsylvania Avenue. The plantings along the driveway incorporated native trees of the original Brinckle property, shown in Figure 36. The photograph depicts the south elevation of Gibraltar's Mansion and the sloping, tree-covered land to its south and west, viewed from a nearby lot prior to Coffin's landscaping, in the late 1910s or early 1920s.

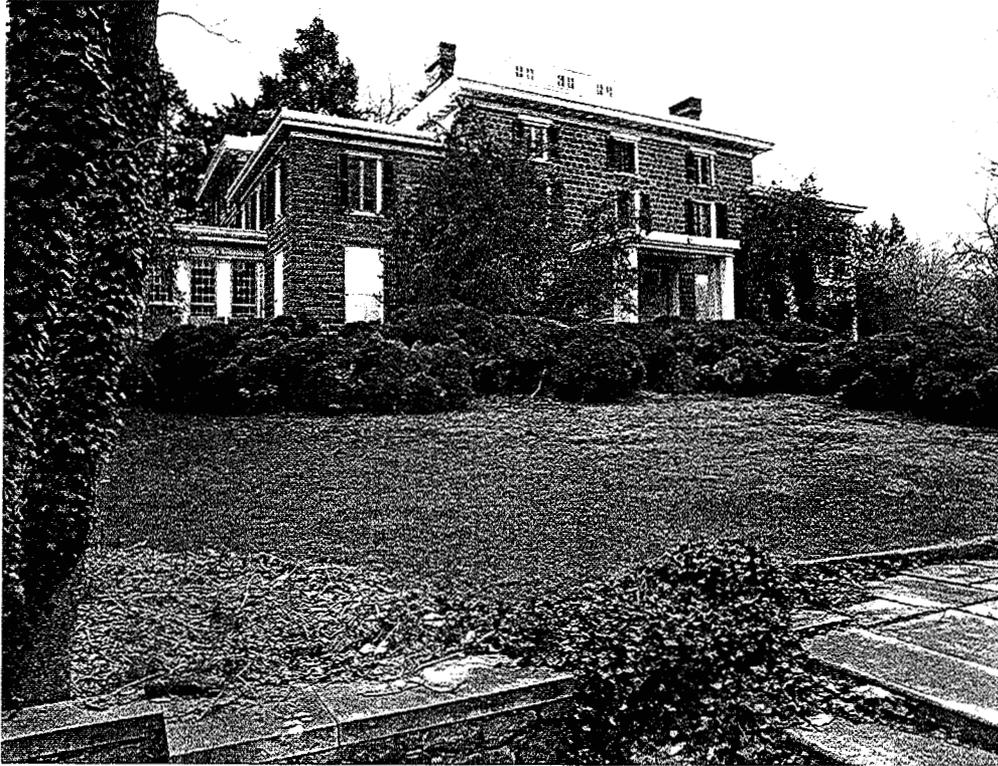
Figure 40: East elevation of Mansion and east lawn with overgrown box hedge. 1997. Photograph by John Lewis.

- The plantings east of the house, in particular the *Buxus sempervirens* ‘Arborescens’ left and right of the entrance porch and the *Buxus sempervirens* ‘Suffruticosa’ lining the 1920s brick walks, are now severely overgrown and diseased (Figure 40). A 1991 photograph of the brick walk connecting the Mansion’s east entrance with the

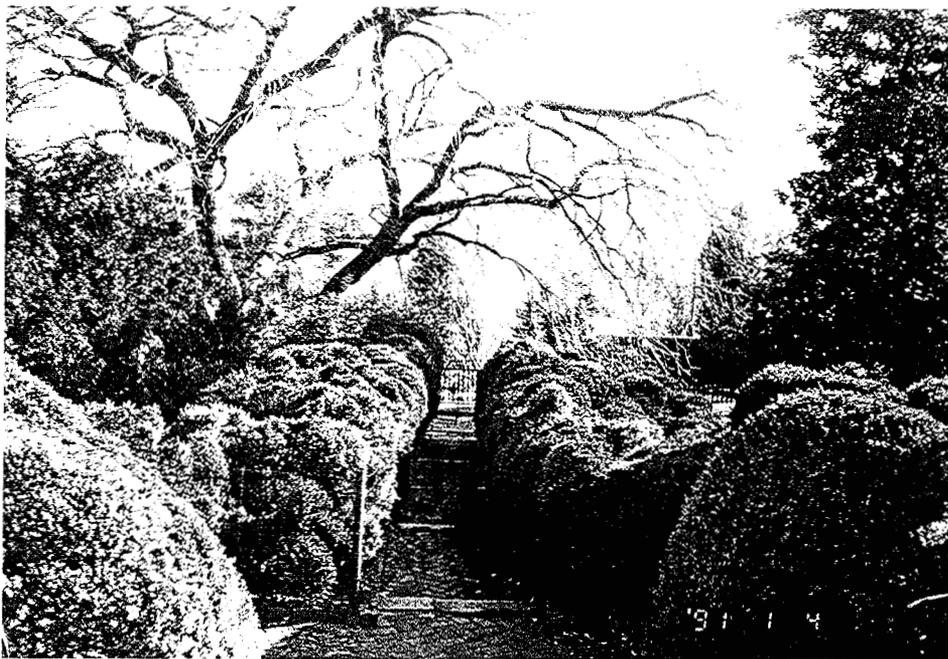
Figure 41: Boxwood-lined brick walk from Mansion to Flagstone Terrace. 1991. Photograph by Richard L. Dayton.

Flagstone Terrace, shows the walk's original herringbone pattern and overgrown boxwood edging. The *Ulmus americana* and *Magnolia grandiflora* in the background are both part of the Evergreen Terrace plantings below (Figure 41).

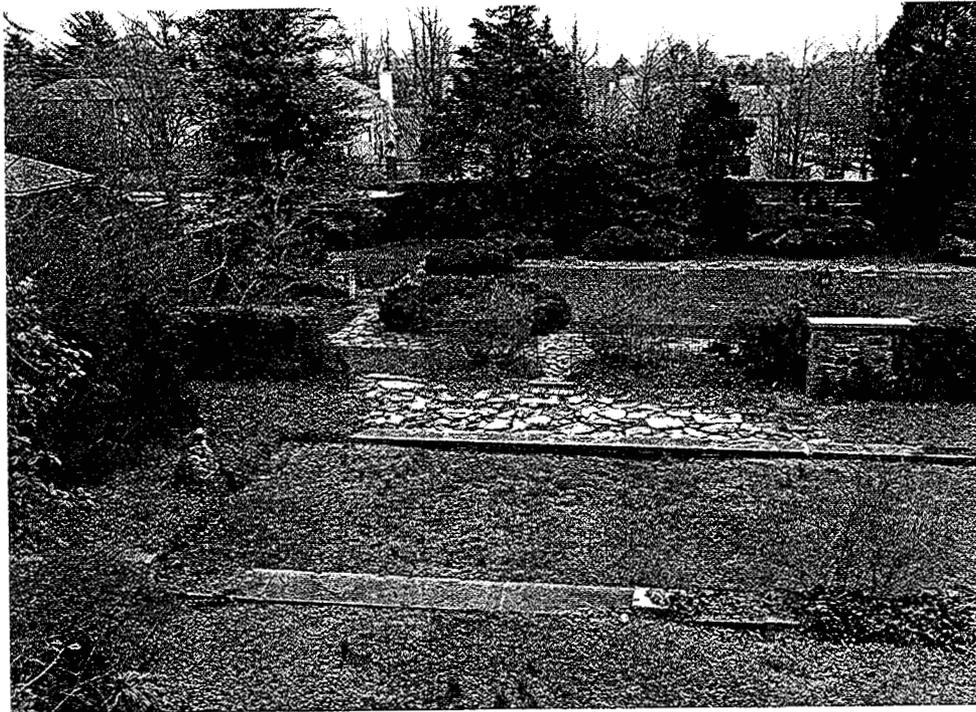
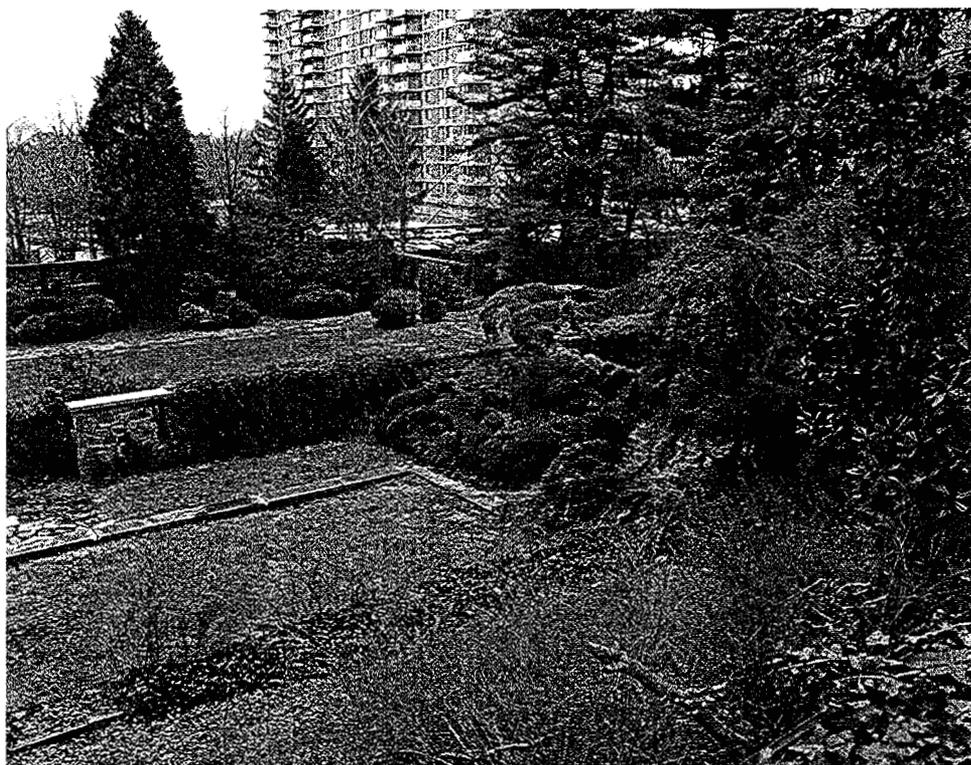
- Figures 42 and 43 provide a recent view from the north end of the Flagstone Terrace onto the Evergreen Terrace, Pool Terrace, Vestibule, and Flower Garden, and the urban development outside the estate walls. While the spatial layout and architectural design elements of these garden rooms are intact, the plantings have changed or disappeared, and many of the garden ornaments are damaged, displaced, or lost.

Figure 42: North half of Evergreen Terrace, Pool Terrace and Flower Garden. Greenhill Avenue. 1997. Photograph by John Lewis.

Figure 43: South half of Evergreen Terrace, Pool Terrace and Flower Garden, and Vestibule. 1997. Photograph by John Lewis.

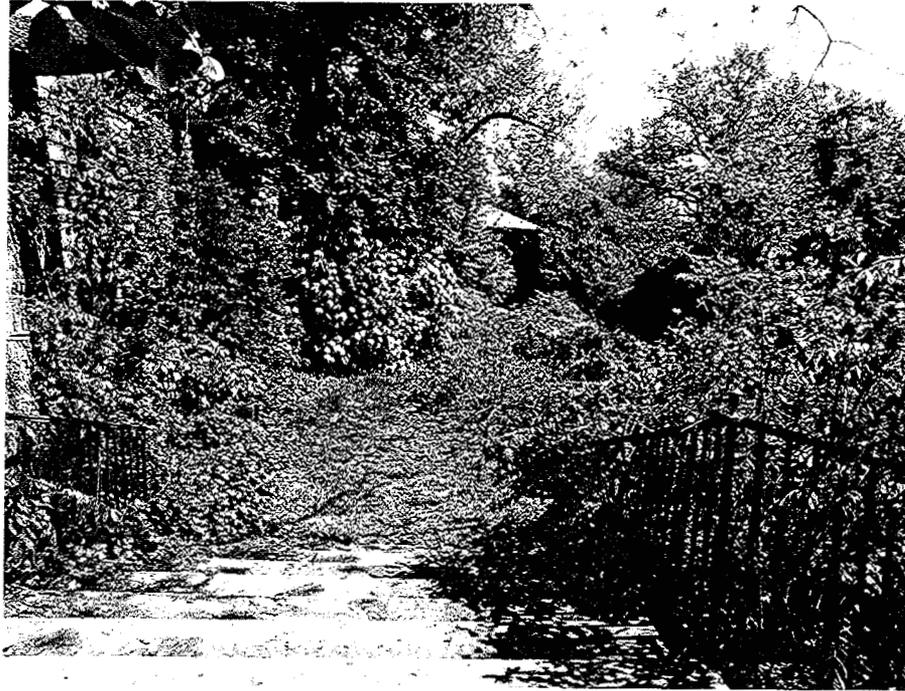
**Figure 44: Current view of Evergreen Terrace. 1996.
Photograph by David Ames.**

- Figure 44 shows the overgrown Evergreen Terrace. The existing *Azaleas*, *Ulmus americana*, *Ilex aquifolium*, *Ilex opaca*, *Juglans nigra*, *Magnolia grandiflora*, *Kalmia latifolia*, *Ligustrum obtusifolium*, and *Viburnum rhytidophyllum* are likely to be part

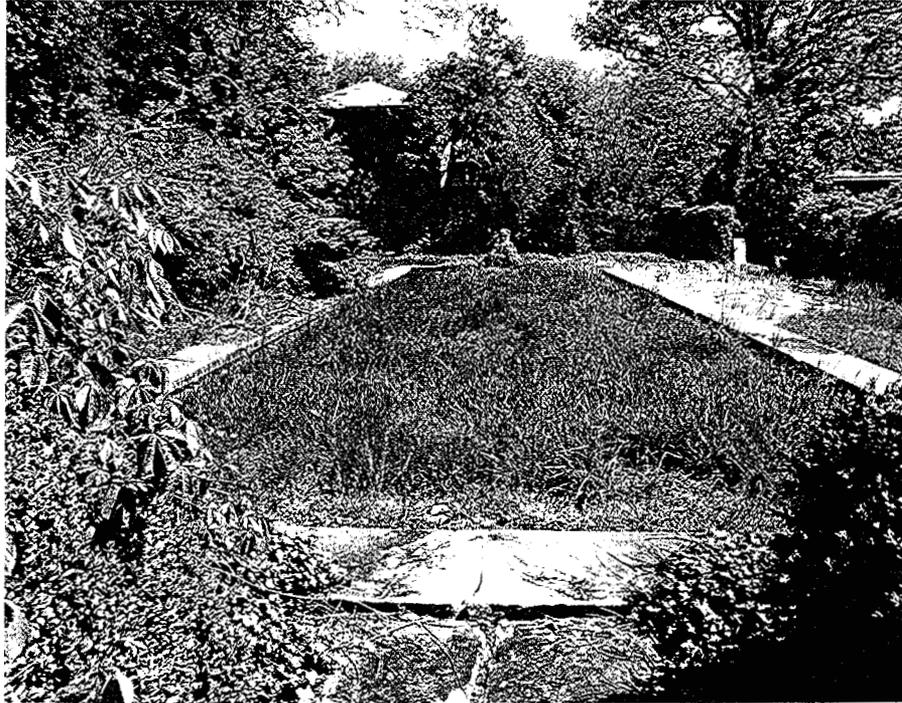
- The swimming and reflecting pool was filled with soil and covered with grass during the 1970s. The concrete coping of the pool and the water spouting ornament at its north end (O-10) are in fair condition. According to historic photographs, the existing ornament replaced an earlier, smaller pool ornament during the 1920s. Three additional cast stone figures, two sitting children and a frog, decorating the sides of the pool during Gibraltar's early years have disappeared. Figure 45 provides a current view of the filled-in pool, surrounded by partly broken, discolored marble flagging, seeded-in *Ligustrum obtusifolium* on the left, and original plantings of *Azalea*, *Buxus sempervirens* 'Arborescens', *Ilex opaca*, *Magnolia grandiflora*, *Magnolia virginiana*, *Malus*, and *Viburnum sieboldii* at the north end. The large *Acer* that used to be in the northeast corner was taken down between the 1930s and 1940s. The staircase (O-9)

**Figure 45: Pool Terrace with filled-in swimming pool. 1996.
Photograph by David Ames.**

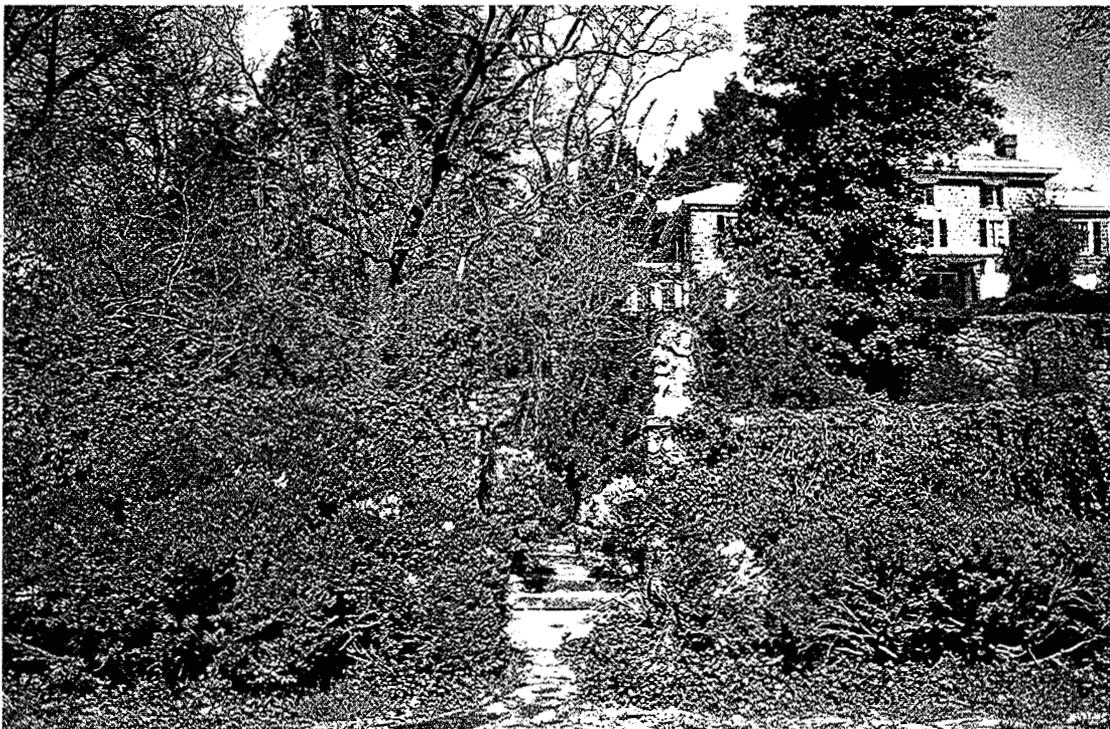
- All *Buxus sempervirens* within the Flower Garden are diseased and overgrown.
- The severely damaged curved stone bench (O-14) at the north end is backed by a *Magnolia grandiflora*, replacing the *Pinus strobus* planted in 1916. The *Viburnum rhytidophyllum* next to the bench and the *Philadelphus*, *Viburnum sieboldii*, and *Iris* lining the walkway in the northwest corner, are not part of Coffin's original design, but have been in place most likely since the 1920s. The original *Thuja occidentalis* hedge and wooden gate that separated the Flower Garden from the service court were replaced with a circa eight foot high stone wall and ornate iron gate (O-12). Two cast stone fruit baskets (O-13) were placed atop the wall to the left and right of the gate.

Figure 46: West border of Flower Garden and entrance to Vestibule. Diseased boxwood. Ornaments atop wall. 1997. Photograph by John Lewis.

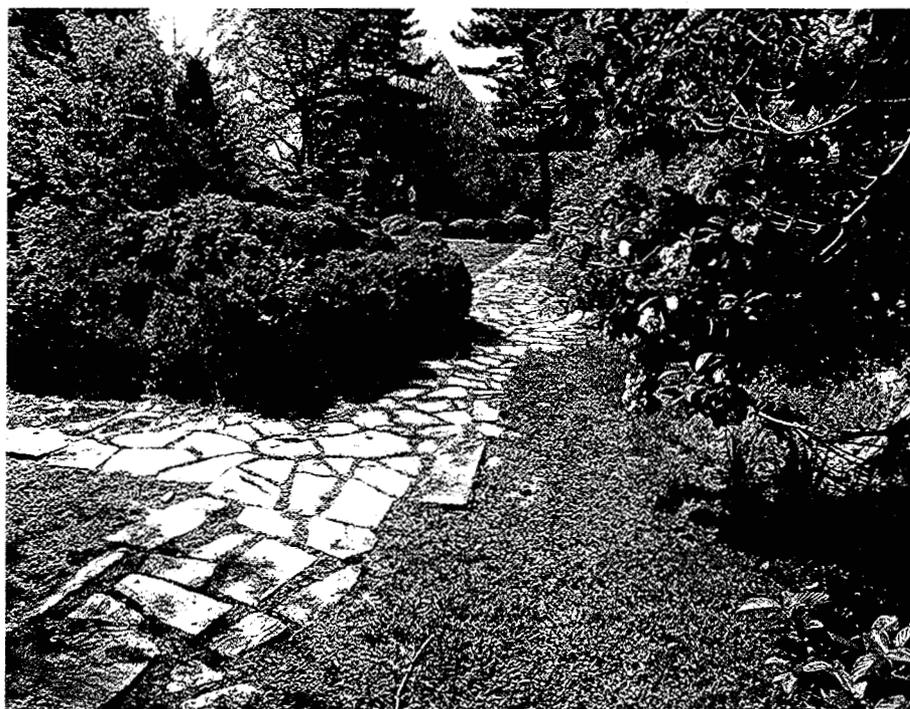
- The walkways still exist in their original pattern, but are in disrepair. The marble slabs are discolored; some are broken into pieces, and weeds are growing between the pavers (Figure 47).

Figure 47: Northwest corner of Flower Garden. Walkway in disrepair. 1996. Photograph by David Ames.

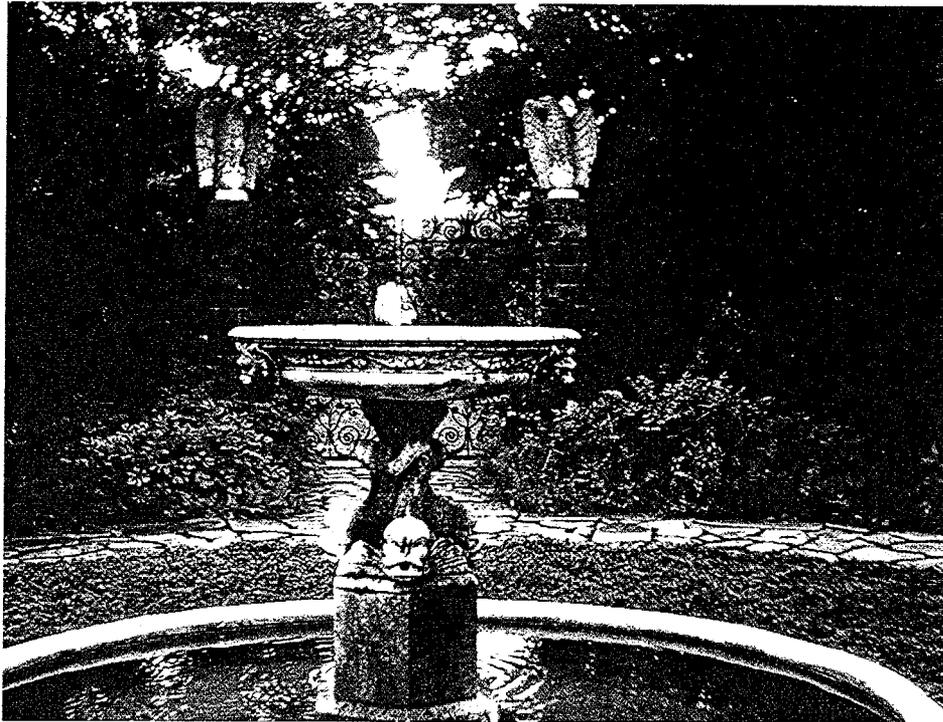
- The circular fountain (O-19) at the south end of the Flower Garden lost its center ornament, a marble "Bathing Venus", during the late 1910s or early 1920s. During the 1950s, the *Hedera helix* and *Pachysandra* surrounding the fountain were replaced by *Ilex crenata* (Figure 48).

Figure 48: Circular fountain and large iron gate with cast stone eagles. 1950s. Courtesy of Preservation Delaware, Inc.

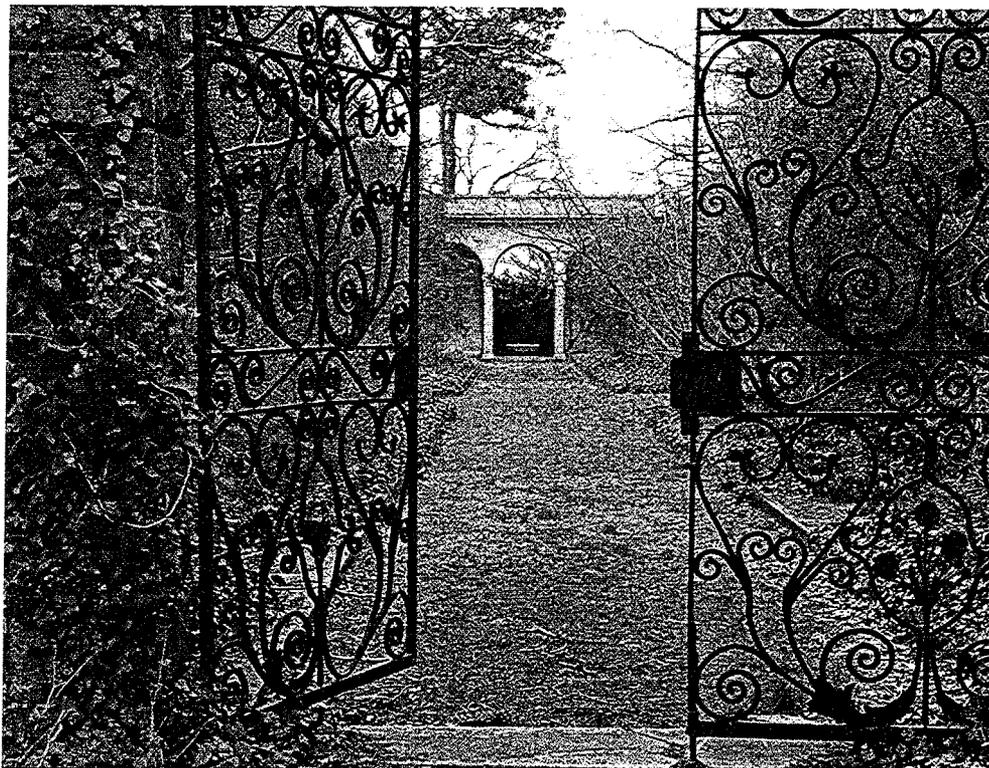
- Figure 49 shows the south end of the Flower Garden, iron gate (O-21) and entrance to the Bald Cypress Allée. Although the majority of the Allée plants are in their original location, the yellow, white and orange *Azaleas*, *Cotinus coggygria*, *Buxus sempervirens* 'Arborescens', *Magnolia x soulangiana*, and *Rosa rugosa* are overgrown, diseased, or dead. The "four seasons" (O-23) and stone vases (O-24) along the neglected grass walk are damaged. The Tea House (O-26) is deteriorated. The cast stone vase east of the Tea House (O-25) and the circular fountain behind it (O-27) are in good condition, whereas the vase west has fallen off its pedestal and

Figure 49: North-south view of Bald Cypress Allée with large iron gate and Tea House. 1997. Photograph by John Lewis.

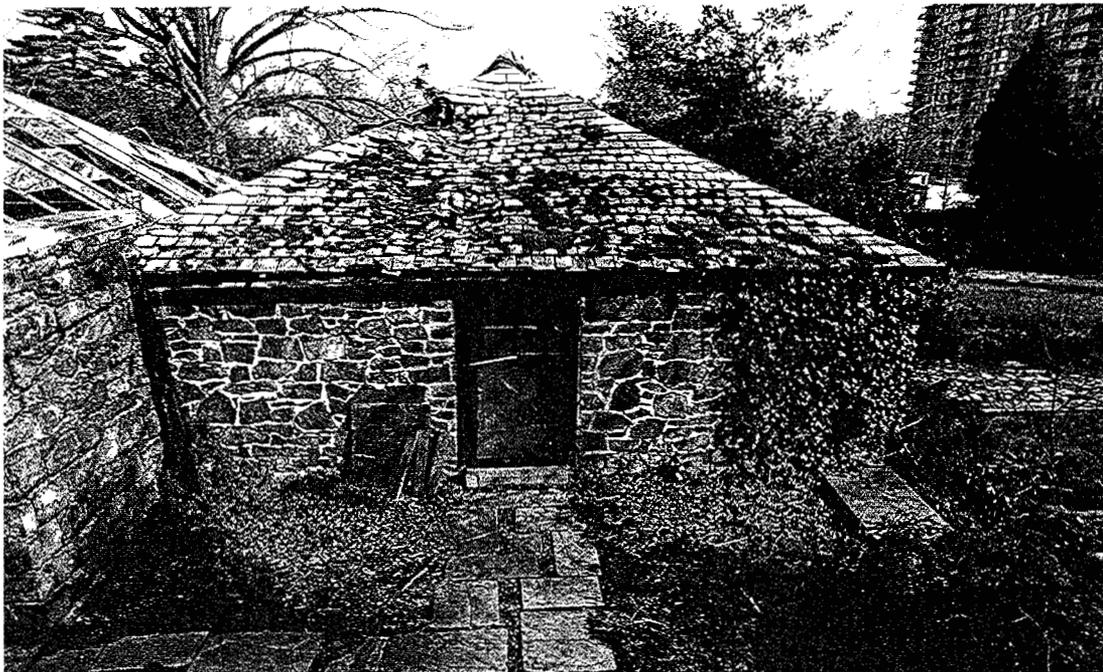
Figure 50: West elevation of Pool House. 1997. Photograph by John Lewis.

- The main house as well as the support buildings and service areas are in disrepair. Figures 50 and 51 show the west elevation of the Pool House, and the northeast corner of the Garden House at the north end of the Bald Cypress Allée, both with severe roof damage and ivy growing up the walls.

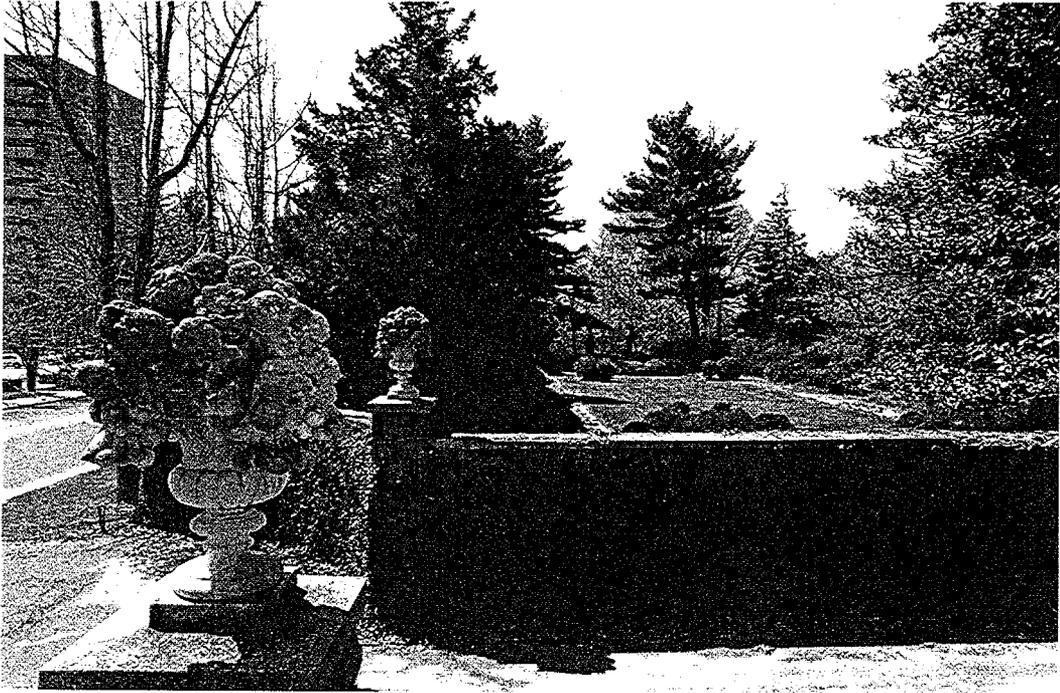
Figure 52: Greenhill Avenue entrance with stone ornaments. View of Flower Garden. 1997. Photograph by John Lewis.

- The Greenhill Avenue entrance leading into the service courtyard was accented with two cast stone fruit baskets (O-0) (Figure 52). Neither Gibraltar's Greenhill Avenue entrance nor its Pennsylvania Avenue entrance had gates.⁷³

Description: Two identical, round fruit baskets. Cast stone. Rectilinear base.
Location: Atop stone pillars framing Greenhill Avenue entrance
Condition: Good-fair. Signs of erosion. No losses.

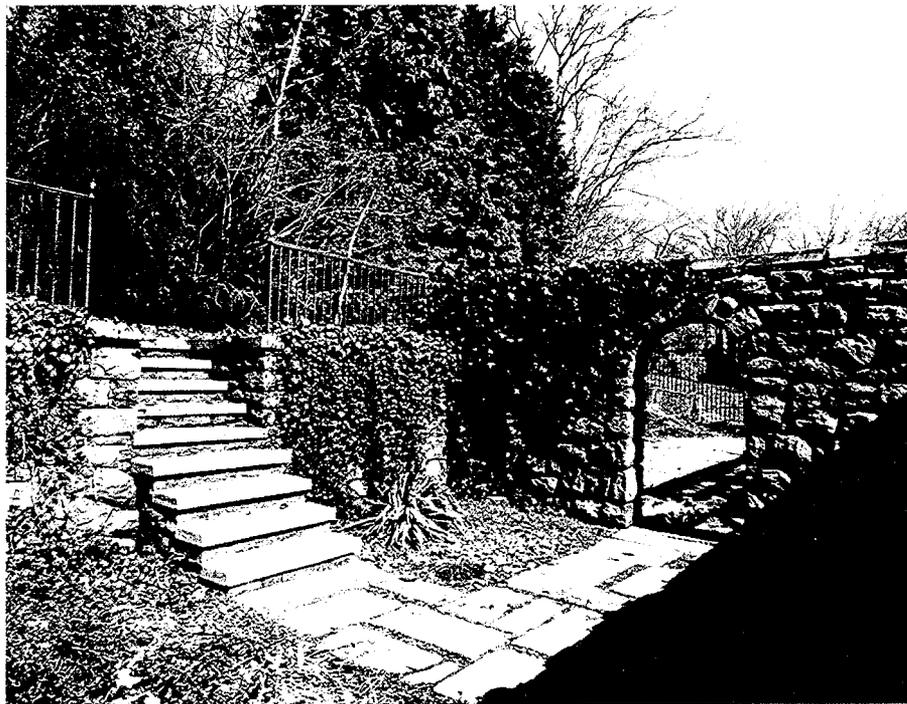
Description: Cast stone staircase. Eight raisers.
Location: Leading up from Pool House Terrace to north end of Flagstone Terrace.
Condition: Good-fair. Some losses and structural damage.

Figure A-3: Staircase (O-1) leading from service area up to Flagstone Terrace. 1997. Photograph by David Ames.

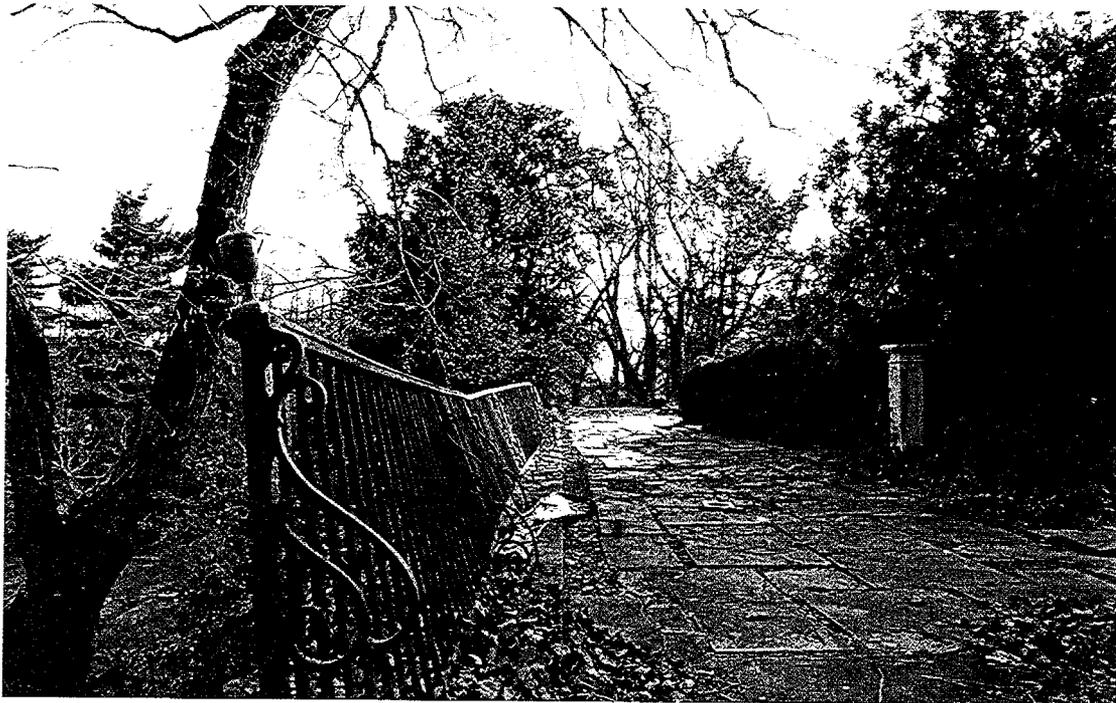
Description: Ornate wrought iron railing with floral pattern and brass finials.
Location: Along east perimeter of Flagstone Terrace, parallel to Mansion.
Condition: Poor. Corrosion and severe structural damage throughout.

Description: Rectilinear cast stone bases.
Location: On north and south end of terrace.
Condition: Fair. Structural damage and losses. Base at south end broken into pieces.

Figure A-4: North-south view of Flagstone Terrace with iron railing (O-2) and stone pedestal (O-3). 1997. Photograph by John Lewis.

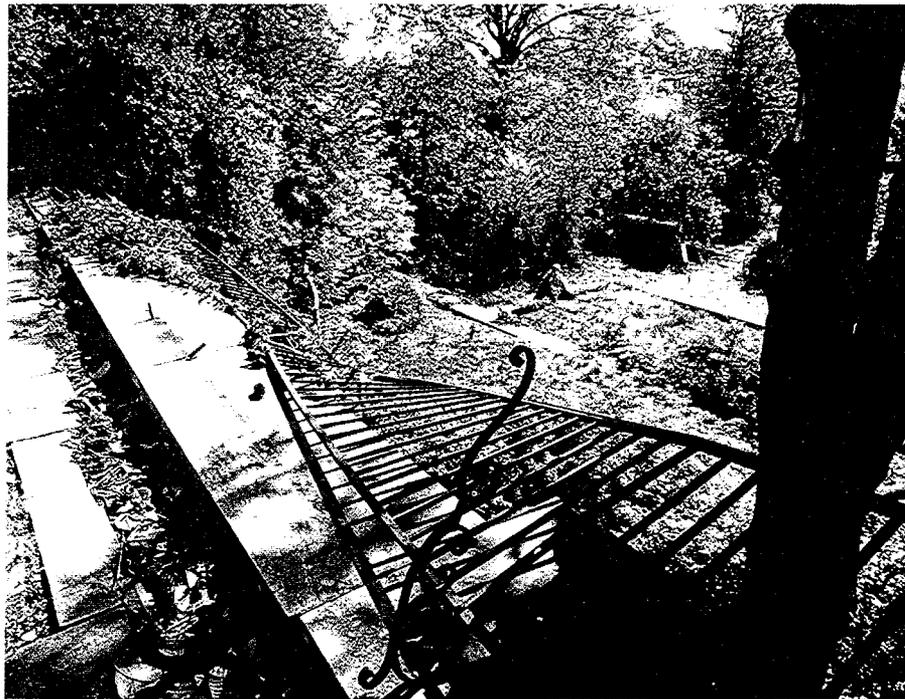
- The Flagstone Terrace contains sinkholes. Its marble flagging is discolored and broken, and the iron railing along its east perimeter is corroded and severely damaged (O-2).

Figure A-5: South-north view of damaged iron railing (O-2) and gardens below. 1996. Photograph by David Ames.

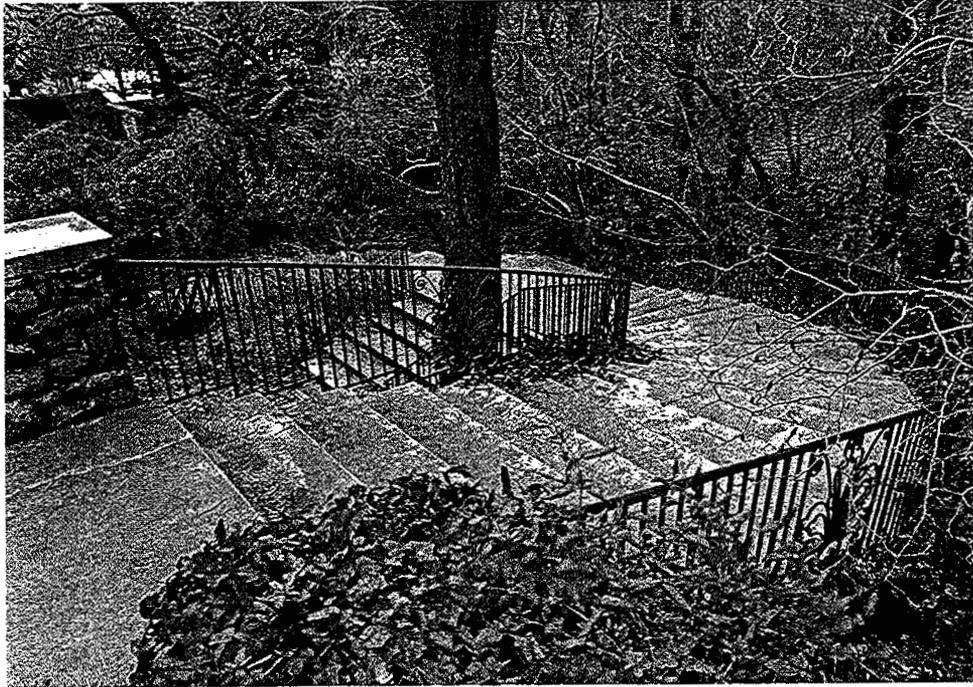
Condition: Good. No structural damage; several marble treads damaged; patches of rust on railing; bent or missing finials.

Figure A-8: Large staircase with iron railing (O-5). 1997. Photograph by John Lewis.

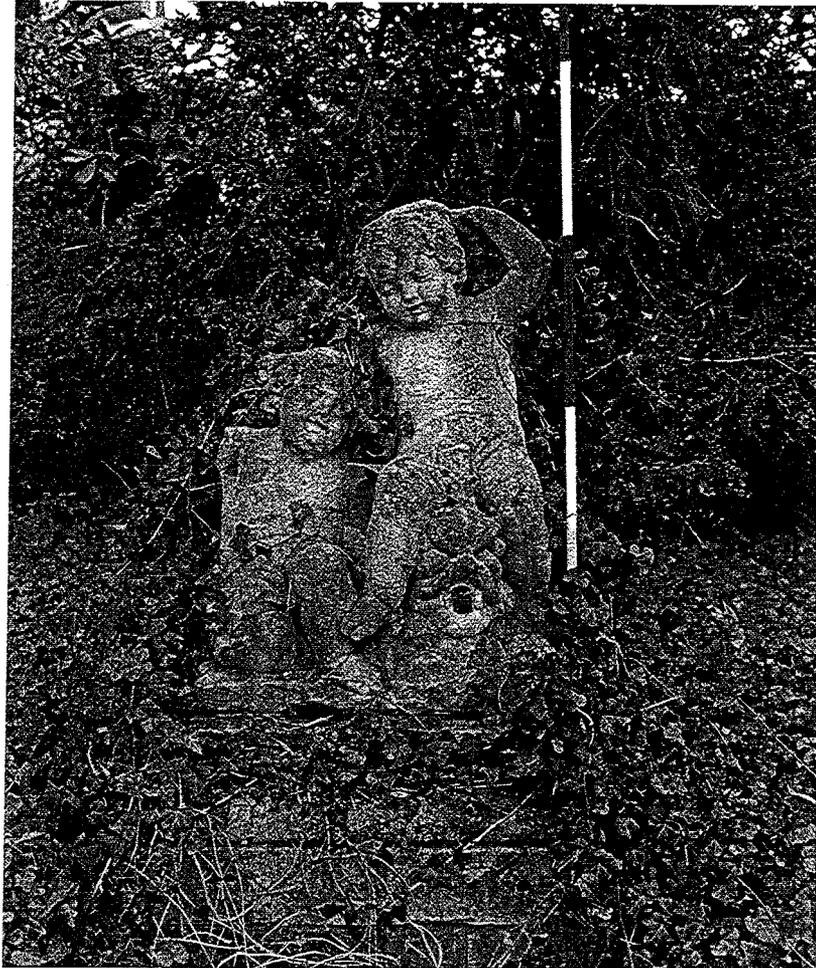
Figure A-12: Cast stone fountain (O-10) at north rim of swimming pool. 1997. Photograph by John Lewis.

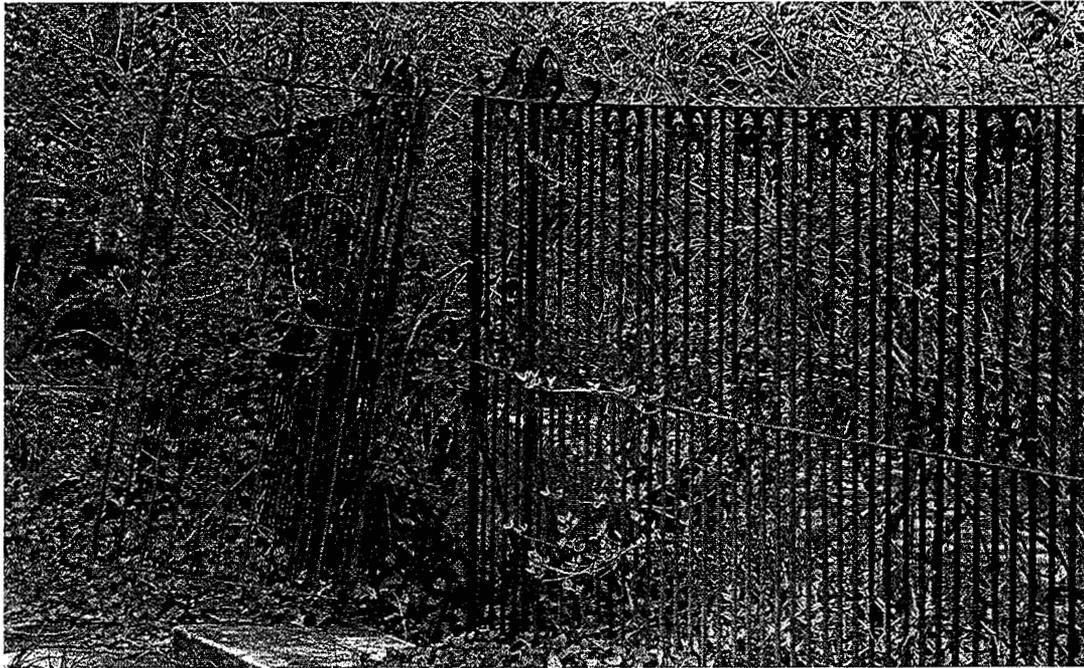
- The iron fence separating the Pool Terrace from the Flower Garden is severely damaged (O-11).
- The Flower Garden has retained its structural elements and spatial layout, including walkways, circular fountain, iron gate, several garden ornaments, and surrounding walls, as well as original trees. The perennial beds are now sown with grass, leaving only a few scattered *Paeonia suffruticosa*, *Iris*, and yellow *Rosa* that were part of the original plantings.

Figure A-13: Iron fence (O-11). 1997. Photograph by John Lewis.

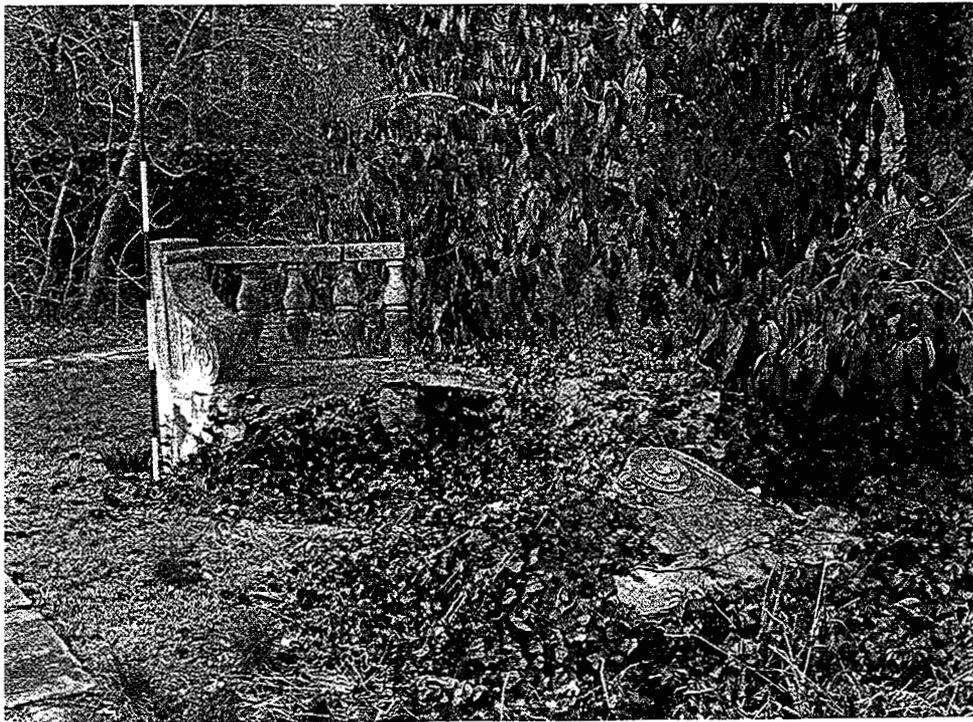
Figure A-14: Cast stone bench (O-14) at north end of Flower Garden. 1997. Photograph by John Lewis.
