**HYDRODYNAMICS AND BEACH EROSION
DURING STORMS ON DELAWARE BEACHES**

A thesis submitted to the Faculty of the University of Delaware in partial fulfillment of the requirements for the degree of Honors Degree in Civil Engineering with Distinction

Spring 2018

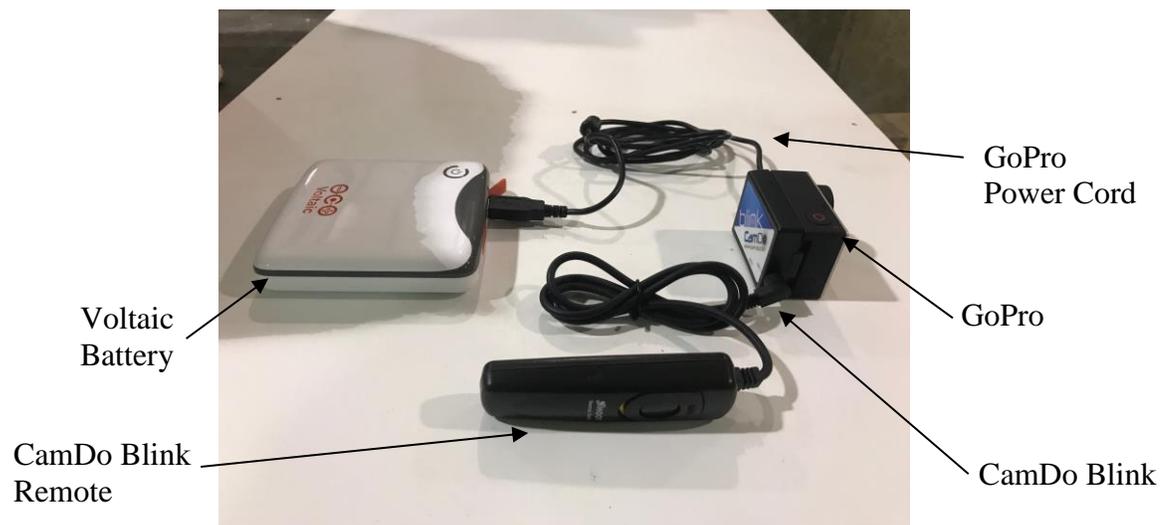
Figure 4 GoPro and CamDo Blink setup

Blink. The button on the remote activates the WiFi, which causes the center of the Blink to light up and flash blue every couple of minutes. The WiFi will turn off after fifteen minutes, at this time the light will blink cyan then turn off. The GoPro is powered using a Voltaic cell, which also powers the Blink through the GoPro. The set up of the GoPro and scheduler is shown in Figure 4

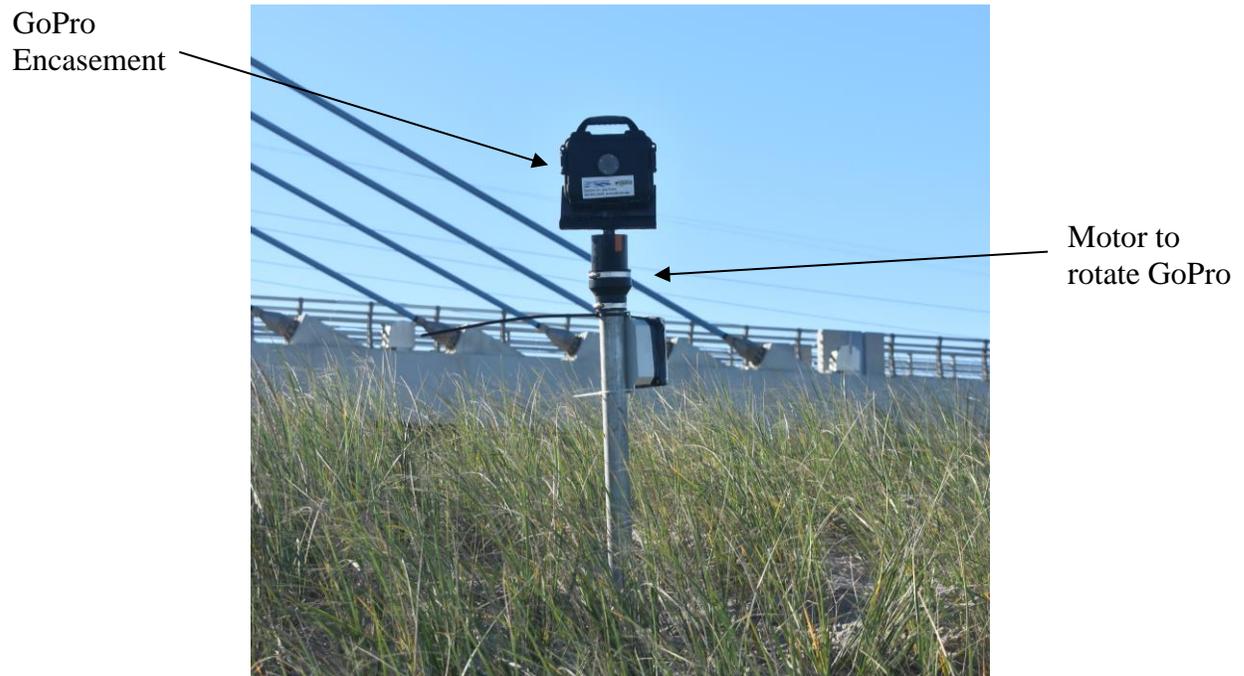
Figure 5 GoPro encasement with motor attachment

option of doing just the CamDo Blink Scheduler without the motor. Figure 5 shows the original layout of the GoPro in its encasement with the motor.

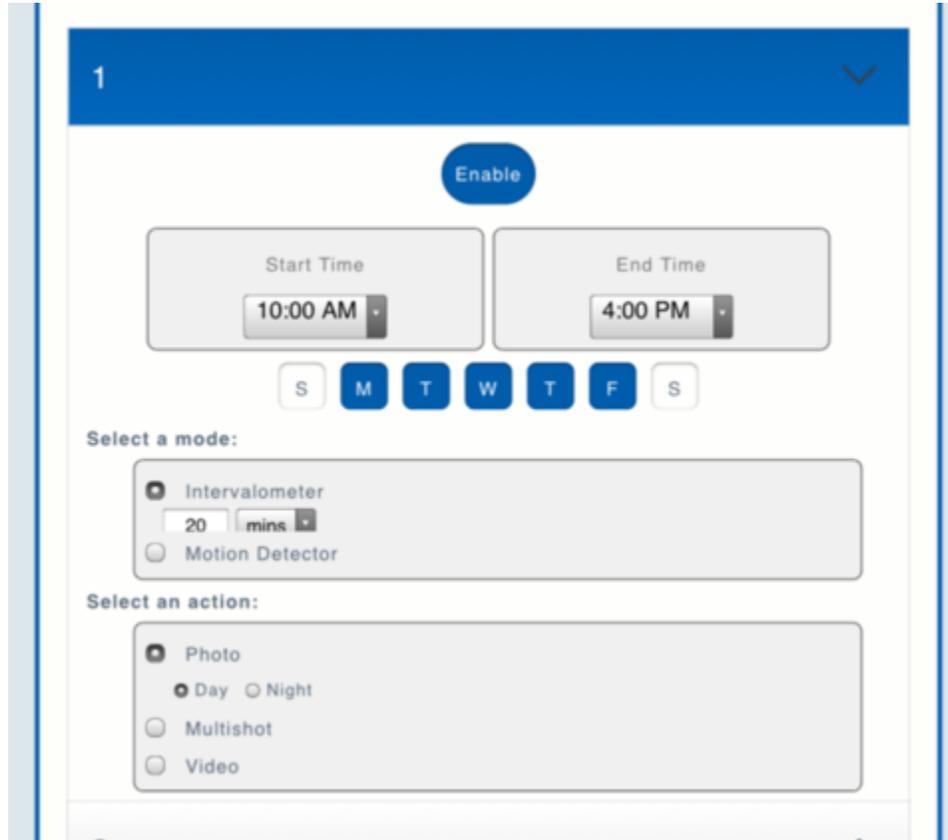
Figure 6 Example of the CamDo Blink webpage with schedule

For the deployments for the two Nor' Easter storms, we instead just left the encasement with the GoPro and programmed it to take a photo every five minutes during daylight times. The webpage where you input the information for the schedule, including the days of the weeks it should run, time frame, time between photos, and mode is shown in Figure 6. For deployments, we would create a separate schedule for each day that we planned to leave it out, each schedule would run during daylight hours.

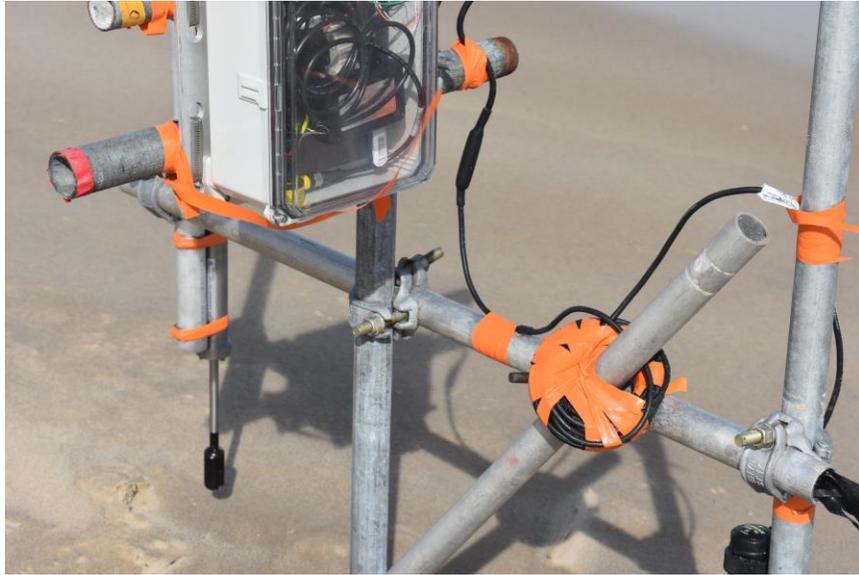
Figure 9 Pipe setup with JFE and ADM

Figure 9 shows a close view of the internal setup of the ADM device in relation to where the JFE is attached. Also, for safety purposes, as well as assuring the data are not lost, we secured the wires for the ADM with cable tape.

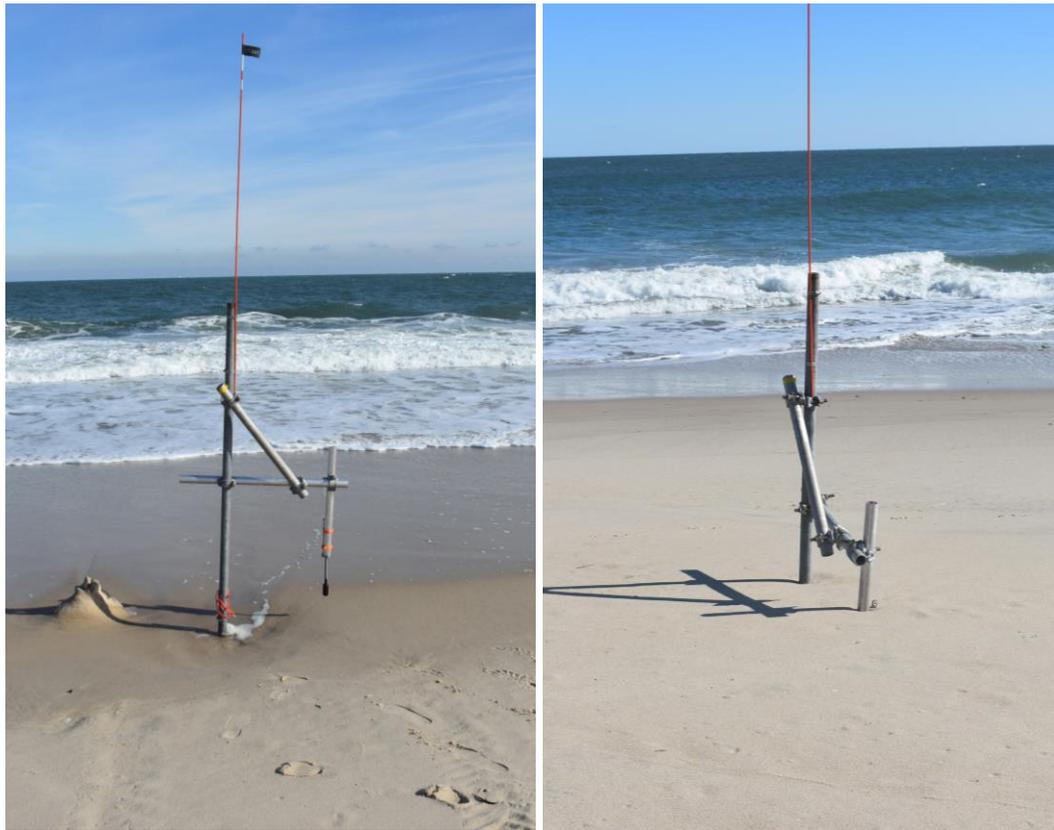
Figure 11 The image on the left shows the original orientation of the pipe, whereas the image on the right is after the pipe rotated 90 degrees clockwise due to the wind.

The series of tests revealed areas where we could improve our system in order to retrieve better data. One specific complication we recognized through the tests was that the horizontal arm coming off the main pipe allowed caused the pipe to rotate in the sand under waves and windy conditions. Therefore, the alignment of all the devices shifted from their original orientation which caused us to be unaware of the orientation of the JFE velocity. Figure 11 shows the original orientation of the pipe compared to how it was after the test deployment.

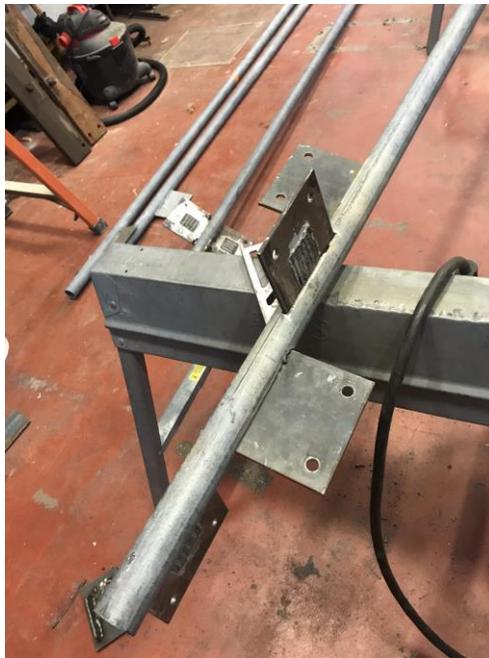
Figure 12 The second fin design for the pipes to resist rotation

In order to combat the rotation issue, four thin metal plates were welded onto the outside of the pipe at about 1.5 feet from the bottom. However, after the second test deployment it was determined that the welds were not strong enough to sustain the force of rotation, so they broke off the pipes. The solution to this issue was to plasma cut slits into the pipe to then insert the plates about an inch into the pipe and then weld around the plate. This would allow for there to be less stress on the welds, since a portion of the plate would be inside the pipe. We also staggered the plates as to create a greater surface area to resist the rotation force. Figure 12 depicts the fins we installed on the pipes after the second test deployment.

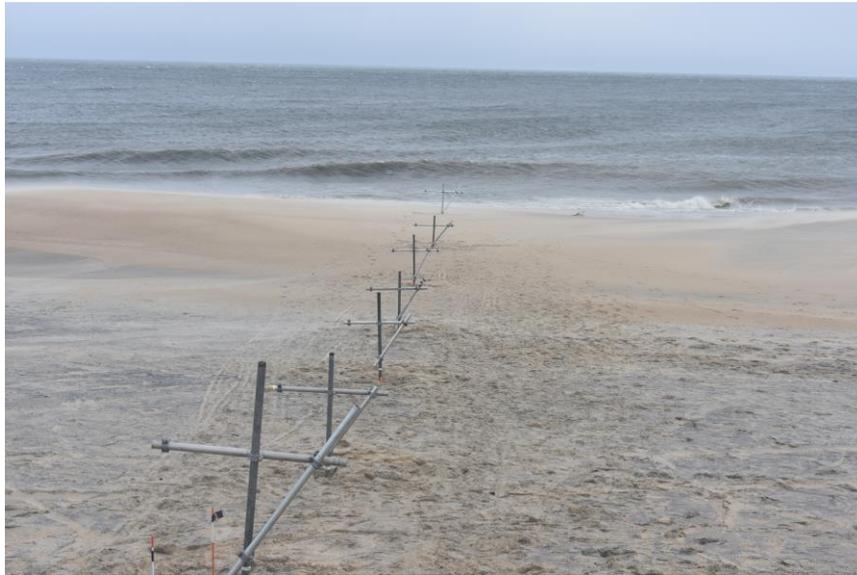
Figure 13 Layout of the Stations for Nor' Easter Riley

Nor' Easter Riley was the first Nor' Easter storm where we were able to test our system of devices . In order to collect the most amount of data we decided to install our devices on March 2nd around 2pm in order to install them as close to low tide as possible. Installing during low tide allows for the pipes and devices to be installed farther seaward. For this storm we set up the seven sites perpendicular to the shore line (Figure 13). The sites were labeled A through G, with A being the farthest seaward, and F being the farthest inland. Labeling the stations allowed us to keep track of the data collected at each station and to draw correlations between each of the stations.

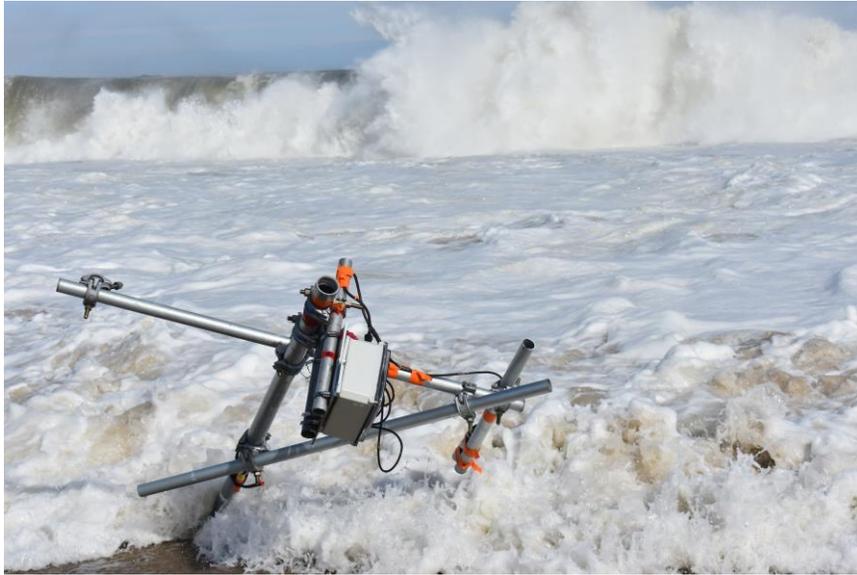
Figure 16 Station A after day one of Nor' Easter Riley

Throughout the course of the storm, the pipe at Site A was significantly warped and fell over (Figure 16). The entire beach eroded approximately 0.75 meters at site A, and the waves were breaking right on the pipe at that location which was shown by the GoPro images, which lead to the collapse of site A.

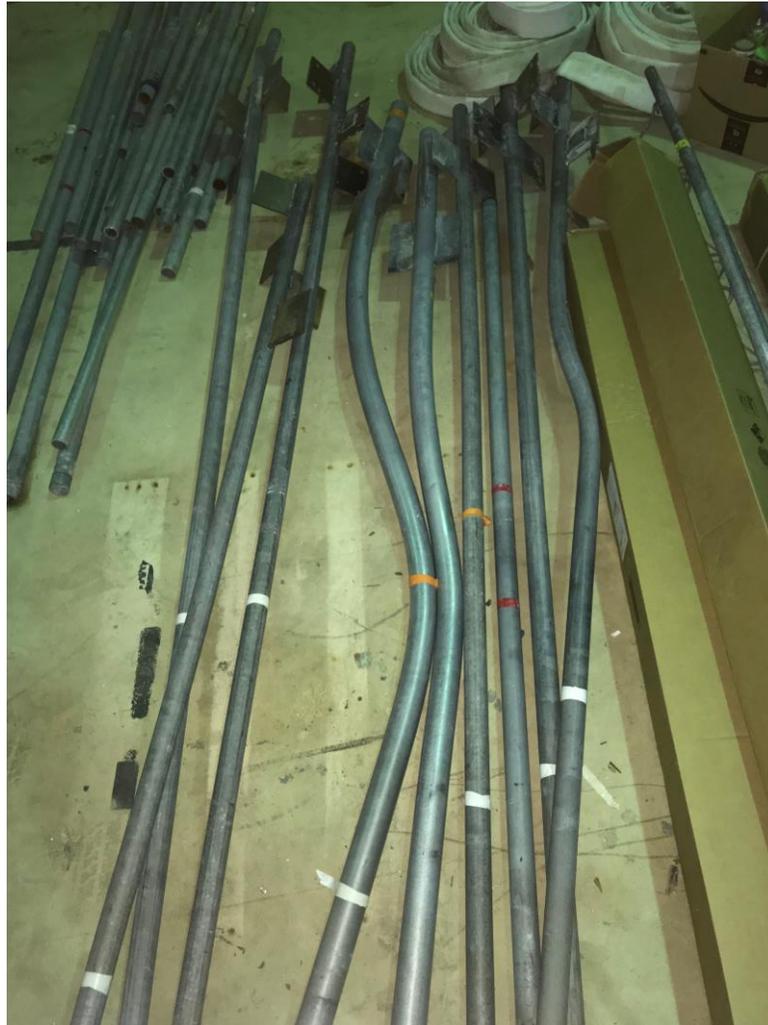
Figure 25 Deformation of the pipes used at each site for Nor' Easter Toby, the pipes with the more drastic curved shape came from sites A through C.

Nor' Easter Toby had more drastic effects on our testing equipment compared to that of Riley. The storm conditions during Toby caused us to lose the JFE on station A. Also, when looking at the pipes after they were removed from the sand, it was

evident that the storm conditions were worse than previous deployments, as it caused deformation of the pipes (Figure 25).
