# Annulus Void Fill Material for Rehabilitated Sliplined Culverts

Volume 1 of 9

*Prepared for:*  
The Ohio Department of Transportation,  
Office of Statewide Planning & Research

*Final Report*

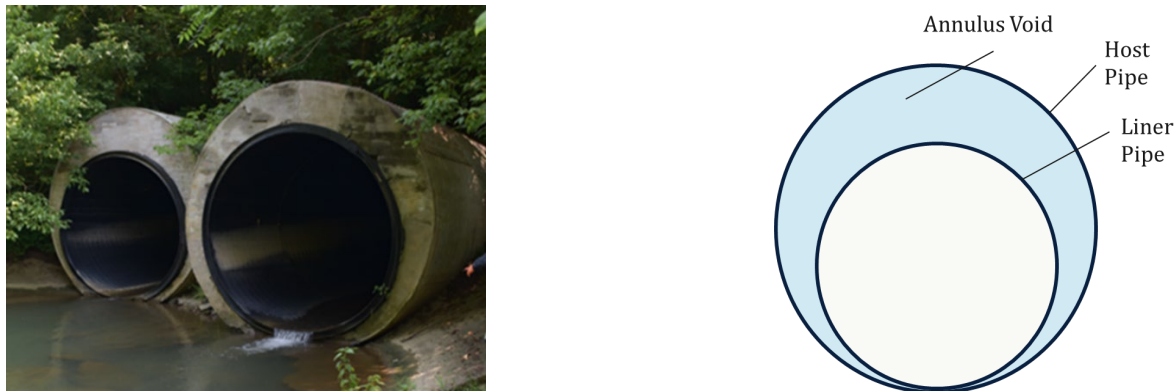
Figure 1: Image (Left) and Schematic Diagram (Right) of Typical Sliplined Culverts.

*Sliplining* is a method commonly used to rehabilitate deteriorated culverts. In this method, a new pipe with a smaller diameter is inserted into the existing host pipe, and the annular space between the two pipes is filled with grouting material (Figure 1). In general, the new pipe used as a liner can be made from various materials. The grouting material may be either low-strength material (LSM), non-shrink mortar (NSM), or cellular grout (CG). The success of the rehabilitation method depends primarily on maintaining the integrity of the hardened grout within the annulus void, and annulus voids of sliplined culverts need to be completely filled to achieve the desired performance. Successful rehabilitation of a culvert extends the service life of the culvert.

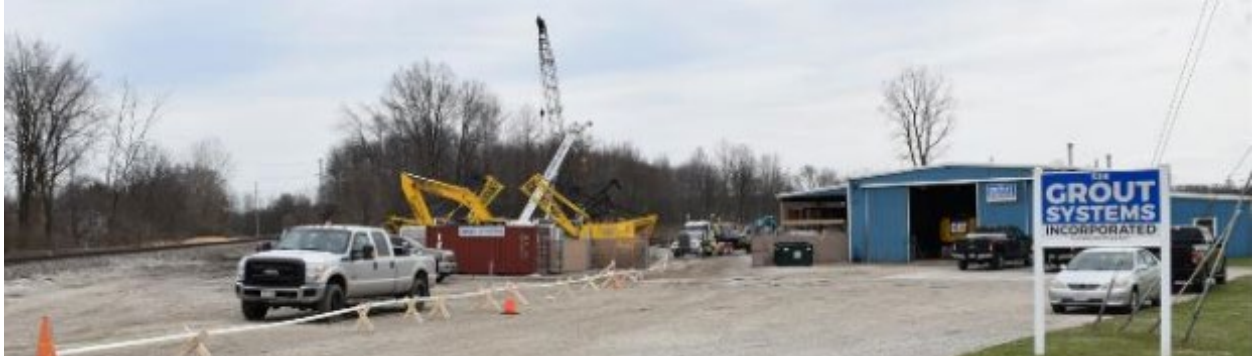
Figure 10: Field Pumping Tests of the Proposed CLSM or Cellular Grout C40.

Pumping tests were performed to evaluate the performance of the mixes for possible field implementation. The pumping of grouts is expected to cause a loss of volume and/or loss of air content when the grouts are pumped over long distances. The CLSM and cellular grouts were pumped through a 2-inch-diameter polyvinyl chloride (PVC) pipe over a length of about 200 ft. with an upslope gradient of 2.5% (see Figure 10). The density and air content of the grouts at three locations along the length of the PVC pipe were determined. Other wet and hardened grout properties were also determined to document how pumping grouts over such lengths might affect these properties.

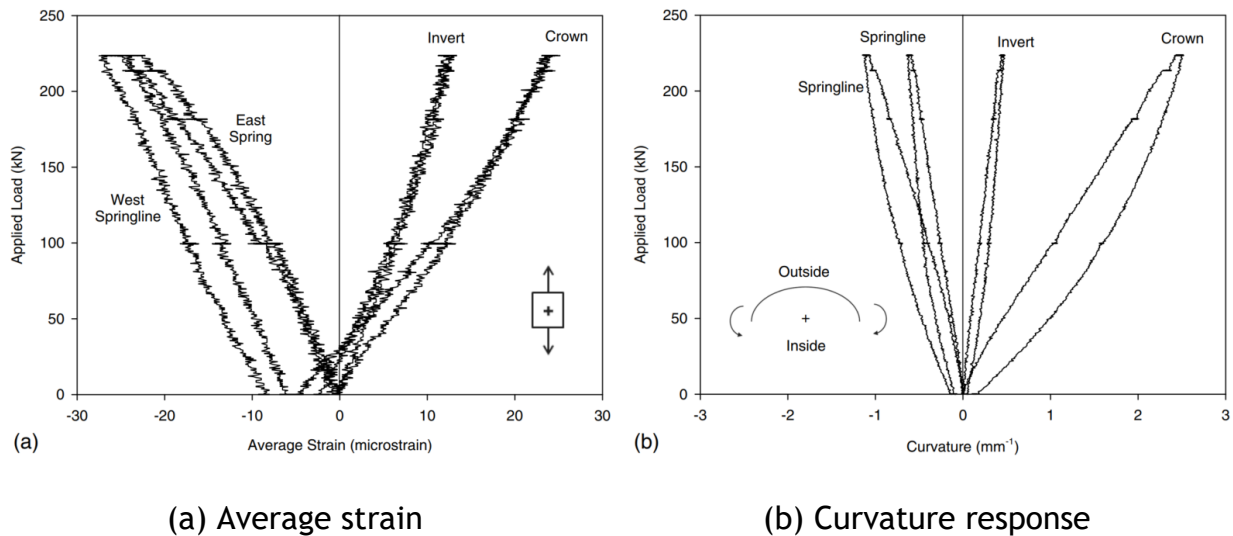
Figure A.31: Response of liner pipe under single-axle loading (Simpson et al. 2015).  
Conversion factors: 1 kN = 224.8 lb, 25.4 mm = 1 inch.

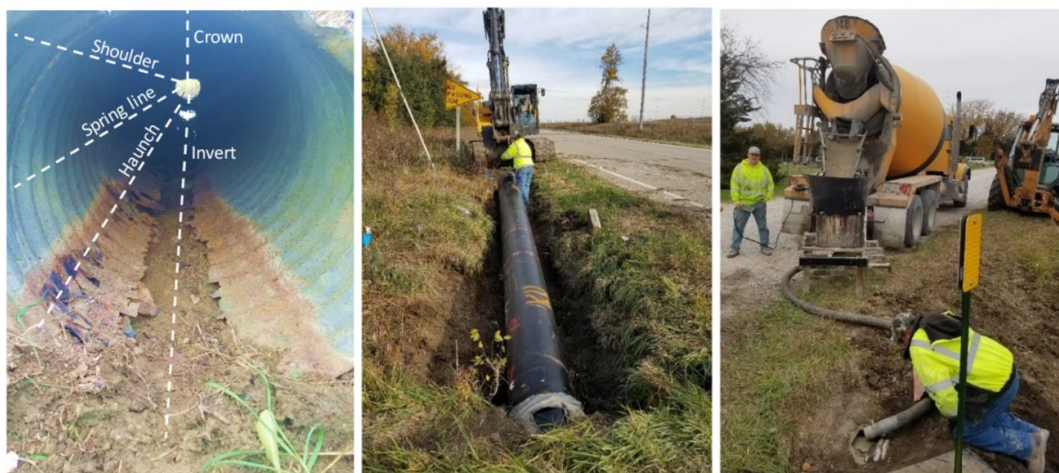
(a) Corroded corrugated steel pipe

The authors selected a corroded corrugated steel pipe located at a T-intersection on the North 482 Road and East 1250 Road (Old 59 Highway) in Douglas County, Kansas. The entire wall thickness along the invert of the pipe was disintegrated due to corrosion (Figure A.53a). After complete removal of the pipe from the soil, the corroded pipe was placed at a shallow depth of 15.75" (400 mm) under an asphalt pavement. A high-density polyethylene pipe (HDPE) was used as the liner pipe (Figure A.53b), and the annulus void was filled with a low-viscosity grout. The mix proportions of the grout were 418 lb/yd<sup>3</sup> (254 kg/m<sup>3</sup>) of cement, 632 lb/yd<sup>3</sup> (384 kg/m<sup>3</sup>) of fly ash, and 810 lb/yd<sup>3</sup> (492 kg/m<sup>3</sup>) of water. The grout exhibited average 7-day and 28-day compressive strengths of 390 psi (2.7 MPa) and 740 psi (5.1 MPa), respectively. The annular space between the liner and host pipes was grouted in a single lift by using a gravity grouting process (Figure A.53c). Wooden blocks were placed as spacers above the liner at both ends of the corrugated steel pipe to prevent uplift of the liner pipe resulting from buoyancy due to grouting. An insulating foam sealant was used to prevent the grout from flowing out of the pipe. Figure A.54 presents a schematic diagram of the cross sections of North 482 Road.

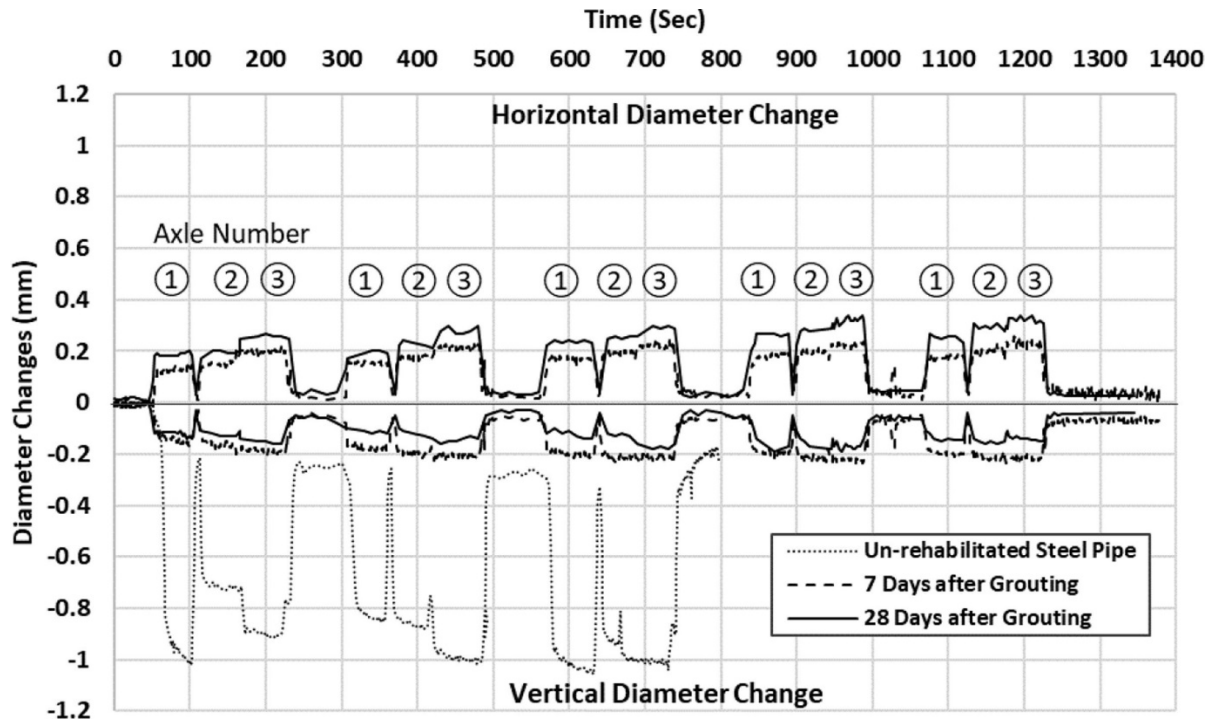
Figure A.57: Vertical and horizontal diameter changes versus time for Section 1. (Rahmaninezhad et al. 2020).

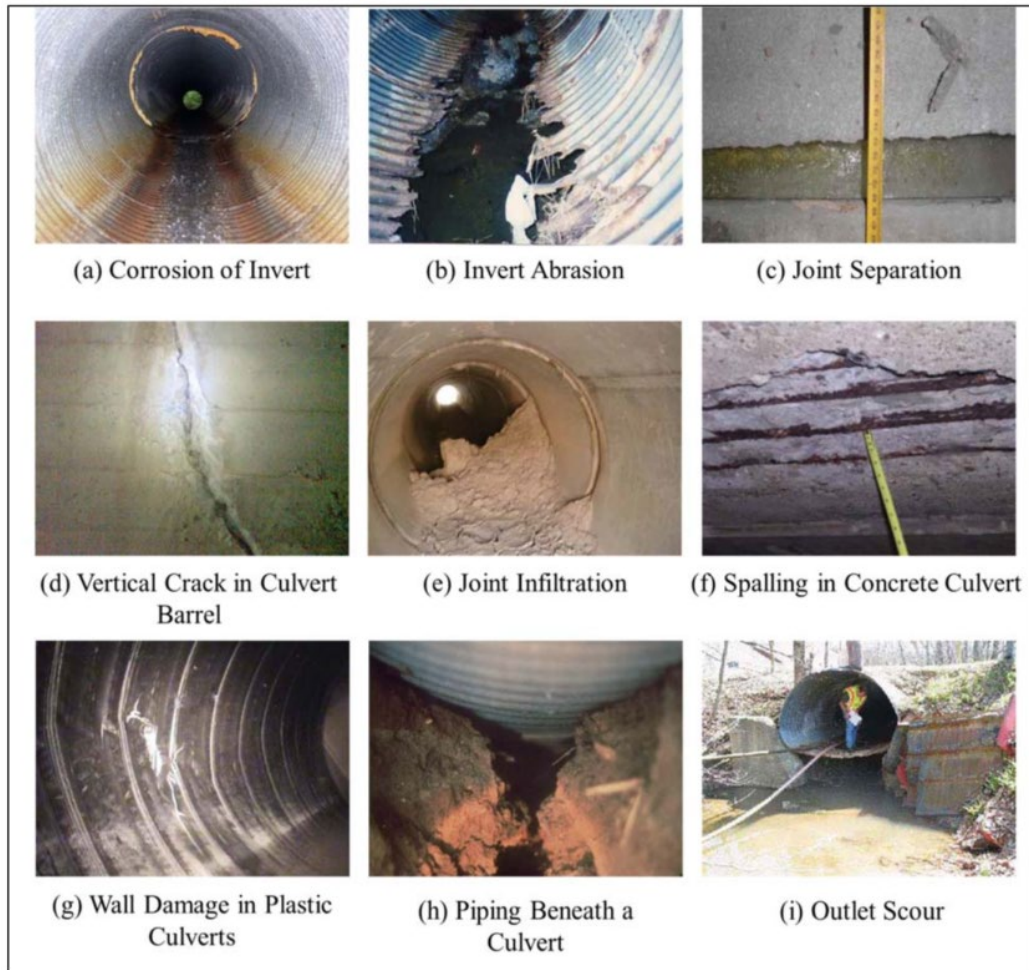
Figure A.68: Common defects observed in culverts (Piratla et al. 2017).

Cracks, invert deterioration, joint misalignment, joint infiltration or exfiltration, corrosion, shape distortion, debris, loss of wall thickness, and bedding voids are commonly observed defects in culverts (Figure A.68). Tables A.45 and A.46 present information about several inspection techniques used to detect defects in culverts that can aid in the selection of an appropriate method (Yang and Song 2009, Agarwal 2010, Allouche et al. 2010, Tuccillo et al. 2010).

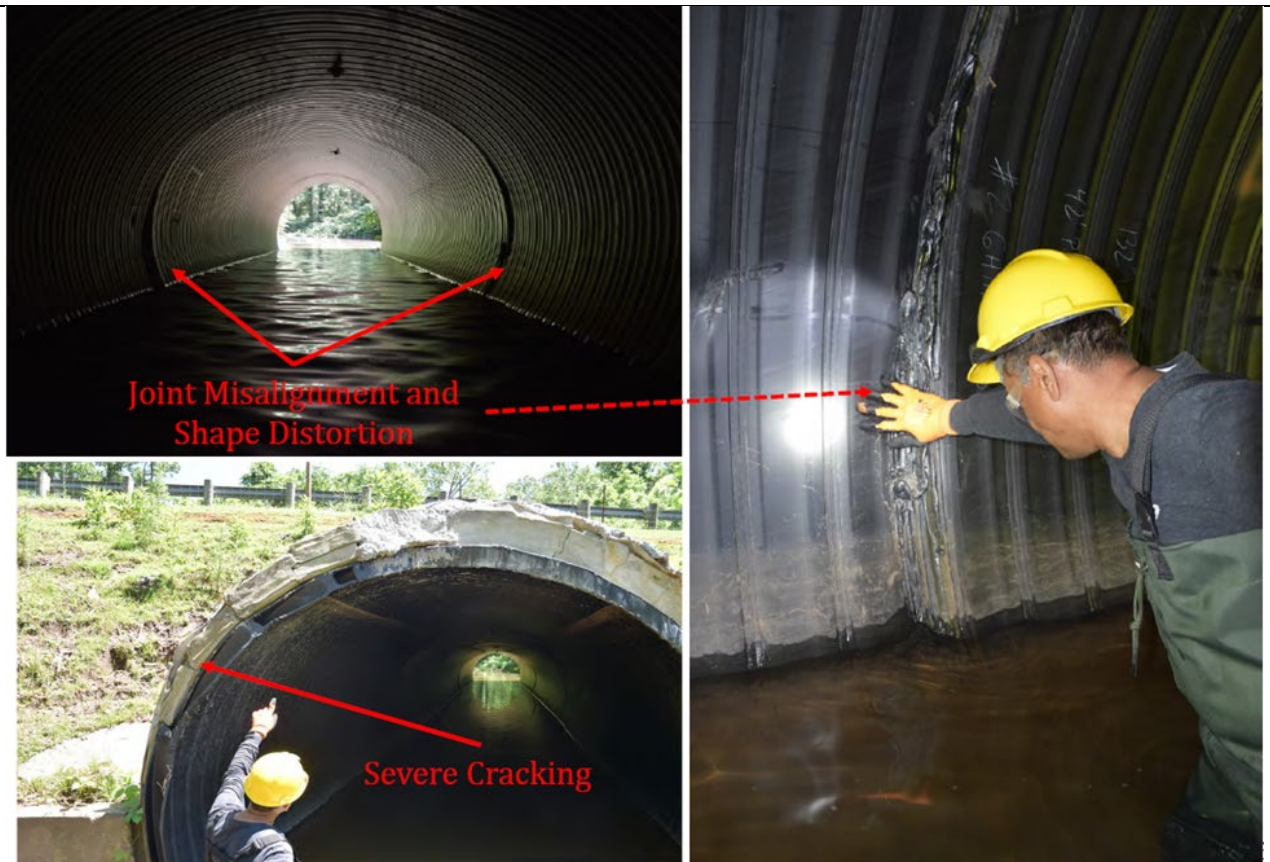
Several Cracks at the Bulkhead and Shape Distortion

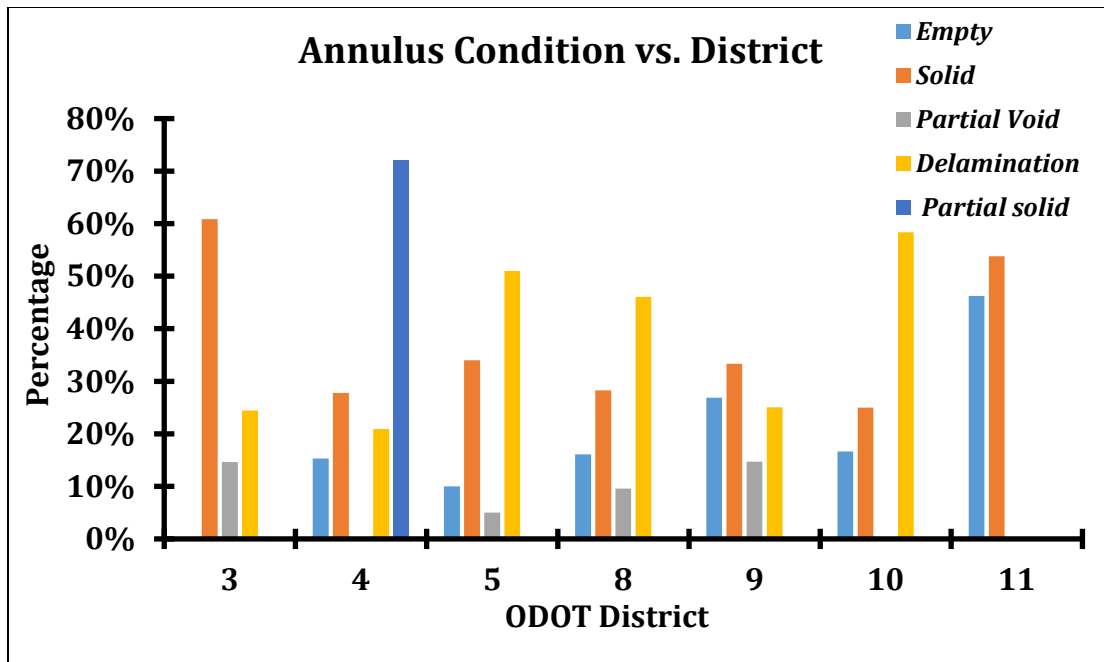
Figure C.36: Percentage of Voids in Sliplined Culverts in Different ODOT Districts.

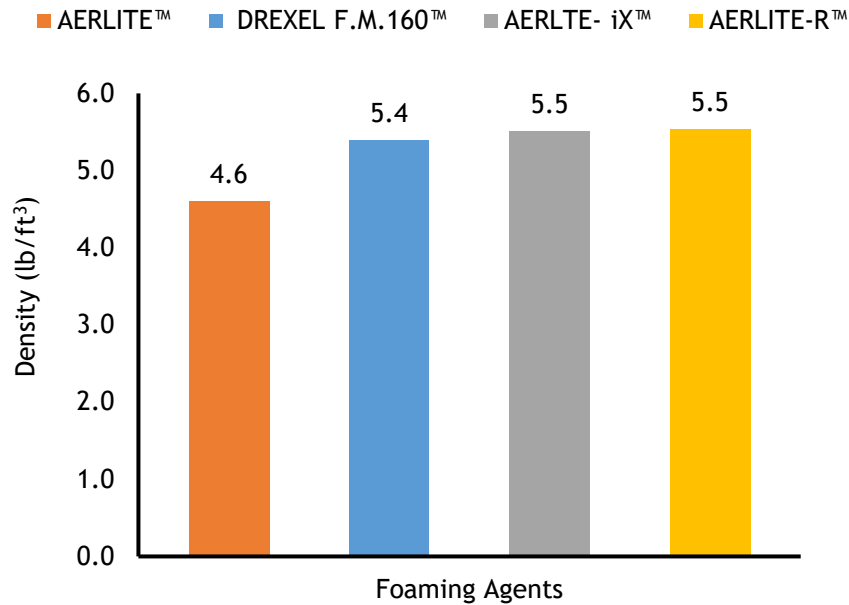
Figure E.26: Foam Density for Four Foaming Agents

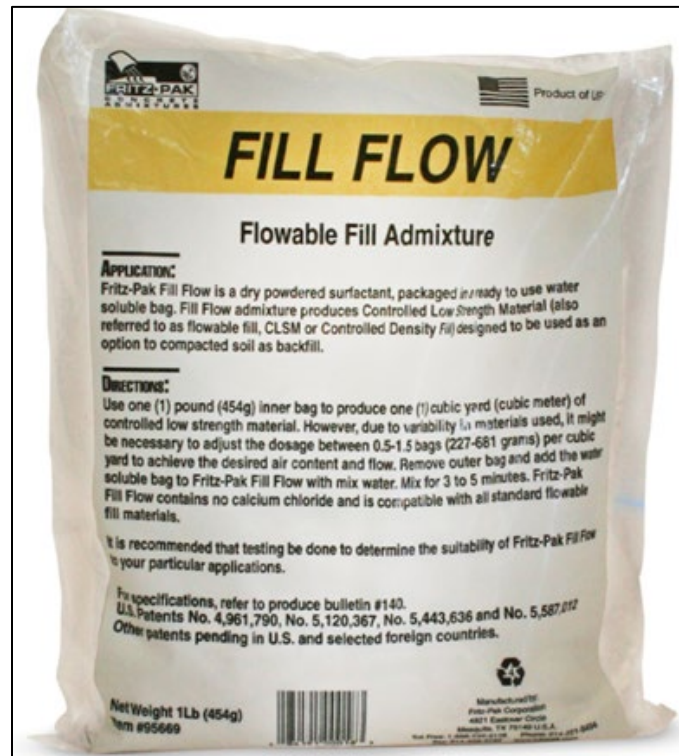
Figure F.2: Fill Flow Admixture.

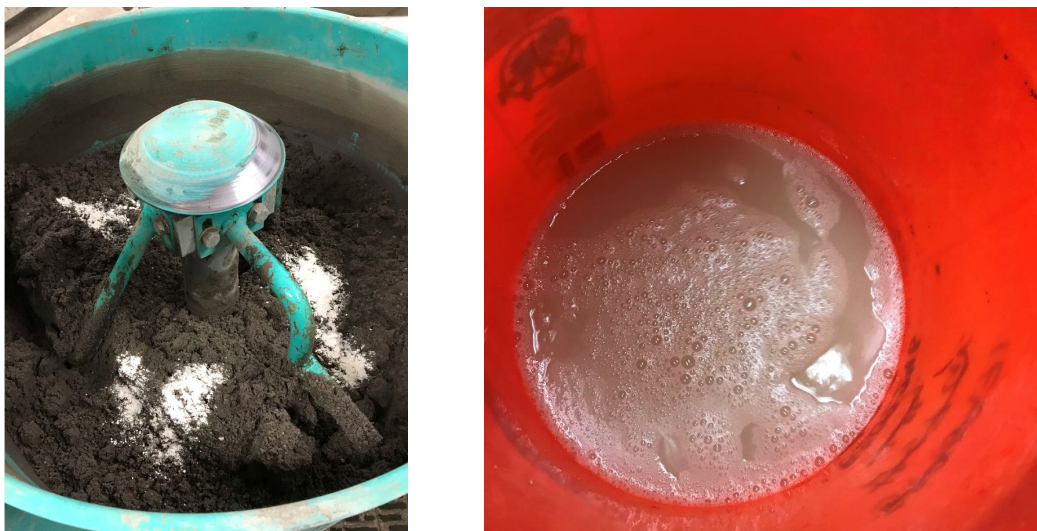
Figure F.3: Mixing Fill Flow: Adding Powder Directly to the Mix (left), Mixing Fill Flow with Water Prior to Adding it to the Mix (right).

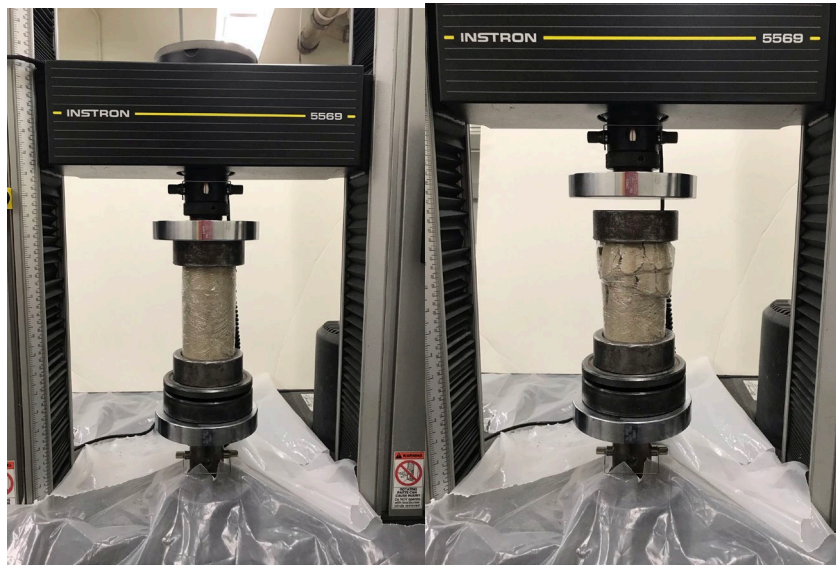
Figure F.13: Unconfined Compressive Strength Test: Setup with Specimen Loaded into Test Frame (*left*), Test Specimen that Failed when Loaded (*right*).

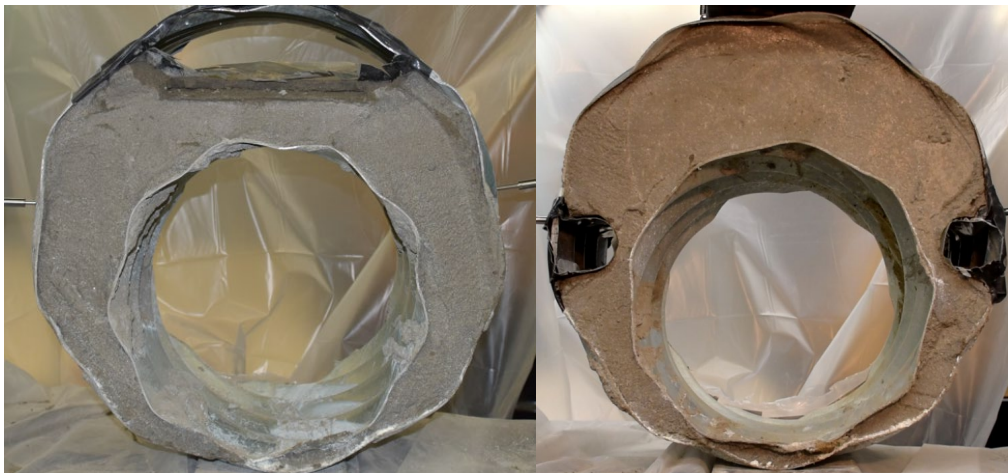
Figure F.24: Sliplined Culvert Specimens: One with a Void at Crown (*left*) and One with Two Voids at the Springline (*right*).

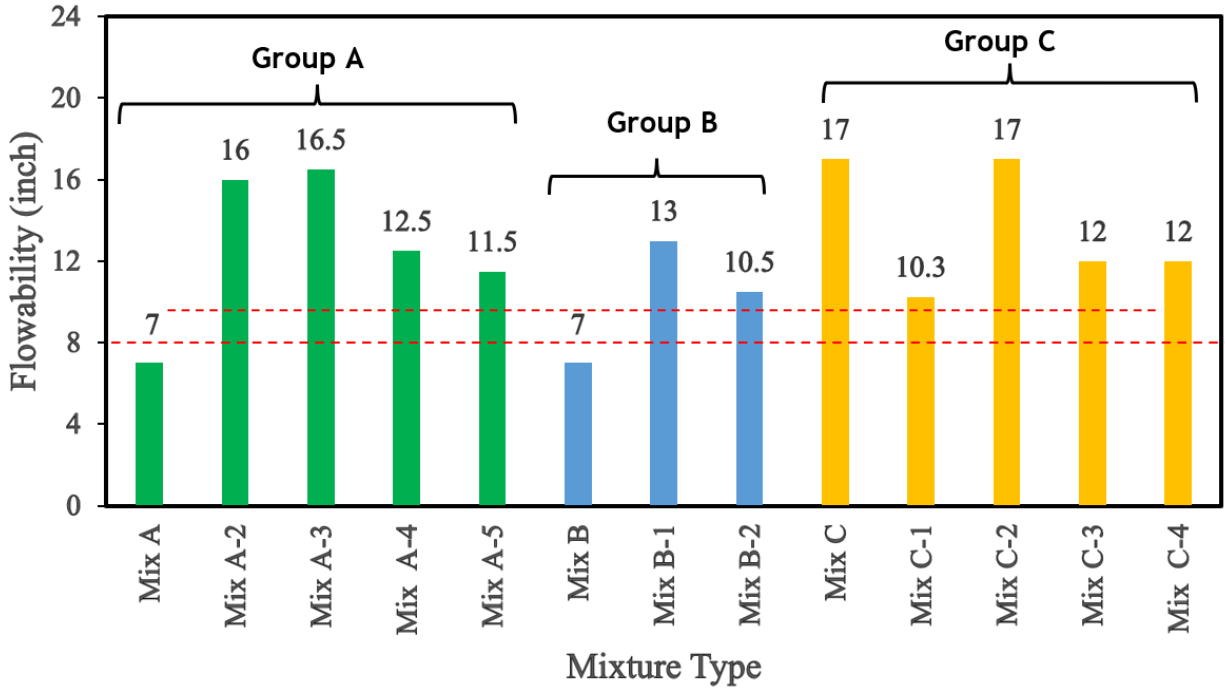
Figure F.26: Flowability of CLSM Mixtures.

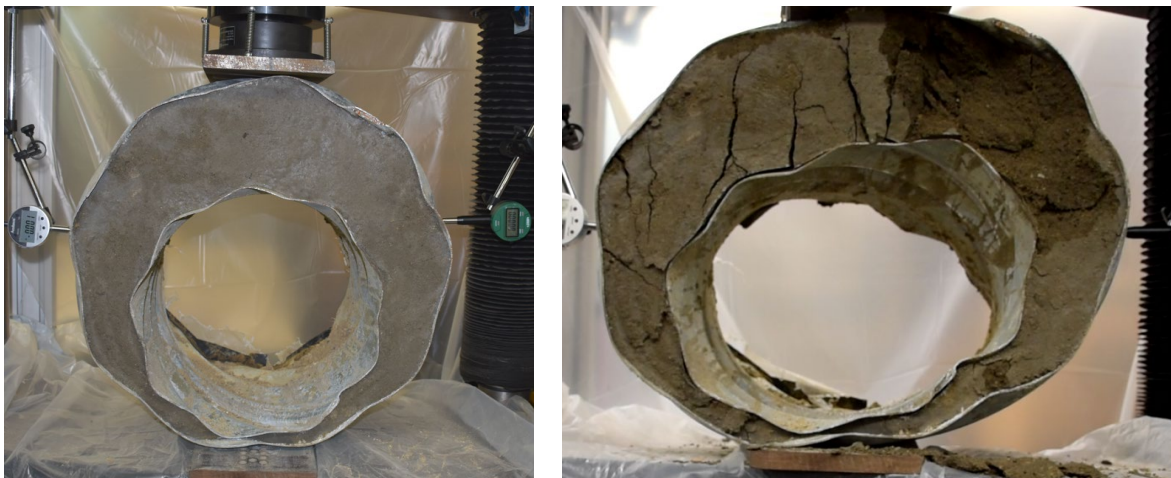
Figure F.42: Sliplined Culvert with CLSM grout Mix A Before (*left*) and After (*right*) the Parallel-Plate Loading Test.

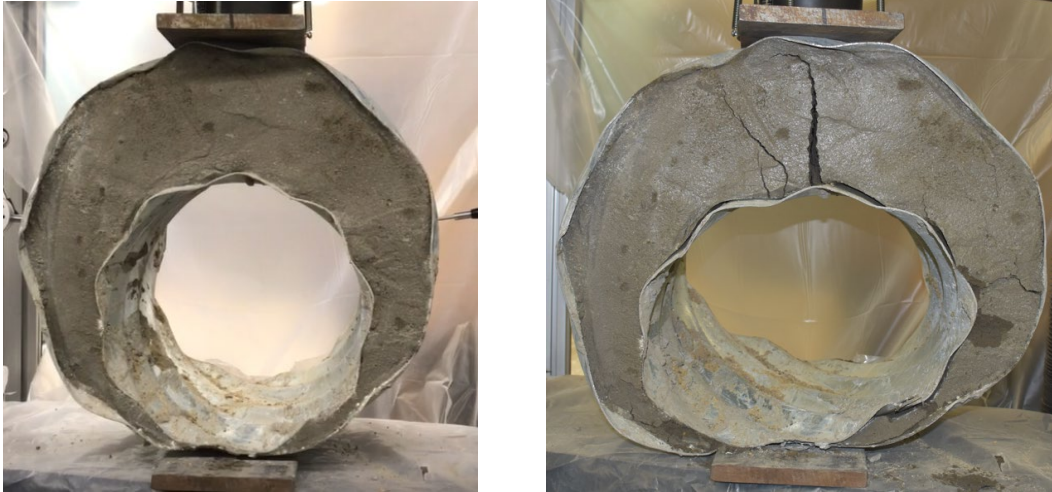
Figure F.43: Sliplined Culvert with CLSM grout Mix A-5 Before (left) and After (right) the Parallel-Plate Loading Test.

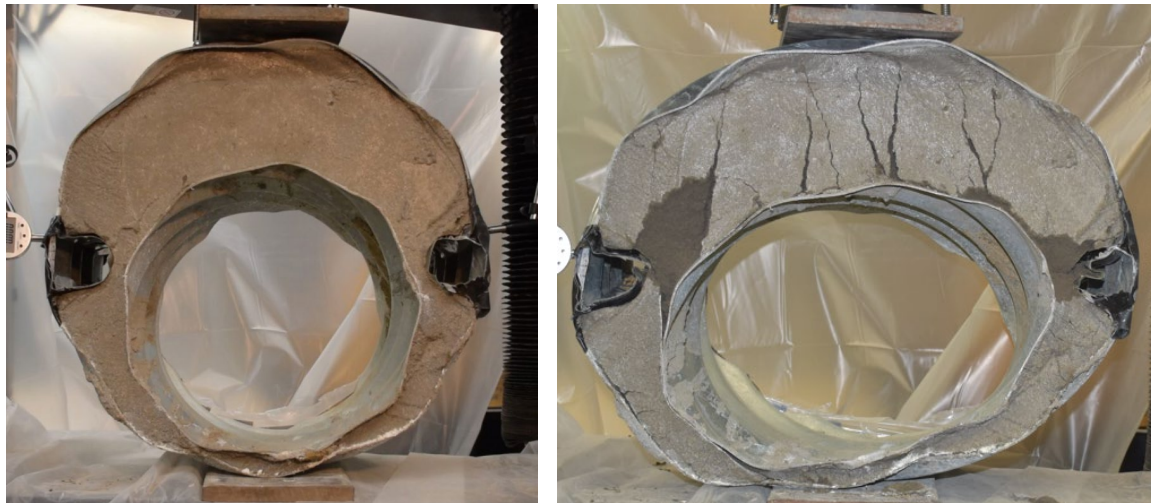
Figure F.47: Sliplined Culvert with Voids at the Springline, Before (*left*) and After (*right*) the Parallel-Plate Loading Test.
