Marian Coffin Gardens at Gibraltar
Arresting Deterioration

University of Delaware: BSLA Senior Capstone

Appdendix A - Inventory of Garden Ornaments and Iron Work: Missing Items (December 1996 & April 2019)

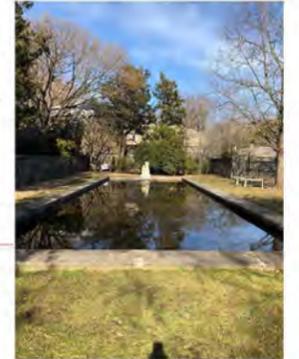
Figure 8: South-north view of Pool Terrace with swimming pool. 2019. Photograph by Jaime Manlove.

The Pool Terrace, located adjacently on the north west side to the Flower Garden, is the second most popular area in Gibraltar. Currently a bog, it catches people's attention, especially in the summertime when the water lilies are in bloom. This area is most photographed for the plants here. In order to maintain this area, the members of MCG need to address the safety hazards in this area first and then focus on maintaining the plants here as well.

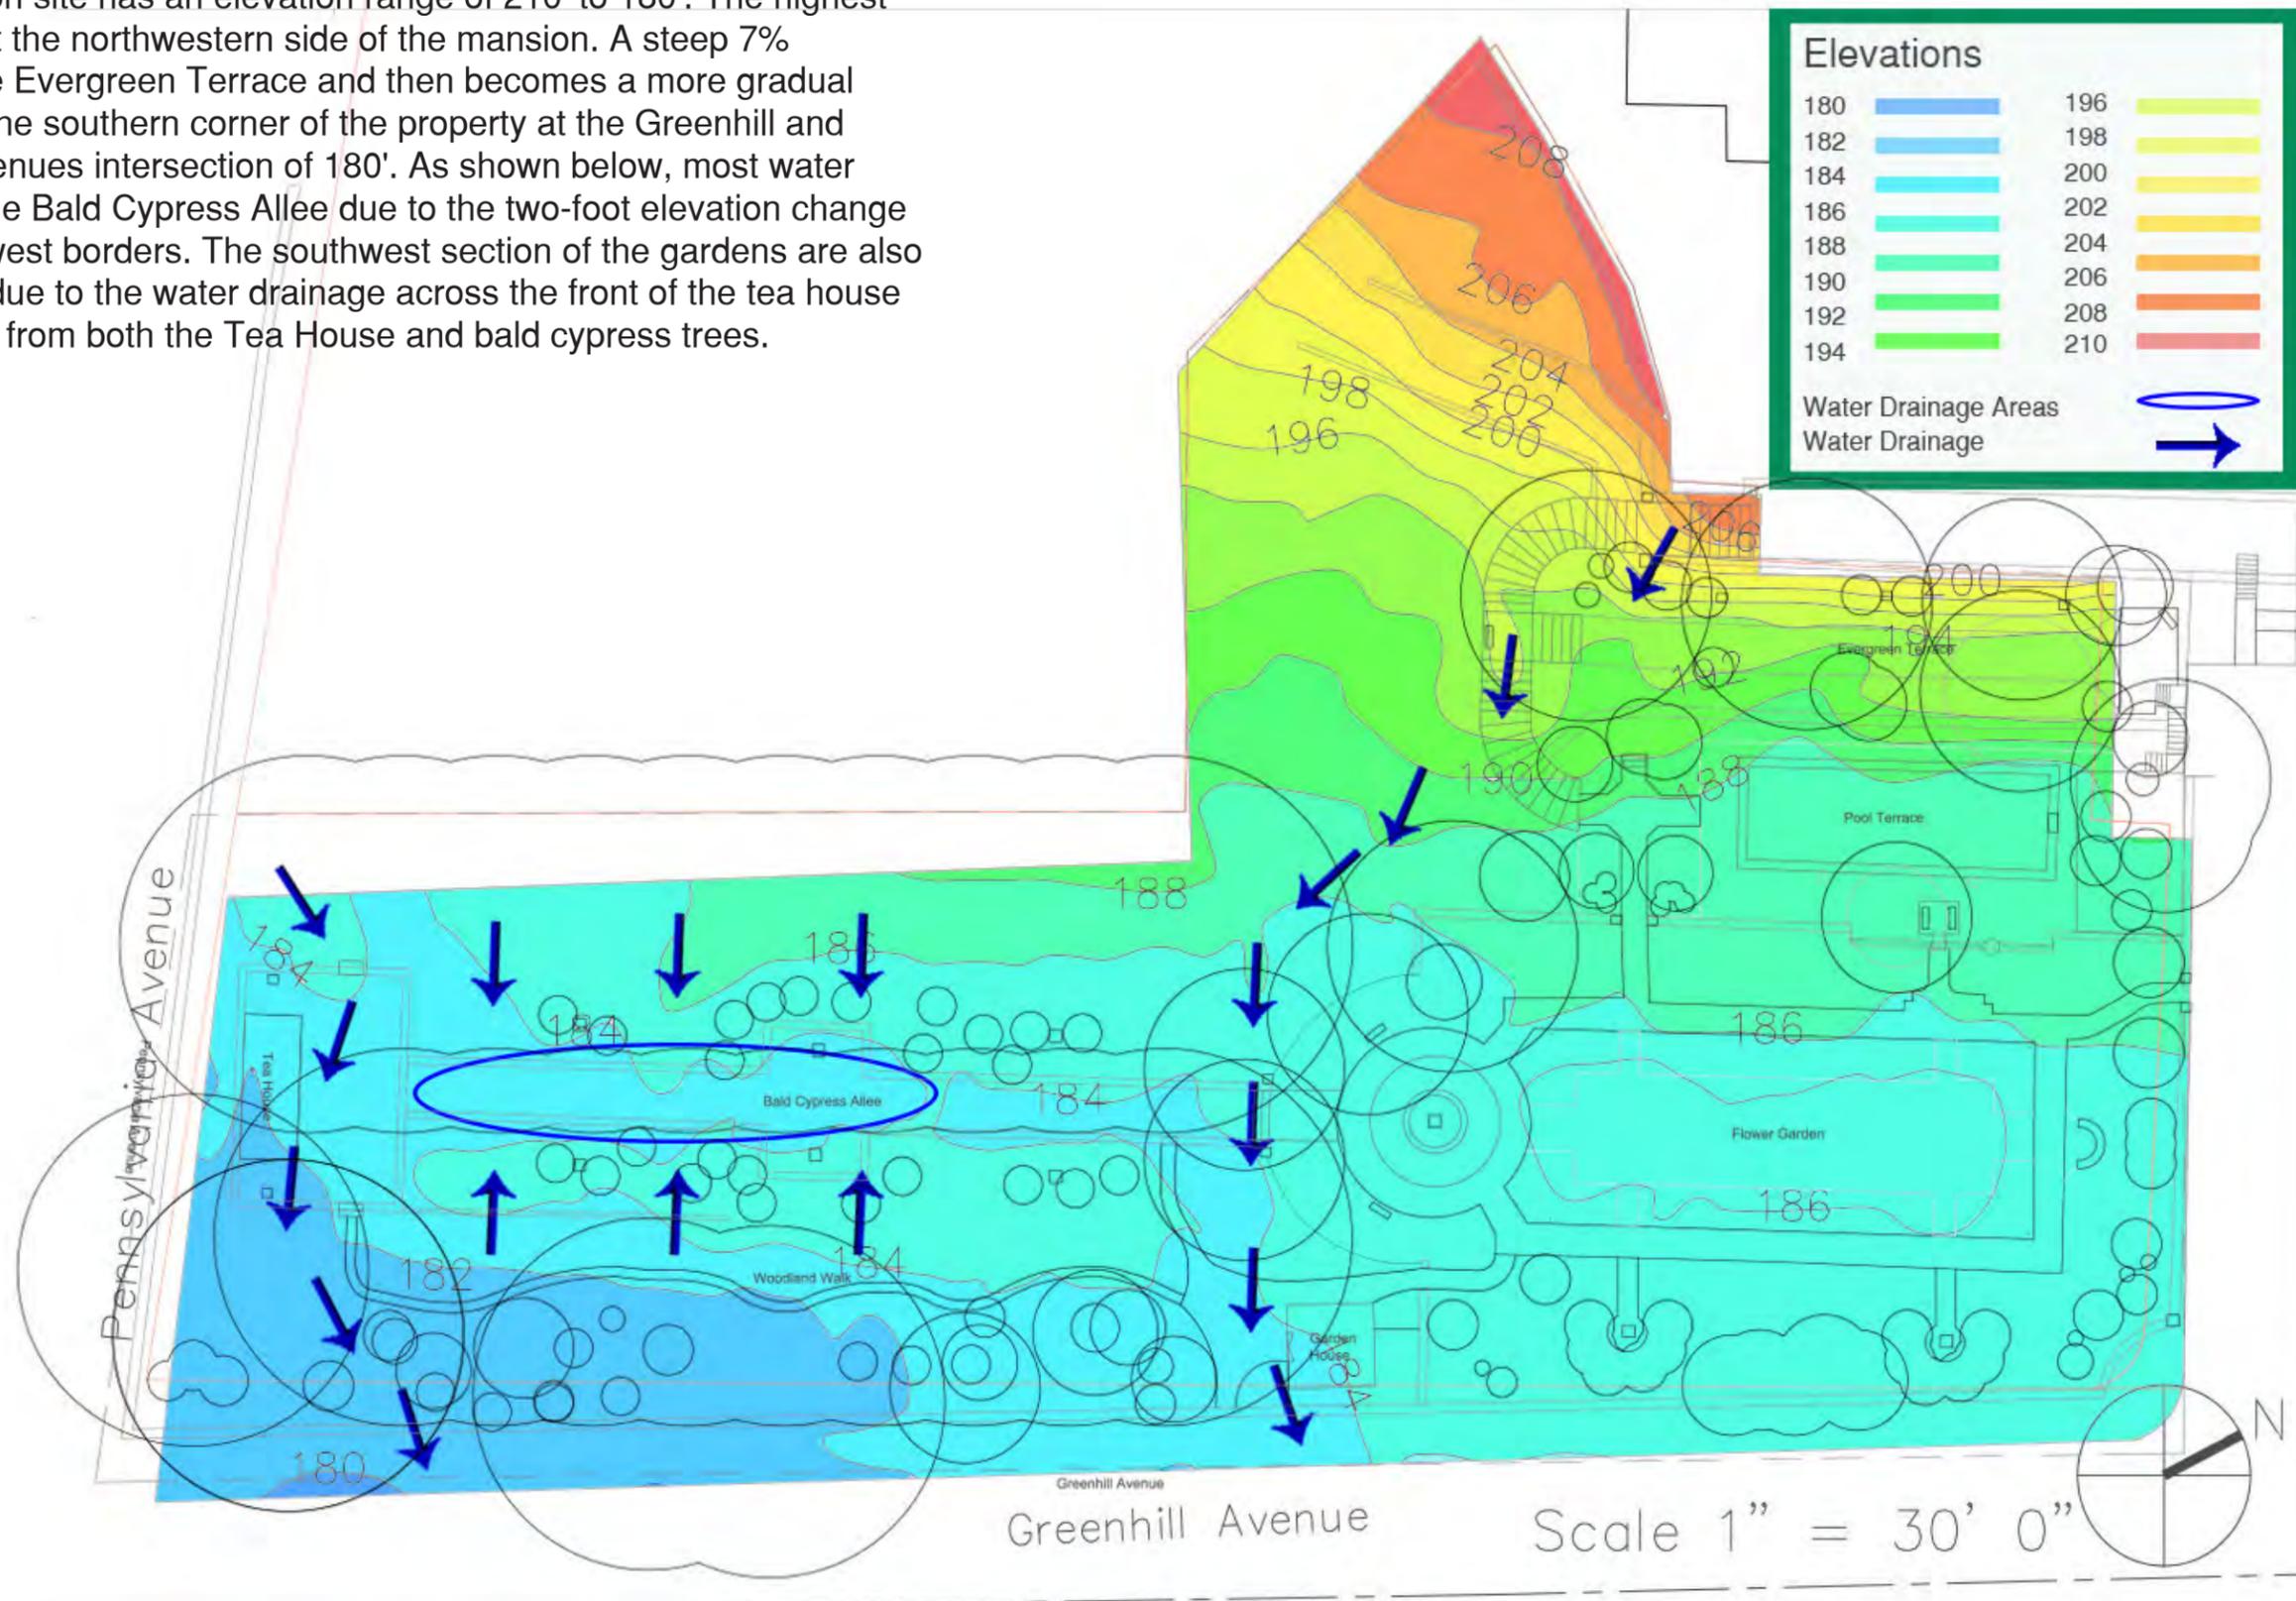
Site Analysis: Topography

The topography on site has an elevation range of 210' to 180'. The highest point is located at the northwestern side of the mansion. A steep 7% slope leads to the Evergreen Terrace and then becomes a more gradual slope leading to the southern corner of the property at the Greenhill and Pennsylvania Avenues intersection of 180'. As shown below, most water accumulates in the Bald Cypress Allee due to the two-foot elevation change on the east and west borders. The southwest section of the gardens are also consistently wet due to the water drainage across the front of the tea house and heavy shade from both the Tea House and bald cypress trees.

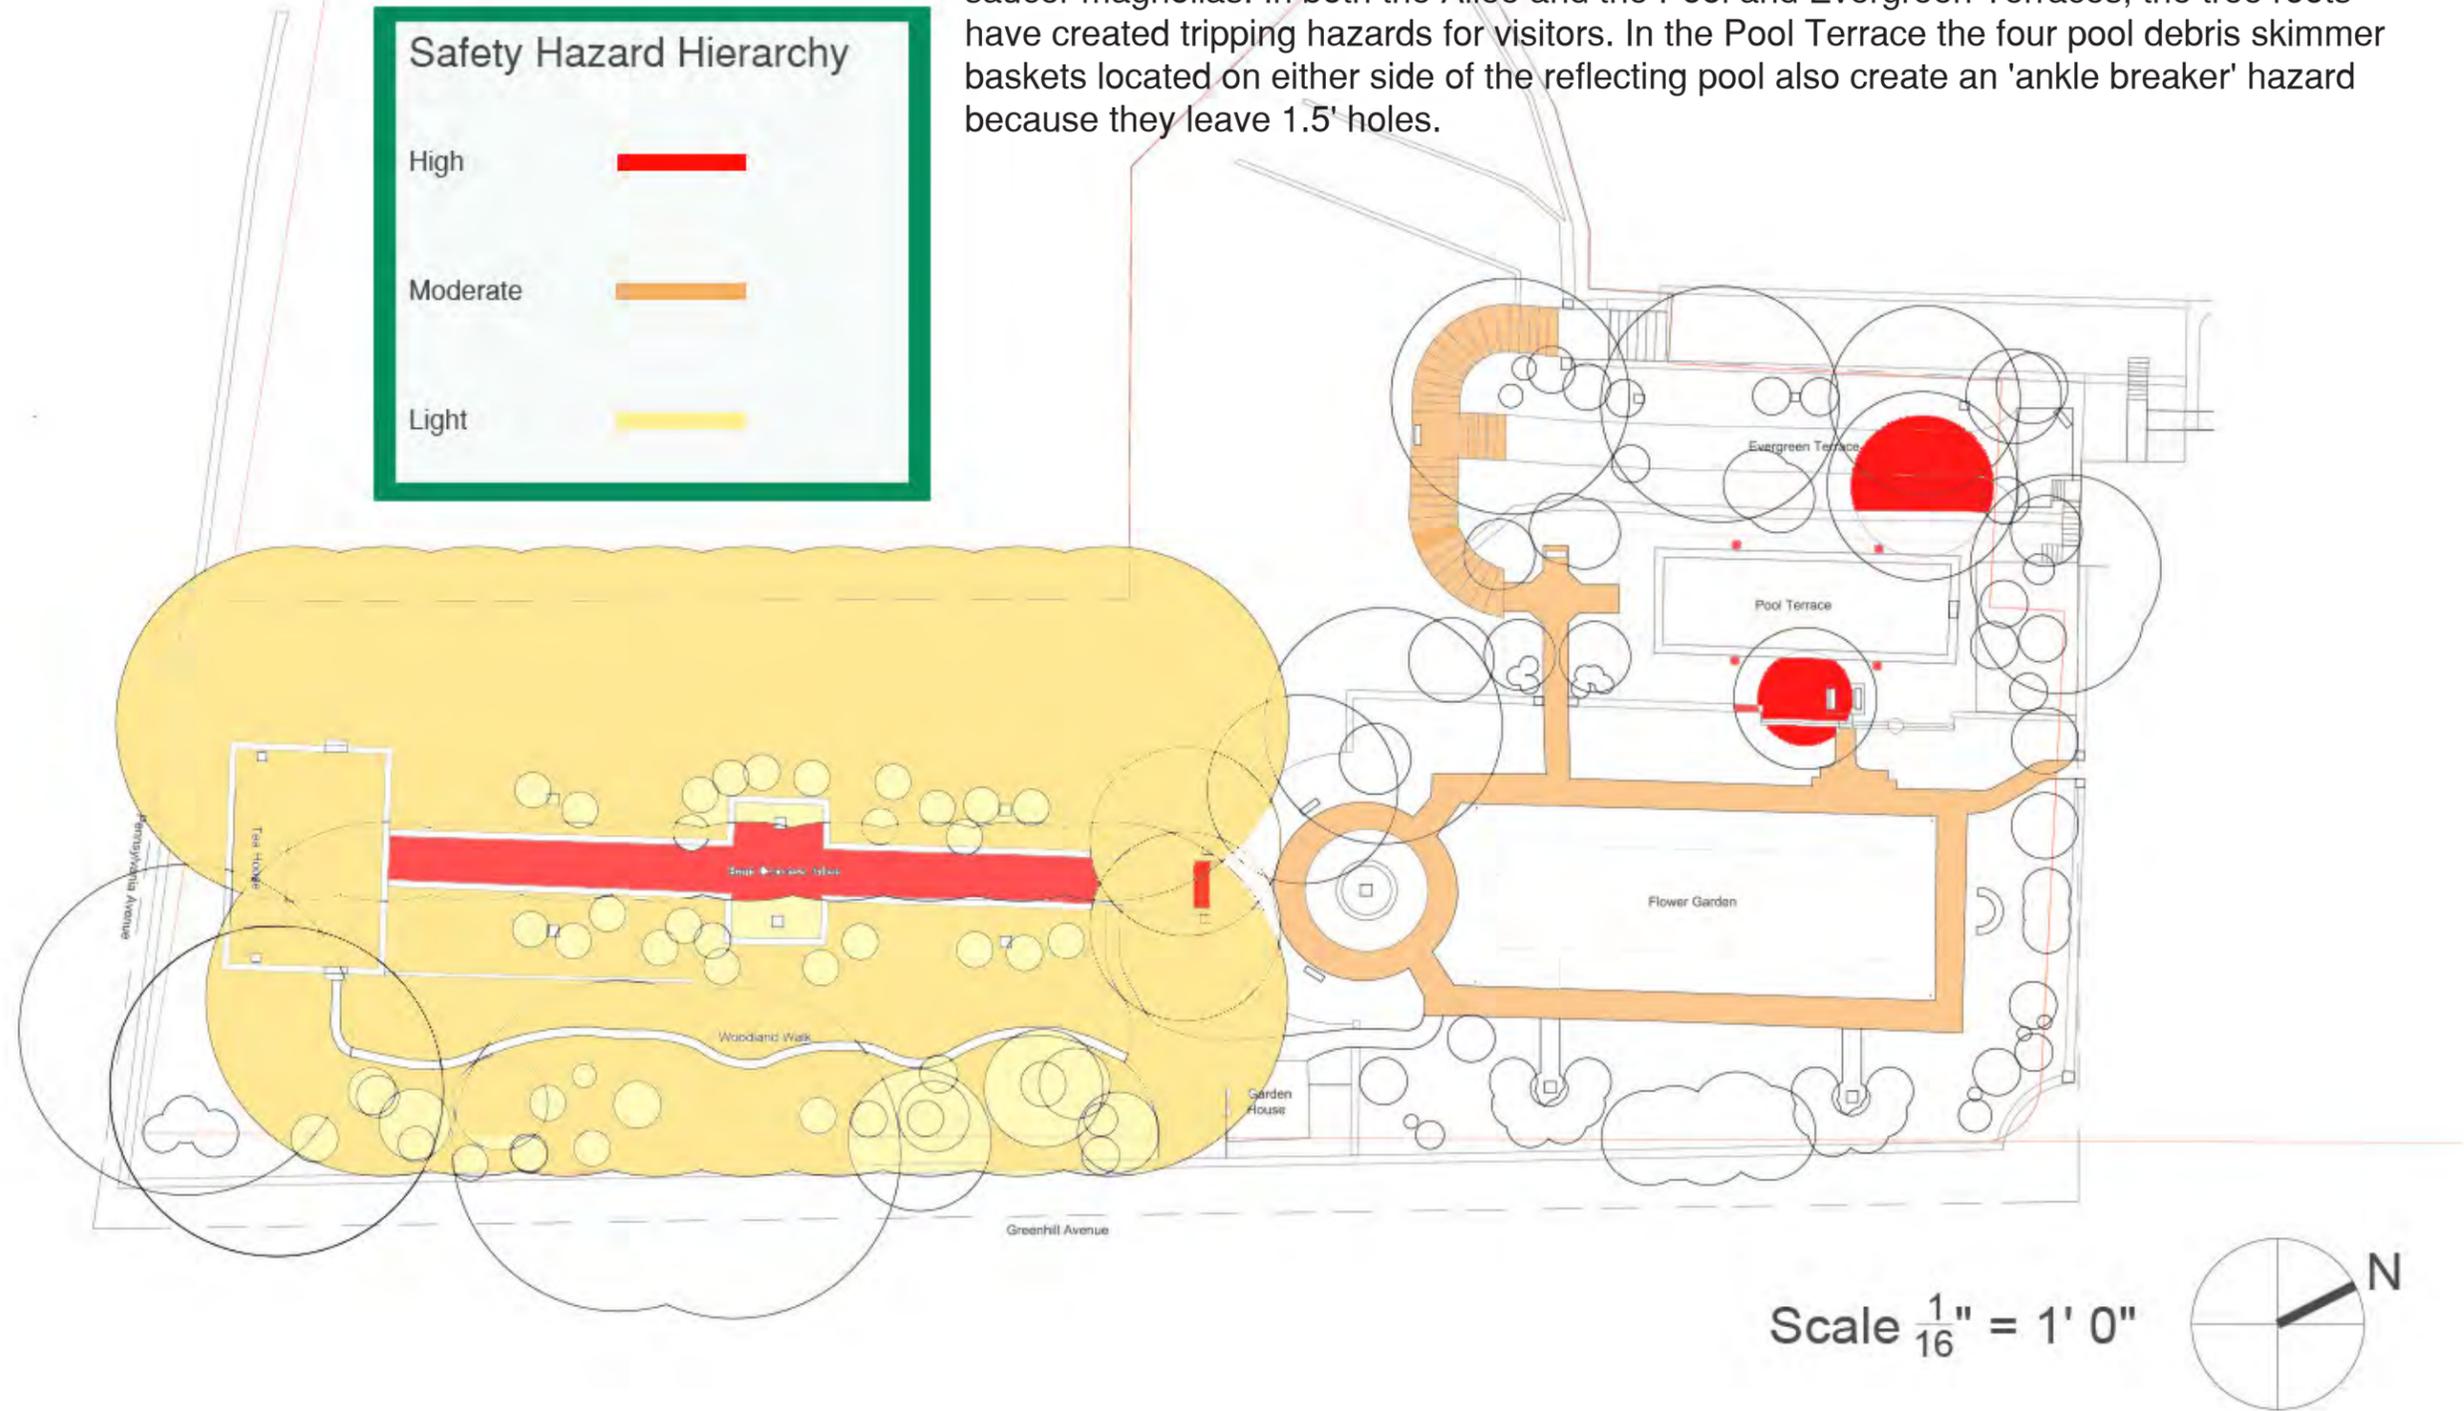
Site Analysis: Safety Hazards

This rendering illustrates conclusions regarding the current safety hazards on site ranging from light to high hazards. The lightest safety hazards surround the Bald Cypress Allee. This dense area of plant material provides an area for people to hide providing a safety threat. The moderate hazards are throughout the Flower Garden (tripping hazard) and the Marble Staircase (slipping). The highest safety hazards are found in the main walkway of the Bald Cypress Allee, at the iron gates, and in the Pool and Evergreen Terraces. The iron gates have rusting present on them and the potential of falling tree limbs of the two saucer magnolias. In both the Allee and the Pool and Evergreen Terraces, the tree roots have created tripping hazards for visitors. In the Pool Terrace the four pool debris skimmer baskets located on either side of the reflecting pool also create an 'ankle breaker' hazard because they leave 1.5' holes.

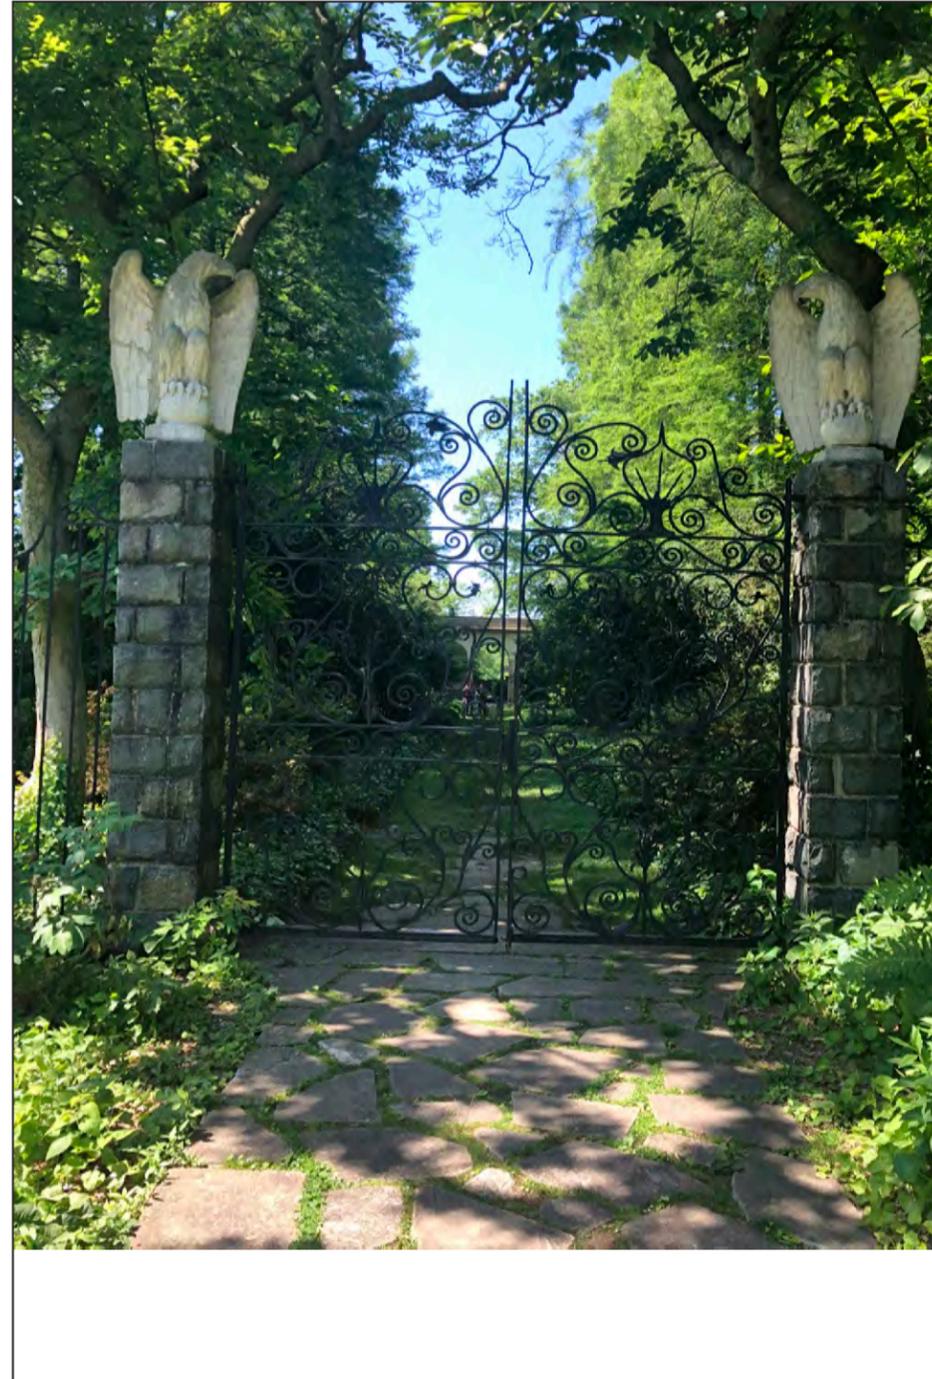
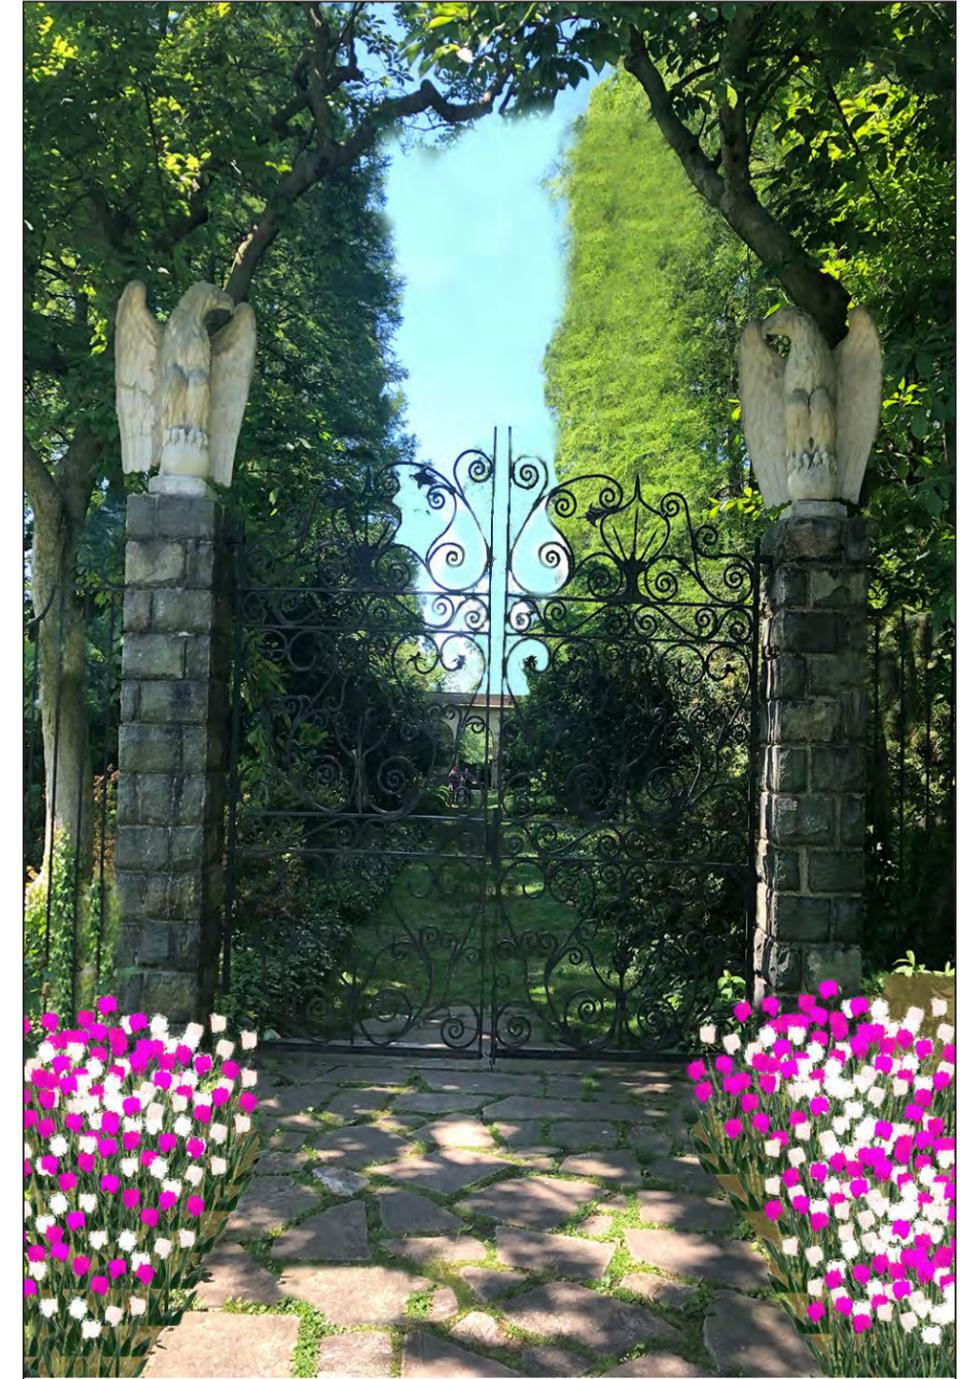
Current

The Iron Gates, located at the south end of the Flower Garden, are more often than not the first thing visitors see upon entering the garden. These gates are the most photographed area of the entire garden mostly focusing on this area's infrastructure. This area greatly needs to have the gates intricate ironwork details repaired, painted and preserved to have the maximum benefit for the garden.

These renderings depict the iron gates throughout the past 100 years. The proposals are based on research about the history of the plantings in this area of the garden and point back to the overall objectives of safety and arresting deterioration of the garden.

Proposed

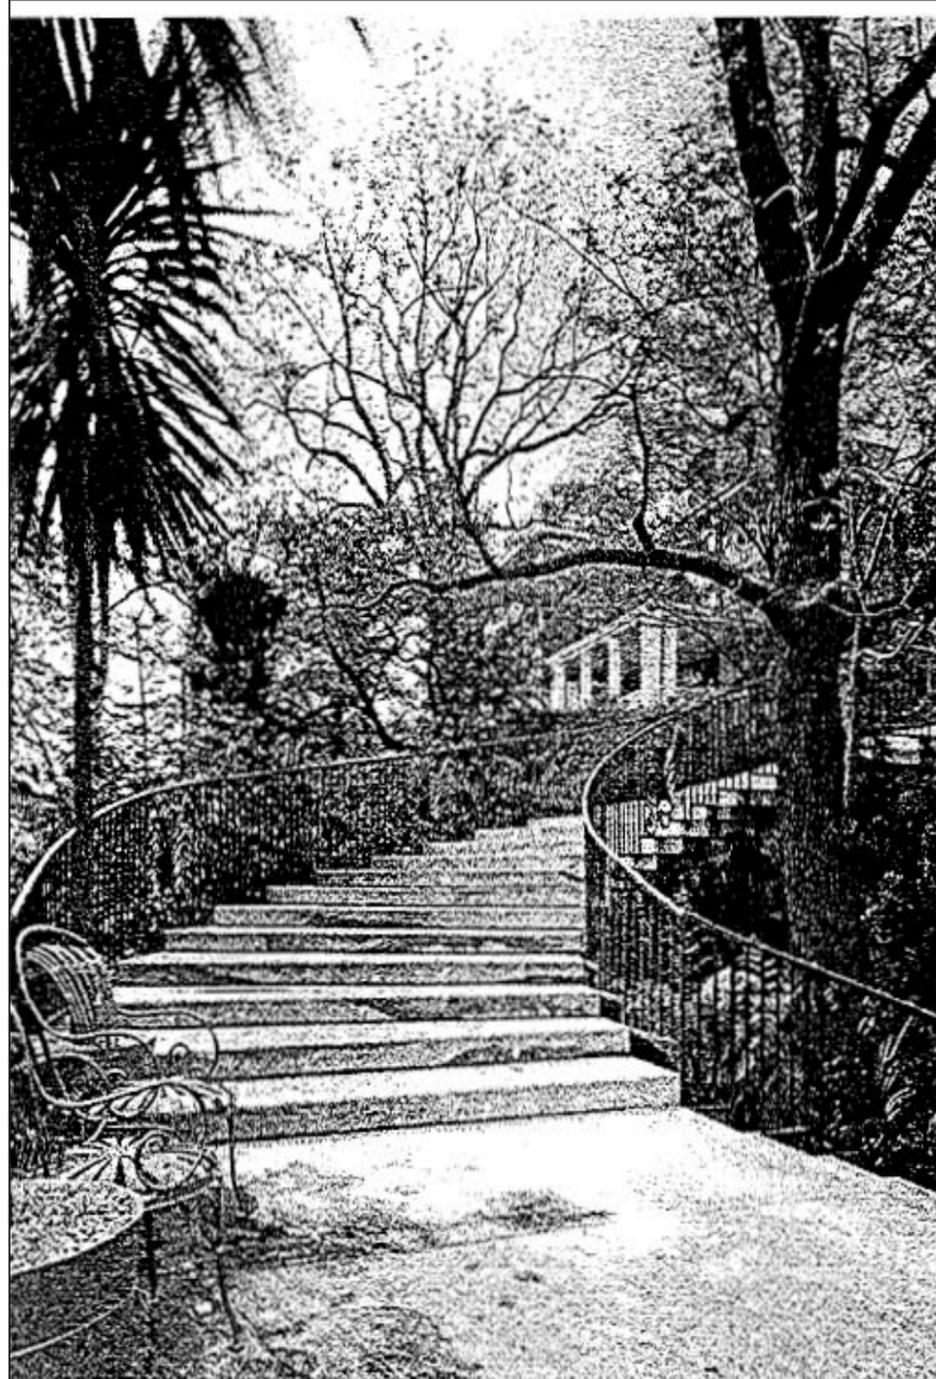
1900-1920's

These images include a historic photo of the stairs and then two renderings. The recommended proposals is very minimal due to the fact that the stairs and are mainly used for foot traffic between multiple terraces.

Proposal: Limb up over hanging trees, clean and repaint ironwork, clean marble staircase.

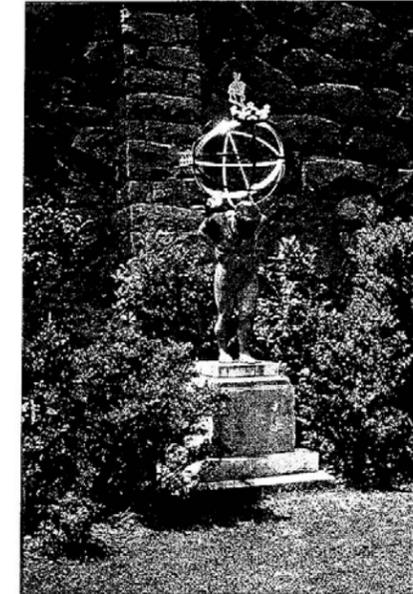
Figure A-11: Lead statue of Atlas (O-8).
Undated. Courtesy of the Sharp family.

Condition (1996): Poor. Figure disconnected from stone base. Feet still attached to stone base. Severe structural damage, especially at knees of figure. Bronze sphere intact and in good condition; now missing.

Condition (2019): MISSING

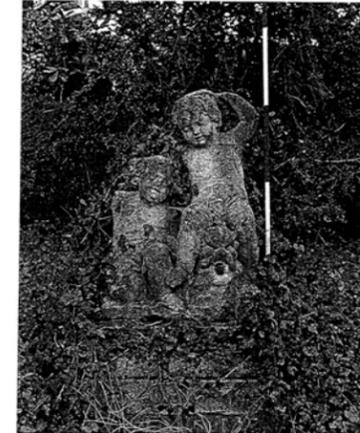
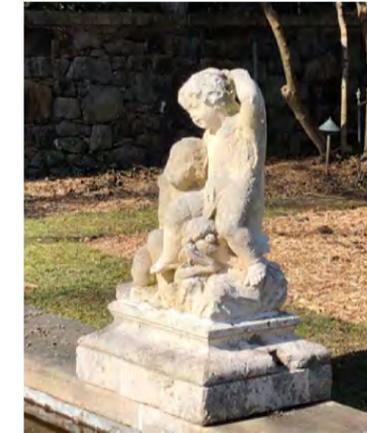
Figure A-12: Cast stone fountain (O-10) at north rim of swimming pool. 1997. Photograph by John Lewis.

Condition: Fair. Corrosion and some losses. Object partially covered with ivy.

Condition (2019): Poor. Bleaching and corrosion. Both right arms missing.

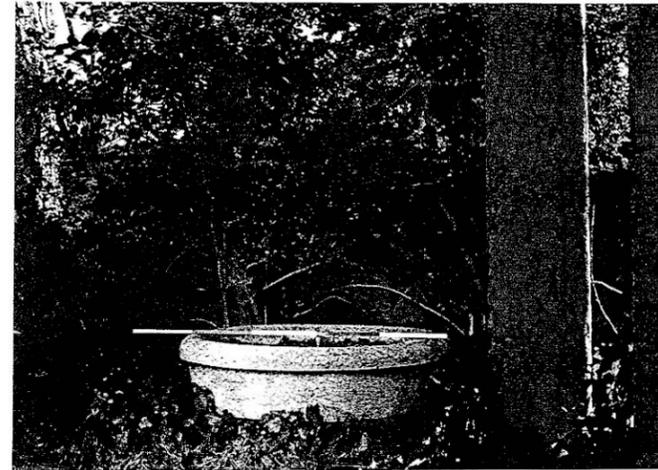
Figure A-26: *Verona Rosso* marble fountain basin (O-27) south of Tea House. 1997. Photograph by John Lewis.

Condition: Good. No losses. Surface of marble is pockmarked due to erosion.

Condition (2019): Good-fair. No losses. Cracking in bowl. Stagnant water.

- A. Safety hazards
- B. Infrastructure - Statues
 - 1. Preservation
 - 2. Cleaning
 - a. Fountain basin
 - 1. Currently no active drainage
 - a. Breeding ground for mosquitoes
- C. Infrastructure - Tea house
 - 1. Drainage
 - a. Remove leaves from roof
 - b. Replace water spouts on backside
 - 2. Cleaning - See Appendix C - Infrastructure Tea House Procedures
 - a. Walls facing Pennsylvania avenue
 - 1. Drainage from roof going down walls
- D. Plants - Ornamental
 - 1. Ivy outer edges
 - a. Cut back about 1 foot
- E. Plants - Grasses
 - 1. Grass area in front of tea house
 - a. Densely shaded → solutions?

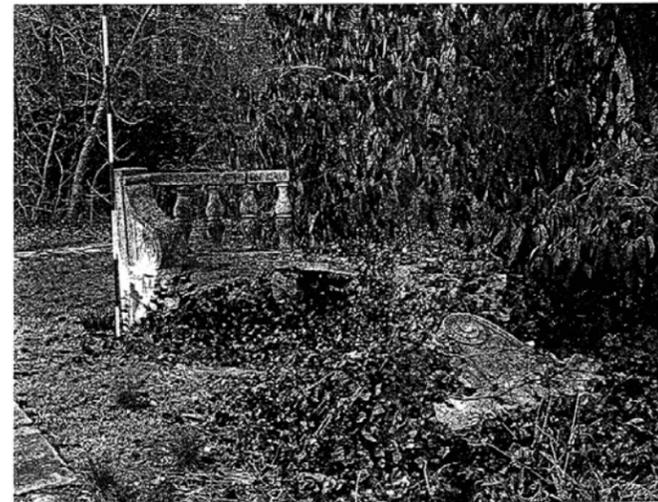
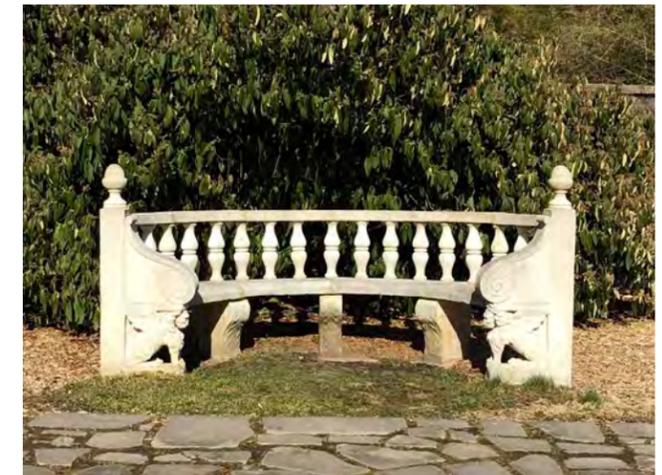
Figure A-14: Cast stone bench (O-14) at north end of Flower Garden. 1997. Photograph by John Lewis.

Condition: Poor. Severe structural damage. Object is broken into large pieces.. Finials and several other parts missing.

Condition (2019): Fair. Bleaching and erosion. Areas of former patching visible. Bandaid healed appearance.

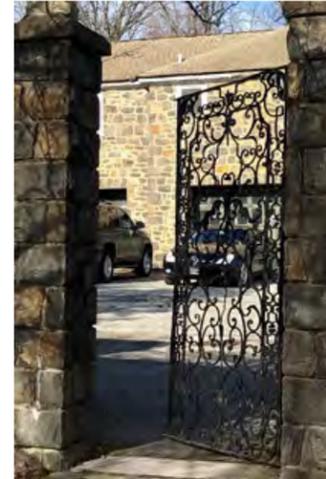
Large Iron Gate (0-21)

Condition: Good-fair. Erosion. Some losses.

Condition (2019): Fair. Erosion. Bent or missing finials.

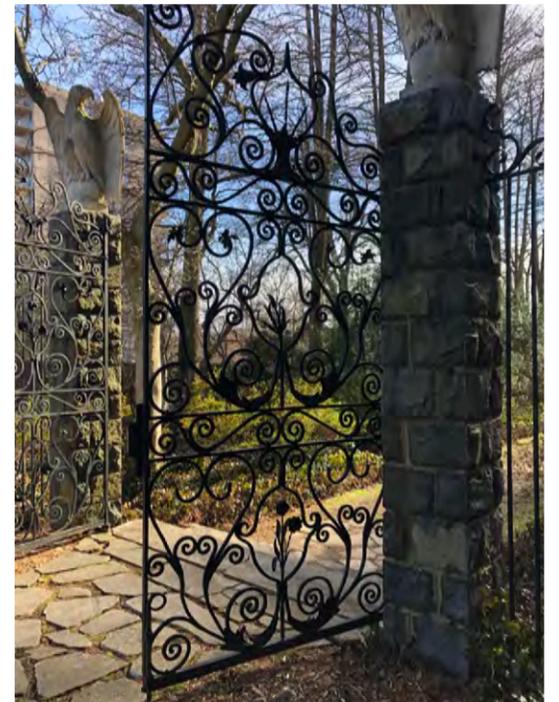
Condition: Poor. Severe structural damage. Corrosion.

Condition (2019): Good. Light rusting.

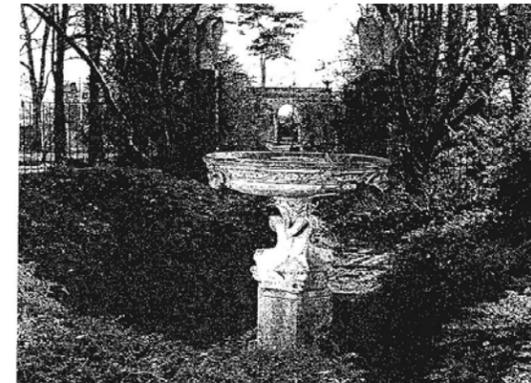
Figure A-18: Cast stone fountain (O-19). 1997. Photograph by John Lewis.

Description: Cast stone fountain with water-spouting dolphin ornaments around central column supporting a round bowl (4'2" in diameter). Bowl adorned with water-spouting fox heads and fruit garlands. Original center ornament, a white marble 'Bathing Venus,' is missing. Overall height without center ornament: 7'4". Fountain located inside a round, 3' high cast stone basin, 11'6" in diameter.

Condition: Fair. Losses in bowl. Structural damage.

Condition (2019): Good. Light cracking in bowl; but no major erosion.

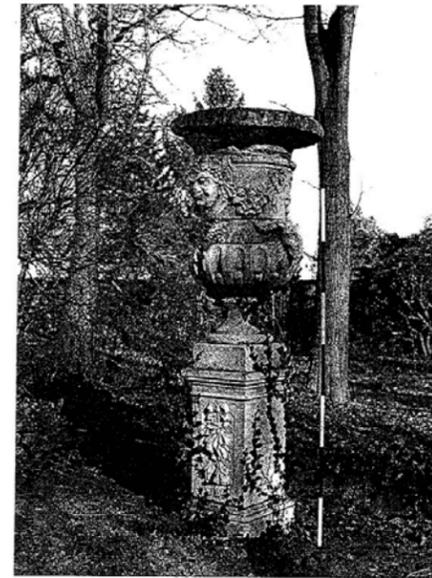
Figure A-23: Cast stone vase (O-24) in center of Bald Cypress Allée. West side. 1997. Photograph by John Lewis.

Condition: Fair-poor. Vase on west side of AllCe has fallen onto its side and broken into pieces. Vase on east side of walk shows signs of erosion and structural damage throughout body. Losses in decoration. Fragment from rim of vase rests next to base.

Condition (2019): Fair. Erosion and bleaching visible. Areas of former patching visible.

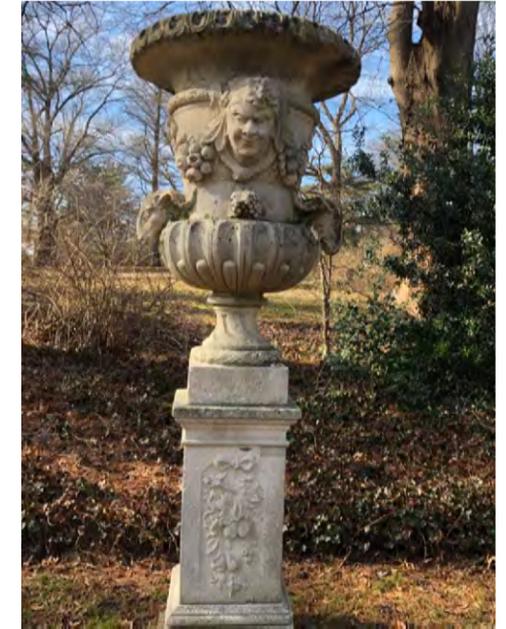
Bald Cypress Allee Pair of Vases (O-25)

Description: Cast stone vases. "Egg and dart" motifs around lip. Each vase atop rectilinear stone base.

Condition: Fair-poor. No losses. Vase west of Tea House broken into pieces.

Condition (2019): Fair. No major losses; signs of erosion. Areas of former patching visible.

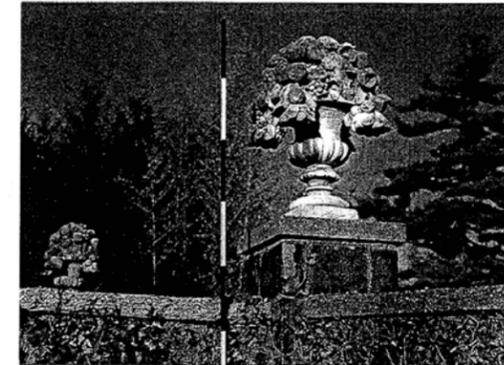
Figure A-2: Cast stone fruit basket (O-0). Greenhill Avenue entrance. 1997. Photograph by John Lewis.

Condition: Good-fair. Signs of erosion. No losses.

Condition (2019): Good-fair. Signs of erosion. No losses.

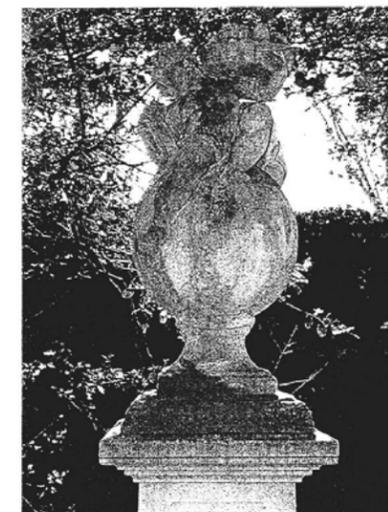
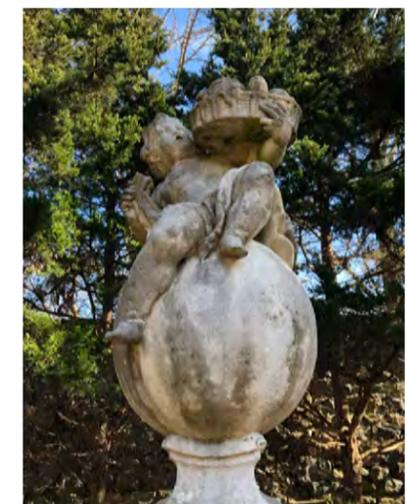
Figure A-15: Cast stone putto (0-16). East side of Flower Garden. 1997. Photograph by John Lewis.

Condition: Fair. No major losses. Surface eroded.

Condition (2019): Fair. No major losses. Surface eroded.

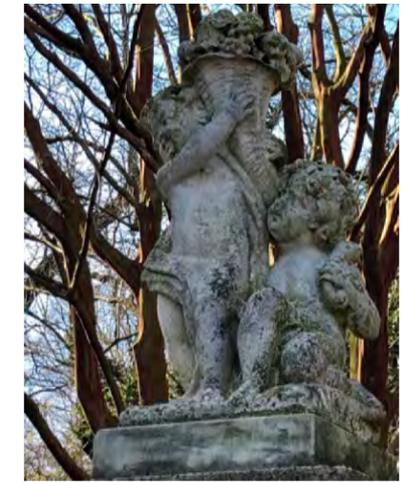
Figure A-16: Lead cupid (O-17) atop stone pillar west of large iron gate. 1996. Photograph by David Ames.

Condition: Objects are covered with ivy which may cause severe structural damage as ivy becomes entrenched.

Condition (2019): Good. No losses. No structural damage.

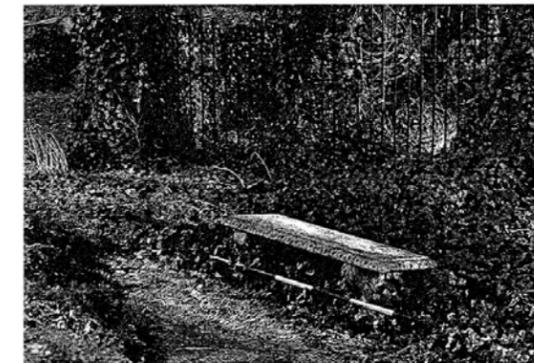
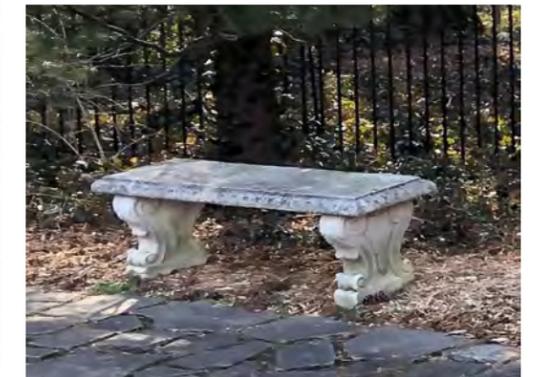
Figure A-21: Cast stone seat (O-20) left of large iron gate. 1997. Photograph by John Lewis.

Condition: Good. No losses. No structural damage.

Condition (2019): Good. No losses. Light erosion.

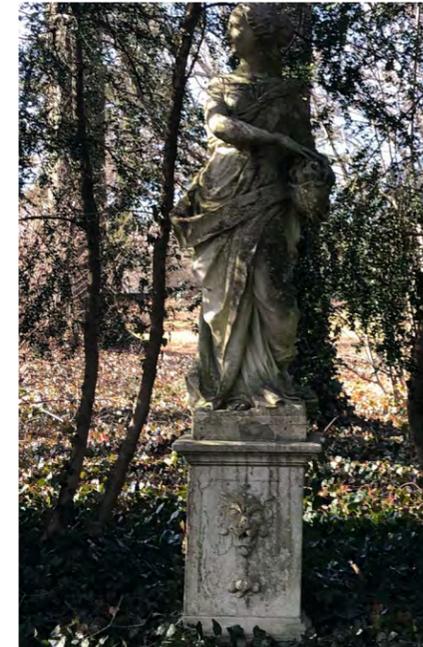
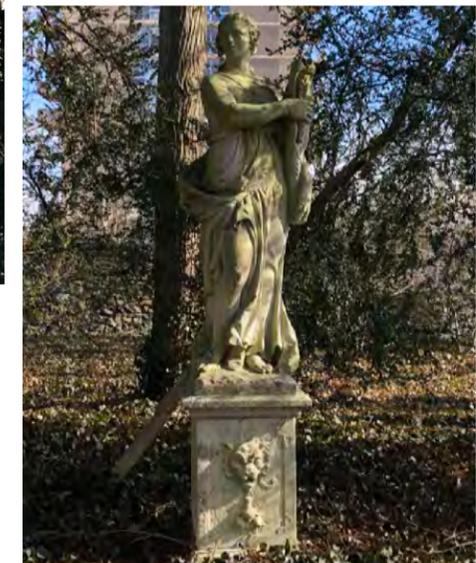
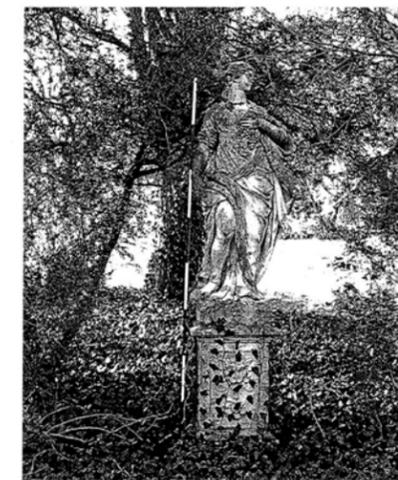
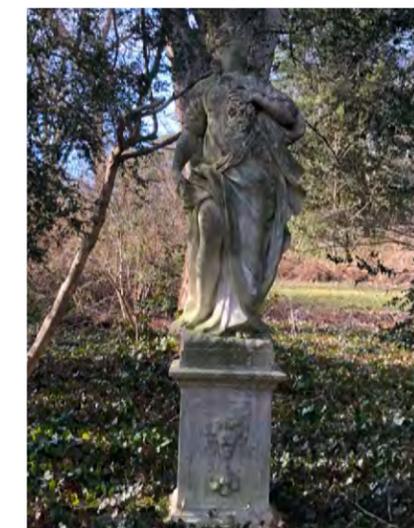
Figure A-22: *Autumn* (0-23-A). One of four seasonal figures. Bald Cypress Allée. 1997. Photograph by John Lewis.

Condition: Fair. Ivy rampant throughout figure. Severe cracks in drapery and leg region.

Condition (2019): Fair. Moss growth.
