**AN INNOVATIVE SENSING APPROACH USING CARBON NANOTUBE-
BASED COMPOSITES FOR STRUCTURAL HEALTH MONITORING OF
CONCRETE STRUCTURES**

A dissertation submitted to the Faculty of the University of Delaware in partial fulfillment of the requirements for the degree of Doctor of Philosophy in Civil Engineering

Fall 2017

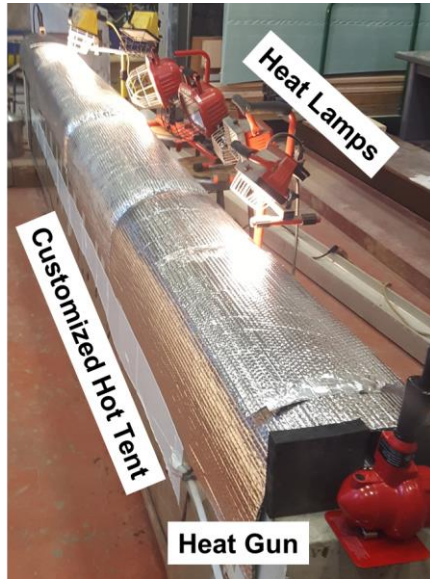
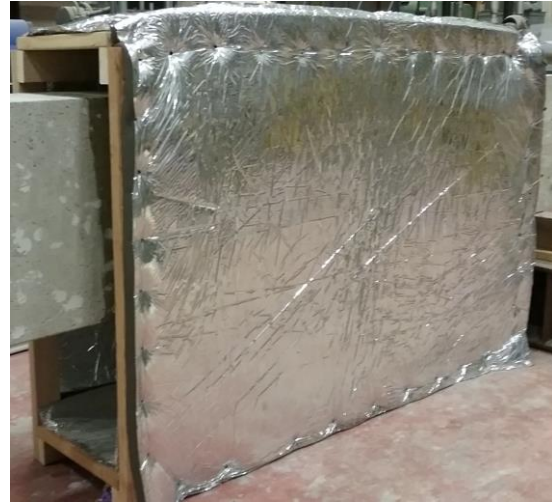
Figure 5.18: Photographs showing (a) the experimental setup for curing the long composite part on the flexure beam and (b) the box hot tent built for curing the shear beam specimen.

After complete infusion was achieved, both parts were kept under vacuum during the cure cycle. Customized thermal tents were built on-site with aluminum foil insulation sheets in order to cover the wet parts and meet the required curing temperature of 75 °C with the assistance of using two heat guns and multiple heating lamps. Figure 5.18 shows the experimental setup during curing. After completing the two-hour 75 °C curing cycle, the specimens were debagged and followed with a one-hour post-curing cycle at 80 °C. Figure 5.19 shows the appearance of the final product. There are no dry spots or voids observed, indicating the high quality of the fabricated hybrid composite.
