**Site Name:** Hayes-Campbell Tenant House

**CRS Number:** K-0000

**Date of Fieldwork:** October 1999

**Type of Documentation:** Level II: Partial Intensive  
Annotated field notes (2 sheets)  
Measured drawings--CAD (1 sheet)  
Black and white 4" x 5" photographs (8)  
Architectural data narrative

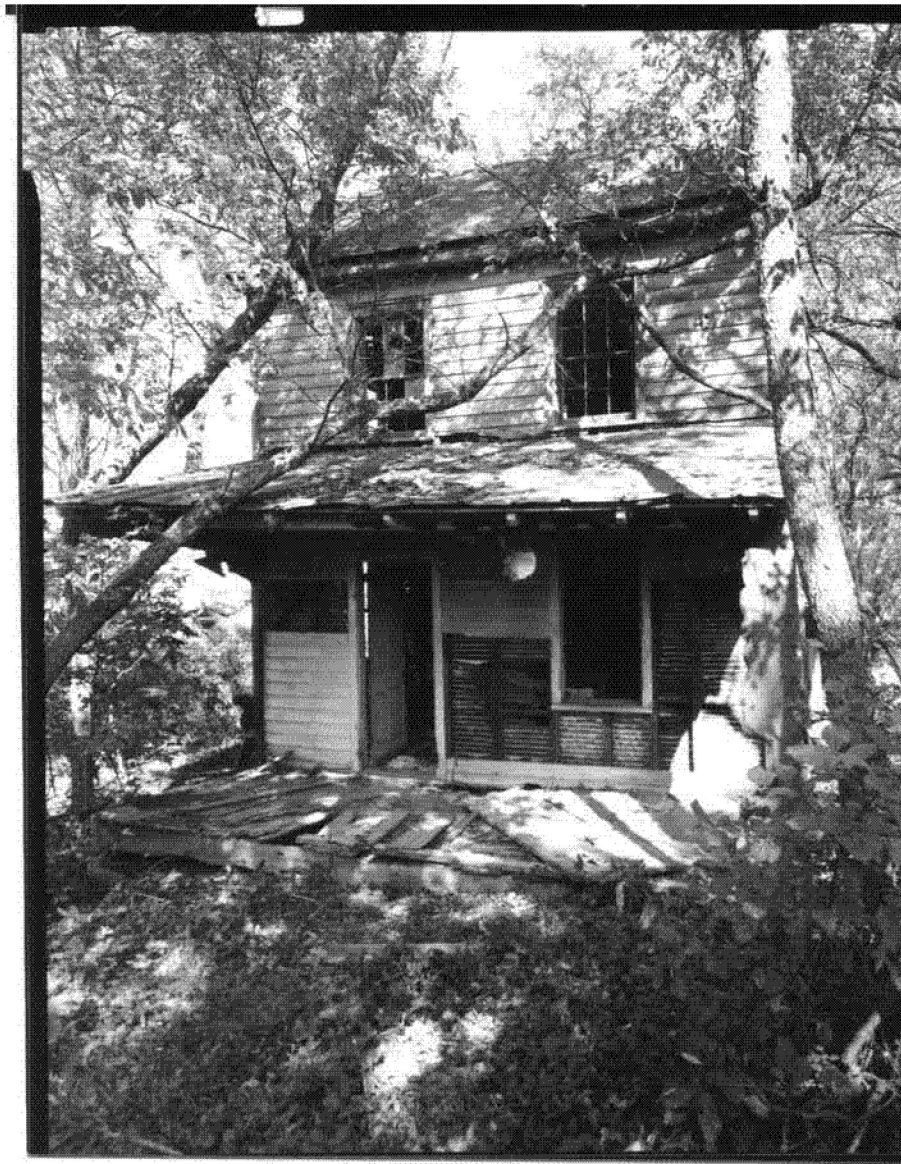
Figure 51: Hayes-Campbell Tenant House, perspective of the southwest elevation looking north.

The main (southwest) elevation is divided into two symmetrical bays. The first floor features an entrance in the northwest bay and a window in the southeast bay. The entrance is through a six-panel wood door. A one-story, open, shed-roofed porch supported by a wood plank platform and turned posts covers the entire elevation. Exposed rafter ends project from the

eaves of the porch roof. The second floor contains two six-over-six double-hung sash windows aligned with the first floor openings.

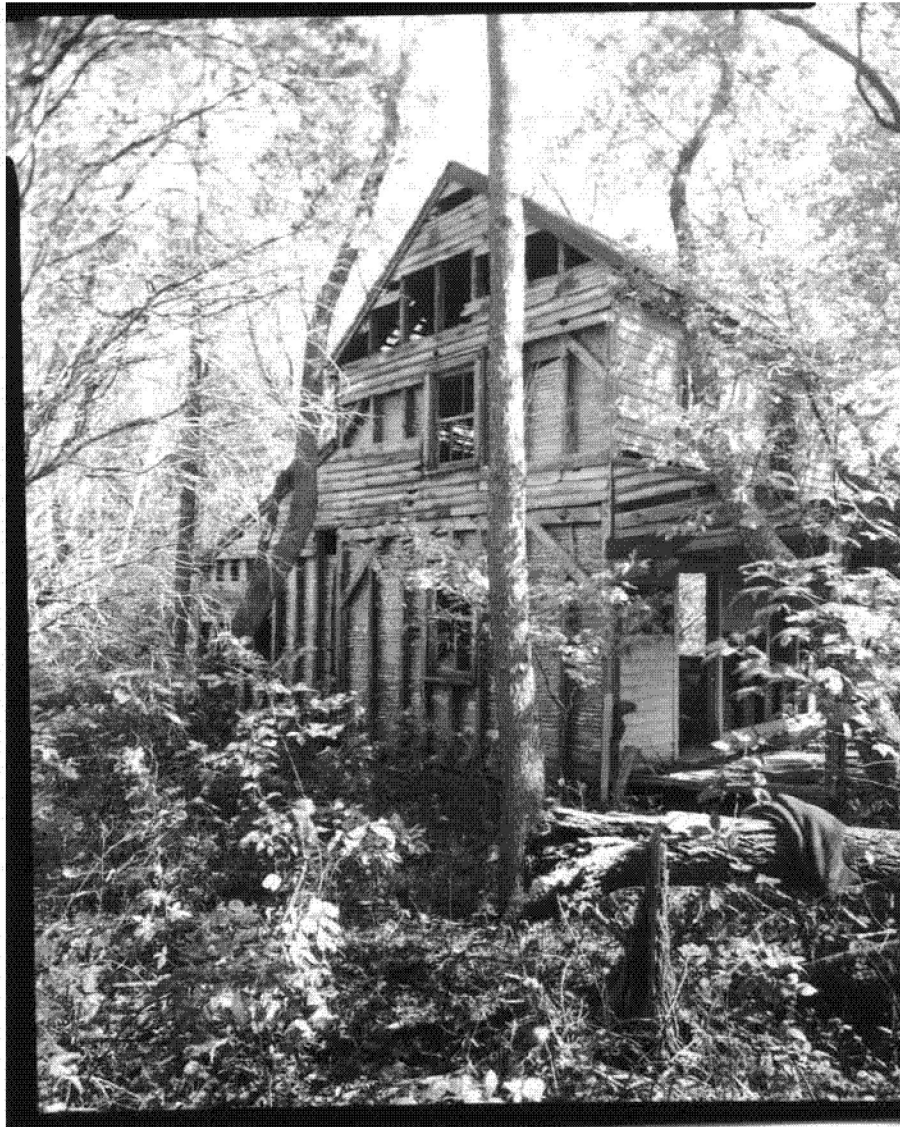
The northwest elevation of the main block has a one window centered on both the first and second floors. One window pierces the northwest elevation of the rear ell. The majority of the exterior wall cladding is missing from this elevation, exposing the framing and interior lath and plaster walls. The northeast, or rear, elevation of the main block houses the rear ell. The southeast elevation of the main block mirrors the northwest elevation but displays a shed-roofed porch across the rear ell, covering a door near the north end of the elevation.

Figure 53: Hayes-Campbell Tenant House, perspective of the northwest elevation looking east.

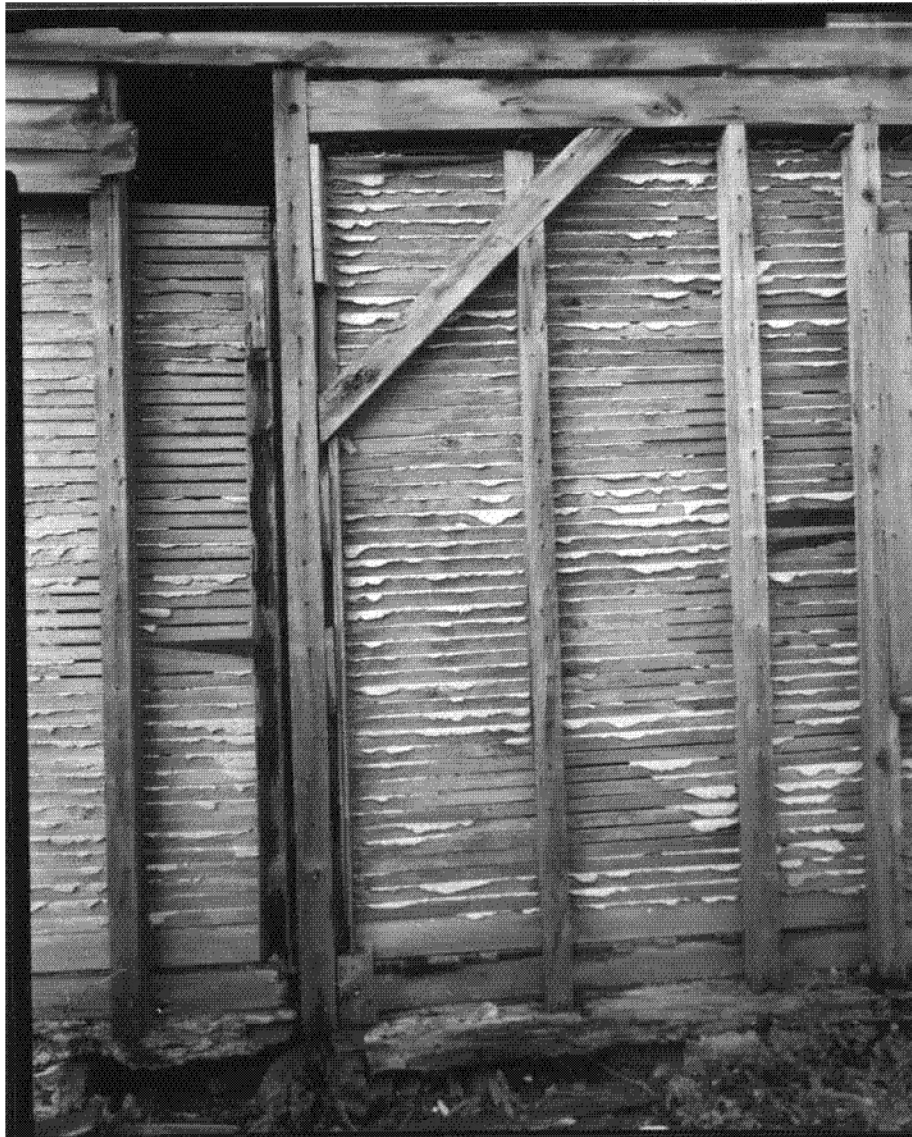
The deterioration of the exterior revealed the unusual framing system, which is an excellent example of the combination of braced-frame and balloon-frame construction. The use of combination framing indicates the tenant house was built during the period when one method was being phased out and a new method was being tested, but not yet fully relied upon. The heavy hewn sill, heavy up braces, and mortise and tenon joinery are characteristics of the braced frame. Multiple, closely spaced, vertical studs and nailed joints, however, appear in balloon frame construction. The result is a hybrid of heavy timber framing and the lighter construction technique of the balloon frame. The employment of both methods dates the building to the third quarter of the nineteenth century, as the balloon frame was introduced to the Mid-Atlantic region during that period.<sup>44</sup> Additional support for a mid-nineteenth century construction date comes from the combination of sash-sawn ceiling joists and circular-sawn lumber.

Figure 54: Hayes-Campbell Tenant House, detail of framing on the northwest elevation.

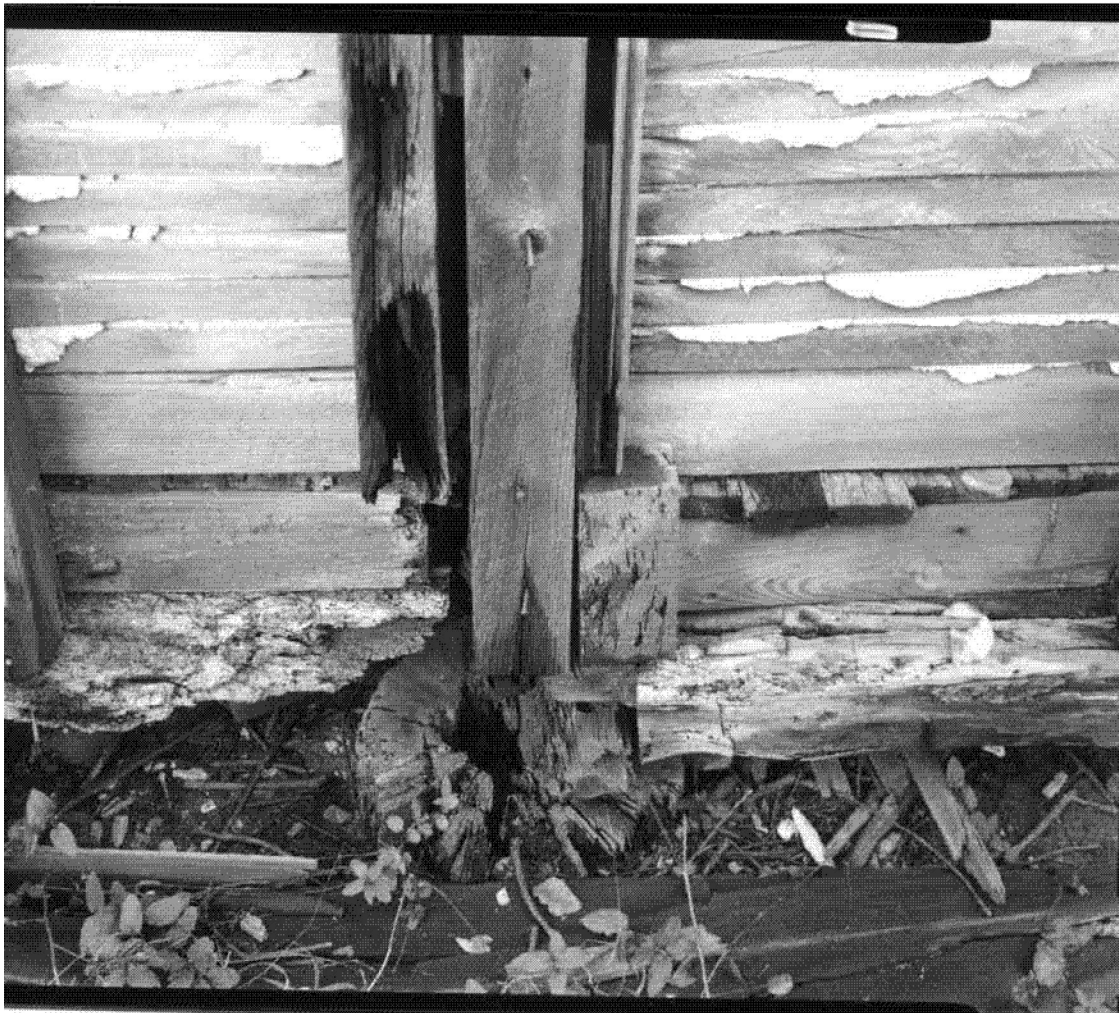
The rough-hewn sill of the dwelling, left round on some of the bottom and with pieces of bark attached in some places, sits on a combination of brick piers and log posts. The frame was covered in clapboards, most of which have fallen off, exposing the frame of the structure. The gable roof is sheathed in standing seam metal and terminates at a simple boxed cornice, while the shed roof on the rear ell is covered with copper. An interior brick chimney with a corbelled cap pierces the northeast slope of the gable roof. Fenestration consists of two-over-two and six-over-six double-hung sash set in rectangular openings with simple wood surrounds.

Figure 55: Hayes-Campbell Tenant House, detail showing sill supported by log post.

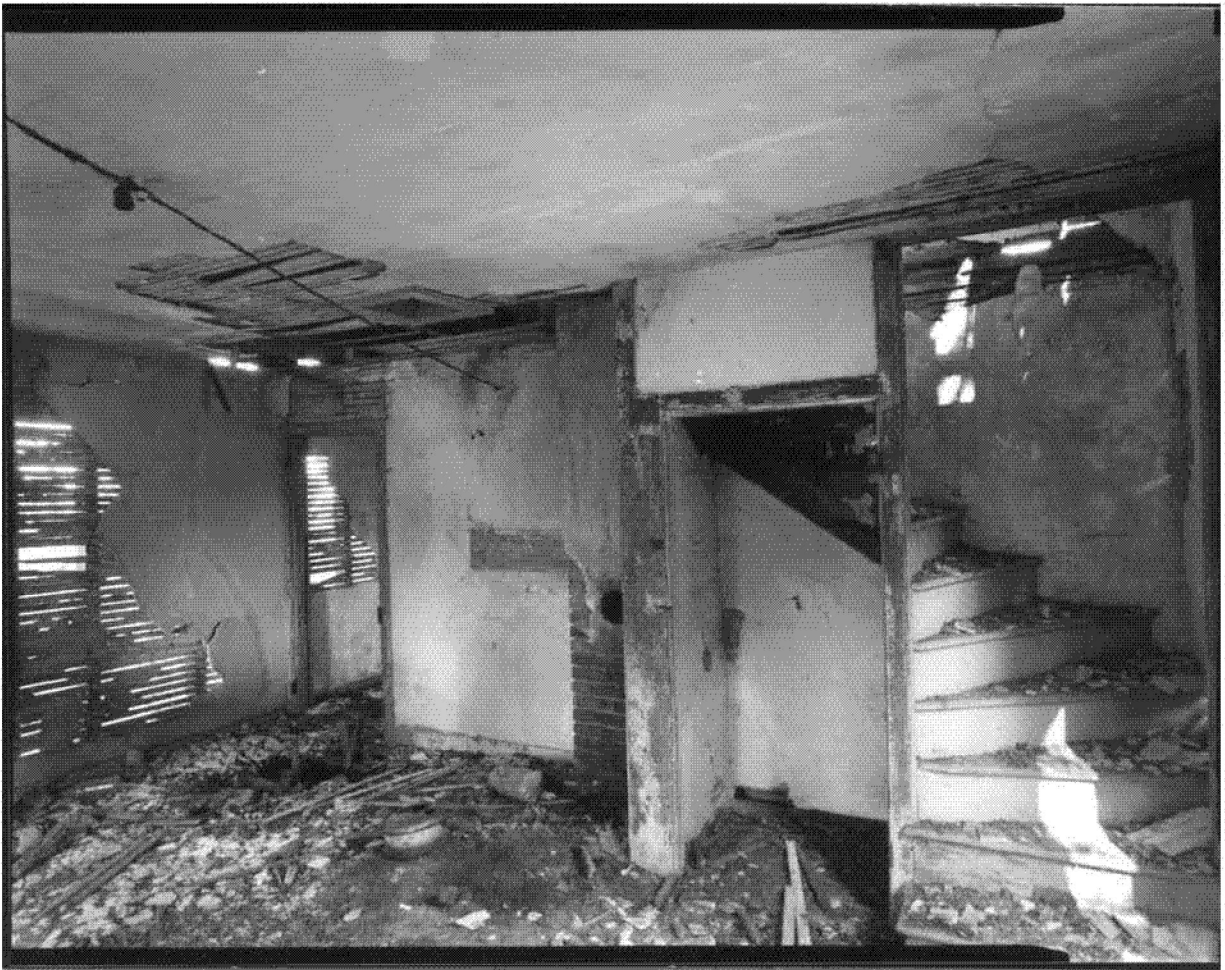
The entrance on the southeast elevation opens into the larger of the two first-floor rooms. The room measures approximately 14 by 16 feet, with a winder stair located in the east corner of the northeast wall. A closet (measuring approximately 3 by 6 feet) is located underneath the stair box. The chimneystack features an exposed stovepipe hole and is located against the closet on the northeast wall. The walls throughout the dwelling are lath and plaster and the floors are hardwood. Windows on each of the three exterior walls light the room.

Figure 56: Hayes-Campbell Tenant House, interior, first floor, view of the northeast and northwest walls in the front block, looking north.

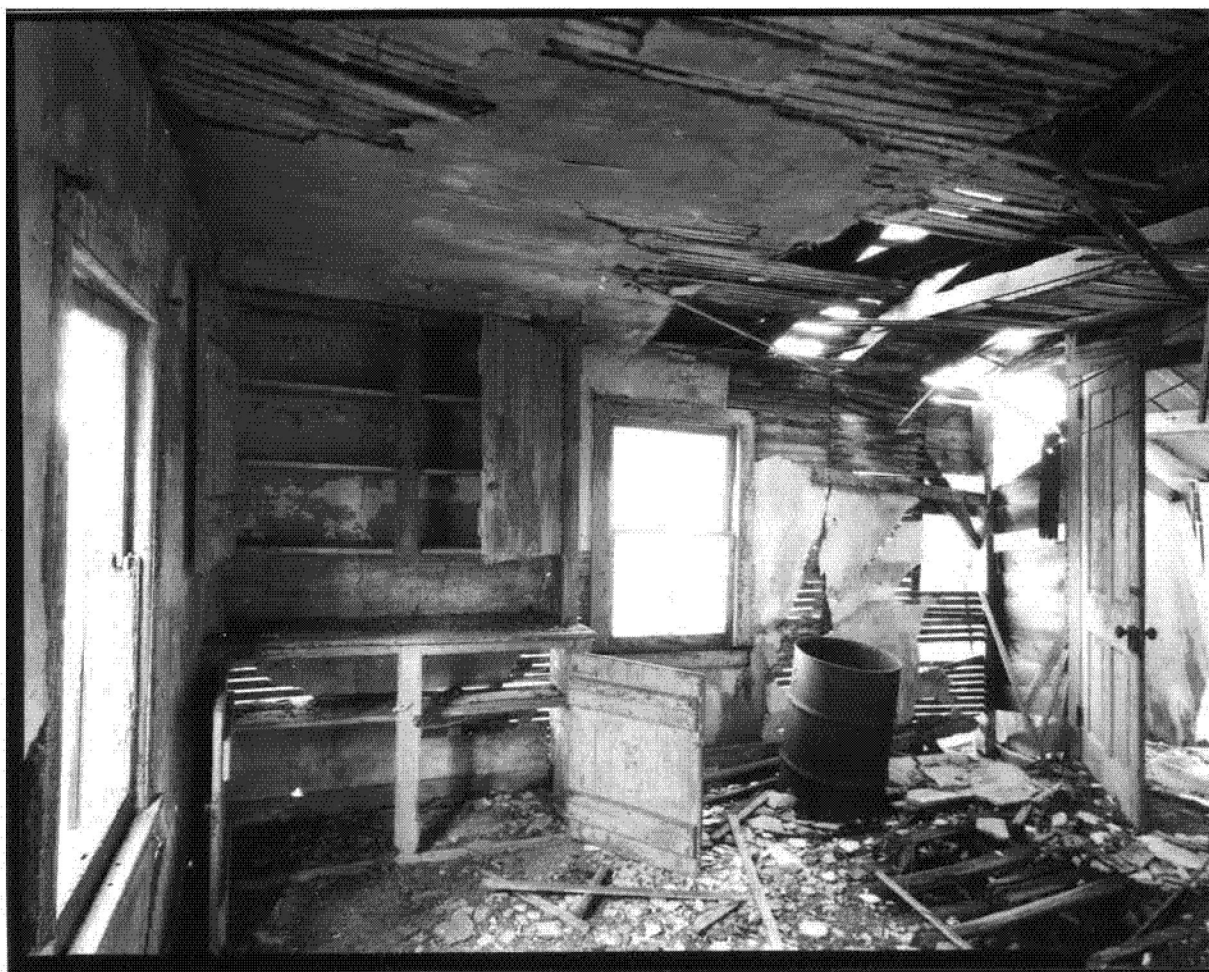
An opening at the west end of the northeast wall leads to the second room (measuring approximately 12 by 13 feet), housed within the rear ell. This room is in very poor condition, with deteriorated walls and floorboards. A built-in cabinet is located at the west end of the northeast wall. The two-piece cabinet features vertical wood doors and shelving. Two windows light the room, one on the northwest wall and one on the northeast. A stovepipe hole is located on the southwest wall. A single, wood panel door at the north end of the southeast wall opens into the enclosed porch.

Figure 57: Hayes-Campbell Tenant House, interior, first floor, view of the northeast wall in the rear ell, looking east.

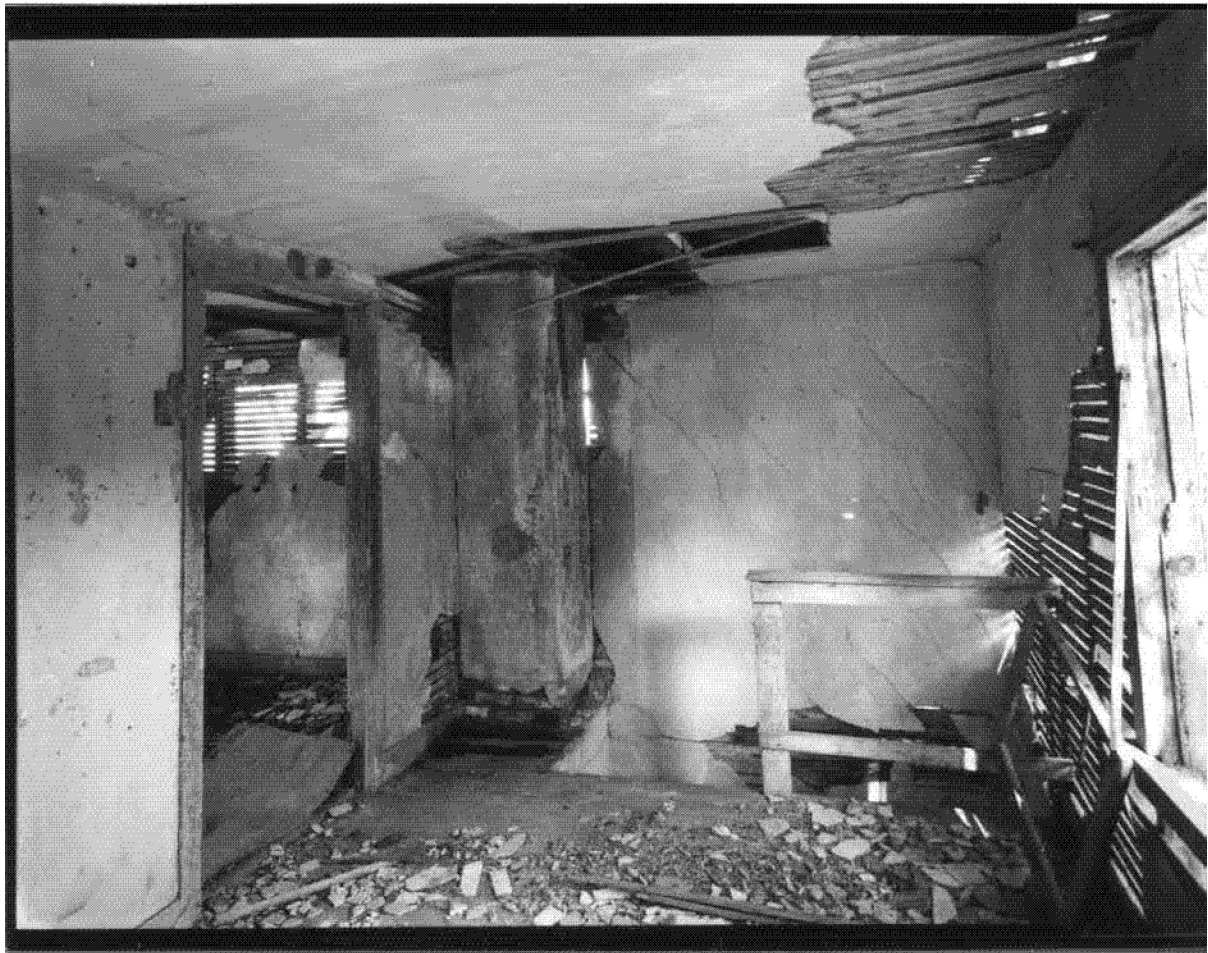
Due to its extremely deteriorated and unstable condition, field notes were not taken for the second floor. Visual inspection revealed that the winder stair opened into one of two rooms above the large first-floor room. Both rooms were finished with lath and plaster. Access to the attic was through a trap door.

Figure 58: Hayes-Campbell Tenant House, interior, second floor, view of the northeast and southeast walls looking east.
