OPEN FILE REPORT No. 14

SINKHOLES, HOCKESSIN AREA, DELAWARE

BY
JOHN H. TALLEY

MARCH 1981

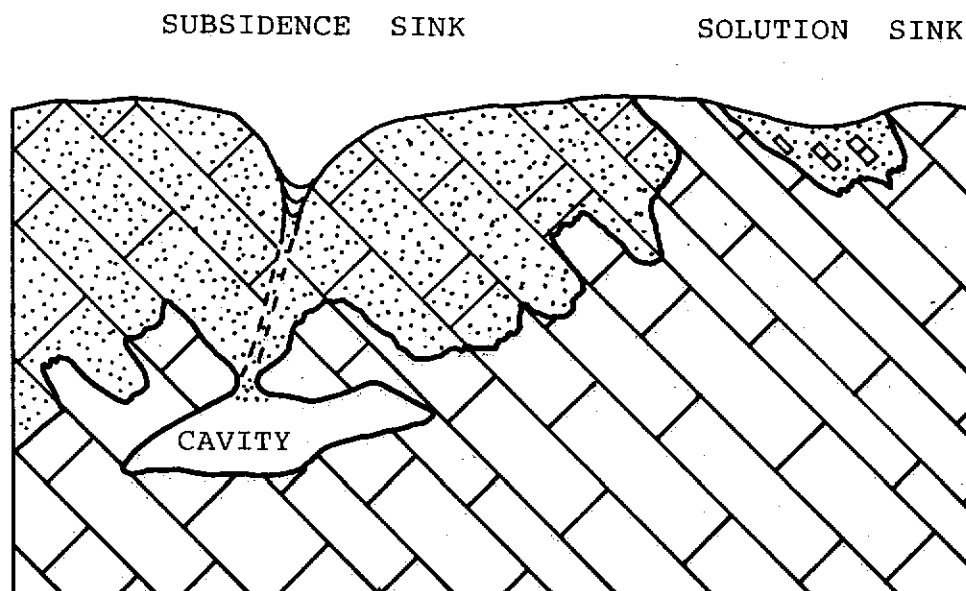
Subsidence sinks usually occur in areas underlain by thick sections of soil and/or weathered rock. Growth of subsidence sinks may be a slow process with the material continually migrating into voids. Rapid episodic growth of subsidence sinks can produce rather large features with nearly vertical sides that resemble collapse sinks (Figure 3).

Figure 3. Hypothetical cross-section showing a subsidence sink and a solution sink (Dotted area represents weathered marble).

Generally, the development of solution sinks (Figure 3) is a very slow process. Initially solution sinks may appear as very shallow, circular, topographic depressions with interior drainage, and thus are very difficult to recognize. Circular vegetative patterns may be associated with solution sinks indicating variations in moisture content within and outside the depression. Water may be ponded on the surface of the sink if the soils within the depression are relatively impermeable. If, on the other hand, the depressions are

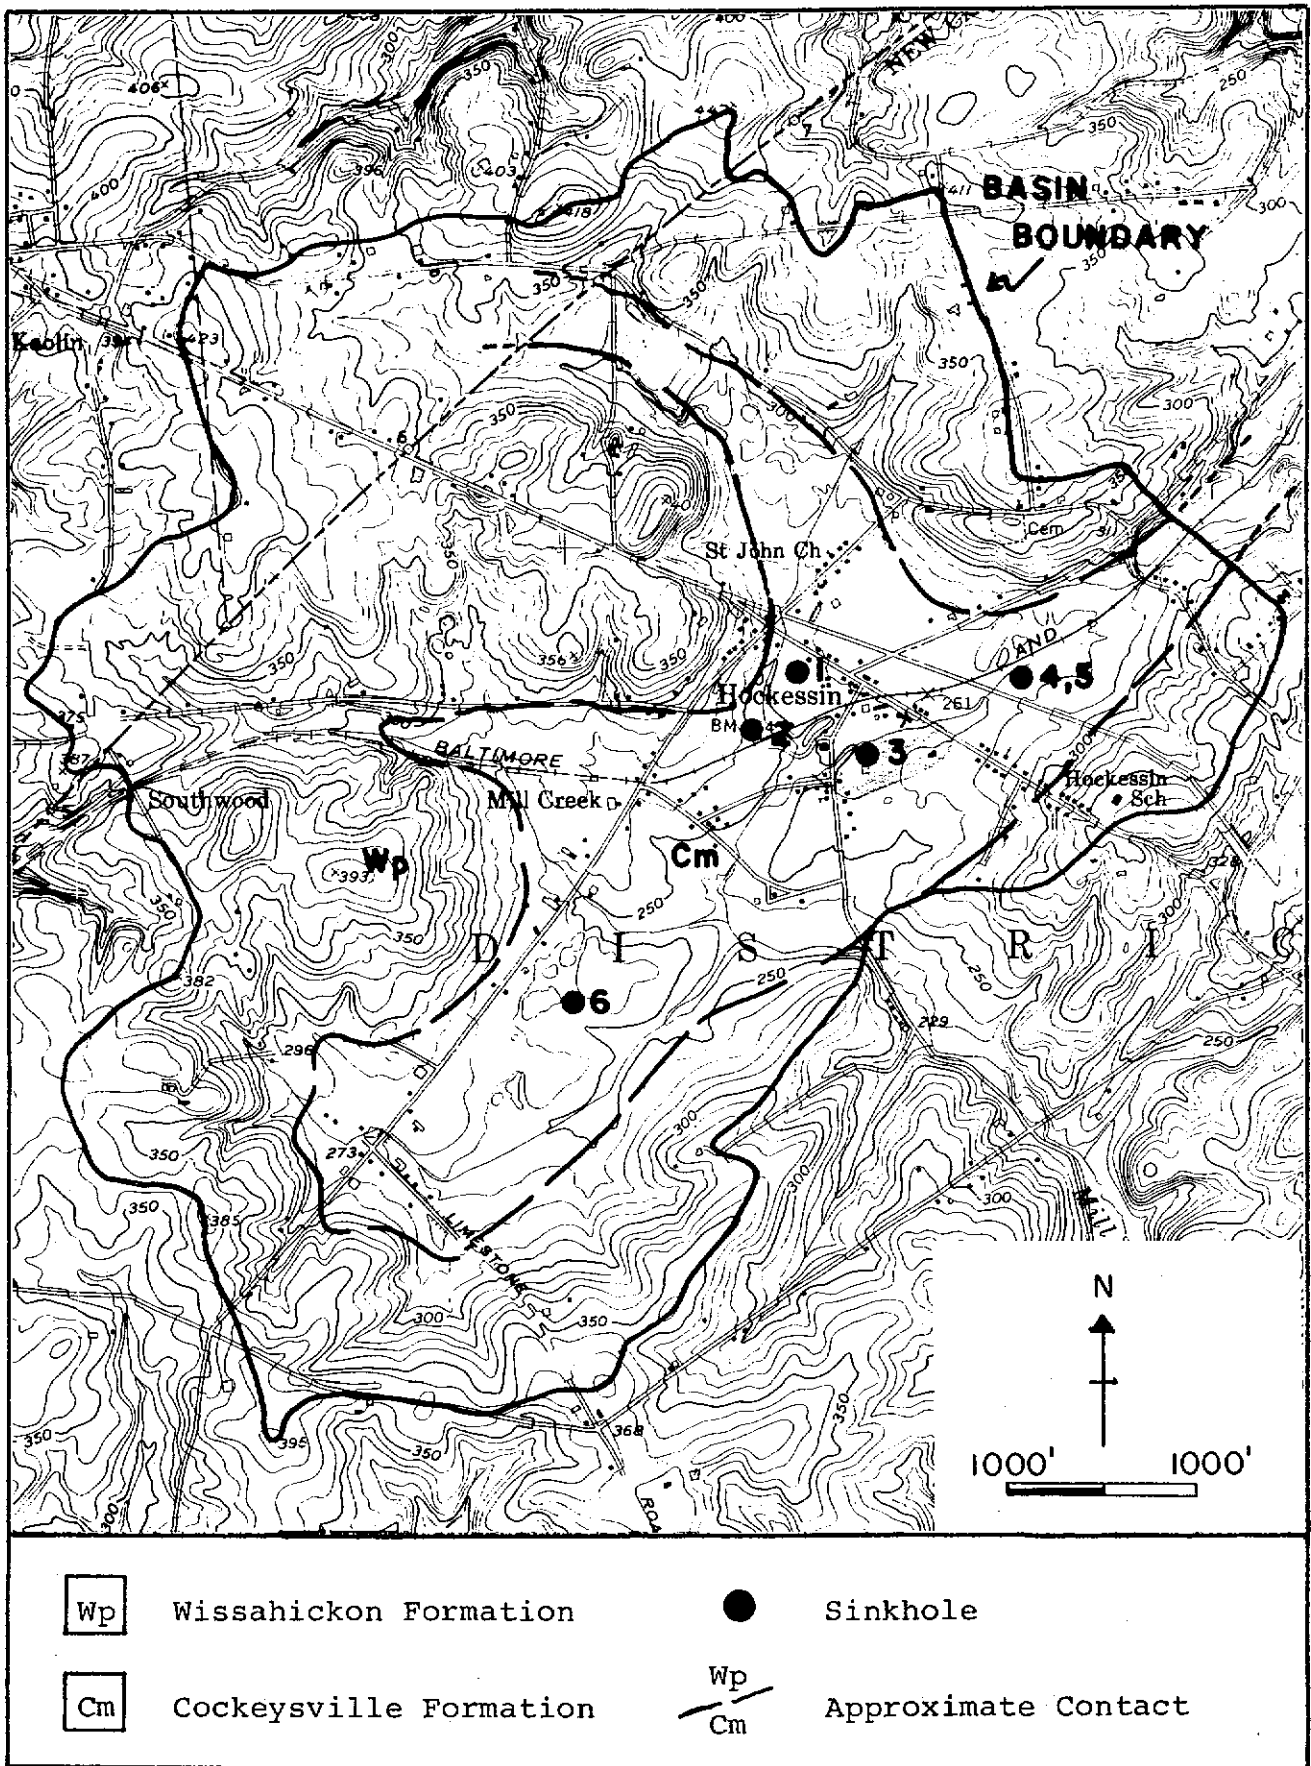
Figure 4. Geologic map of the Upper Mill Creek Drainage Basin (after Woodruff and Thompson, 1972).

The only exposures of marble in the valley occur in sink-holes 2 and 3 (Figure 4). Otherwise, the Cockeysville Formation is present only in the subsurface. It consists of fine- to coarse-grained white calcitic and dolomitic marble with interbeds of calcareous schist. The predominant soil type, Glenville silt-loam, is moderately to poorly drained and typically contains a layer of fragipan that usually retards the infiltration of surface water. Fragipan is "a loamy, brittle, subsurface horizon that is very low in organic matter and clay, but is rich in silt or very fine sand" (U. S. Soil Conservation Service, 1970, p. 95). During dry periods the firm and brittle fragipan soil may dry and crack thereby forming paths for rapid infiltration of surface water. Fluvial silts, sands, and gravels deposited along the present streams were derived from areas of higher elevation occupied by the Wissahickon Formation.

The locations of six sinkholes identified in Hockessin Valley are shown on Figure 4.
