**RIVERBANK EROSION RATES  
IN THE WHITE CLAY CREEK WATERSHED, PA**

A thesis submitted to the Faculty of the University of Delaware in partial fulfillment of the requirements for the degree of Master of Science in Geology

Spring 2018

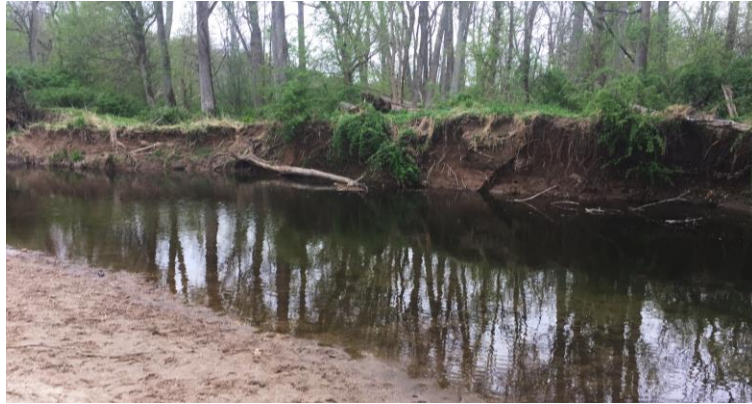
Figure 3.2. An image depicting the eroding bank at site 2, the stream with the highest drainage area.

At each study reach, one eroding bank was identified and chosen, except at sites 10 and 11 where three eroding banks were chosen at each. Some eroding banks were first identified by rapid changes in channel planform observed from comparing historical aerial images and others were identified directly in the field. To be identified as an eroding bank, the banks had to be close to vertical and no vegetation growth (besides the occasional cluster of moss) could be growing on the exposed bank face. Examples of eroding banks identified in this study can be seen in Figures 3.2, 3.3, and 3.4.

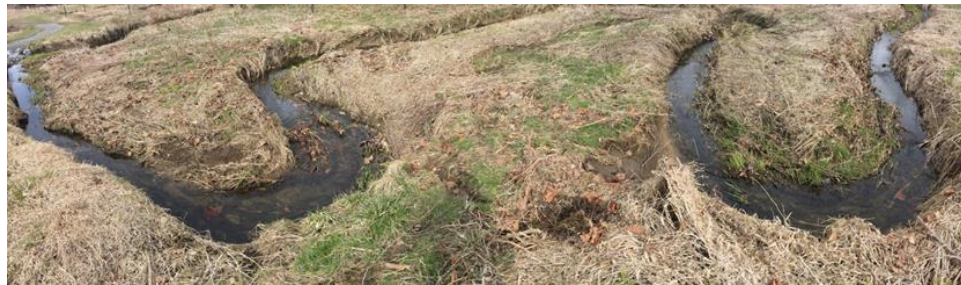
Figure 3.3. An image depicting some eroding banks at site 16, the lowest order stream.

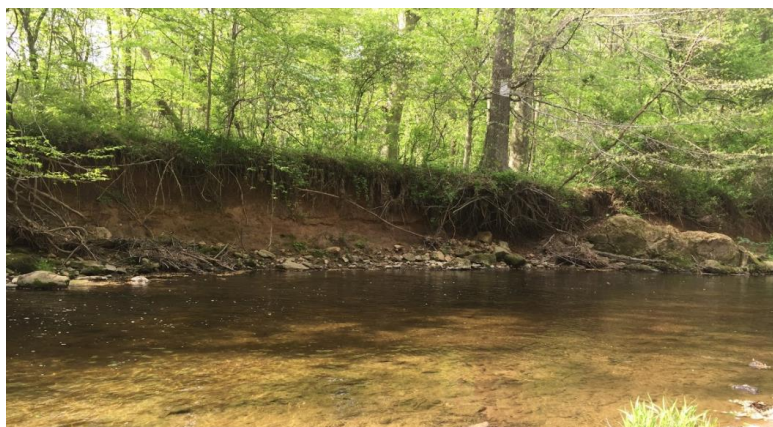
Figure 3.4. An image depicting the eroding bank at site 12, a third order stream.

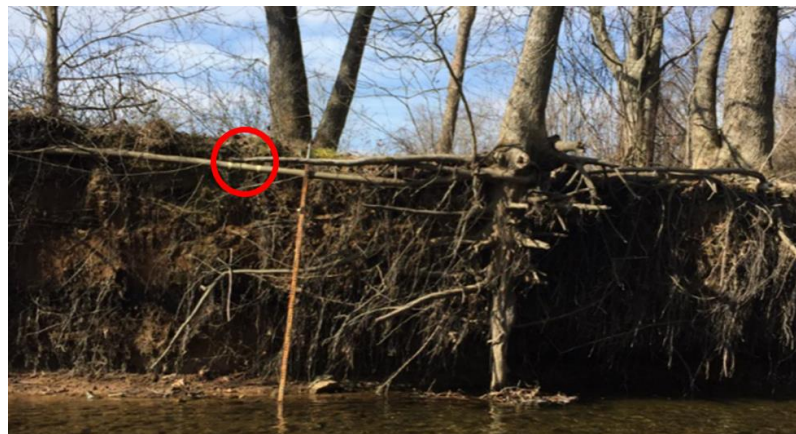
Figure 3.5. An image depicting exposed tree roots along an eroding bank at site 1. The sampled root is marked.

Using these criteria, four to eight root samples were collected at each eroding bank as seen in Figures 3.5 and 3.6. The species of each sampled tree was determined, and a tree corer was used to find the age at breast height. The tree's age was determined once the core was secured to a mount and sanded.

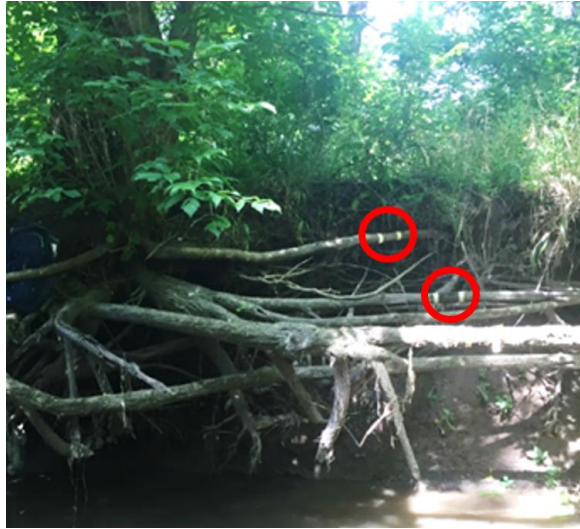
Figure 3.6. An image depicting exposed tree roots along an eroding bank at site 9. The two root slices taken are marked.

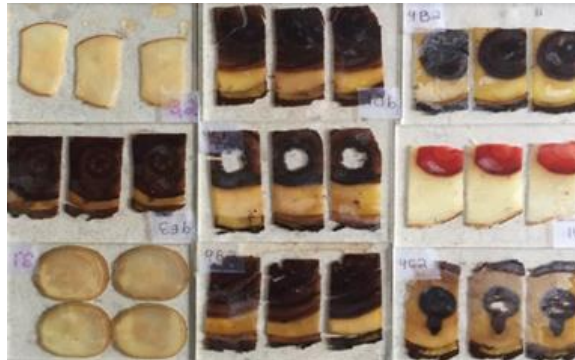
Figure 3.8. An image of root samples after being sliced with a microtome and prepared on microscope slides.

The sampled root is taken back to the lab where it is cut to fit a microtome, being sure to include in the piece the center of the root as well as the bark on at least one side. The microtome is used to slice the root sample into thin layers, and water is used to keep the root slice on a microscope slide as seen in Figure 3.8.

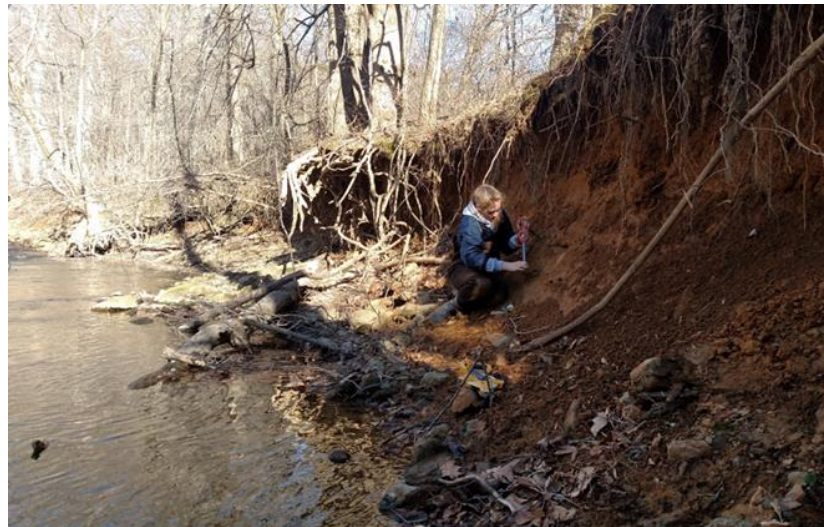
Figure 3.10. An image showing the use of a dial indicating torque wrench for measuring bank strength on the eroding bank at site 12.

The bank strength was measured at each bank using a dial indicating torque wrench. After clearing a sample location, a 60 x 120 mm vane was pounded into the bank the same amount at each location. At each bank ten to twelve measurements were taken as seen in Figure 3.10, spread vertically up the bank and horizontally

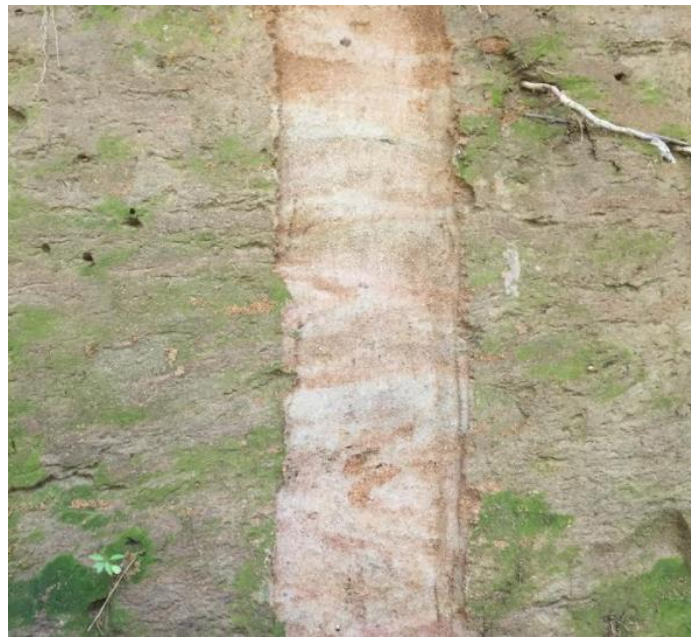
Figure 4.4. An image depicting the thick layer of stratified and folded colored sands and muds in the eroding bank at site 12.

there is about 80 cm of gravel, consisting of mostly matrix-supported pebbles, cobbles, and boulders. The bank at site 6 has two layers. The bottom layer consists of about 98 cm of boulders in a matrix of mud and sand. It appears clast-supported with clasts ranging in size from 25 cm to 130 cm. The top layer is about 70% muddy fine to medium grained sand and 30% boulders ranging from about 25 cm to 90 cm. Roots appear throughout this top section. The eroding bank at site 12 varied from mostly layered mud and sand near the downstream portion of the bank to areas of mostly large boulders and bedrock near the upstream portions of the bank. The upstream portion includes a thick layer of stratified and folded colored sands and muds (Figure 4.4).

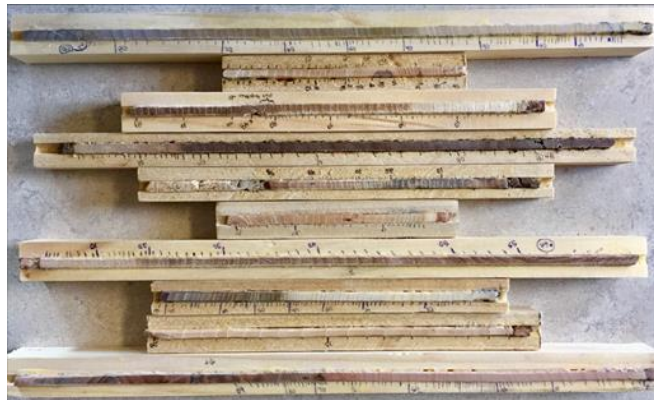
Figure 4.12. An image depicting tree cores used to find the age at breast height of each sampled tree.

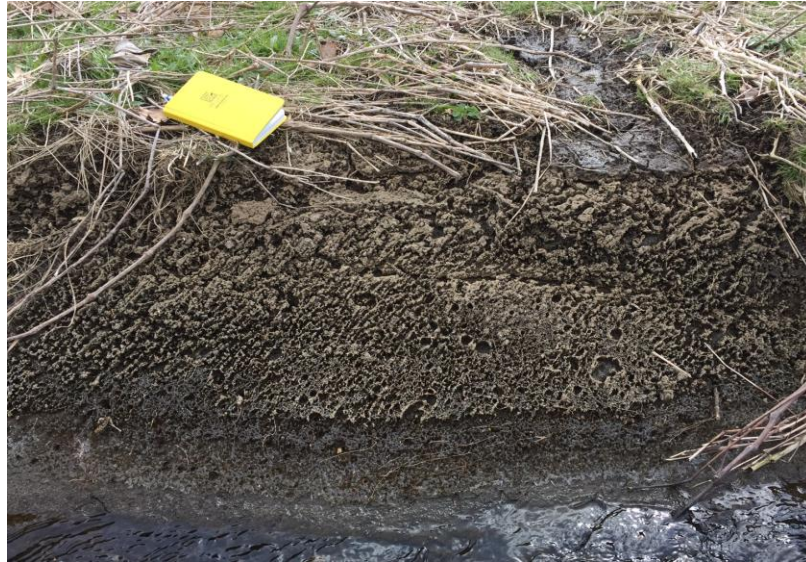
Figure 5.12. An image depicting freeze-thaw structures on an eroding bank at site 16.

The influence of freeze-thaw processes on erosion rates was not included in this study. Others have initiated studies to document these processes. It appears that freeze-thaw cycles may have a large impact on certain banks as needle-ice and other ice structures have been observed on many of the banks in this study (Figures 5.11, 5.12, and 5.13). This is not surprising as winter temperatures in this area often reach above and below the freezing point daily.

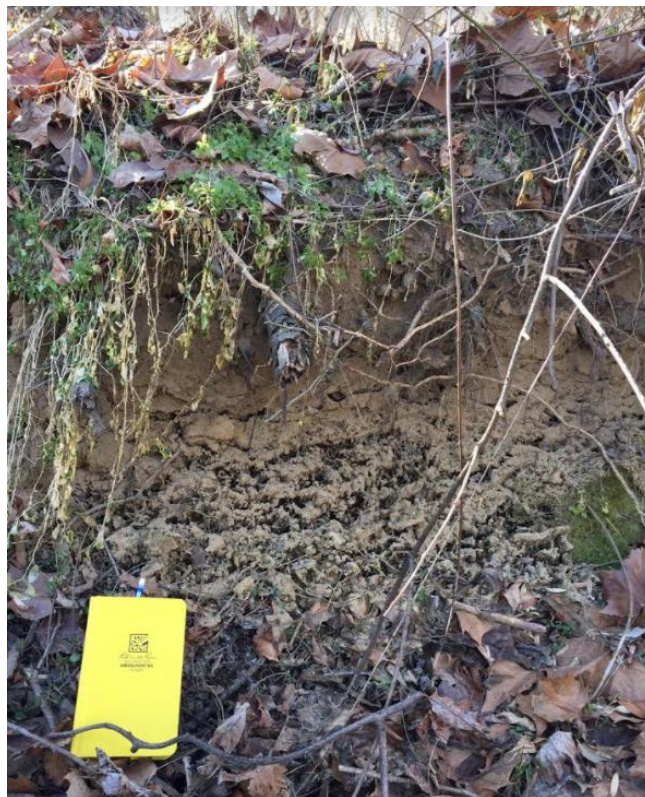
Figure 5.13. An image depicting freeze-thaw structures on the bank at site 11.
