**THREATENED RESOURCES DOCUMENTED
IN MARYLAND, 1995-96**

Center for Historic Architecture and Engineering
College of Urban Affairs and Public Policy
University of Delaware
Newark, Delaware

1996

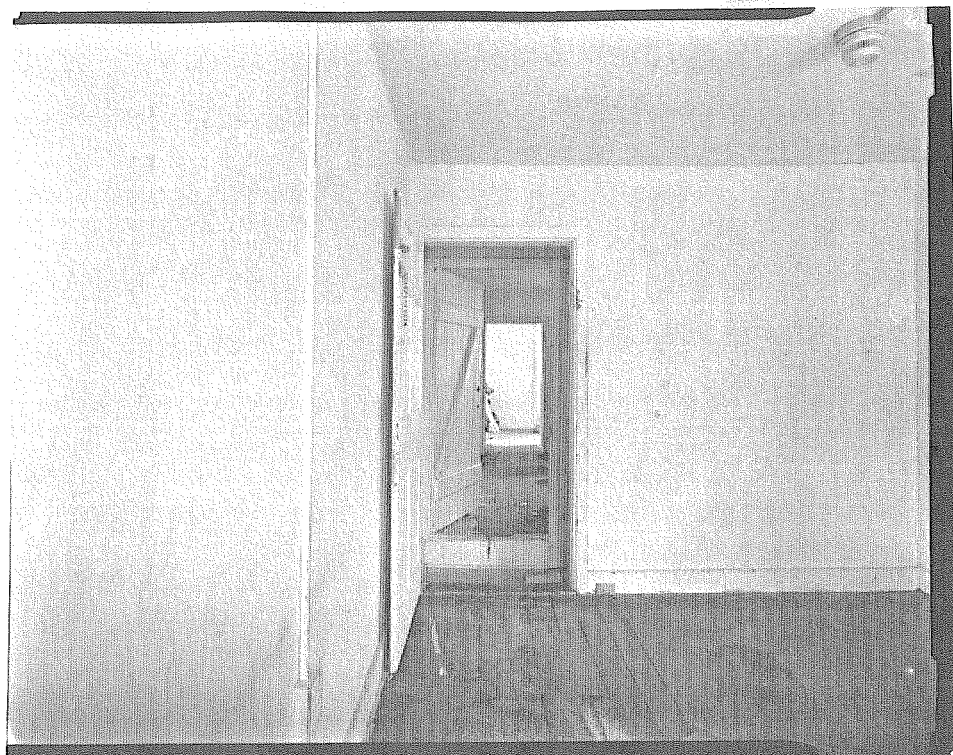
Figure 12: 111-113 Ice Street, second floor: view from the northeast room through the stair-passage to the kitchen wing, looking west.

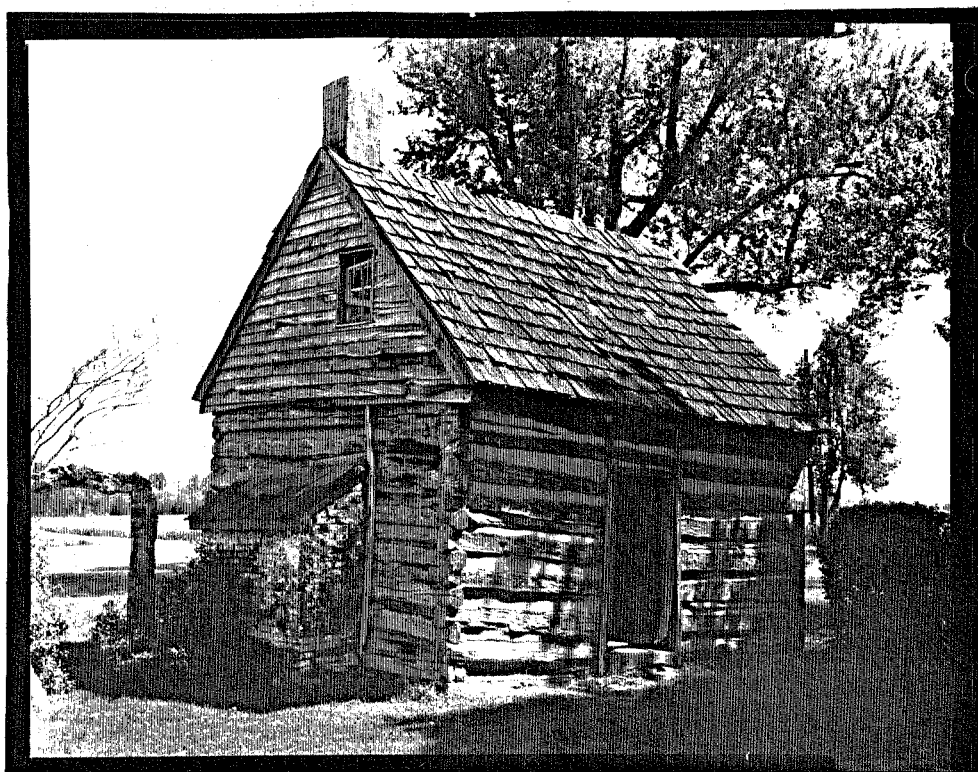
Figure 19: Webb House, perspective of the south and west elevations looking northeast.

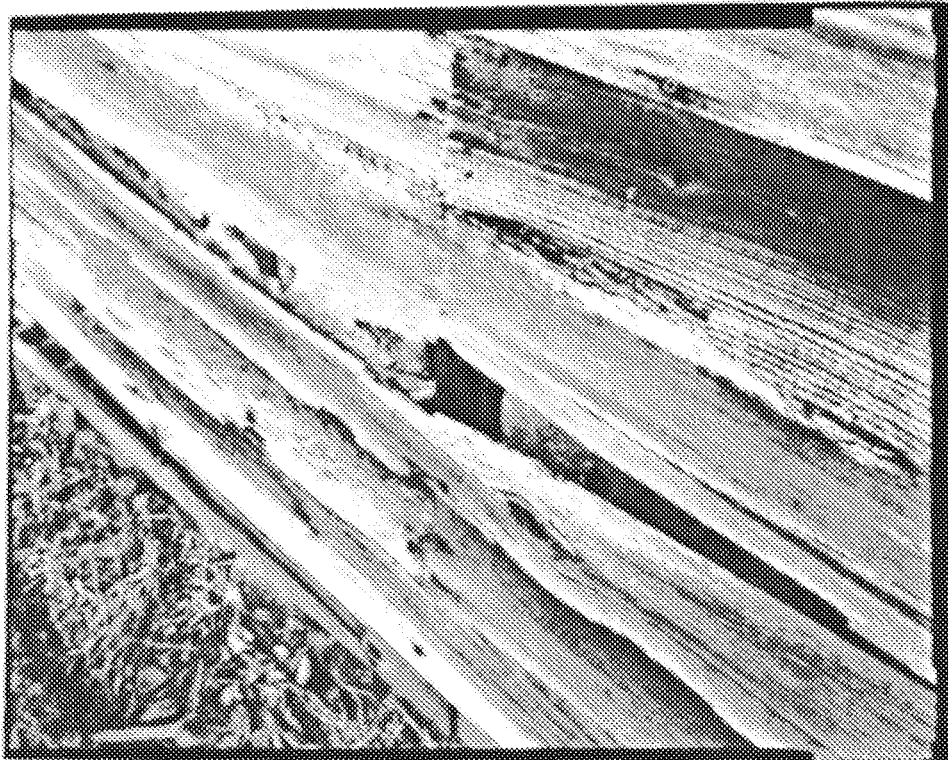
Figure 64: Grasslands Quarter, detail of siding on southwest elevation, looking east.

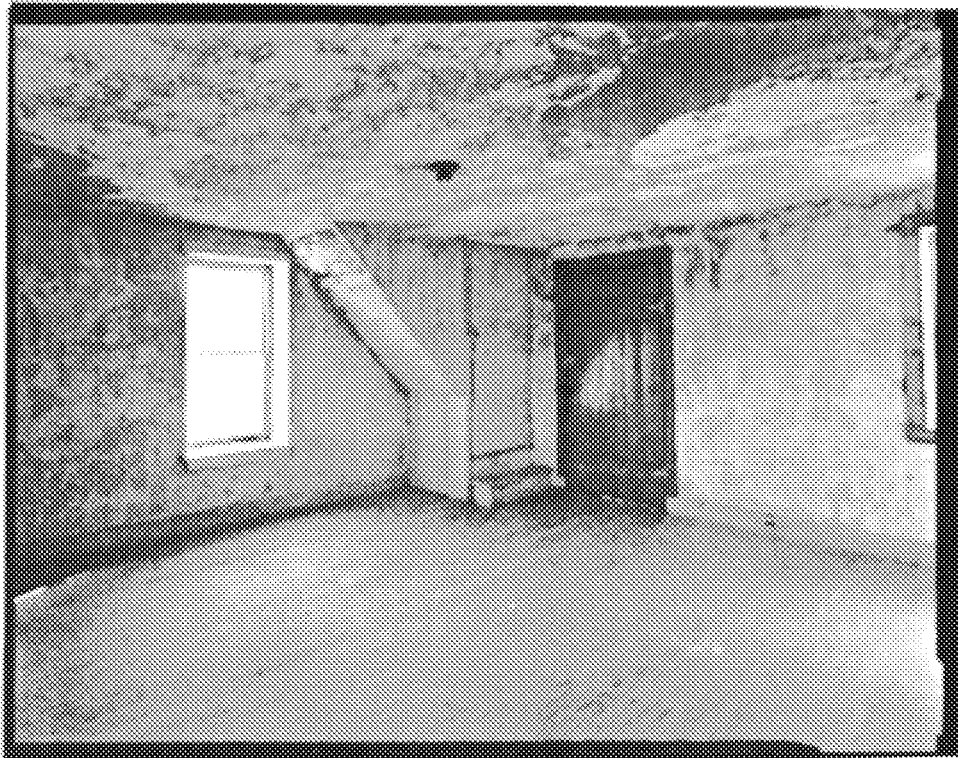
Figure 82: Hampton Quarter 3, first floor: perspective of stair in west corner of southwest room looking west.

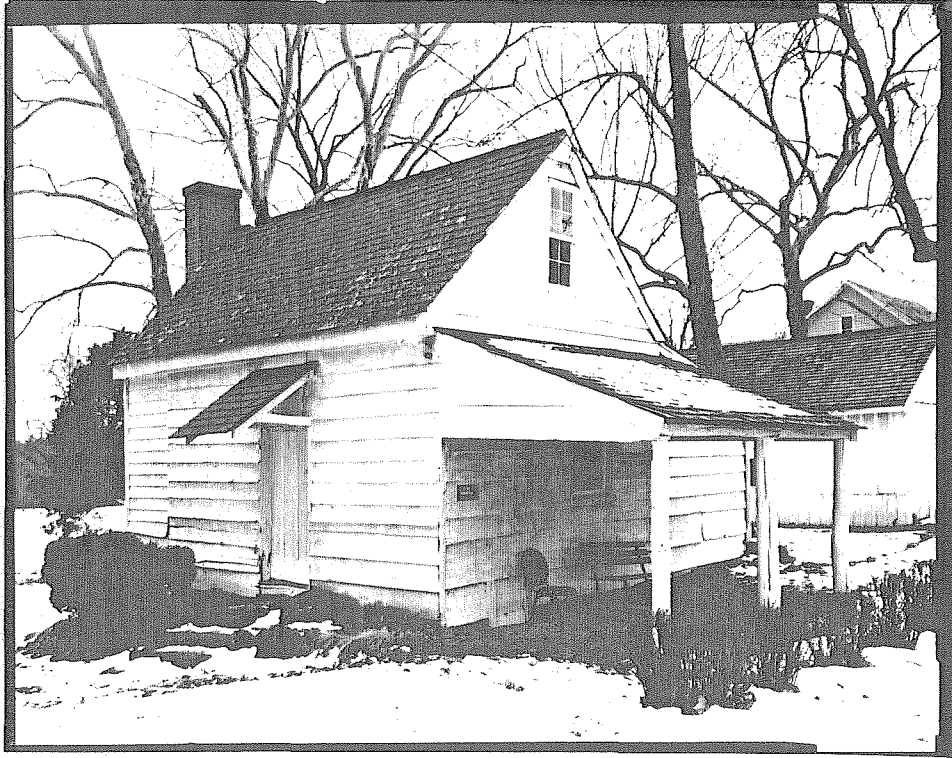
Figure 98: Bunker Hill Quarter, perspective of northwest and northeast elevations, looking south.

The slave quarter is a one-story frame structure, measuring 20' by 20', covered with

beaded weatherboard siding. The roofline is oriented northwest to southeast, consistent with the other outbuildings along the street; however, the entrance into the quarter is on the northeast elevation. The gable roof is covered with wooden shingles. An extension to the southeast gable end is noted by the seam in the exterior siding and on the interior walls and ceiling as well. An exterior chimney is located at this gable end. The base is uncoursed stone and the stack is brick. A shed addition covers the southwest elevation. This addition and the southeast gable end extension are covered with random-width weatherboard siding. A shed-roofed porch, supported by three posts, extends from the northwest gable end of the quarter.

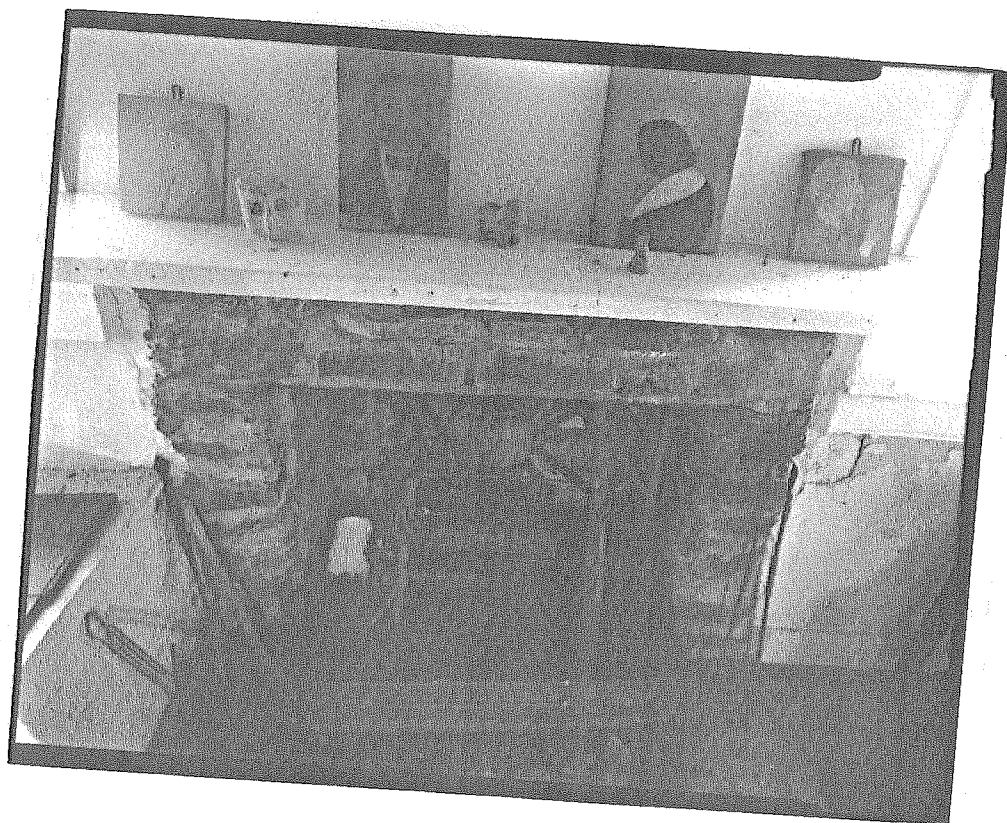
Figure 105: Bunker Hill Quarter, first floor: detail of fireplace on southeast wall, looking southeast.

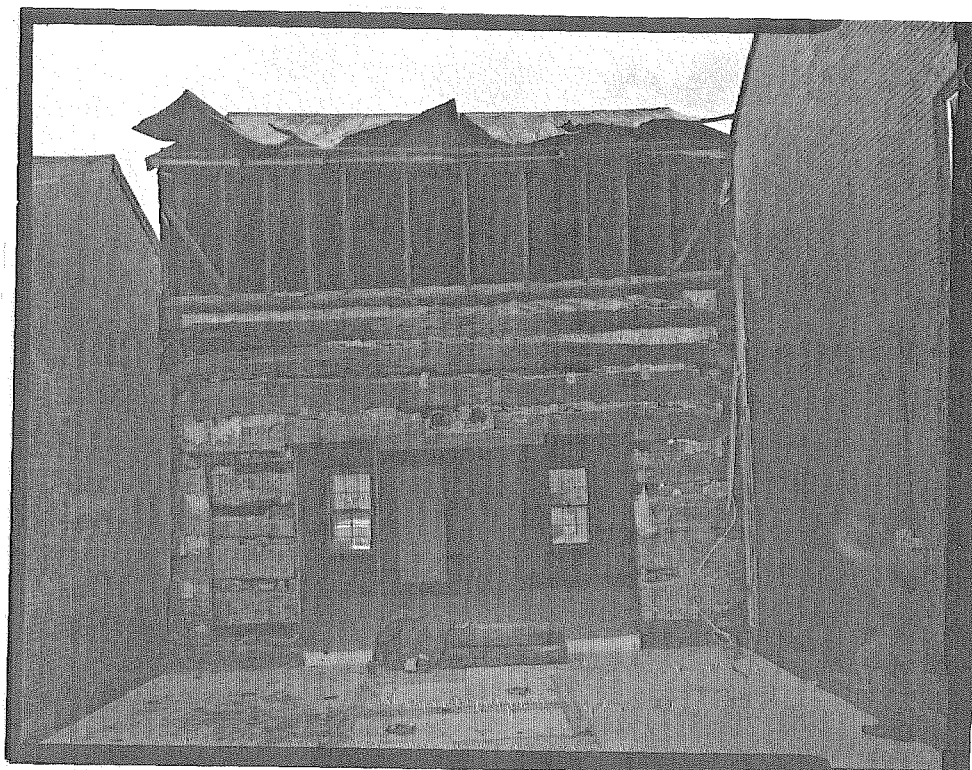
Figure 110: Ice Street, view of east elevation of log tenant house, looking west.

The east elevation has been heavily remodeled, but shows evidence of a door opening in the southeast corner. On the interior walls there is evidence of a window in the southwest corner of the south wall, and of a fireplace on the north wall. The fact that there are only traces of one fireplace suggests that the original structure was a one-room plan of 13' by 20', and was later altered into a duplex by the addition of a partition wall. Evidence was found of a winder stair in the northwest corner next to the fire place.
