Site Name: Cherbourg Round Barn

CRS Number: K-862

Type of Documentation: Level II: Partial Intensive
Annotated field notes (1 sheet)
Measured drawings--CAD (1 sheet)
Black and white 4" x 5" photographs (8)
Architectural data narrative

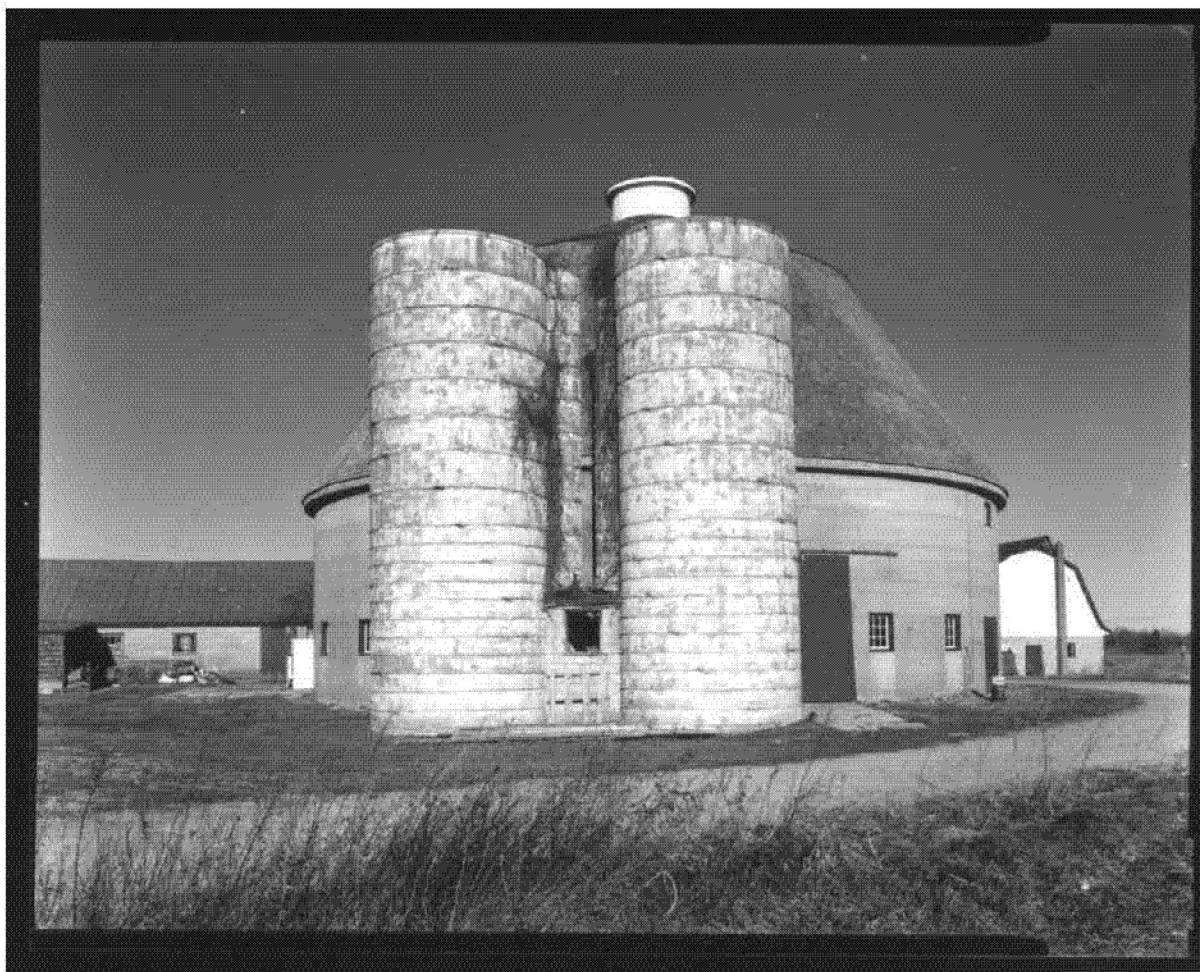
| K-862-2 | View of the south side looking northeast |

Figure 61: Cherbourg Round Barn, view of the south side looking northeast.

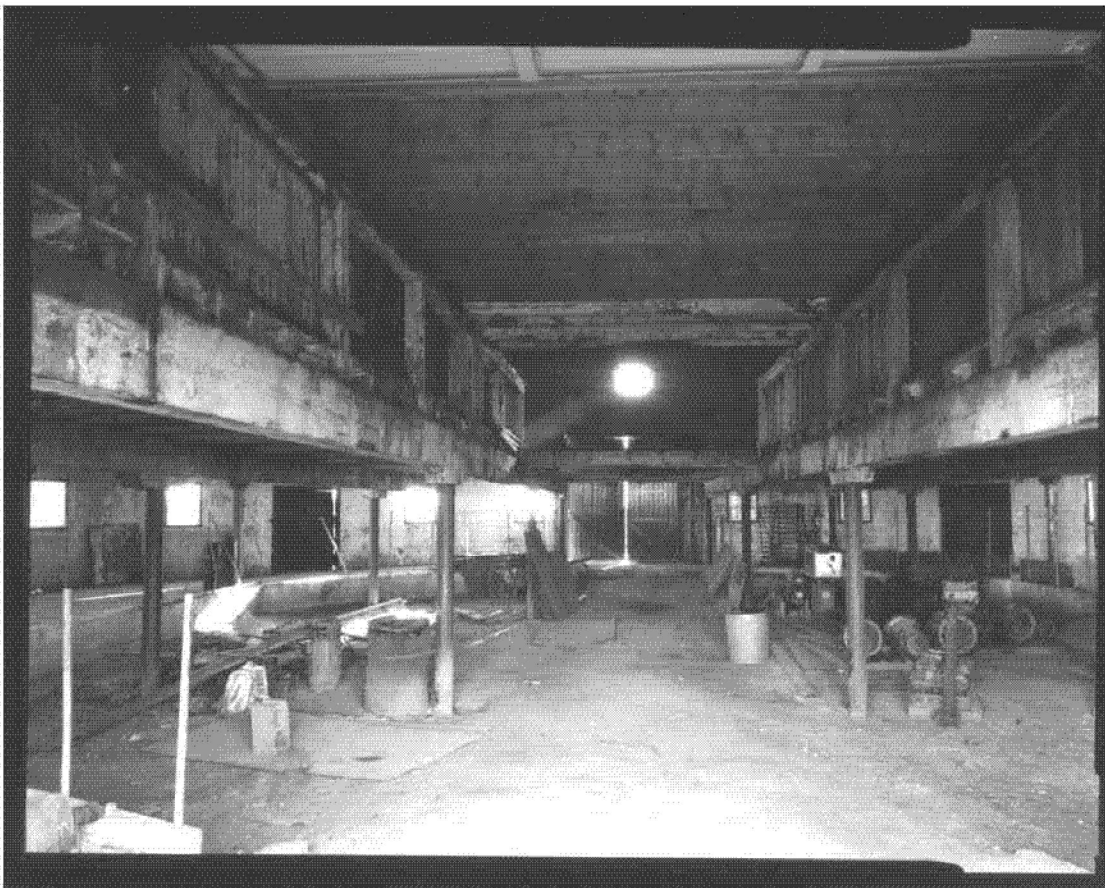
| K-862-7 | Interior, first floor: view of milking area looking southwest |

Figure 66: Cherbourg Round Barn, interior, view of first-floor milking area looking southwest.

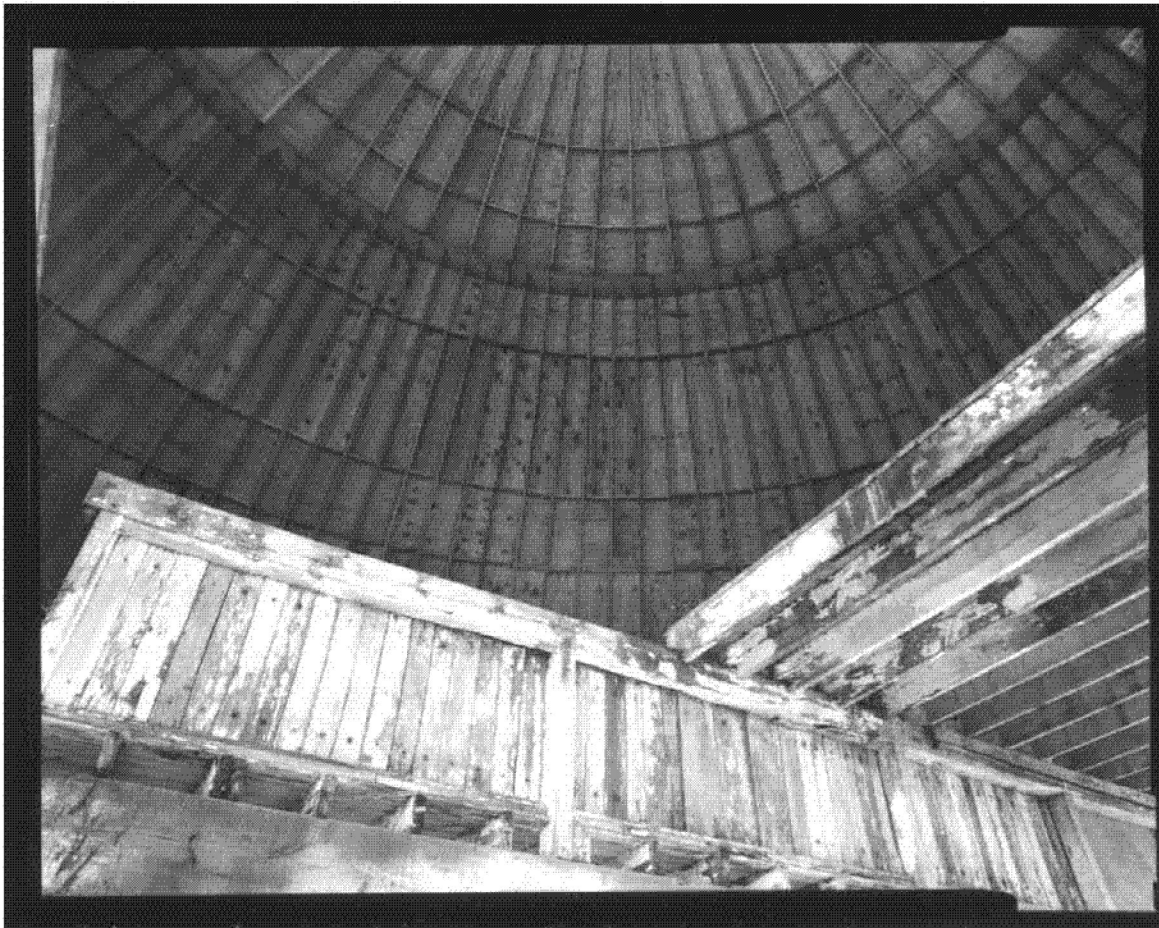
| K-862-8 | Interior, view of roof framing looking south |

Figure 67: Cherbourg Round Barn, interior view of roof framing looking south.

In August 1999, a storm blew in the roof and forced it to capsize on the hayloft floor, which was also badly damaged. Rather than demolishing the barn, the Cartanzas undertook the massive reconstruction of the roof. Completed in October 2000, the new roof is not an exact replica of the original, as it was required to meet current building codes, but it is based on period drawings for round barns. Its exterior appearance mirrors the original, in its shape, its cedar shake shingles, and the cupola at the top.⁶²
